NASA/CR-2002-211774

Design and Test of an Improved Crashworthiness Small Composite Airframe

James E. Terry
Terry Engineering, Andover, Kansas

August 2002

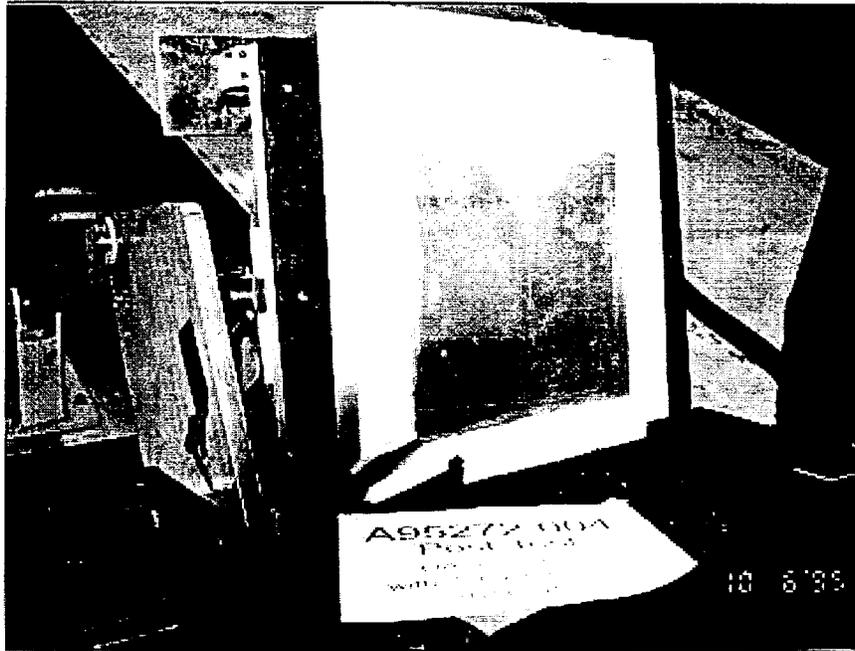
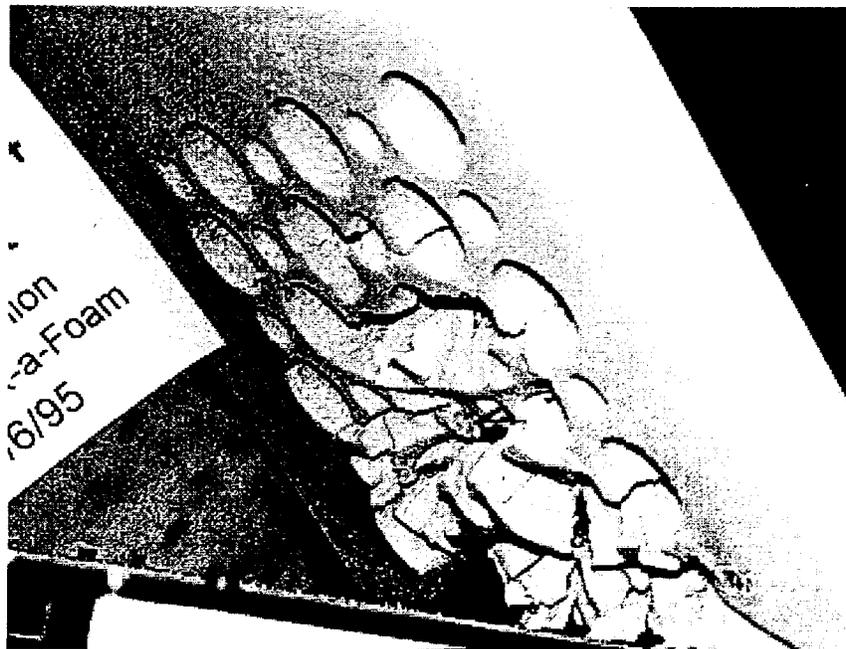
(c), Post Test Showing Aluminum Plate

(d), Post Test Energy Absorber

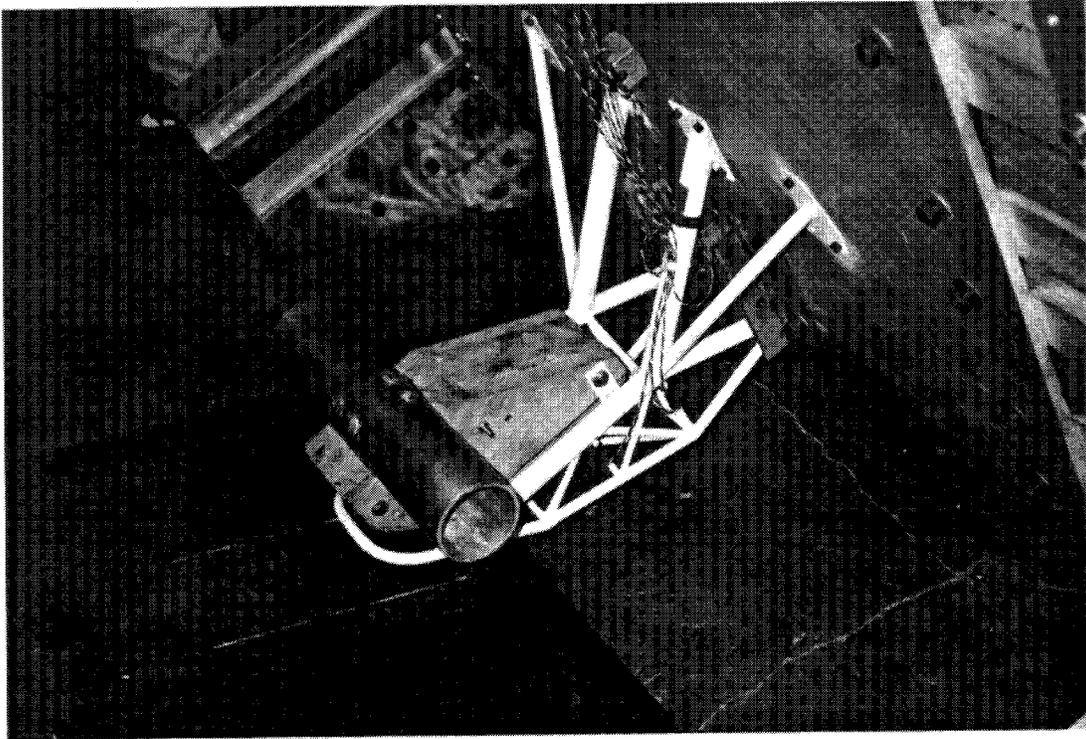
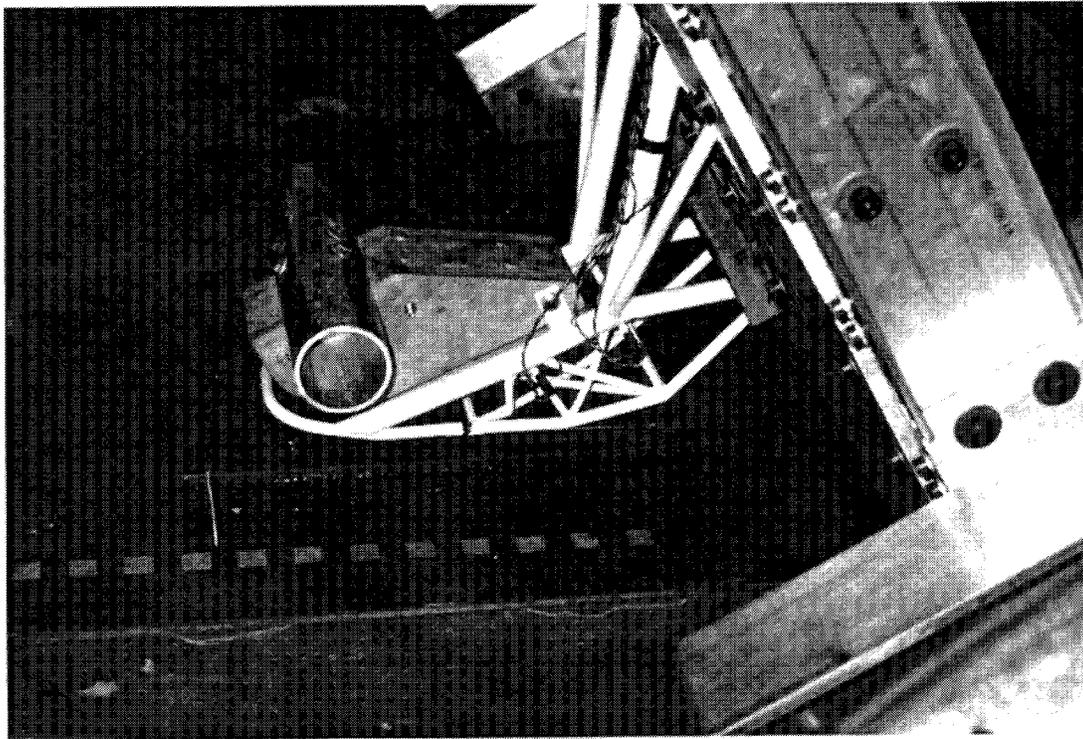
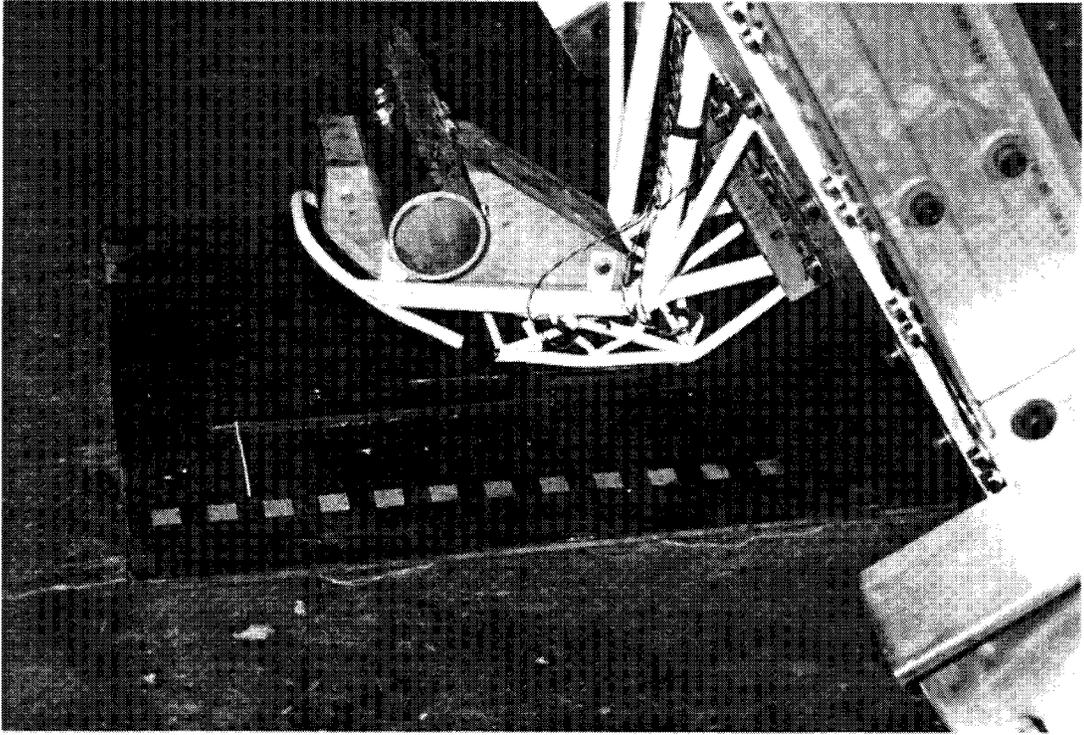
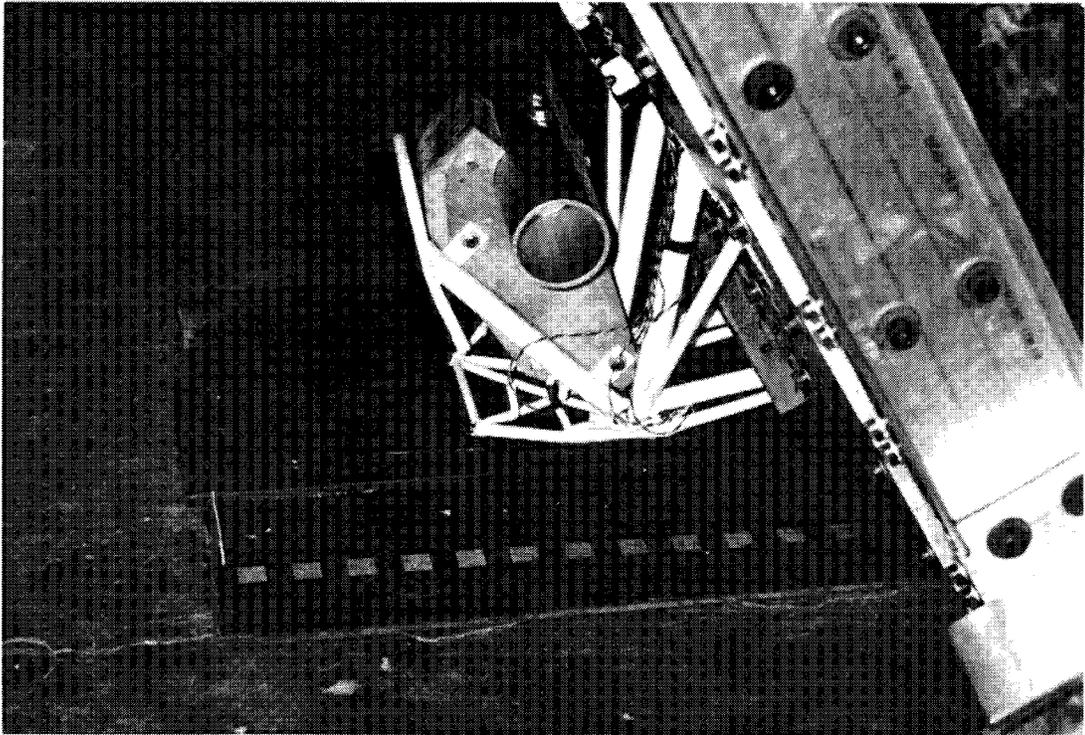
Figure 12, Half Scale Engine Mount 5

Detail design changes were made for mount 5 to try to delay this fracture while tube sizes were maintained the same as 4 (Figure 12(a-d)). These changes had little effect because the failure mechanism was not correctly analyzed. The failure was in bending at a weld joint and not a tensile failure of the tube itself as had been assumed. Figure 12(a) shows mount 5 installed on the test rig prior to test and Figures 12(b-d) show representative pictures during the test. All quasi-static tests were run continuously at about two inches per minute stroke rate. Data for mounts 3-5 are compared in Figure 13. Details of the failures were changed from the earlier mounts but the overall results were similar for mounts 4 and 5. Instrumentation for mounts 1 through 4 included actuator stroke and force. Five strain gages were installed on mount 5 to give additional details of the failure patterns. Gages were installed at the locations shown in Figure 14 with the data shown in Figure 15

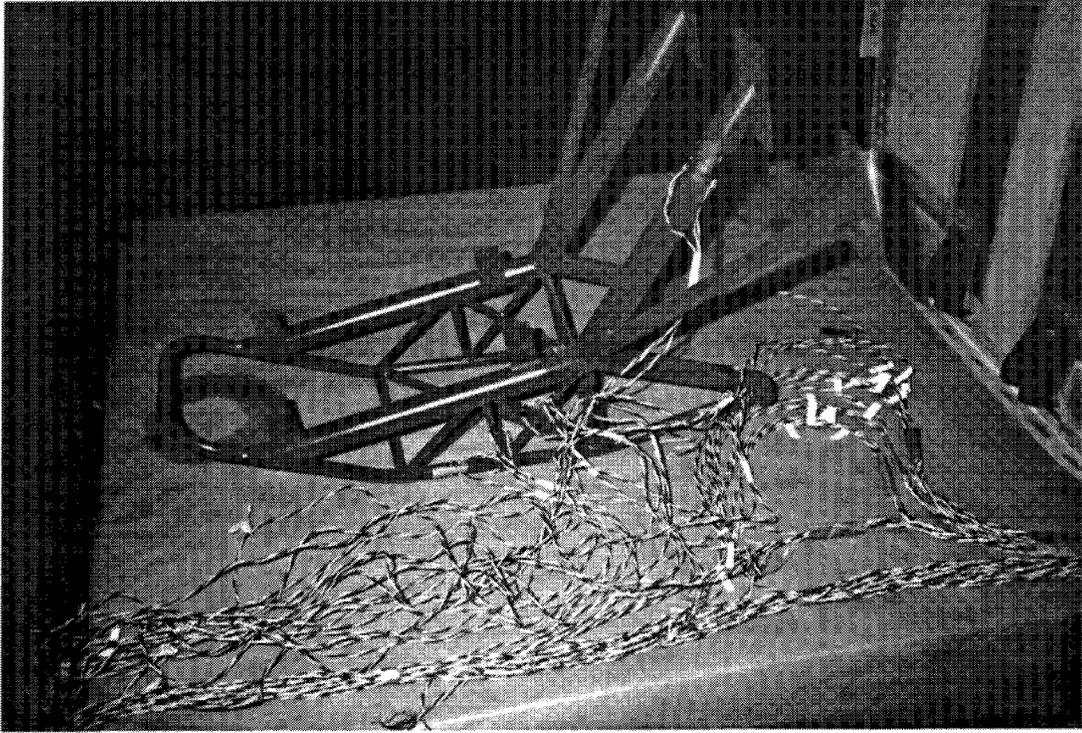
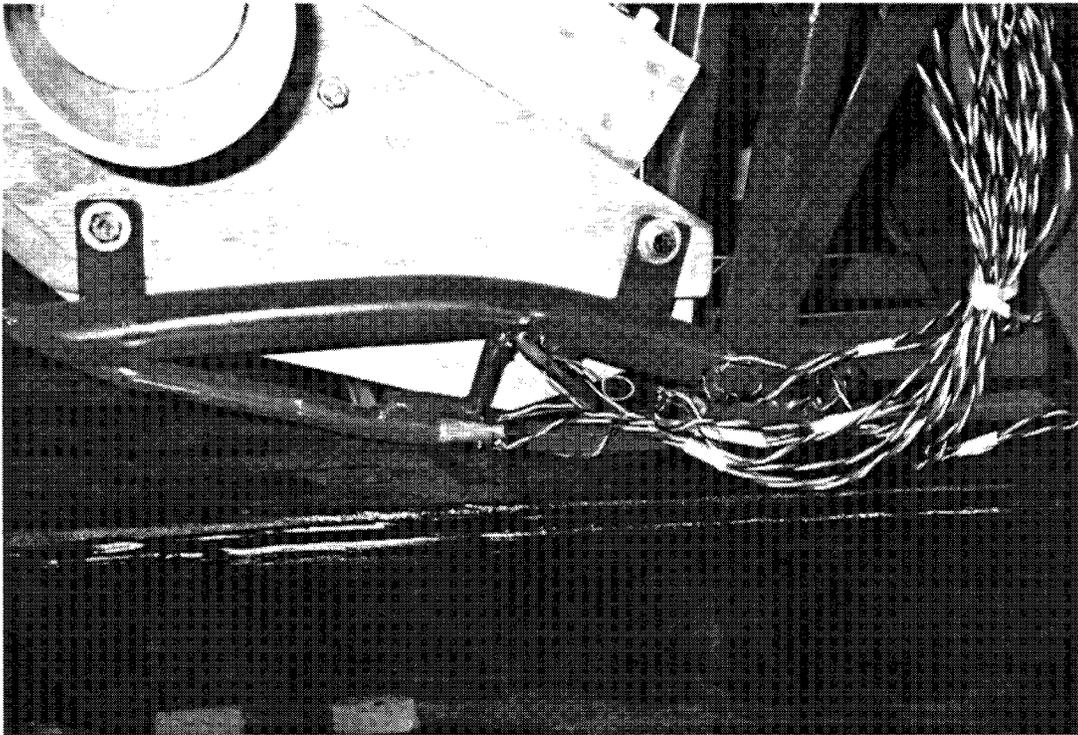
Figure 18, Half Scale Mount 6

Mount 6 was fabricated after completion of the first two full scale mounts and was the same as mount 5 except that the rails were bent at key locations rather than welded. It was intended to be as close to a half scale model of the first two full size mounts as available tube sizes would allow. Mount 6 was used on both the first two soft soil tests (see below for discussion of the soft soil tests) with only minor bending of the front of the mount where it goes around the front of the engine. The primary actuator load was much higher than it had taken to deform mount 5 on a hard surface indicating either that mount 6 was much stronger than mount 5 or the soft soil loading was different than expected. We decided to test mount 6 on a hard surface to compare the results to the two soil tests and to the results of mount 5 on a hard surface. Test results (Figure 17) showed that the intended similarity in strength to mount 5 had been achieved and that the lower rail fracture had been eliminated. Mount 6 is shown prior to test in Figure 18(a) and after test in Figure 18(b). This test also confirmed that loading in soft soil is of a different nature than hard surface loading and this will be discussed in more detail in section 6 below.

The engine mount (Figure 24(a-b)) was expected to deform similar to the hard surface test of mount 6 as shown in Figure 18(b). There is much less deformation in the full scale mount than mount 6 and further, the deformation is of a different type. Whereas the tubes between the rails buckled on the half scale tests, they punched into the rails with very little buckling on the full scale mount. It appears that material strength and/or resistance to column buckling is higher under dynamic loading than static loading by a greater margin than expected. For example, Figure 42 shows strains about twice the level at which buckling occurred in the half scale tests and this tube was nearly straight after the test. Airframe accelerations were consequently higher than expected. The half scale test of mounts 5 and 6 indicated an acceleration of about 20 g while Figure 25 shows several times that much at the firewall. The higher than expected loads forward leads to higher than expected angular acceleration. Combining the linear and angular accelerations leads to the measured acceleration in the Z direction decreasing moving aft and in fact changing direction between the baggage compartment and the tail. This characteristic is predicted by the analysis and can be seen in the data by comparing Figures 25, 26, and 28. One indication of the high angular acceleration is the fracture in up bending of the aft fuselage (Figure 24(c)) with the tail Z accelerometer measuring the order of 100 g (Figure 26).

Early runs with the engine represented by a rigid body mass had the rigid body tied directly to nodes in the engine mount which had the effect of making the engine mount rail rigid between the tie points. Half scale tests showed that the rail deformed by bending upward between mount points as shown in Figures 18(b) and 95(b). Small triangular brackets (Figures 47-49) were added to the rail with the engine mass tied to the tips of the triangles to allow some flexibility in the rail and make the model more representative of the test results. This modification brought the model into closer agreement with test results.

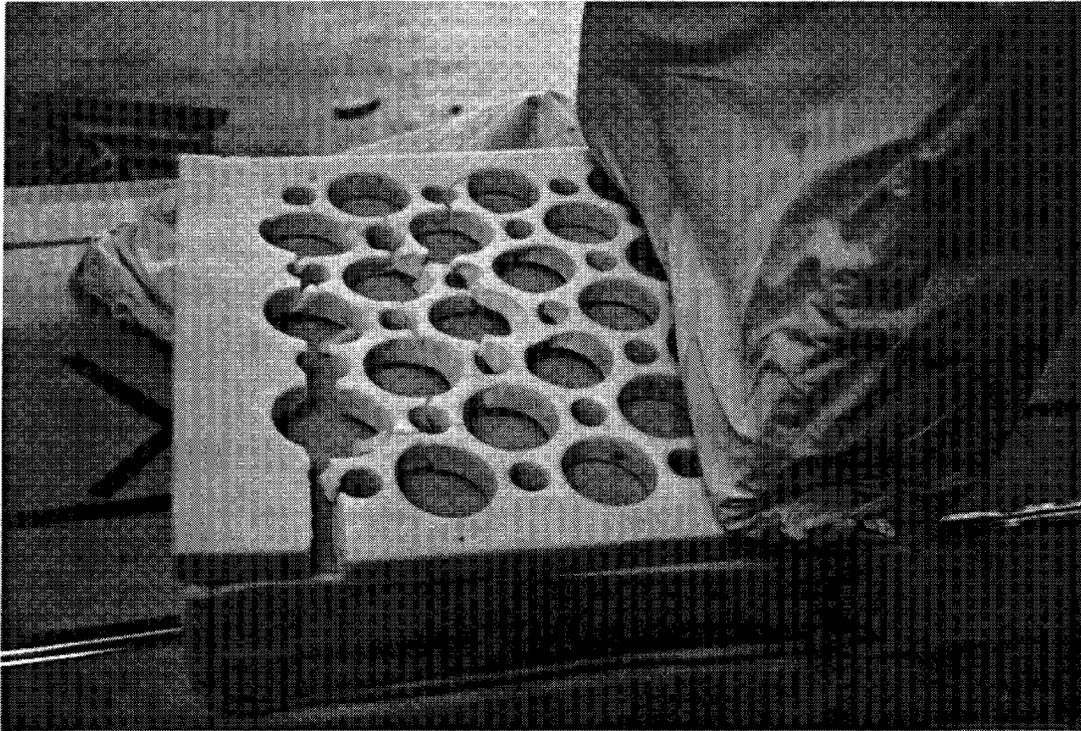
(e), Copilot Under Cushion Energy Absorber

The left hand seat gave a lumbar load approaching 3800 pounds (Figure 27) with no visible evidence of permanent deformation of the diaphragm. Performance of the right hand seat as seen in the copilot lumbar load (Figure 30) was better with a maximum lumbar load of about 2400 pounds. Figure 24(e) shows the right seat under cushion energy absorber after the test. This energy absorber was originally two inches thick but had been reduced to one inch due to a head clearance problem. Both lumbar loads were well above the 1500 pound limit but the right seat results were encouraging in that they were well below the pilot's rigid seat data. Lumbar loads were not recorded for the second impact on either seat by either data system.

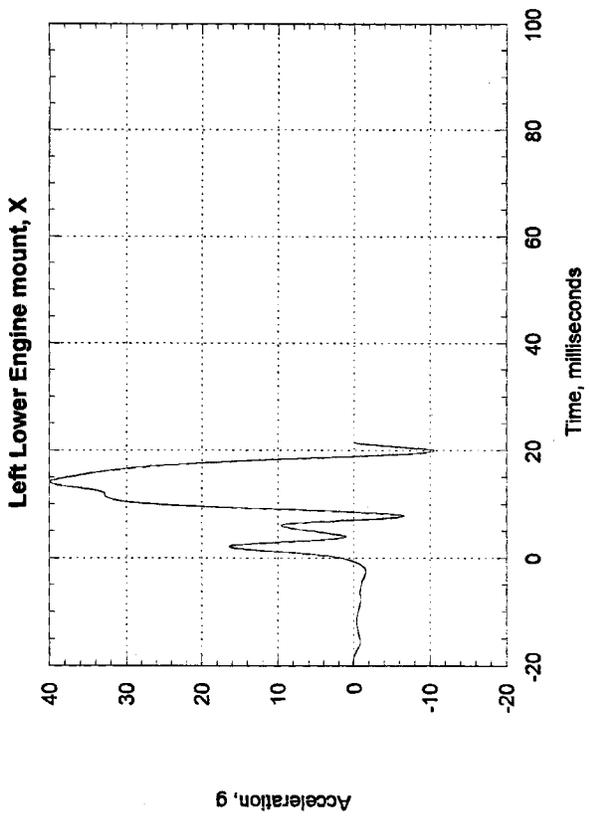
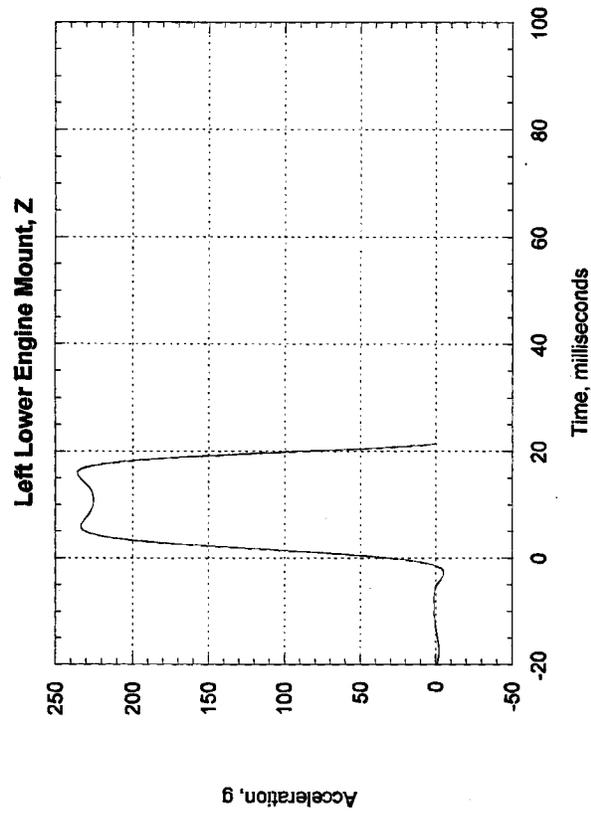
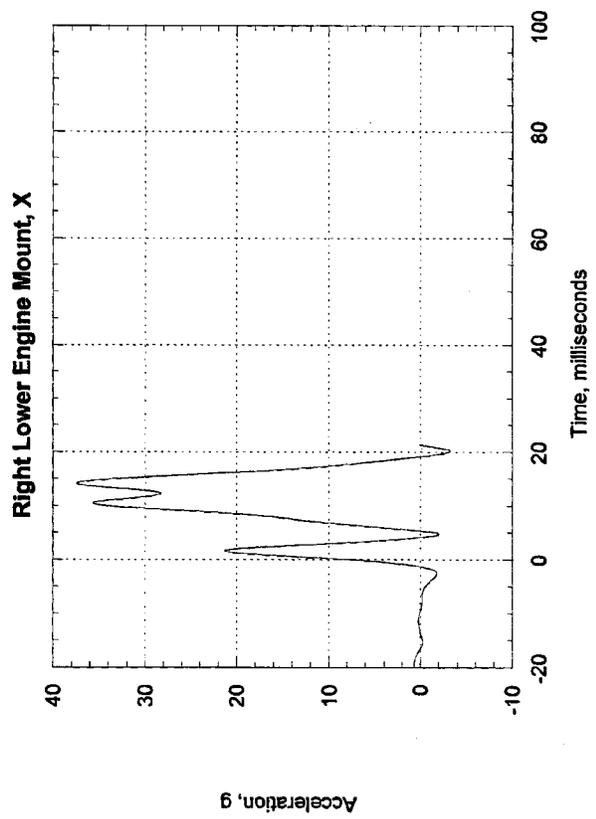
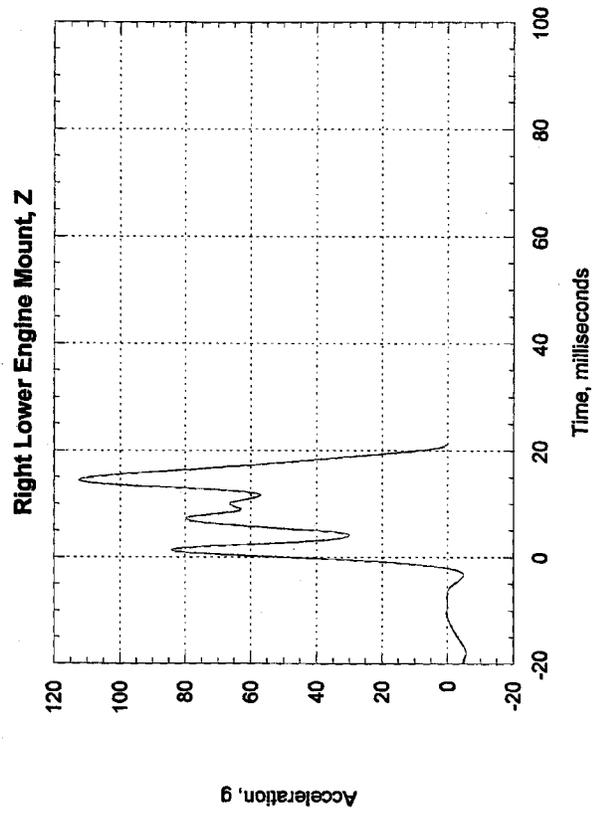
Figure 25, Test 1, Lower Firewall Accelerations

Firewall acceleration was about 50 g based on a 39 point moving average of the analog data (digital data shown in Figure 25 shows higher acceleration and the differences are unexplained) so compares best at yield strength between 150,000 and 175,000 psi while time to slap down shouldn't be expected to agree with test data due to the actual angle and calculation angle. Note that Z axis is normal to the airplane reference line in the test data and the Y axis is normal to the impact surface in the analysis (Y axis was used instead of Z axis in analysis because sample constant acceleration calculations showed more uniform accelerations). Deformation of the engine mount also showed about the correct deformation although the mechanism is different. The analytical model (beam) doesn't allow for the deformations in cross section of the test mount.

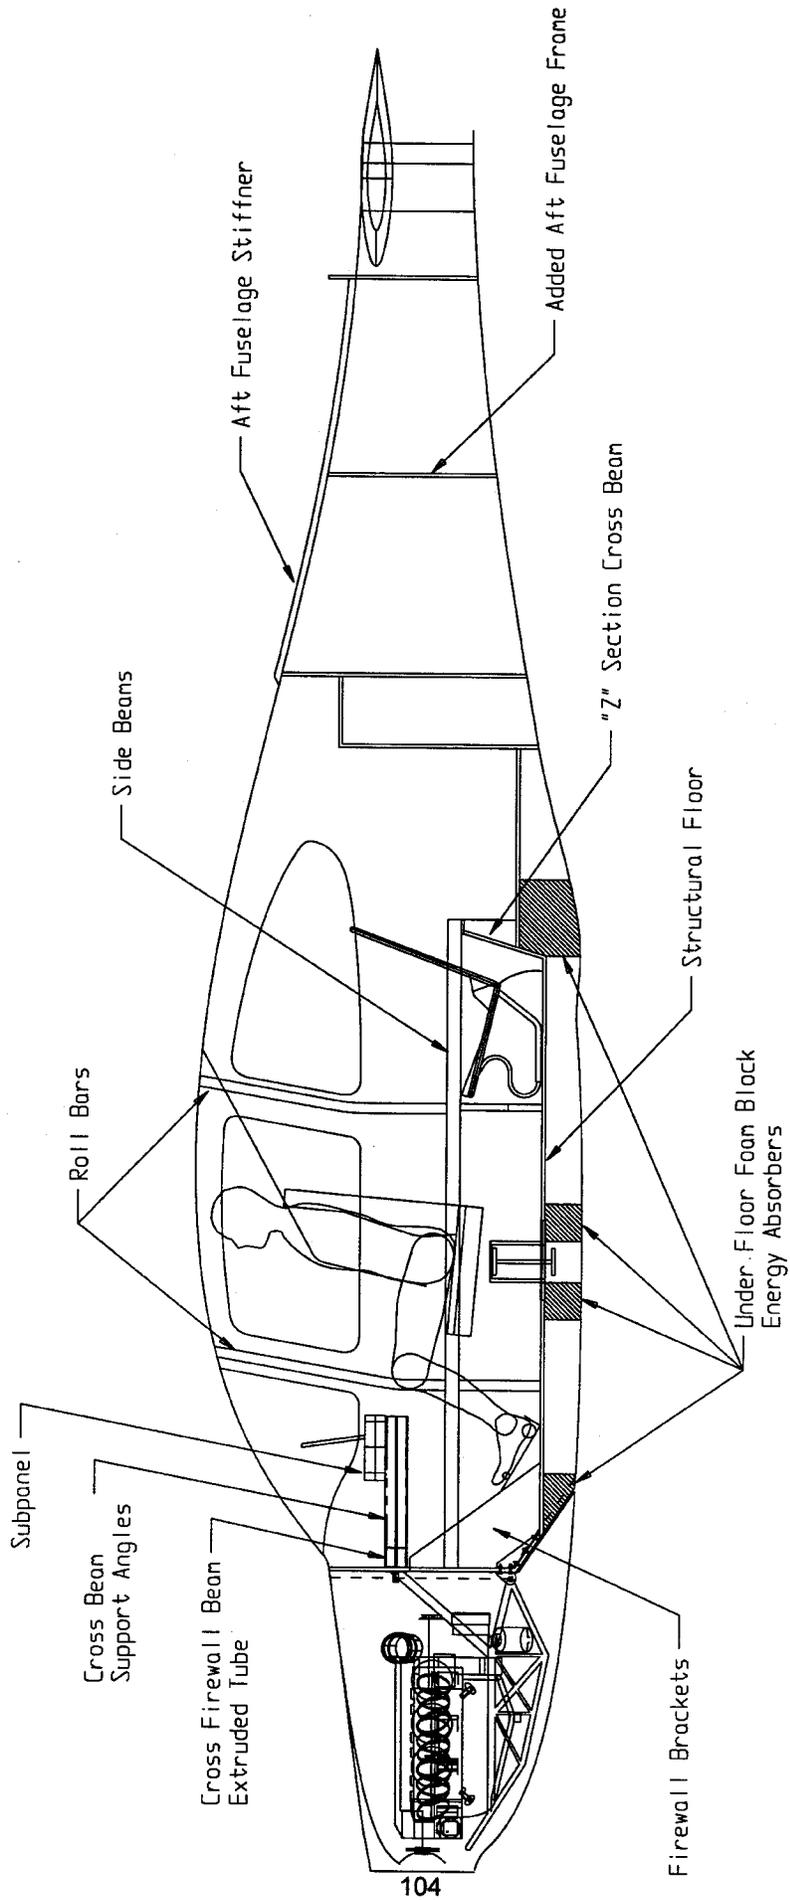
Figure 55, Structural Concept, Airplanes 3 and 4

Both test 1 and the analysis indicated that the rear seat area had higher decelerations than the front seats in the hard surface impact. Two changes were made to try to improve survivability in this area. The rear energy absorber was extended outside the loft for more stroke with a fairing as illustrated in Figure 55. And a stroking rear seat was installed as shown in Figure 56(e). This

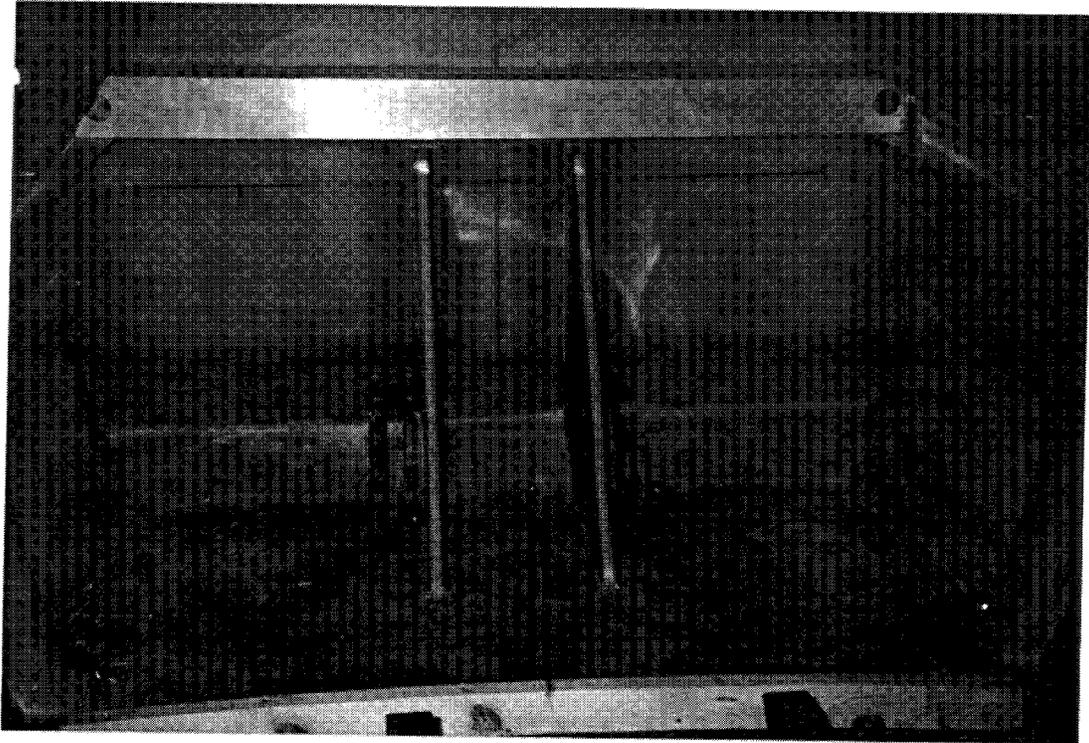
(a), Back Side of Firewall

The upper engine mount loads were taken into the fuselage by a straight beam (Figure 56(a)) behind the aluminum cross tube which transferred the loads into a beam under door by shear. These beams were small in comparison to those in the first two airplanes and can be seen in Figures 56(a) and (d). Figure 56(d) also shows the simulated instrument subpanel and the air bag installation for test 3. A wide angle lens camera was mounted on the subpanel and it was found in test 1 that substantial torsional rigidity was needed to keep this camera in position. Two 2 by 10 boards were used as an inexpensive way to provide secure camera and air bag mounting and to simulate the size and position of the subpanel.

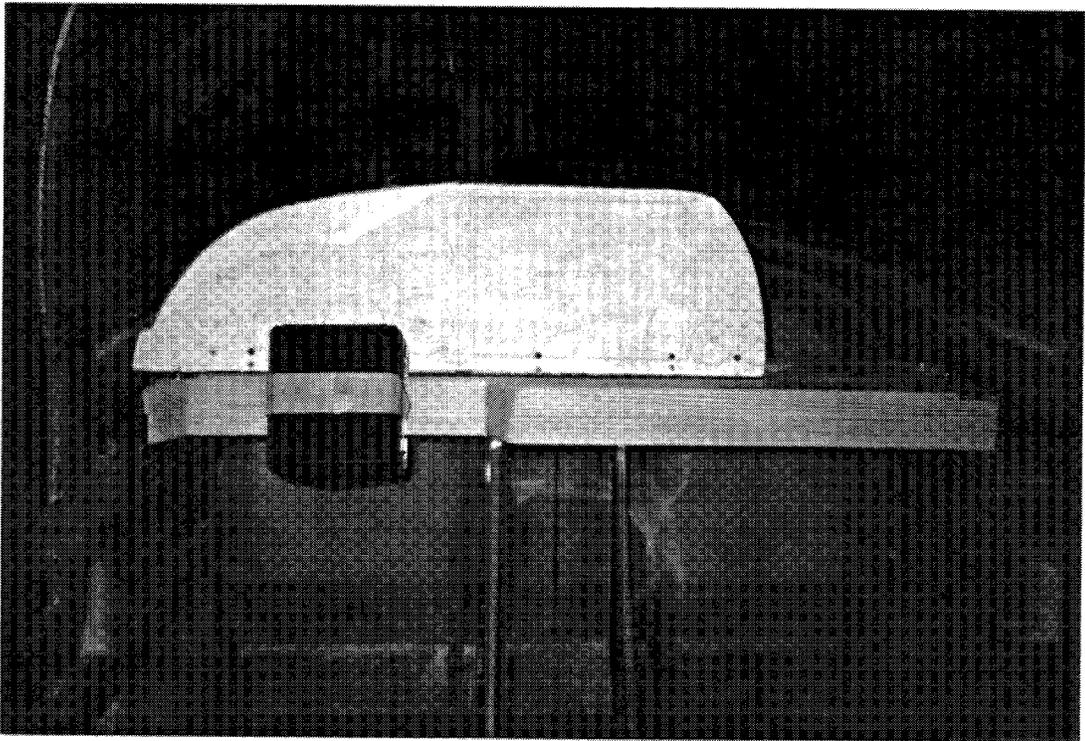
(d), Simulated Instrument Panel, Subpanel, and Installed Air Bag

(PABS) currently being certified for bulkhead rows in the Jetstream 41. The air bag system used in the test consisted of two components: an air bag module mounted on the pilot's side instrument sub-panel, and a crash sensor mounted on the floor near the firewall. The installed air bag is shown in Figure 56(d) and the sensor was mounted on the floor just below the bottom of the picture. It was between the two braces shown near the center of the firewall behind the lower engine mount fittings. The copilot's position was tested without an air bag in order to provide comparative occupant data.

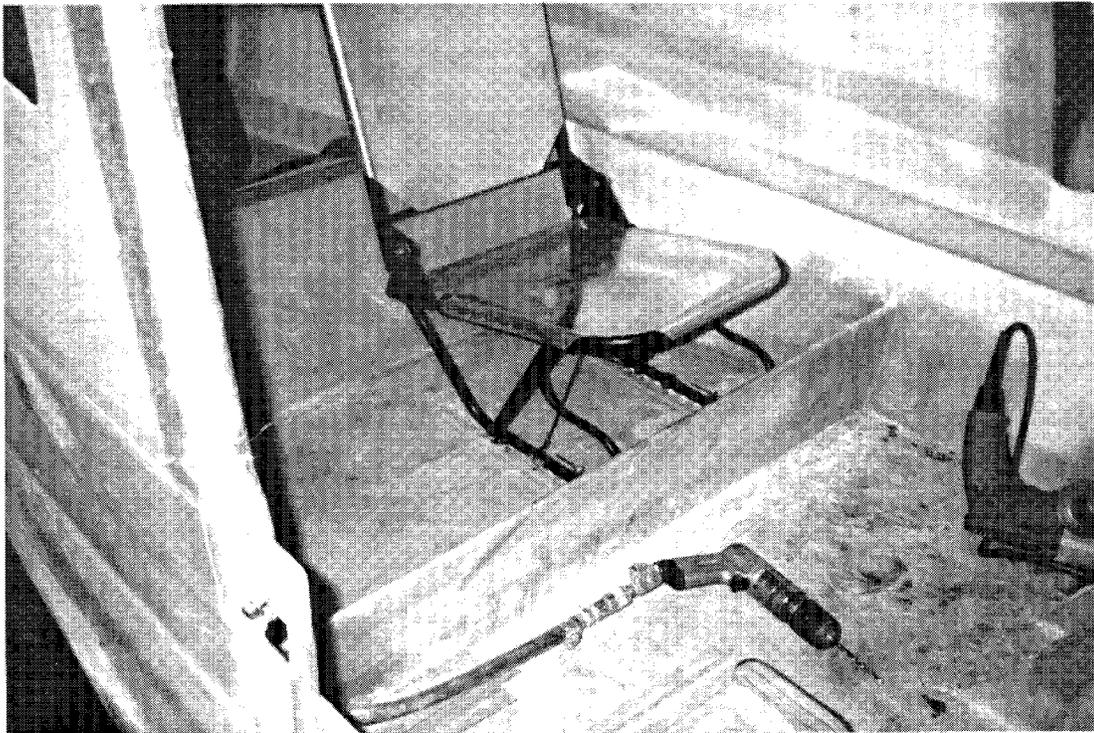
(e), JAARS Seat in Rear Location

seat will be described more below. A partial frame was added as shown in Figure 56(f) to resist shoulder harness loads for the rear seat passenger. Loads from the rear energy absorber were taken by a "Z" section cross beam (Figure 56(e)) behind rear seat which formed the front edge of the baggage compartment.

The analysis described above and the test data from test 1 both show that the rear seat is subject to high acceleration during the second impact, "slap down", and that there is not enough stroke in the under floor energy absorber to attenuate the impact to the level required for a non stroking seat to limit the lumbar loads. Figure 54(c) shows the velocity of the rear seat at the second impact to be about 380 inches/sec. The stroke required to decelerate at a constant 20 g to zero velocity is 9.34 inches while the extended energy absorber only has a five inch stroke. Only about 3.5 inches stroke is available within the loft lines. It was thought that a combination of the extended energy absorber and a stroking rear seat could limit the lumbar loads to less than the allowed 1500 pounds. A JAARS "S" leg middle seat was acquired and mounted in the rear seat position (Figure 56(e)) for test 4. This seat limited lumbar loads to less than 1500 pounds in sled tests to loading higher than the FAR 23.562, Test 1 requirements. While this seat is in use by two non-profit organizations, it is not commercially available.

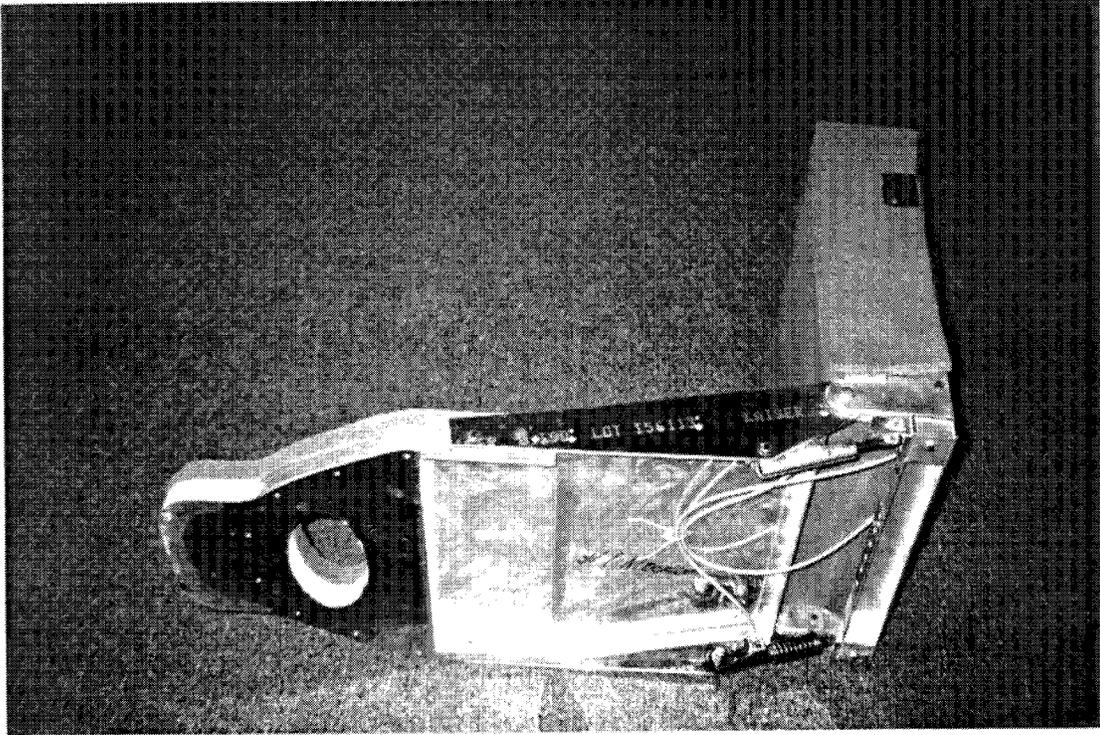
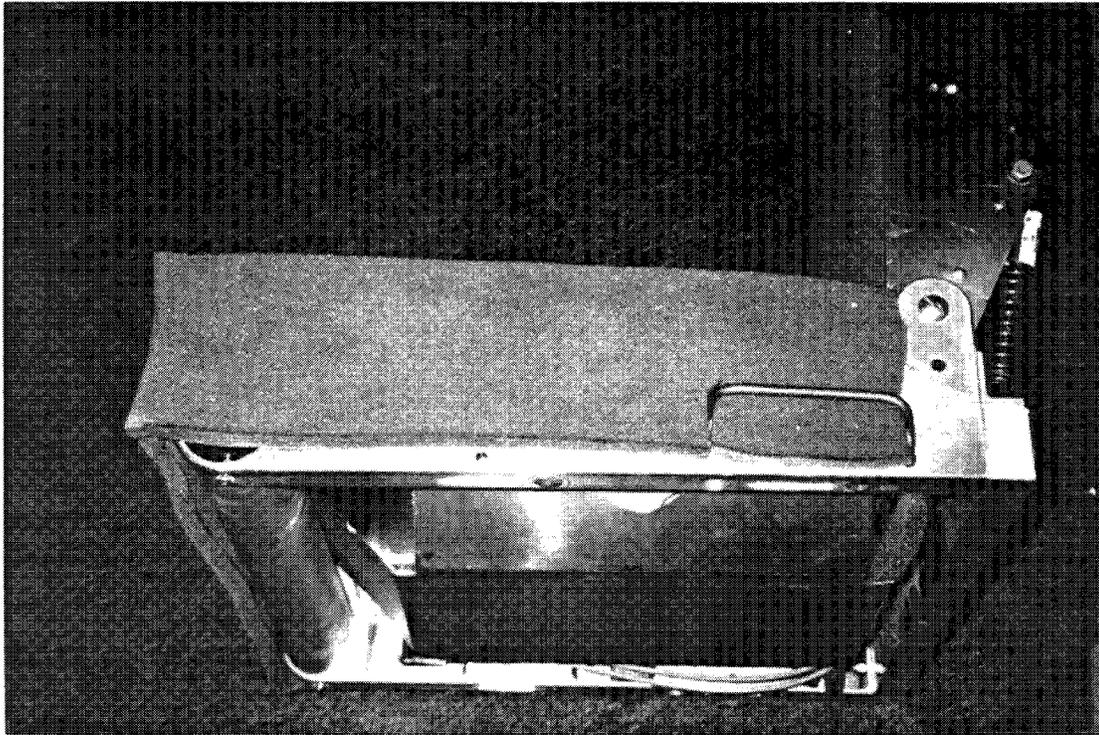
Figure 57, IDI Seat for Pilot Location, Test 4

The pilot's seat was a developmental seat from Impact Dynamics, Inc. (IDI) currently under development for a new airplane program. This seat, shown in Figure 57, is designed to meet the FAR 23.562 requirements when mounted over the main spar. The energy absorbing material is contained within the seat and the mounting is assumed to be rigid with respect to the airframe. It is planned to be adjustable fore and aft but was mounted to a steel framework fastened to the spar box for this test. The back angle is also adjustable but was fixed for this test. The restraint system was airframe mounted.

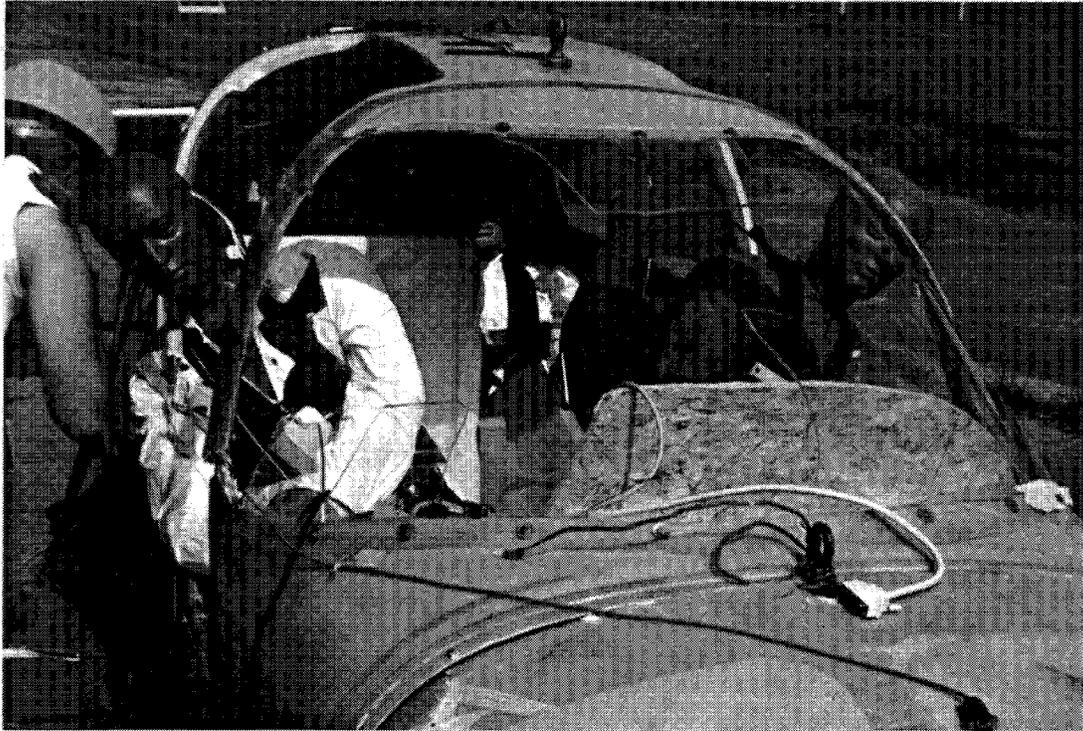
(a), Cockpit View

The windshield shattered at about 30 milliseconds after impact followed shortly by failure of the forward roll bar and side beams under the doors just aft of the forward edge of the door as shown in Figure 60(a-b). Both doors also came loose early. This allowed the forward fuselage to rotate upward approximately 12 degrees (Figure 59) and the engine mount did not deform as much as predicted (Figures 60(c-d)). Analysis had indicated the engine mount would collapse completely as shown in Figure 53 but the analysis did not allow for the forward fuselage failure, loss of the doors, or for the physical size of the engine and its oil pan. This engine has a cast aluminum oil pan and the front portion was shattered by the impact as shown in Figure 60(e). Forward mount brackets (portion attached to the engine) were broken but the aft brackets were intact. The mount did deform more than in test 1 and the deformation was more like that from the quasi-static tests.

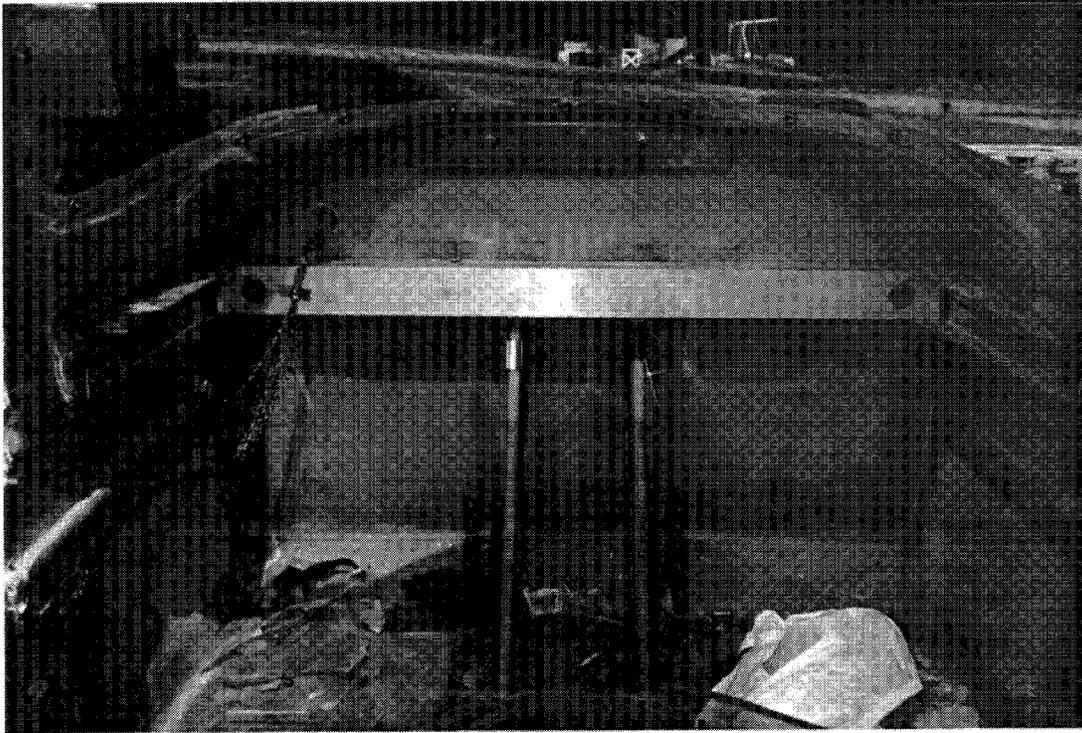
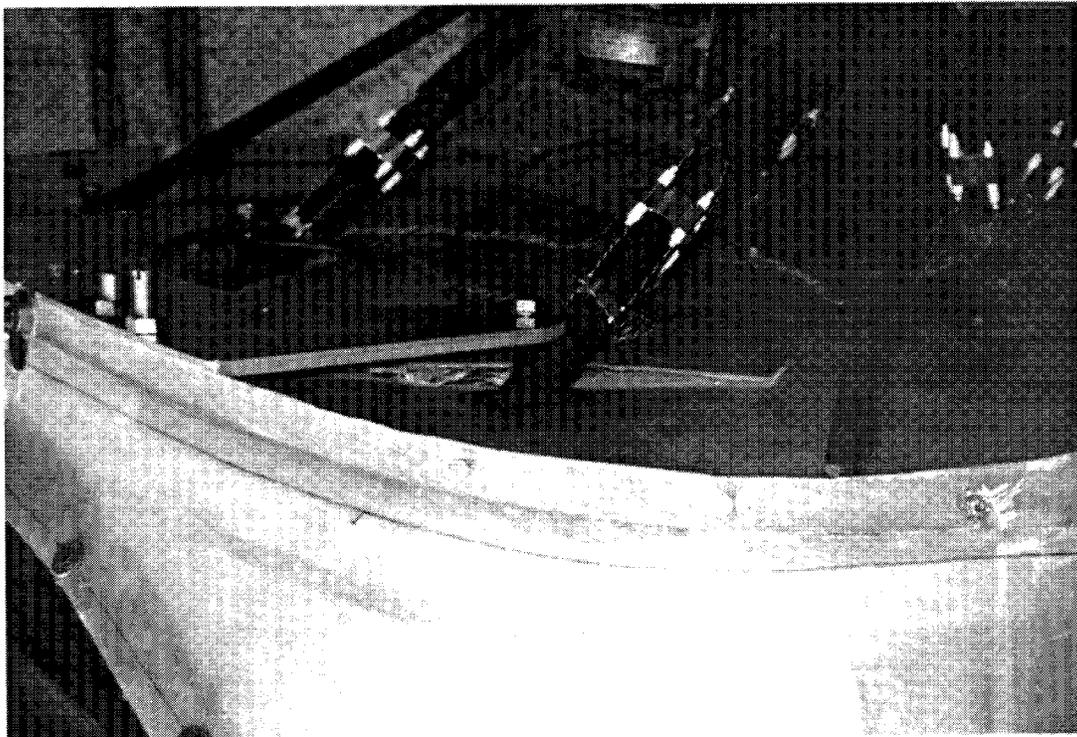
(g), Back Side of Firewall

There was no loss of cabin space and the deformation of the forward cabin was not enough to cause major damage to the legs of the front seat occupants. There was some fracturing of the slanted firewall segment on both sides as shown in Figures 60(f-g) but no penetration. There was no loss of structural integrity of the firewall at the braces near the floor but there was damage to the firewall beside the braces both above and below the cross tube as shown in Figure 60(h). Bond line failures along the upper engine mount support beam and some failure of the side shear panel can be seen in Figure 60(i). Bond lines also failed on both sides of the "Z" beam above the rear energy absorber as shown in Figure 60(j). There were a number of other areas of failures of bond lines and fracturing of fibers in transition locations.

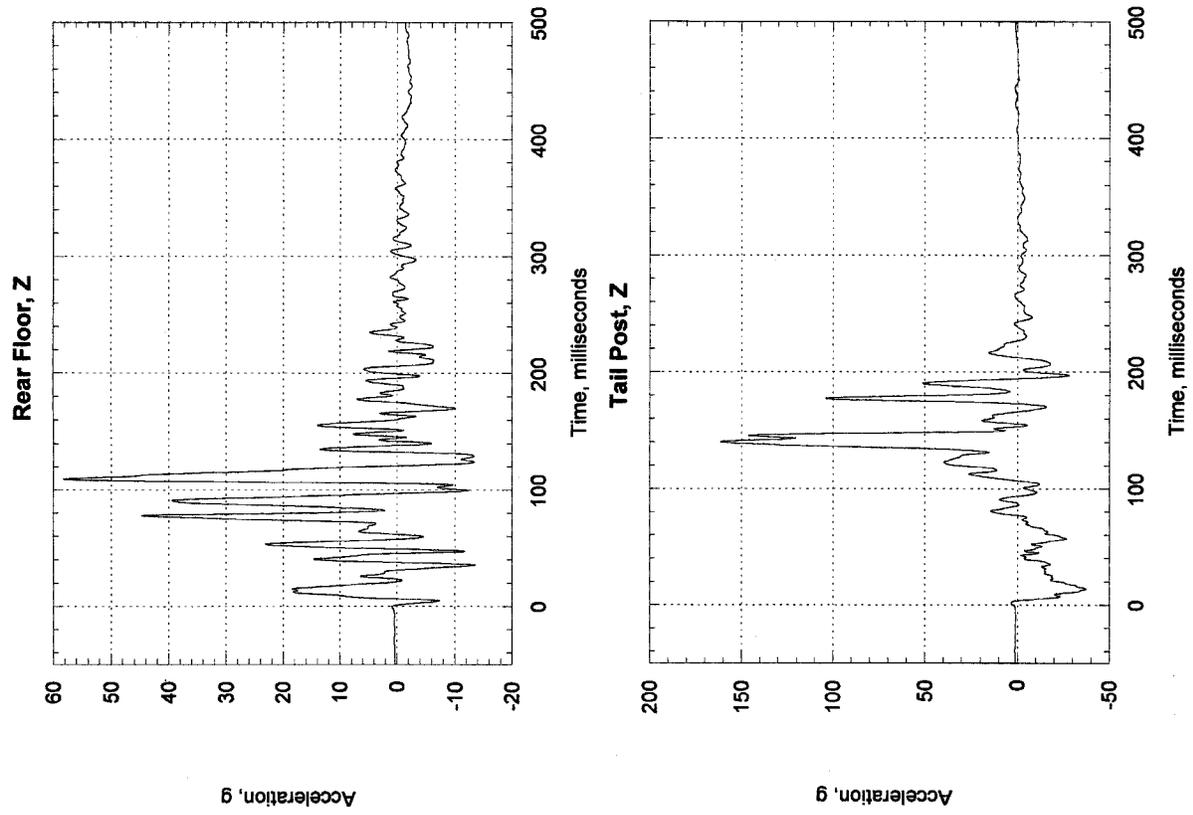
Figure 62, Test 4, Aft Airframe Accelerations

Accelerations at all locations were much lower than for test 1 including the tail post (Figure 62) which was less than half that for test 1. The pilot's lumbar load was well under the 1500 pound limit at about 1100 pounds (Figure 64). Copilot's lumbar load was over the limit at near 1700 pounds (Figure 66) yet the under cushion energy absorber showed no permanent deformation. This is not understood since the same design had performed well in the tests described in section 3. The foam material was from a different batch and it may be that there is enough variability from batch to batch to make the difference. There is a lot of high frequency hash on the pilot's pelvis trace but changing the filter to delete this confirms that the pilot's pelvis had lower accelerations than the copilot's pelvis showing that the lumbar loads have the correct relationship.
