NASA/CR-2002-211774

Design and Test of an Improved Crashworthiness Small Composite Airframe

James E. Terry
Terry Engineering, Andover, Kansas

August 2002

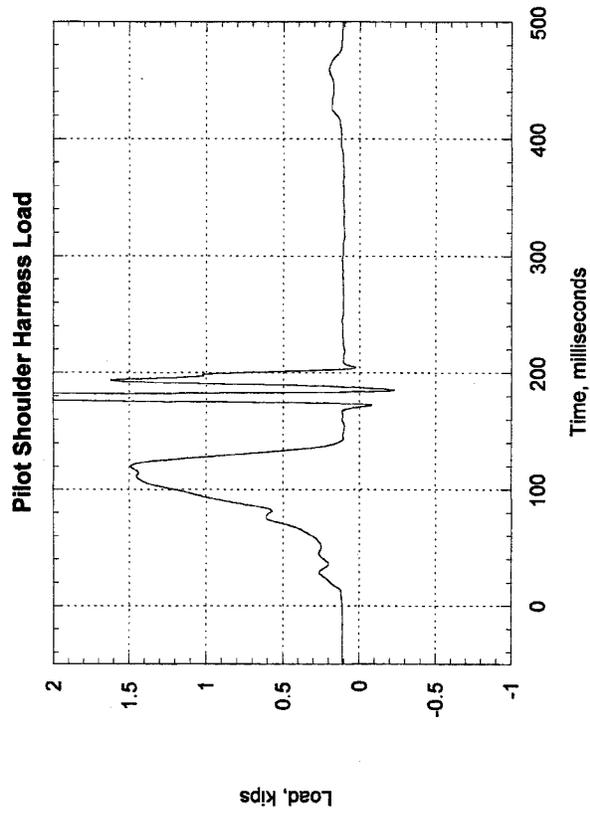
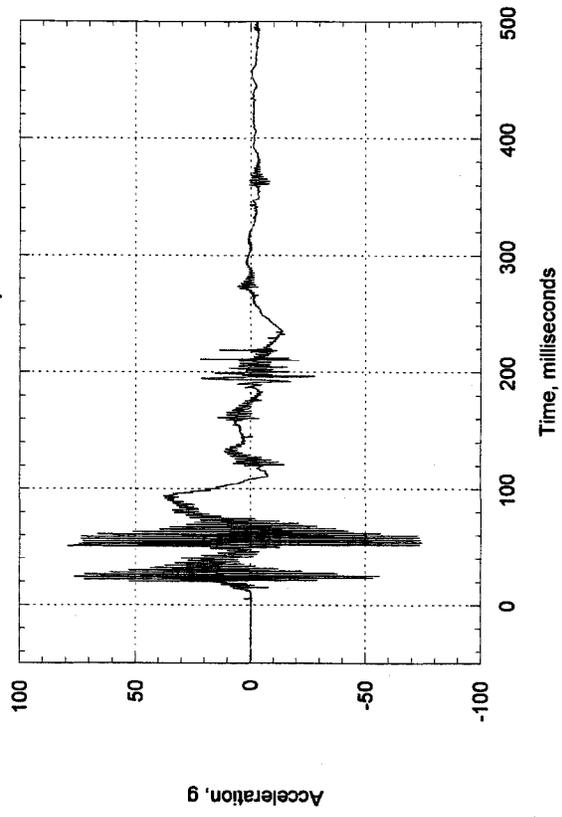
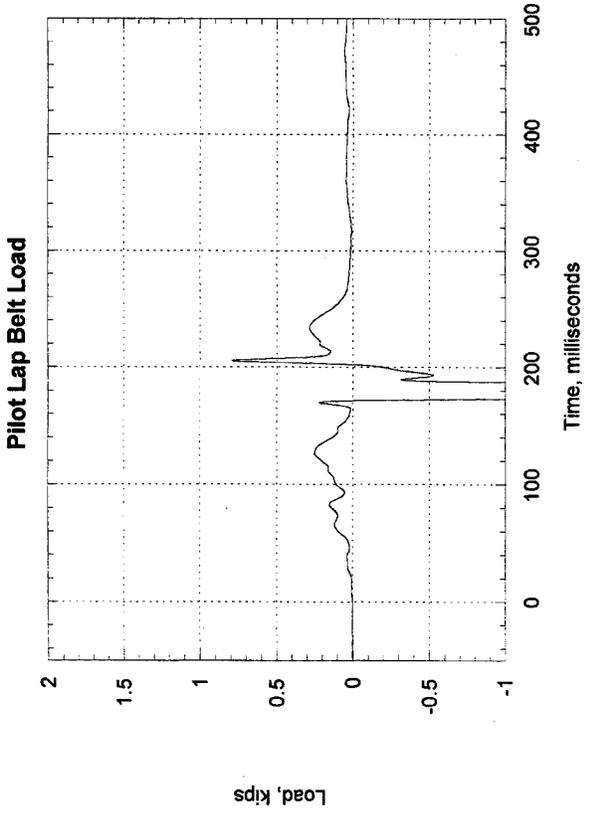
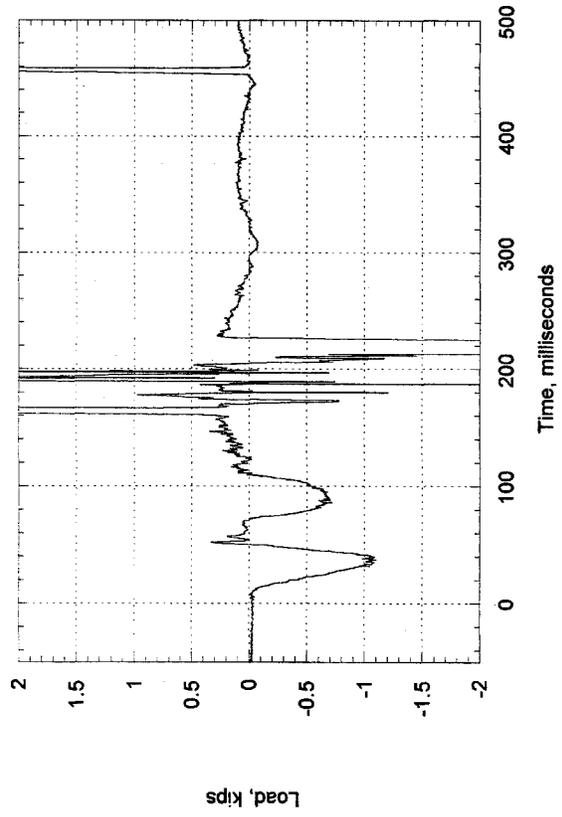
Figure 64, Test 4, Pilot

Accelerations at all locations were much lower than for test 1 including the tail post (Figure 62) which was less than half that for test 1. The pilot's lumbar load was well under the 1500 pound limit at about 1100 pounds (Figure 64). Copilot's lumbar load was over the limit at near 1700 pounds (Figure 66) yet the under cushion energy absorber showed no permanent deformation. This is not understood since the same design had performed well in the tests described in section 3. The foam material was from a different batch and it may be that there is enough variability from batch to batch to make the difference. There is a lot of high frequency hash on the pilot's pelvis trace but changing the filter to delete this confirms that the pilot's pelvis had lower accelerations than the copilot's pelvis showing that the lumbar loads have the correct relationship.

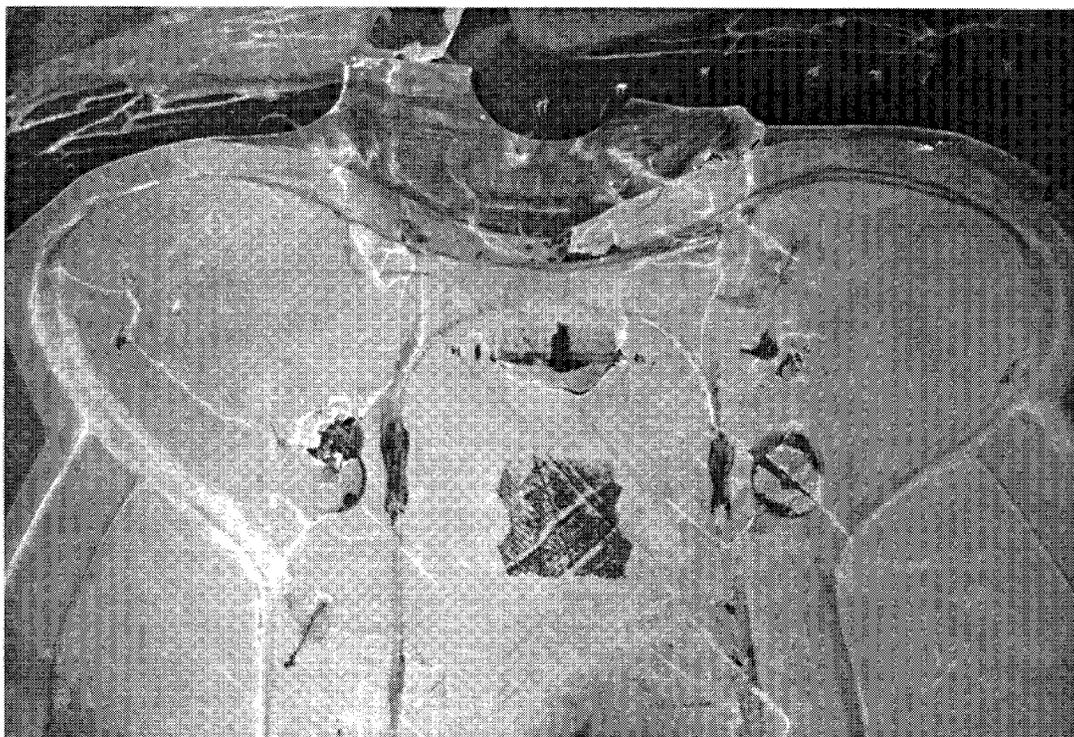
(d), Inside Cowl

Design of the cowling was similar to that for $\frac{1}{2}$ scale test 3. Figures 102(a) shown the honeycomb pad under construction and Figure 102(b) show the completed lay-up just before curing. The pad was four layers of $\frac{1}{4}$ inch Nomex honeycomb with a single ply of fiberglass between layers. The cowling shell had been made before design of the cowl was complete and a skirt had to be added to extend the cowl to the slanted firewall surface. This made for a change in stiffness just forward of the firewall and the cowl broke on both sides at this location (Figures 101(b-c)). This left a forward facing scoop but there was very little soil inside the cowling indicating this failure was late in the sequence.

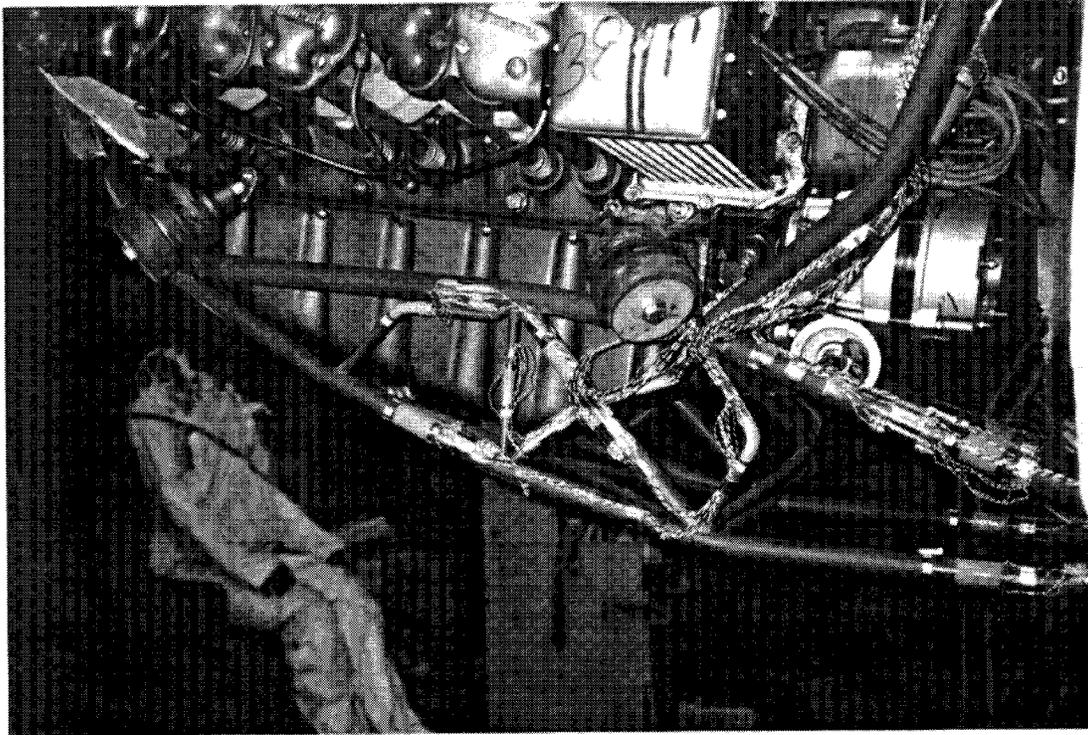
(e), Engine Mount

An impact sequence is shown in Figure 100 and shows the airplane coming out of the crater at low speed coming to rest a short distance from the crater. Representative post test pictures are given in Figures 101(a-f). The cowling and engine mount performed nearly as designed and very similar to the $\frac{1}{2}$ scale tests, that is, the cowling maintained a sliding surface (Figure 101(b-c)) and the engine mount deformed upward (Figure 101(e)) to prevent the front of the airplane from simply sticking in the ground. Several engine components, such as oil cooler, magnetos, and starter, were closer to the mount posts than planned due to a somewhat idealized CAD model used in the design. These parts rotated up into the mount posts bending the posts as shown in Figure 101(e) so that energy was absorbed both in the lower part of the mount and in the posts.

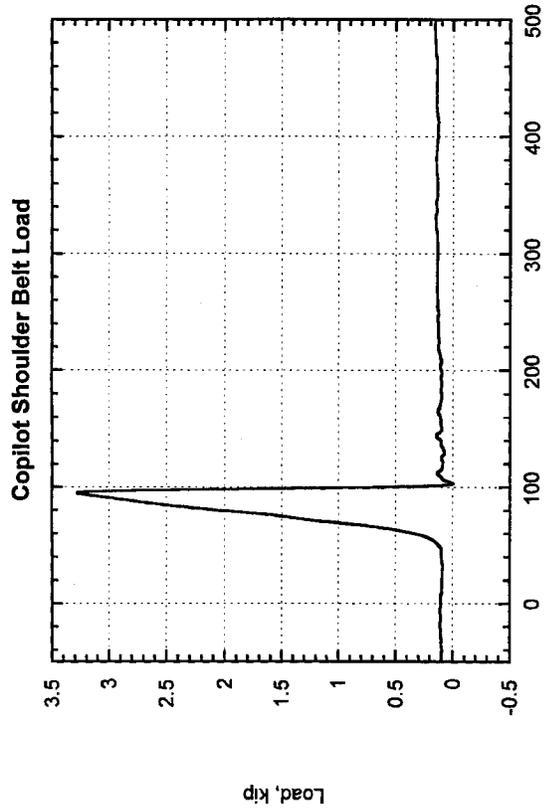
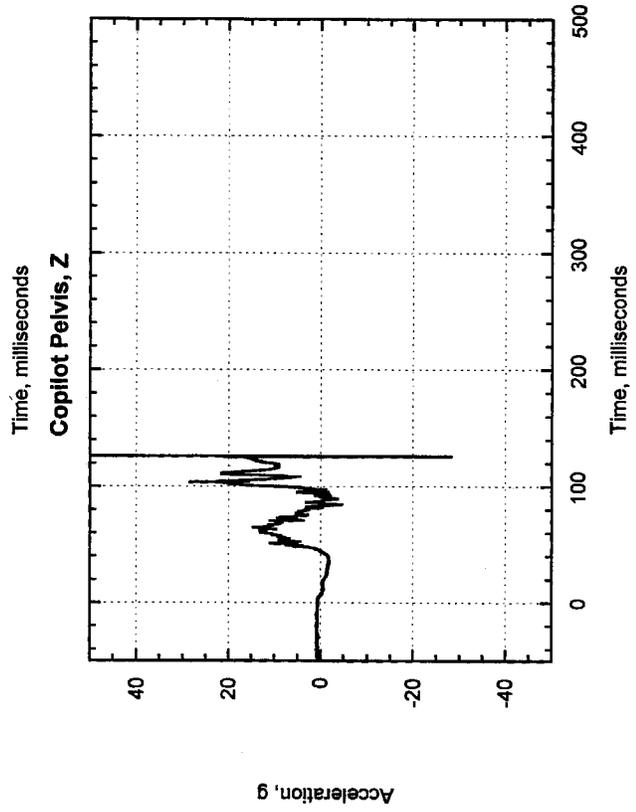
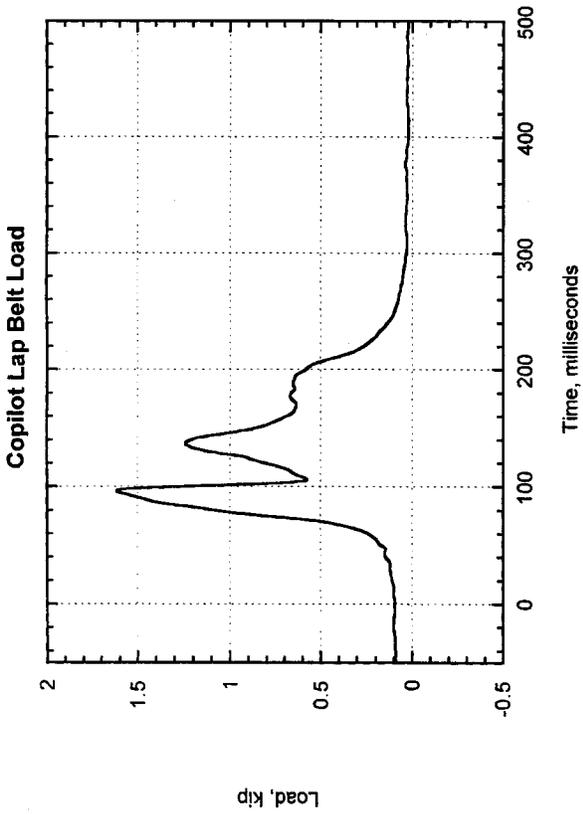
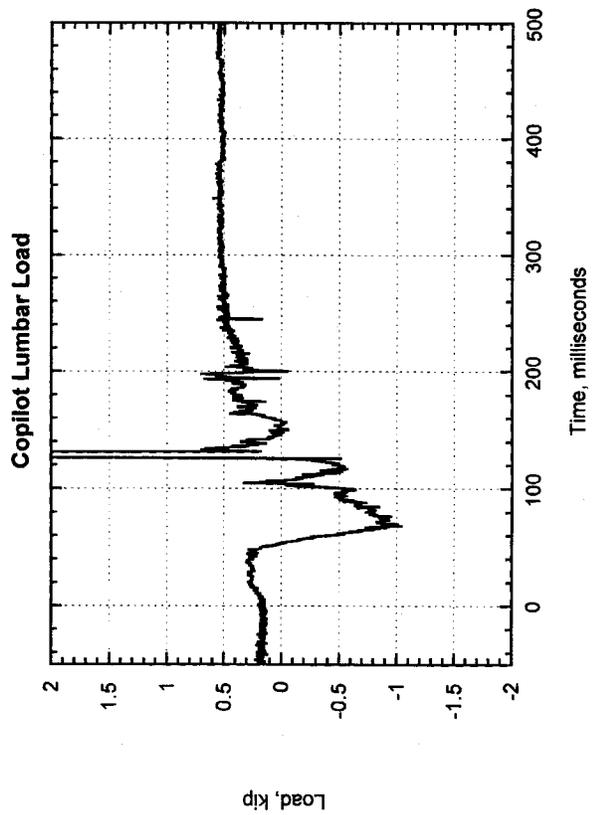
Figure 108, Test 2, Copilot

Test data are given in Figures 103-123. There was no loss of cabin volume. Both dummies hit the instrument panel because the pilot seat came loose at the rear attachments due to an installation error and the copilot shoulder harness inertia reel bracket failed at about 3240 pounds (Figure 108). Shoulder harness force is limited to 2000 pounds in FAR 23 so it appeared a that a significant reduction in load for the harness was required. It can be determined from the pictures that the dummies were forward of the seat backs and there was some slack in the harnesses at impact. The airplane is suspended in an approximately 65 degree nose down position for several minutes in the pretest period. There were load cells on the harnesses and the weight of these cells tends to extend the harnesses and a slow motion of the belt won't lock the inertia reels. The dummies had been taped to the seats with tape fastened over the shoulder to the seat back. The tape is partially cut to initiate tearing at impact and it appears it may have released early. While

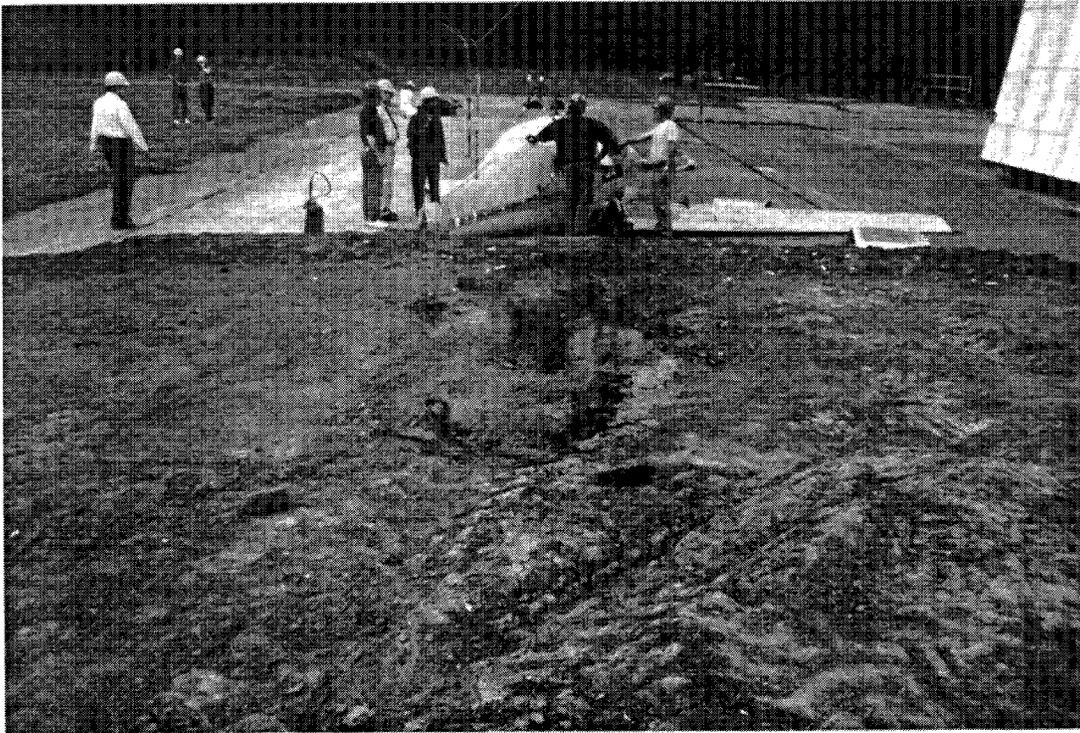
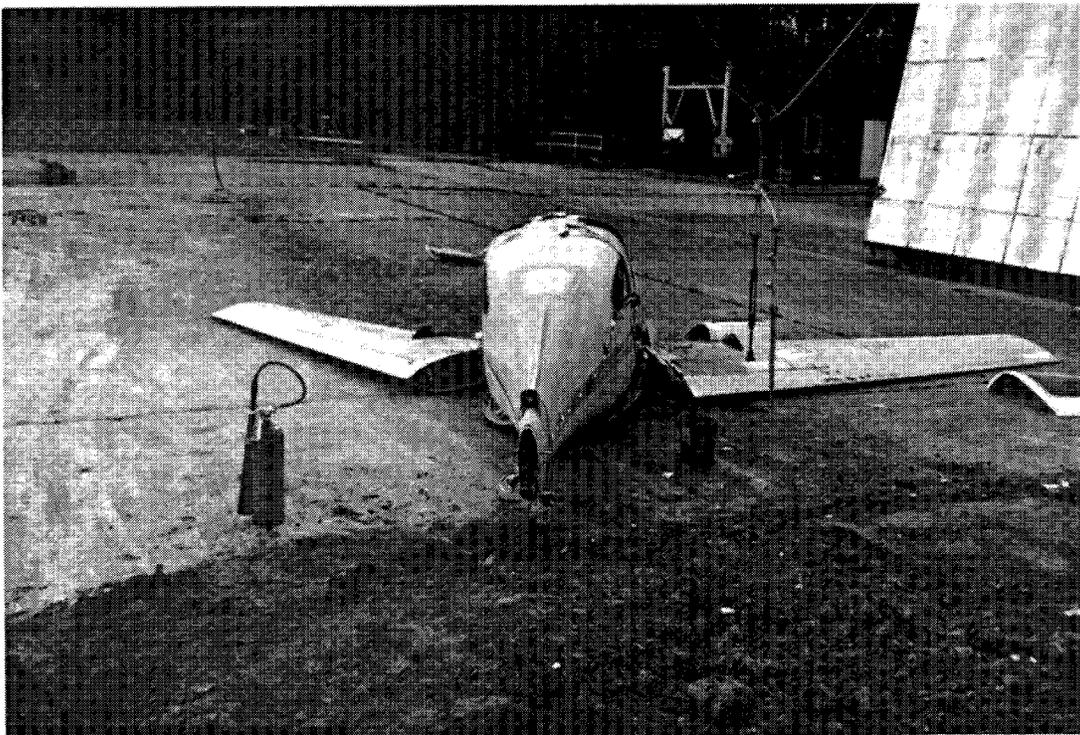
(a), Post Test Airplane Position and Crater

An impact sequence is shown in Figure 125 and shows the airplane making a crater and then coming out of the crater at low speed. It then slid off the soil bed and came to rest on the concrete surface just out of the frame for these pictures. Representative post test pictures are given in Figures 126(a-l) and data are given in Figures 127-146.

The crater depth was measured in a grid pattern and the volume of the crater integrated. Approximately 4.8 cubic feet of soil was ejected from the crater. Soil density measurements showed this soil to weigh about 80 pounds per cubic foot leading to the weight of soil ejected of 390 pounds or .155 times the weight of the test airplane. Figure 43, Volume III of Reference 5 gives the impulsive aircraft acceleration for these test conditions to be approximately 11g. Figure 127 shows two acceleration peaks approximating 20g with a central portion lower but above 11g. The correlation between data and Figure 43 of Reference 5 is not as good as for test 2. As in test 2, airfield index readings were in the same range as before the test showing no evidence of soil compaction in the crater as was found in the ½ scale tests.

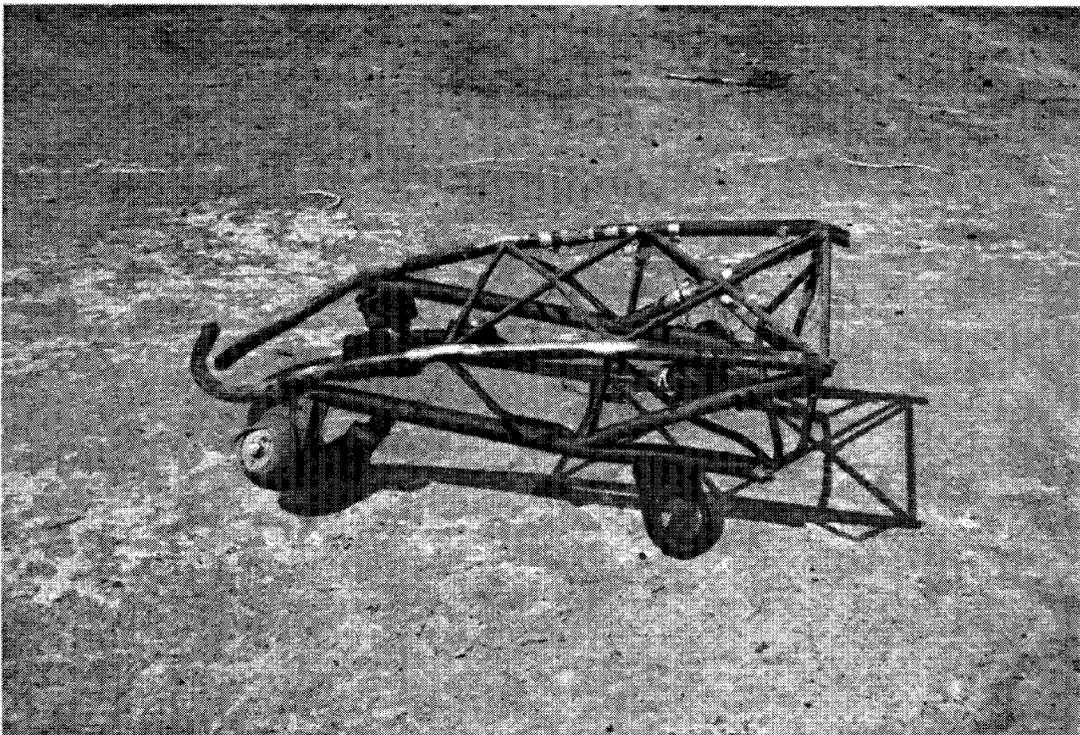
(d), Engine Mount

Performance of the cowling and engine mount was similar to that of test 2 except that the forward portion of the engine mount broke free and remained attached to the engine as the engine was thrown forward away from the airframe (Figure 126(b-e)). Strain gage data shown in Figures 135-140 show that the engine mount absorbed energy for 140 to 160 milliseconds before breaking away and this time interval covered the primary event. Strain gage data from the posts (Figures 135-136) indicate that the mount failure occurred as the airplane rotated up out of the crater which reverses loading on the engine mount. Several differences can be noted between test 3 and test 2 where the mount did not fail in this manner. Impact attitude was 3.9 degrees lower which was shown in the hard surface analysis to be a more severe impact. Engine mount post attachments to the upper rails had been moved aft one inch to increase engine accessories clearance and this nearly doubled the distance from the aft engine mount brackets to the post. The engine and accessories rotated upward bending the posts in test 2 which probably relieved loads in the rails. There was more clearance between the accessories and the mount in this test so the posts were not bent.

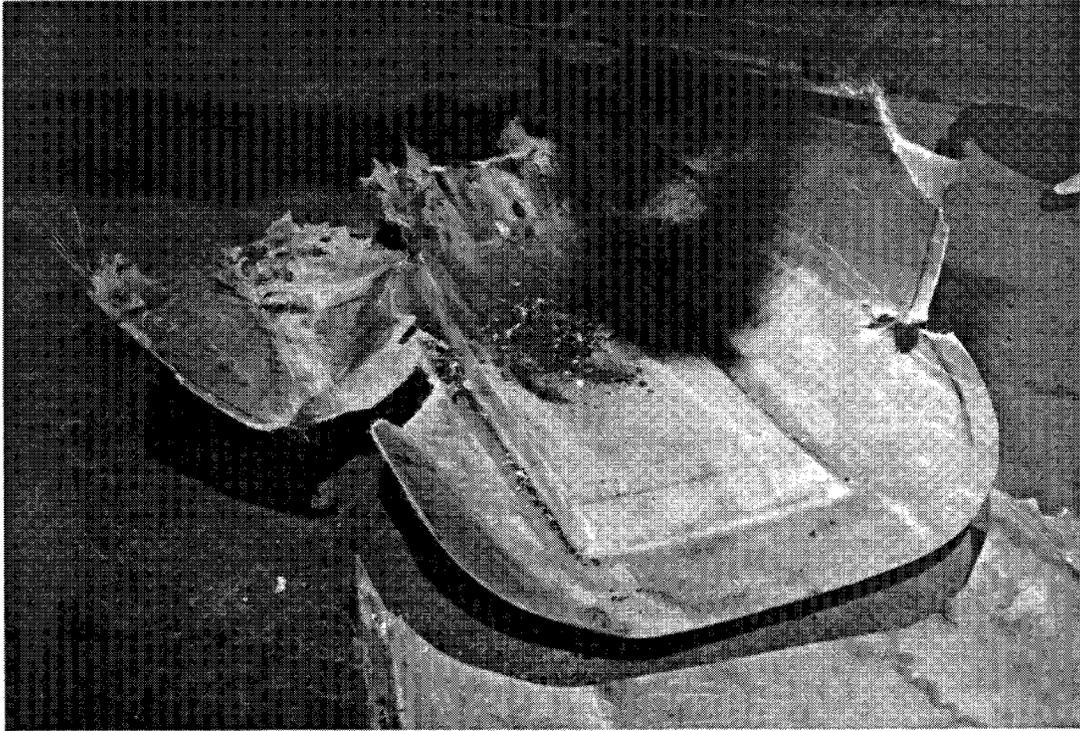
(e), Lower Cowling

The cowl worked well, similar to the cowl in test 2 except that it fractured where the forward portion of the pad met the central portion of the pad (Figure 126(e)). The cowling pad for test 2 was made from honeycomb as described above and had a less abrupt intersection of the two portions of the pad. Foam was used for the pad on test 3 to allow use of wet lay-up fiberglass. Observation of the half scale tests showed the skirt of the cowl to be in compression and fastening

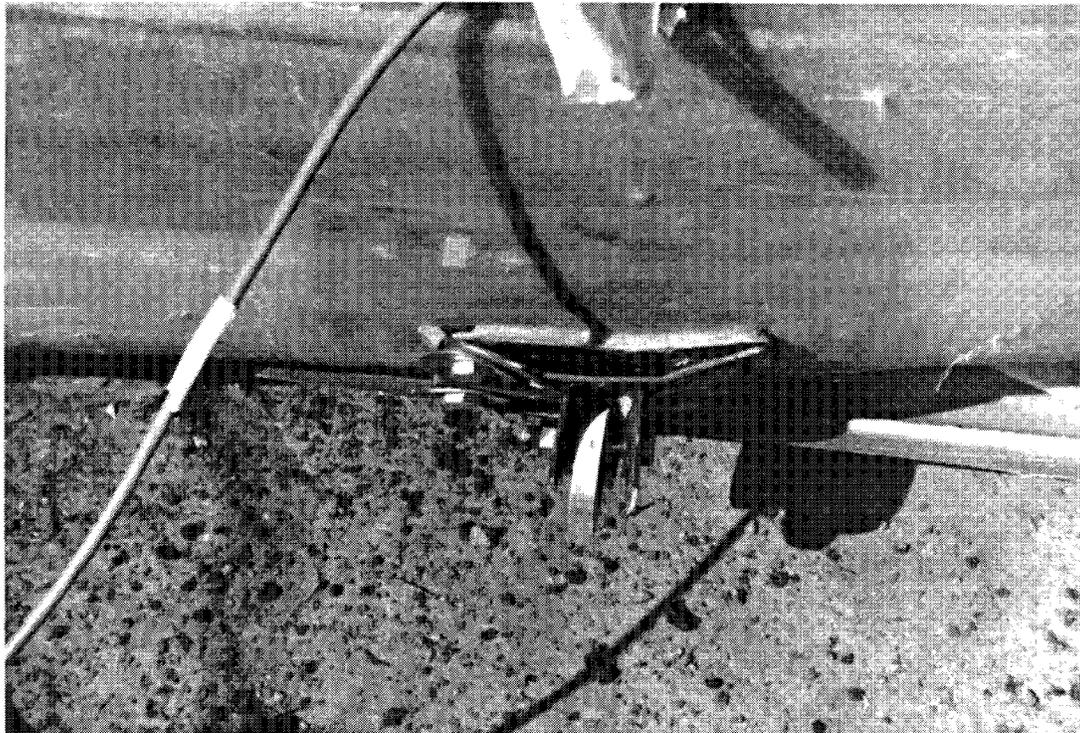
(f), Rear Wing Spar Fitting

Both wings broke forward because the fittings built into the rear spar pulled through the end of the spar. These fittings were aluminum inserts, shown in Figure 126(f), designed to increase bearing strength. The wing for test 3 was the same wing used in test 1. This wing was refurbished to fix the visible damage prior to test 3 but it cannot be determined if there was prior damage to these fittings. It should be noted that test 1 on hard surface produced higher loads normal to the floor than parallel to the floor while test 3 on soft soil produced the opposite results. Upper main spar caps failed at the side of the fuselage while the lower spar caps separated from the web in what appeared to be a bond line failure, possibly with an incomplete bond.

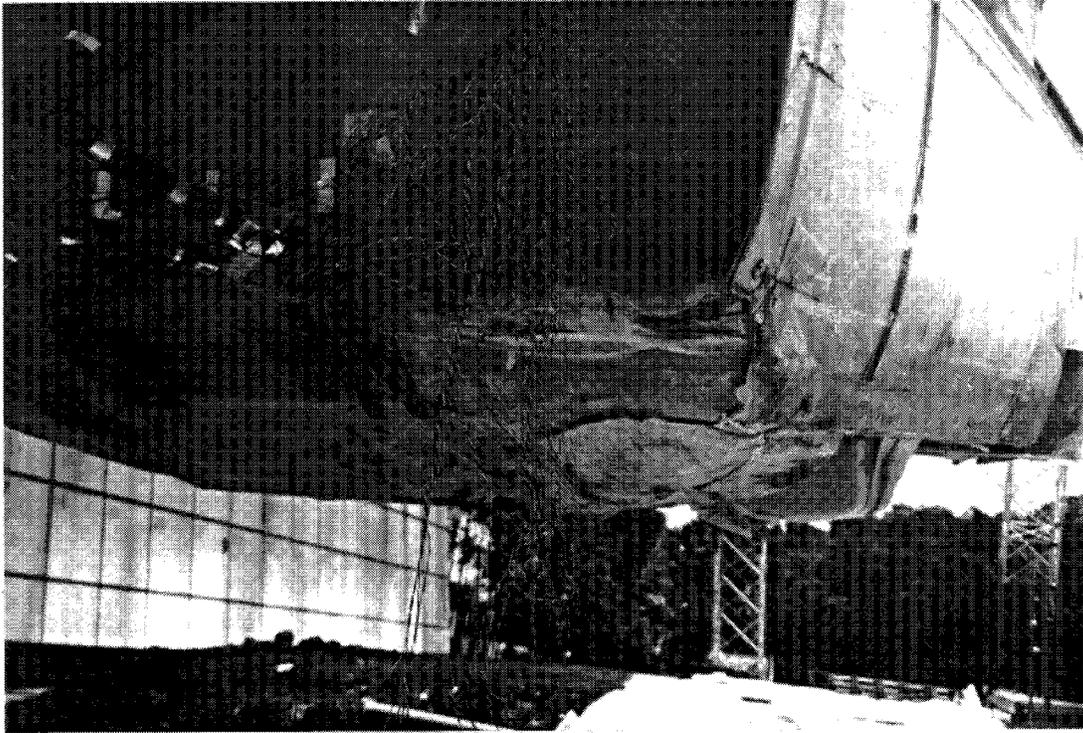
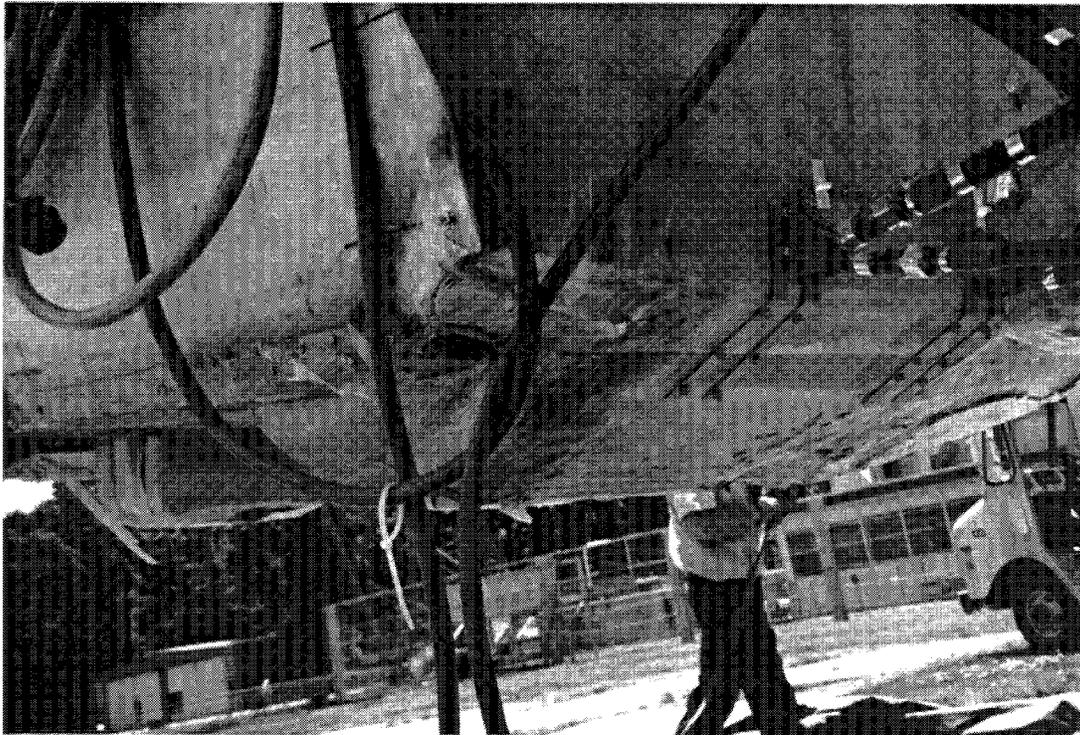
The slanted floor of the firewall was fractured toward the outside edges as shown in Figures 126 (g-h) but was not penetrated so the foot space was not compromised.
