RESTORING REDUNDANCY TO THE MAP PROPULSION SYSTEM

James R. O'Donnell, Jr.*, Gary T. Davis*, David K. Ward*
NASA Goddard Space Flight Center, Greenbelt, Maryland 20771, USA

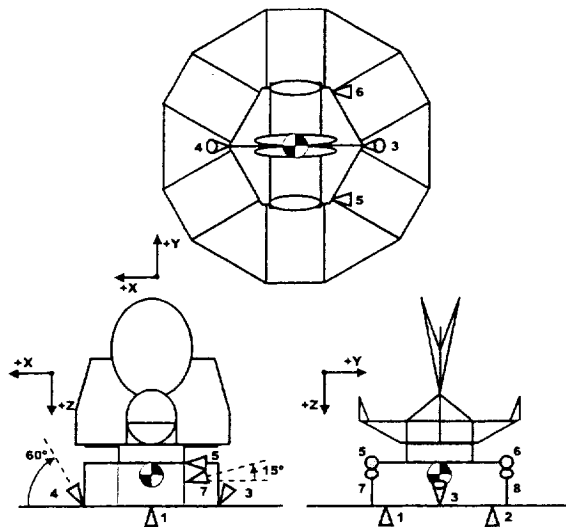
Figure 3: Original Thruster Layout

Thrusters 5 and 6 were placed on the $-X$ face of observatory along the Y axis, providing a thrust in the $+X$ direction and $\pm Z$ torque for attitude control. This design provided both decoupled attitude control thrusters and thrust vectors in three different directions. This feature allowed the observatory to thrust in any direction without exposing the instrument to the sun, critical to maintaining the needed thermal stability during stationkeeping maneuvers at L_2 . (The approximate locations of thrusters 1–6 are shown in Figure 3; thrusters 5 and 6 were actually aligned with the center of mass at this point in the design.)

In order to maximize the utility of the added thrusters, the team decided to mount them in a canted direction to provide functional redundancy for all three thruster pairs. In order to achieve this, thrusters 5 and 6 were moved in the $-Z$ direction with respect to the spacecraft center of mass (CM) and thrusters 7 and 8 were added on the $-X$ face of the observatory with a 15° cant from the XY plane to provide thrust vector in the $+X$ and $+Z$ directions, as shown in Figure 3.

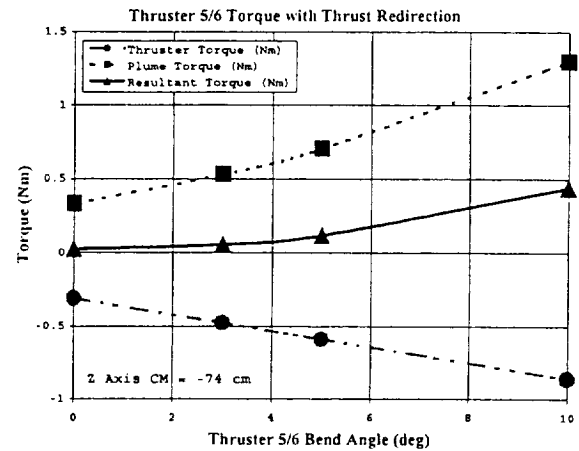
Figure 4: Results of Thruster 5/6 Bend Option

Two groups of thrusters were considered for redesign: thrusters 5–8 or thrusters 1 and 2. Because thrusters 5 and 7 share a mounting bracket, as do thrusters 6 and 8, redirecting the thrust axis of thrusters 5 and 6 might also change the thrust direction for thrusters 7 and 8. After considering the possibilities of moving or changing the cant of thrusters 5 and 6, this option was eliminated for two reasons. First, the proposed change to both thruster brackets interfered with spacecraft structural members, making the modifications nearly impossible. More importantly, any redirection of the thrust direction for thrusters 5 and 6 in order to create a larger torque in the $-Y$ axis would also create a larger plume impingement torque in the $+Y$ axis. As shown in Figure 4, the plume impingement torque increased faster, eliminating any torque benefits gained by the increased moment arm relative to the CM.

Instead, the team determined that rotating the thrust from thrusters 1 and 2 in the XZ plane allowed them to be used for $-Y$ torque control in place of thrusters 5 and

6 in the event of a thruster 4 failure. A small 5° – 10° redirection would not significantly affect the fuel budget, since thrusters 1 and 2 would only be used for ΔV during the shorter stationkeeping burns once MAP reached L_2 .

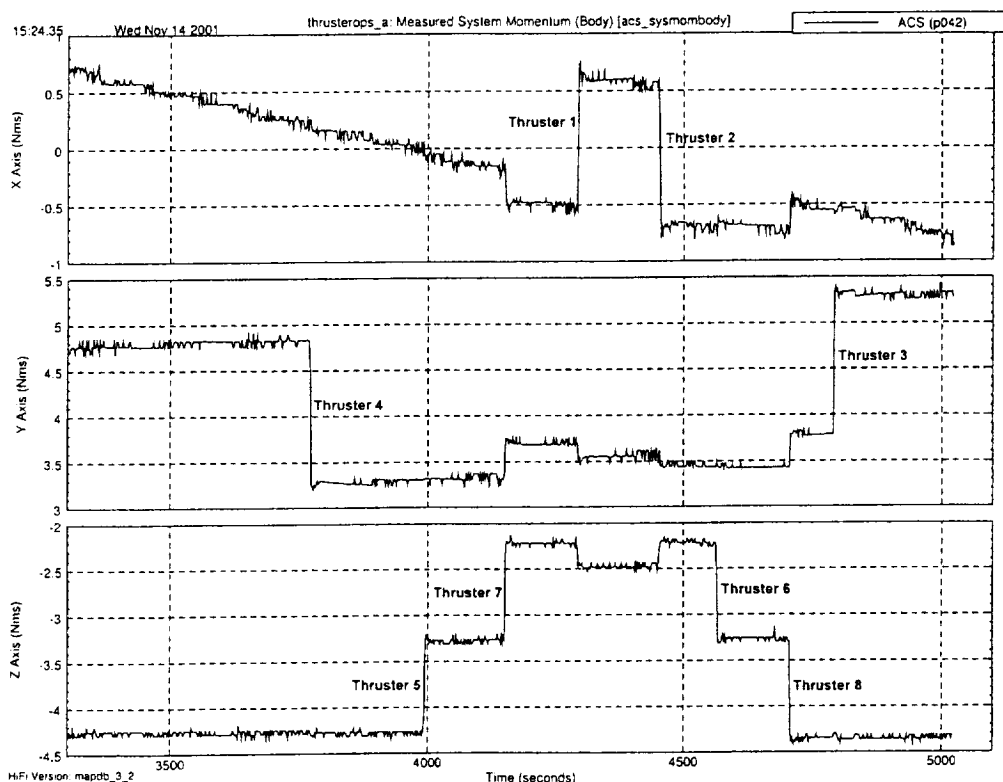
Figure 10: Thruster Pulse Check Momentum Effects

A specific order for the thruster tests was determined by the ACS team so that the tests would tend to decrease rather than increase the system momentum. Figure 10 shows the system momentum magnitude difference caused by the first round of thruster one-shots. As each thruster was fired during the first round of tests, the momentum changes were only 73–82% of the expected values.

The propulsion team did not find these results to be of concern, surmising the low value to be caused by the initial lack of hydrazine between the thruster seats, and that the second round of thruster pulse checks would yield momentum changes closer to the expected value. When the second round of tests also produced lower than expected results, a different theory was suggested, that the 400 millisecond thruster firings were not long enough for the thrusters to reach a steady-state temperature, decreasing their effective thrust. In this case, the consistency and relative performance of the thrusters became the proof of correct thruster function.

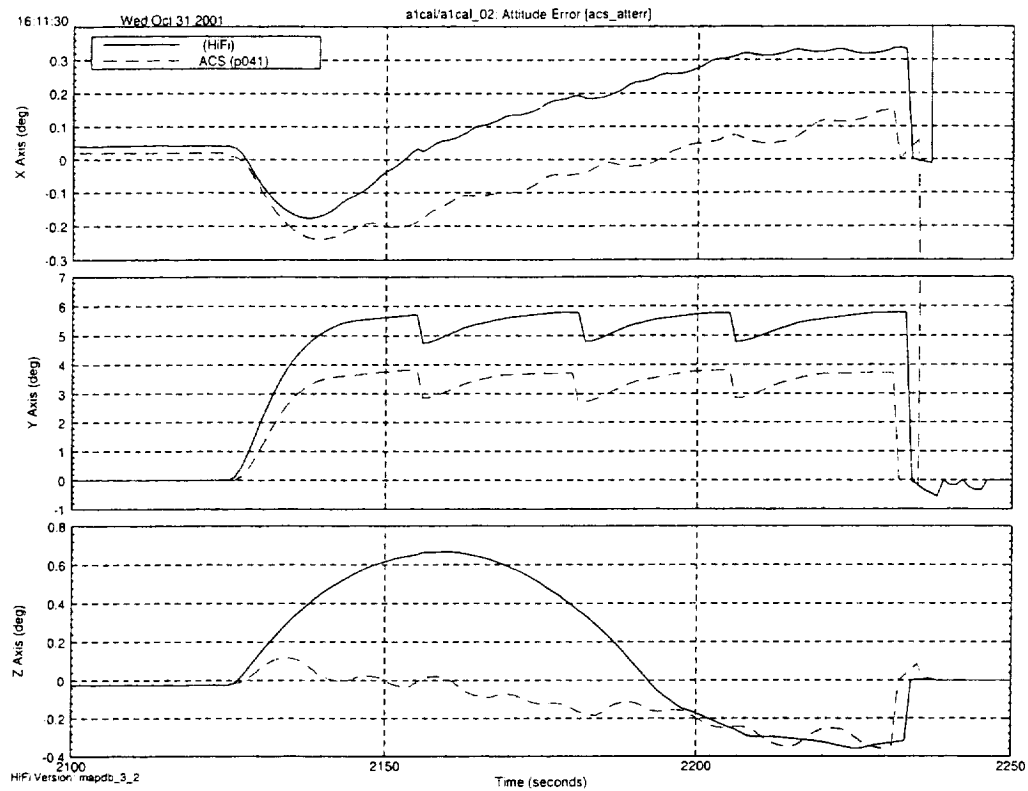
Figure 11: +X Calibration Maneuver Predicted and Actual Attitude Error (Pre-Calibration)

Figure 11 shows the attitude error from the first Delta V calibration burn, along with the expected performance as determined from HiFi simulation. The performance was much better than expected, with a thruster 4 duty cycle of 28% and a Y axis attitude error just under 4°. This was potentially good news—the lower duty cycle meant less fuel usage along with the smaller attitude error—but there was some concern about finding a viable explanation for the better performance. After analysis, a CM 2.785 cm from its predicted value and thruster plume impingement torques 50% of their expected magnitudes was found to allow accurate predictions of thruster mode performance. Figure 12 shows the actual vs predicted performance of the burn after calibration, with much better concurrence.

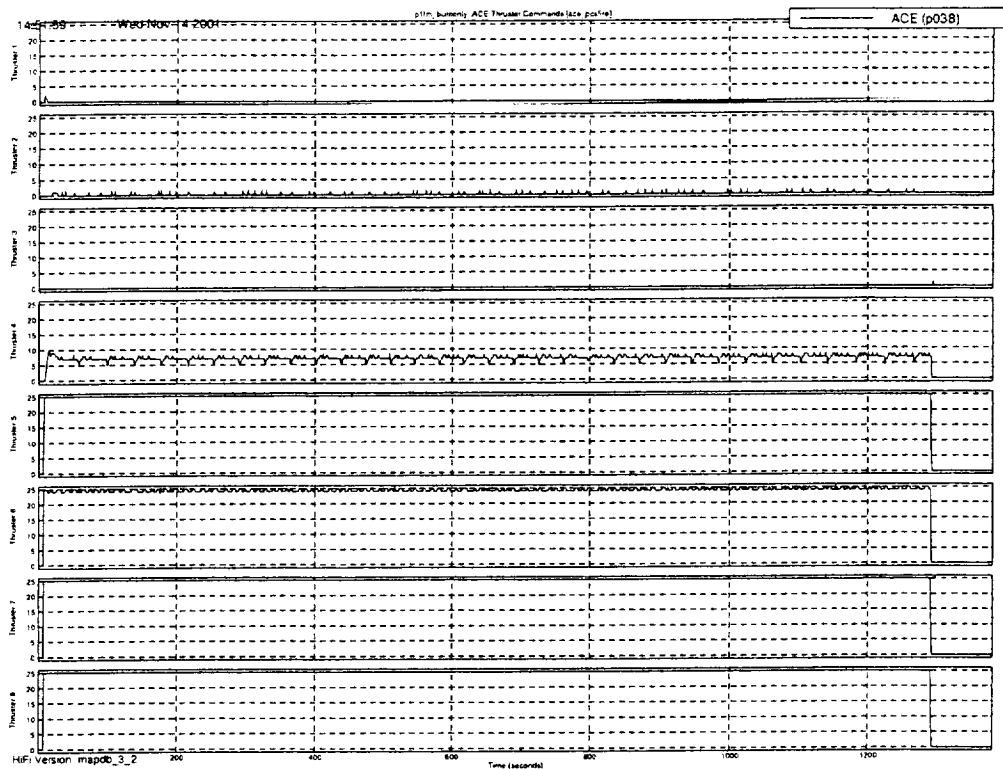
Figure 13: Perigee Maneuver 1 Thruster Commands

Figure 13 and Figure 14 show the thruster commands and attitude error flight data from the first perigee maneuver, a 20 minute burn that was the longest performed. As shown, the thruster 4 duty cycle and attitude error performance were consistent with that seen in the calibration burn. Except for some excitement due to an “anomalous force” acting on the spacecraft near perigee,¹¹ the first maneuver proceeded nominally, both from an ACS and a trajectory point of view. The remaining orbit maneuvers at the second and third perigee and the final correction maneuver were also nominal and put MAP on a good trajectory for its encounter with the moon and its path to L₂.
