RM A7D28 *Douglas**C-74/1*~~LANGLEY SUB-LIBRARY~~**NACA****RESEARCH MEMORANDUM**

AERODYNAMIC CHARACTERISTICS OF A PORTION OF THE

HORIZONTAL TAIL FROM A DOUGLAS C-74 AIRPLANE

WITH FABRIC-COVERED ELEVATORS

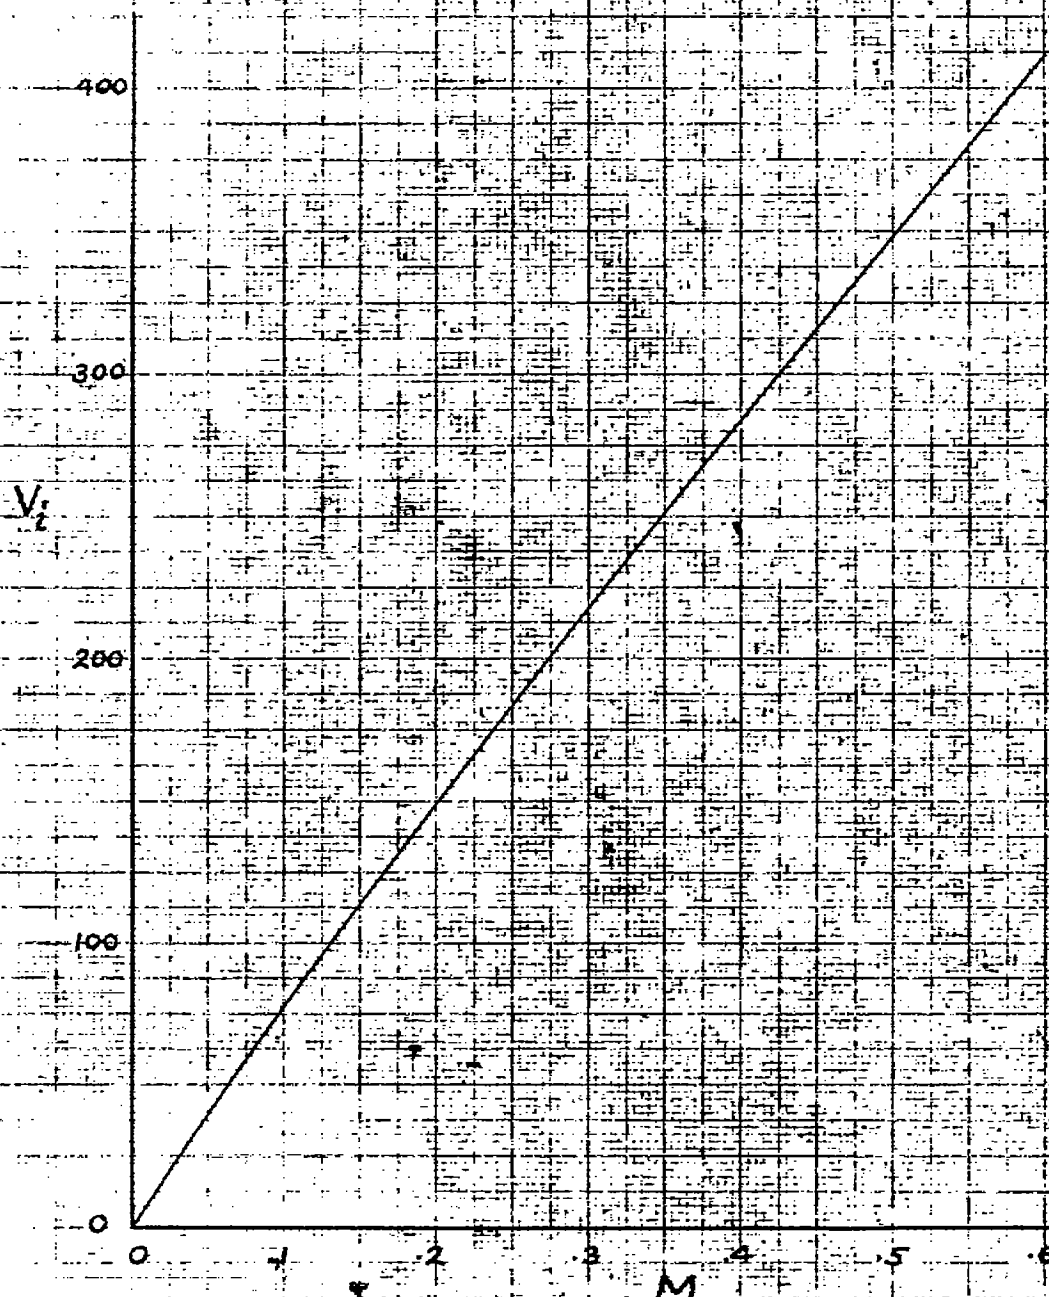
FIGURE 23.— VARIATION OF INDICATED AIRSPEED WITH MACH NUMBER FOR THE CONDITIONS IN THE WIND TUNNEL DURING TESTS OF THE HORIZONTAL TAIL FROM A DOUGLAS C-74 AIRPLANE

Figure 23 shows the variation of the indicated air speed with Mach number in the wind tunnel. It is probable that the elevator surface deformation and aerodynamic characteristics were at least partly affected by the increase in dynamic pressure with increase of Mach number. In applying the results of the wind-tunnel tests, the values of indicated airspeed should be considered along with the Mach number.
