# COLUMBIA

## ACCIDENT INVESTIGATION BOARD

REPORT VOLUME IV  
OCTOBER 2003

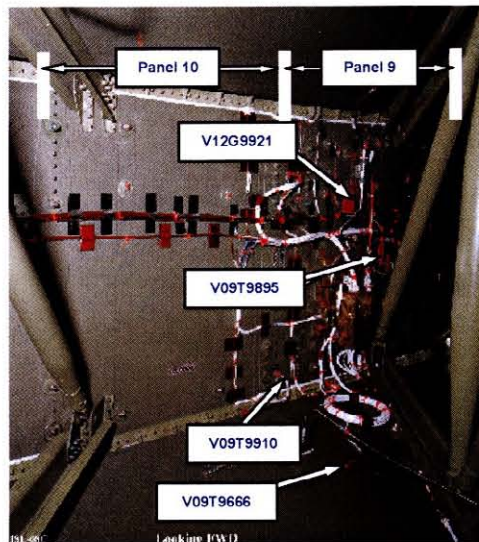
Figures 9 and 10 depict the physical location of the MADS/OEX sensors in the Panel 9/10 area of Columbia's left wing. Figure 9 is a photograph of the backside of the wing spar, looking forward. The approximate locations of RCC Panels 9 and 10 are shown near the top of the photograph. Fortunately, this region of the wing on Columbia was instrumented for the Orbiter Experiments (OEX) activity early in the Shuttle Program, and the instruments were still operational and recording data during STS 107. Data from four sensors are extremely valuable in helping understand the temporal events leading up to the failure of the wing leading edge system: V12G9921, a strain gage mounted to the spar; V09T9895, a thermocouple mounted to the back of the spar at the Panel 9 location; V09T9910, a thermocouple mounted to the clevis which held RCC Panel 9 in place (under an "earmuff" which insulated the clevis); and V0T9666, a thermocouple mounted in a tile in the lower wing, near the tile surface, close behind the number 9 carrier panel tiles. V09T9910 is imbedded in the RCC mounting hardware, which secures the panel to the spar.

Figure 9: Photograph of Rearward Side of Columbia's Left Hand Wing Spar, Looking Forward. OEX Sensor Locations are Depicted.

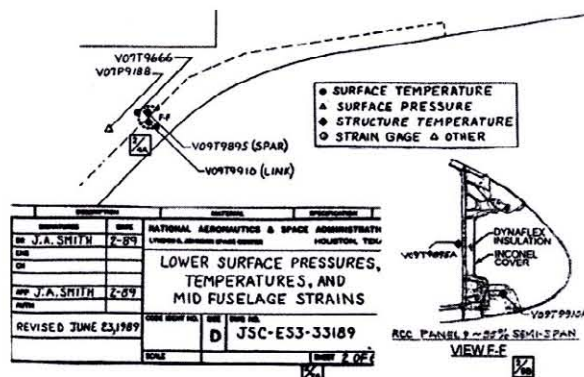
To help visualize the geometric location of the sensors, Figure 10 shows portions of an engineering drawing from a document describing the OEX instrumentation. As can be seen, top and side views are shown along with a key identifying the type of sensor.

Figure 10: Portion of an Engineering Drawing Depicting the Location of OEX Sensors.

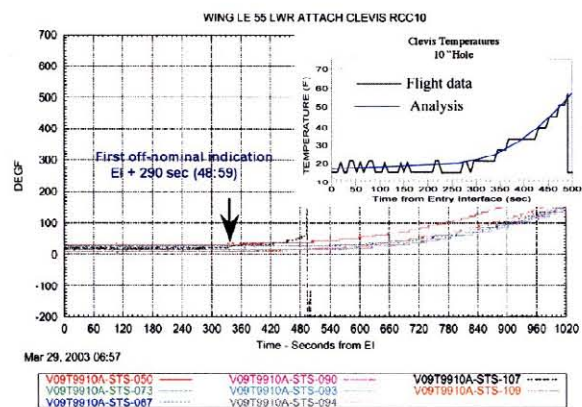
Figure 12: OEX/MADS STS-107 Flight Data and Thermal Analysis (Reference 12).

Figure 12, prepared in the same format as Figure 11 displays the time history of a thermocouple imbedded in the clevis fastener at the lower edge of the RCC located between Panels 9 and 10. The temperature changes recorded on the RCC clevis during STS 107 entry, appear to be quite small, but it is noted that this thermocouple is highly insulated and attached to a large thermal mass.

A thermal analysis by NASA (Reference 12) has shown that a hole of 6 -> 10 inches in diameter in the lower RCC Panel 8, could account for the early behavior of the thermocouple. The result of this analysis is shown in the inset in Figure 12. The “stepped” curve is the flight data while the blue, smooth curve is the result of the referenced analysis.

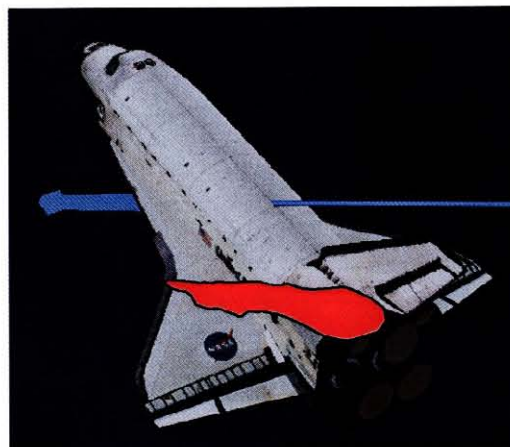
Figure 16 depicts a possible explanation for some of the early (near 13:50:00) communication dropouts observed during Columbia's entry. As known from many years of experience with entry of vehicles, small amounts of charged species (electrons and ions) between an antenna and the receiver can cause communication signal attenuation and even its total loss. As shown in the figure, a possible explanation for some of the early signal attenuation could have been electrons and ions, along with molten materials from the wing hardware, being entrained in the flow and transported to locations between the antennae behind Columbia's cockpit and the receiving TDRS communications satellite.

Figure 16: Entry Plume is Possibly Affected by Damaged Structure Accounting for Communications Dropout.

At the request of the authors, D. Potter of Sandia National Lab performed a scoping study (Reference 15) which shows that melting aluminum would provide charged species concentrations in sufficiently large quantities for signal attenuation in the 13:50:00 -> 13:50:30 period. However, to date (July 2003) analysis by NASA has failed to provide an understanding of how the flow behind Columbia could have provided a pathway to place the charged species and/or molten metal between the antennae and the receiving satellite. Darling (Reference 4) has pointed out that the communications drop out occurred at times quite close to several major debris shedding events and to the breach of the LW spar. However, a definitive link between the two is still conjectural.

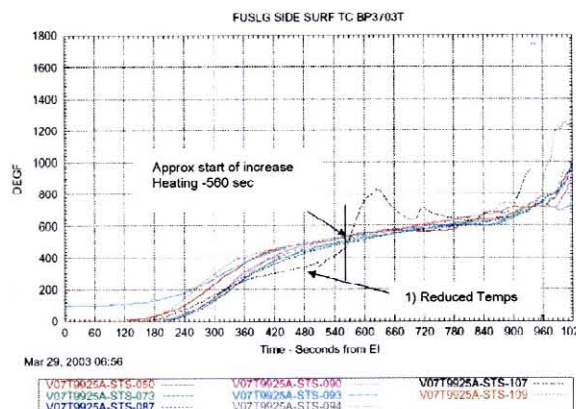
Figure 17: Representative Fuselage Sidewall Thermocouple Data.

Figure 17 displays the left fuselage sidewall thermal profile for thermocouple VO7T9925A in the standard MADS/OEX format wherein the data for STS 107 are compared to those from other, similar entries of Columbia. As can be seen, there is an out-of-family lower temperature trend at EI + 360 seconds, correlating to GMT 13:50:09. This early below nominal, and later, above nominal temperature observation on the fuselage sidewall, for a number of thermocouples has been explained by the NASA team led by J. Caram (Reference 16) to arise from flow disturbances propagated from the wing leading edge. The study depends upon a combination of hypersonic wind tunnel data and CFD analysis. The reader interested in detail is referenced to this report and the Aerothermodynamics section of the CAIB report (Reference 17).

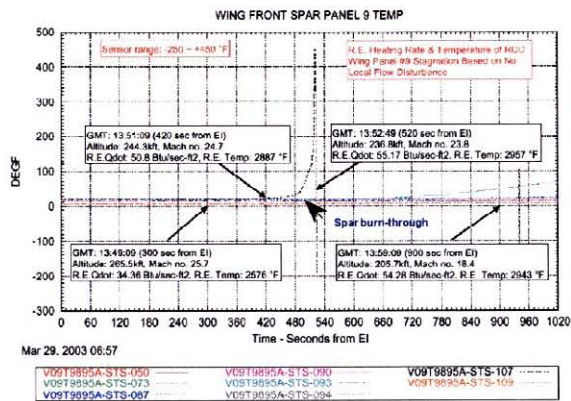
Figure 20: OEX/MADS STS-107 Flight Data.

Figure 20 displays the temperature recordings from thermocouple V0T9895A, located on the inside of the spar, behind Panel 9, as discussed in Figures 9 and 10 above. These data are quite valuable in understanding the progression of damage to the wing leading edge. As seen, the first off-nominal indication begins at 420 seconds after EI, GMT 13:51:09 with a very slight increase in temperature. Later discussion of this figure will focus on the burn through of the spar.

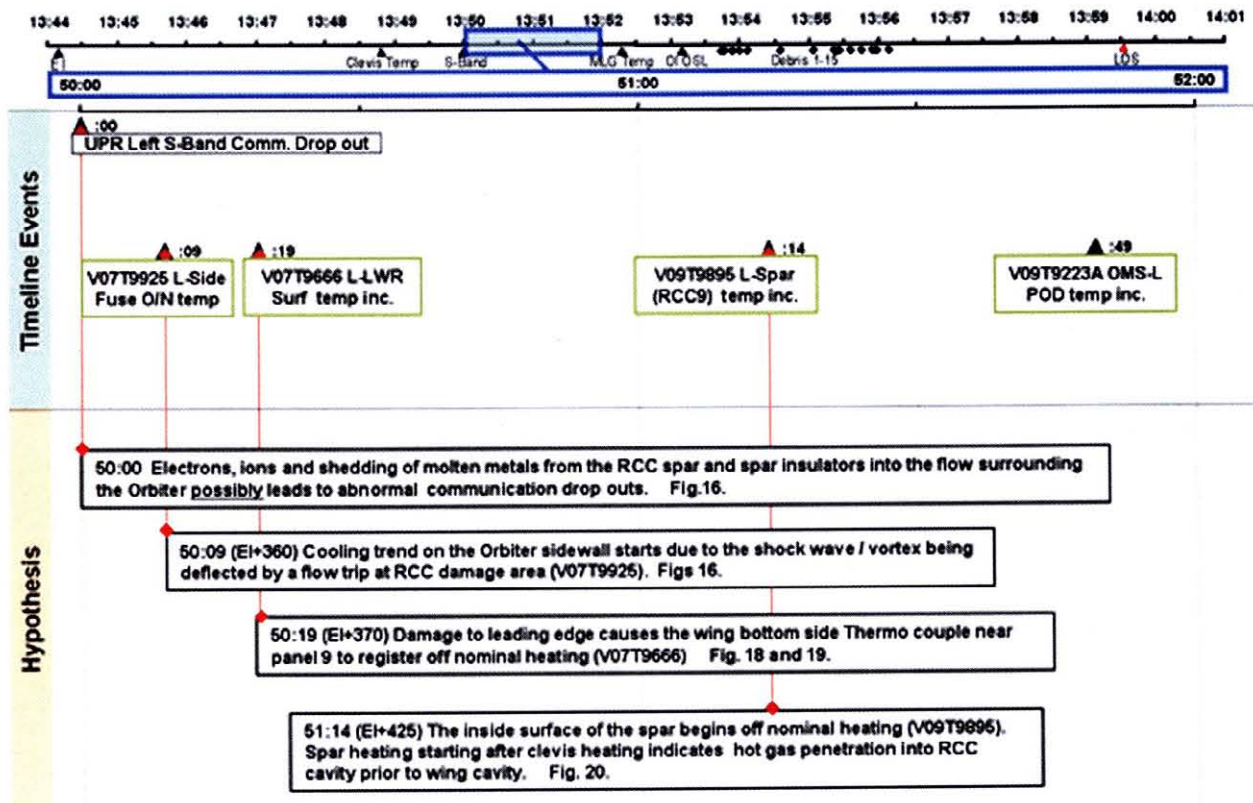
Figure 21: Timeline Versus Hypothesized Events – 13:50:00 to 13:52:00.

Figure 21 graphically depicts the timing of communication drop out and additional events recorded by the OEX sensors. The captions are self-explanatory. The MADS/OEX off-nominal data in the wing leading edge and spar are additional evidence that a breach existed in the RCC at the EI. The below nominal temperatures recorded on the fuselage sidewall is consistent with the hypothesized damage in the wing leading edge in the RCC Panel 5-8 area. The spatial correlation by the streamline analysis in Figure 19, showing how the outflow from the lower juncture of RCC Panel 8 and 9 can affect the lower tile thermocouple behind Panel 9 and the above nominal behavior of thermocouple V07T966, is additional and compelling evidence for the existence of a breach in the Panel 8/9 area. It is clear from this figure that the temporal evolution of the heat flow shows that the hot gas penetration began in the cavity in the wing leading edge prior to heating in the wing box behind the spar.

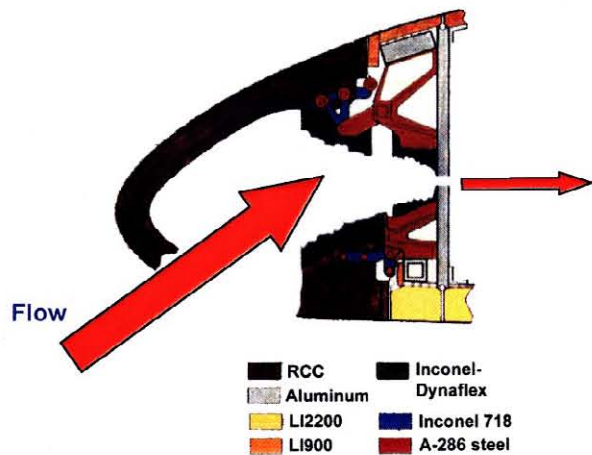
Figure 22: Spar Breach Occurs at EI + 487 Seconds.

the back of the spar behind Panel 9. This rapid increase at EI + 487 seconds strongly suggests an appearance of a plume of superheated air and that spar penetration had occurred. According to study (Reference 13 and 19) by NASA, this timing for spar burn-through is consistent

with a thermal analysis for a 6 -> 10 inch diameter hole in the RCC Panel 8, failure of the leading edge wire harnesses and bit flips observed in the wheel well.

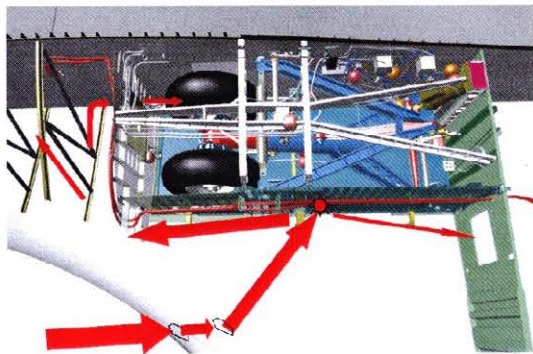
Figure 23: Hot Gas Begins to Fill Wing Box.

Figure 22 and 23 are artist's concepts of the burn-through and hot gases filling the wing box.

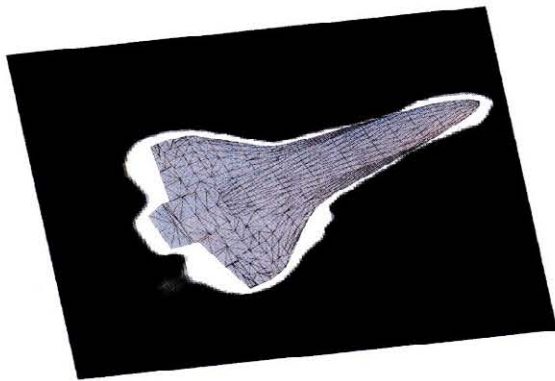
Figure 25: Starfire Photo from Kirtland AFB. GMT 13:57:14. Model Scaling and Orientation Based on Telemetry from NASA. The Columbia Model was Provided by NASA.

Figure 25 is a photograph of Columbia, taken at GMT 13:57:14 from the Starfire Facility at Kirtland AFB in Albuquerque, NM. At this time, Columbia was about 50 miles NW of Starfire at an altitude of about 40 miles, it had an 80 degree left angle (with the left wing down) and a 40 degree angle of attack. Therefore, the view of the vehicle is from the forward, bottom, left side, so that any hot plumes spilling over the top of the left wing leading edge or out of the top of the wing near the leading edge are visible.

The image records the appearance of the shock layer around the vehicle. As is indicated by the model grid overlay, the left side of the fuselage would be visible if it were not for the shock layer brightness and the slight wrapping around of the flow over the lower part of the forward fuselage. The apparent enlarged portion of the nosetip area is also due to the shock layer expanding around the forward fuselage from the stagnation point at the lower part of the nosetip. The shock layer is also visible through the short (a few meters long) wake that persists behind the vehicle.

The left wing has two apparent "bulges" on the leading edge and two corresponding wakes behind the wing. The authors believe that these are due to the following: hot flow and burning material ejected upward over the wing leading edge from the Panel 8 area; and a large plume of hot gases and burning material and debris ejected upward from the breach in the top surface of the wing aft and outboard of the Panel 9/10 area.

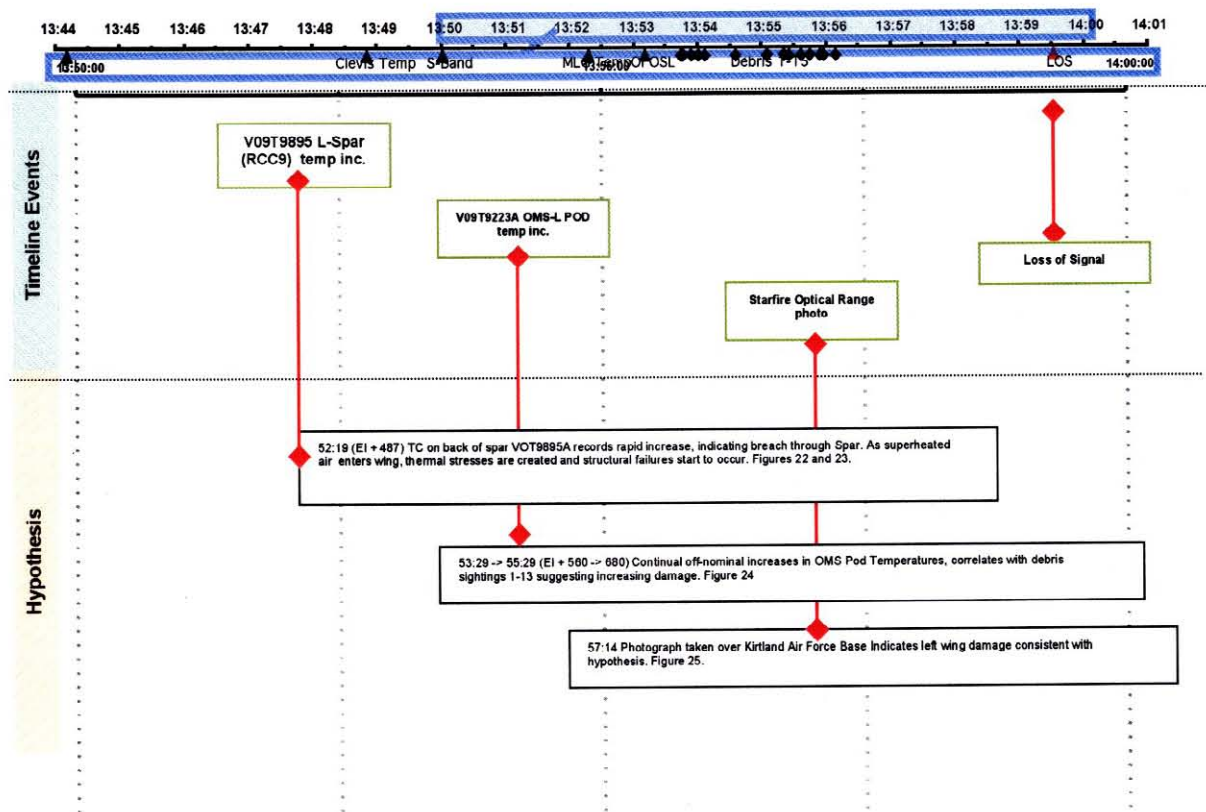
Figure 26: Timeline from 13:50:00 Through Loss of Signal 13:59:32 Versus Hypothesized Events.

The captions within Figure 26 displaying the comparison to the hypothesis and the timeline between GMT 13:52:00 and 14:00:00 are self-explanatory. During this time, the breach through the spar and internal heating to the wing box and wheel well have rendered the loss of the vehicle inevitable. The temporal progression of damage to the TPS has been outlined herein with the exception of the shedding of tiles and RCC panels/parts. Geographic locations of the recovered TPS debris and ballistic analysis suggest that much of this occurred over Texas. Others have written in detail on the analysis of debris sightings, sensor readings, etc. and it is outside the scope of the “Follow the TPS” charter to dwell further on these topics.

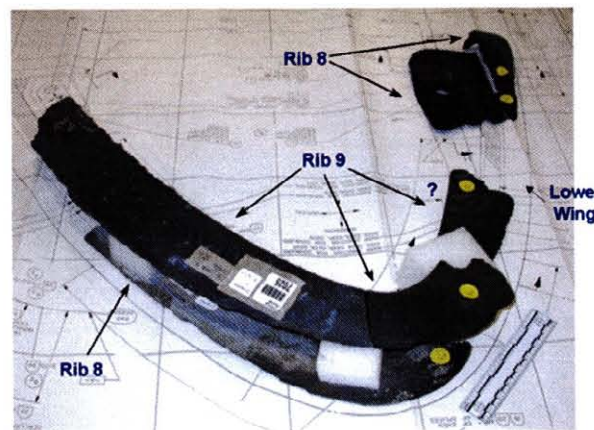
Figure 29: RCC Panels 8/9 Ribs (Inboard View).

Figure 29 is a photograph showing an inboard view of recovered parts of RCC ribs from Panel 8 and 9. Here, the two recovered and identified parts of the inboard rib of Panel 9 are sitting on white foam blocks. The recovered parts from the outboard rib of Panel 8 described in Figure 28 are now shown lying on their full-scale drawing. Note that the yellow tags here are labeled "NA," meaning not ablated and verifying the statements made in the discussion of Figure 28.

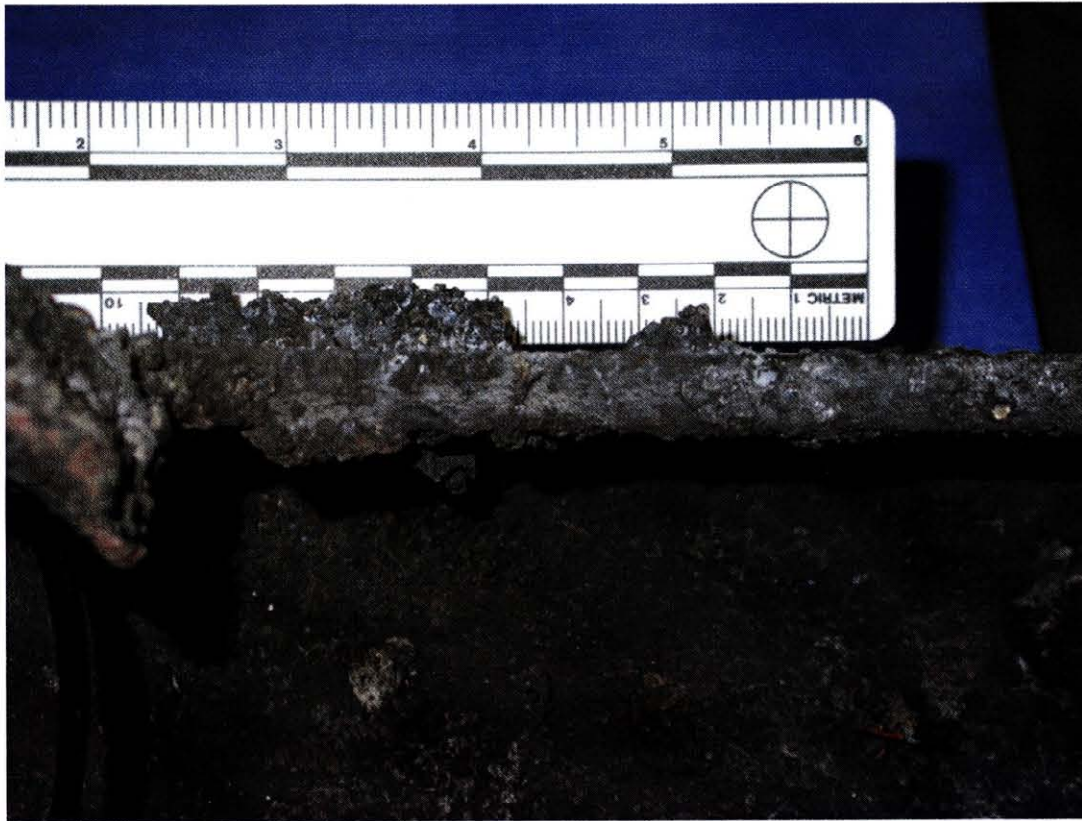
Figure 32: Slag Deposits on Upper Edge of Panel 8 on the RCC Side of the Vent.

Figure 32 is a close-up photograph of what was the RCC side of the vent gap on the upper Panel 8. See Figure 5 for an assembly drawing of the vent. As can be seen, there is a heavy accumulation of slag (up to 0.4 inches thick). This indicates that the gap at the top and outboard edge of Panel 8 and possibly Panel 9, were opened up from their normal configuration (0.114 to 0.164 inches) to at least 0.25 to 0.4 inches, and that melt from the interior fittings and insulation deposited there as the superheated air attacked the interior components of the WLESS and exited out of this vent location. The opening of the vent spacing could have happened at the time of the foam strike, or as the wing began to deform at the time of break-up; but most probably, it occurred during the long, high heating portion of the flight.

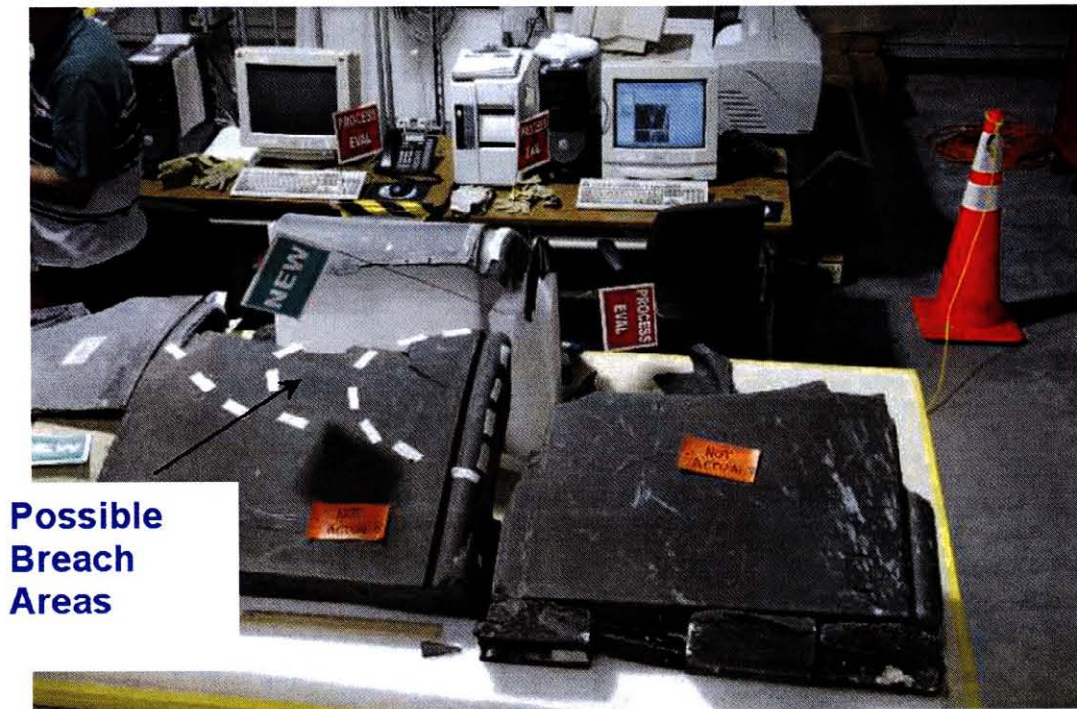
Figure 33: Probable Initial Breach in Panel 8.

Figure 33 shows the probable initial breach location on the lower Panel 8 area. The size of the hole is difficult to determine, but could be bounded by the three dotted locations outlined by white tape. Analysis by NASA discussed above suggests the damage is consistent with a hole of 6 → 10 inches in diameter. All of these are consistent with the flow patterning seen on the debris and the Computational Fluid Dynamics flow calculations to be discussed below. The authors note that areas this large would be consistent with the “piece” shown by DoD radar observations that “left” Columbia on day two of its orbital maneuvers. A part of a broken T-seal (possibly from Panel 8, located between Panels 8 and 9) could also account for the “piece” observed leaving the shuttle on day two of orbital operations. Note that on this photograph, the two recovered Panel 8 carrier panel tiles are not shown.

The authors believe that in addition to a breach in Panel 8, the upper part of the T-seal between Panels 8 and 9 must have been missing or severely misaligned for a major part of the entry. This is required to account for the severe erosion of the upper RCC Panel 8 outboard and Panel 9 inboard ribs shown in Figures 28 and 29 and discussed above. Flow patterns of the recovered upper Panel 8, suggest this happened as discussed in Reference 20.

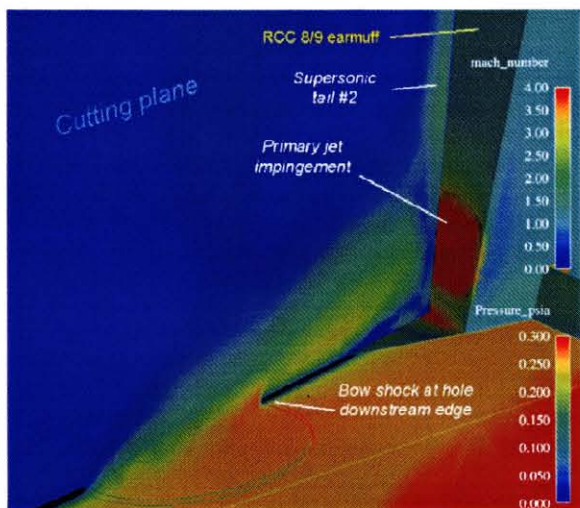
Figure 38 (a): CFD Predictions for Wall Static Pressure and Mach Number for a 10" Hole in RCC Panel 8, Corresponding to Solution in Figure 37. Static Pressure is Color Coded on Walls and Mach Number Distribution is Shown on the Cutting Plane.

Figure 38 (a) from the Boeing Propulsion and Power group depicts the static pressure on the WLESS internal walls and the Mach number on the cutting plane, which passes through the 10 inch diameter hole. The results indicate that all of the external boundary layer and some of the local inviscid (freestream) flow is ingested into the WLESS channel. The primary jet strikes the earmuff at a near-normal incidence (80°). Its stagnation pressure exceeds the freestream-shock pressure because of a precompression by the oblique vehicle shock.

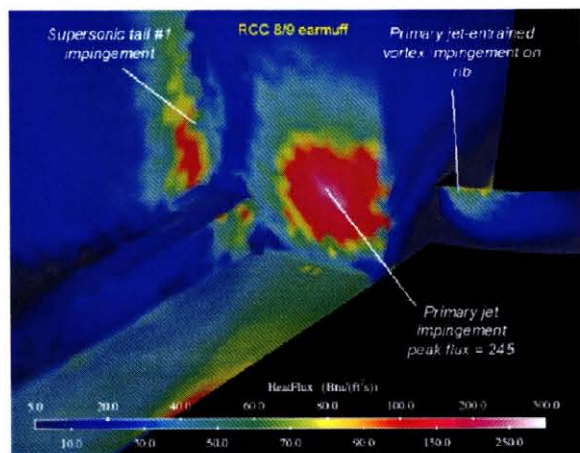
Figure 38 (b): CDF Predictions for Convective Heat Flux on Hot Tubs, Earmuff and Rib for a 10" Hole in RCC Panel 8, Corresponding to the Solution in Figure 37.

Figure 38 (b) shows CFD predictions for convective heat transfer to the spar insulation (hot tub), spanner insulation (earmuff) and the RCC outboard rib corresponding to the solutions shown in Figures 37 and 38 (a). The heat fluxes on the earmuff at the center of the jet impingement are significantly higher than that of an undamaged wing, immediately upstream of the breach in Panel 8 with a finite catalytic wall (Reference 18) (300 vs. 27.3 Btu/ft<sup>2</sup>s).

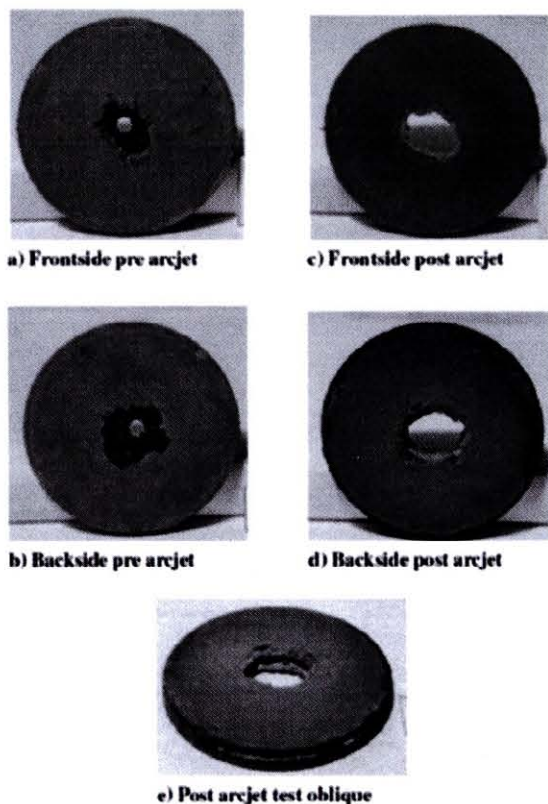
Figure 40: NASA/JSC Model Number 1159, Pre and Post Arc Jet Exposure at 2500 °F and 50 psf, 400 Second Exposure. (Reference 5).

Figure 40 displays photographs of the test article number 1159 pre and post arc jet test. Test conditions resulted in a surface temperature and pressure on test article number 1159 of 2500 °F and 50 psf, respectively. The exposure was for 450 seconds. Figures 40 c) -> 40 e) show that in this case, the hole growth grew by oxidation of the exposed carbon-carbon substrate. The oblique view in Figure 40 e) illustrates the “dishing out” of the carbon sandwiched between the SiC front and back coating. For these test conditions, Curry, et. al., did not expect hole growth owing to loss of the SiC coating because of its stability up to temperatures in the range of 2800-3000 ° F and this was confirmed by the tests.

It can be concluded from these tests that the dominant mechanism for the ablation of RCC with the coating removed is diffusion-controlled oxidation. At the higher temperatures, SiC coating loss is expected. This result, which causes “knife edging” for a circular hole suggests that if RCC was damaged in a linear fashion, one would see formation of knife-edges in superheated air heating environments existing for hundreds of seconds in conditions like those in the arc jet tests discussed in Reference 5. This observation was the basis for the discussion of the “knife edging” seen in the RCC Panel 8/9 debris from Columbia.

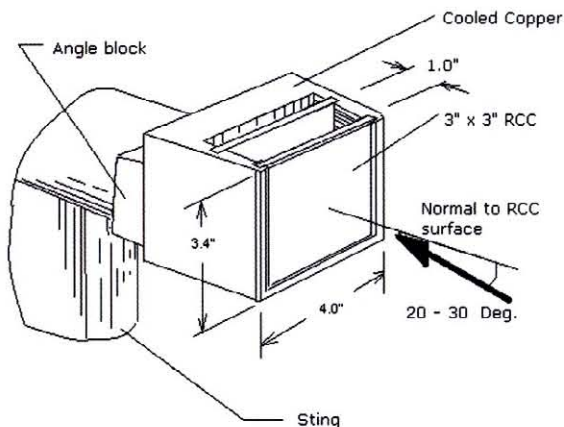
Figure 42: NASA/JSC Arc Jet Test Set-up for Linear Knife-edge Tests at Large Angle of Incidence (70°). Test to Simulate Flow Impingement on RCC Ribs.

The first test, with two parallel plates shown in Figure 42 with flow impinging at 70 degrees to the flat face was intended to simulate the flow inside the wing impinging on RCC ribs. The results of the test on the parallel plates was inconclusive, because the surface temperatures attainable, without damaging the model holder, were not high enough to cause ablation of the SiC coating.

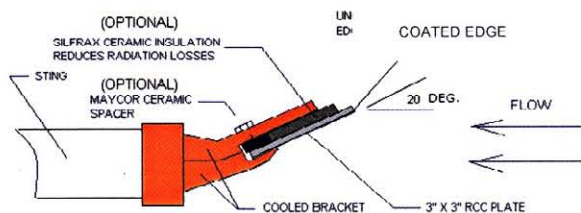
Figure 43: NASA/JSC Arc Jet Test Set-up for Simulation of RCC Knife-edge Erosion at Low Angle of Incidence (20°). Test Intended to Simulate Flow on Lip of Hole in RCC Panel.

The second test article, shown in Figure 43, was intended to simulate flow on the windward lip of a hole in Panel 8. This test, with a flow angle on the single plate at 20 degrees incidence showed that knife edging would occur when the temperature on the coated leading edge of the plate was above 3250 °F. Table 3 specifies the test conditions thought to simulate the enthalpy and impact pressure present in the damaged wing during Columbia's entry on STS 107.

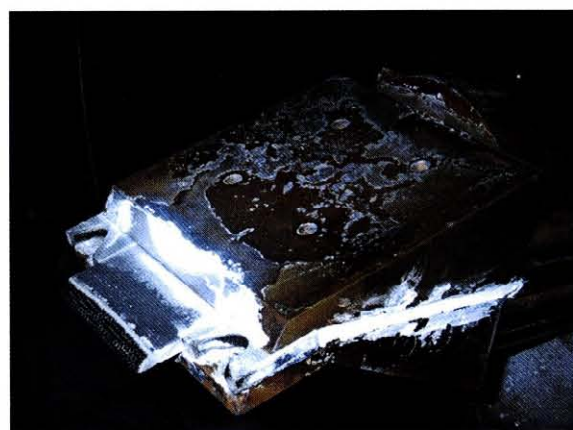
Figure 44 (b): Post-test Photograph Showing Knife-edges in Both RCC Test Article and Closeout.

Figure 44 (b) is the corresponding post-test photograph of the test article. Here, erosion of the SiC coating is apparent, as is the formation of a knife-edge on the primary RCC sample, where the highest temperatures occurred. The edge temperature was in excess of 3200 °F or greater as shown by the failure of the SiC coating. Furthermore, as shown in Figure 44 (c) knife-edges also formed in the SiC coated RCC closeouts where flow from the primary RCC sample was impinging.

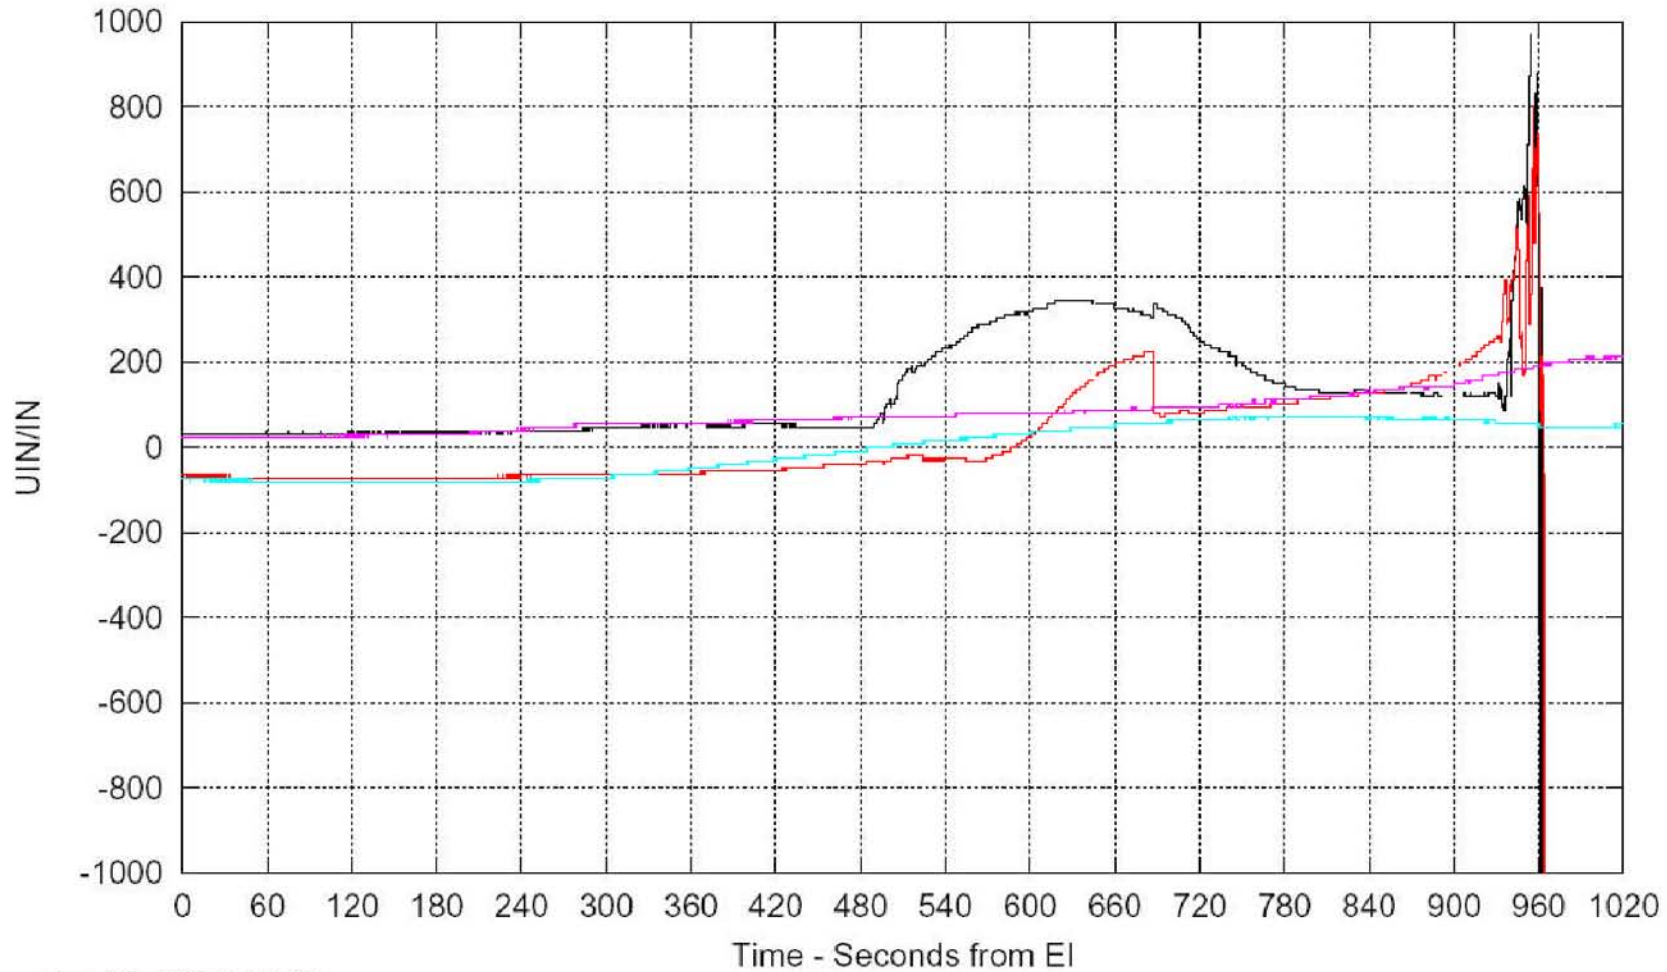
x1040 Spar Caps Strain Comparison

- Left Wing x1040 Spar Cap Gauges Show an Anomalous Trend Initiating Between EI +500 and EI +600 Seconds. Web Gauges Have “Snapshot Mode” Data Which Suggest Off-nominal Trending After EI +500 Seconds
  - The spar cap gauges are two of only three left wing gauges which did not fail prior to vehicle breakup
  - Further analysis is in work to assess potential explanations for these anomalous signatures
- Some Mid Fuselage and Right Wing Spar Cap Gauges Show Mild Discrepancies Versus Previous Flights
  - Discrepancies are more subtle
- A Number of Right Wing Skin Gauges Show off Nominal Trending Initiating Near EI +500 Seconds
  - Currently under further investigation

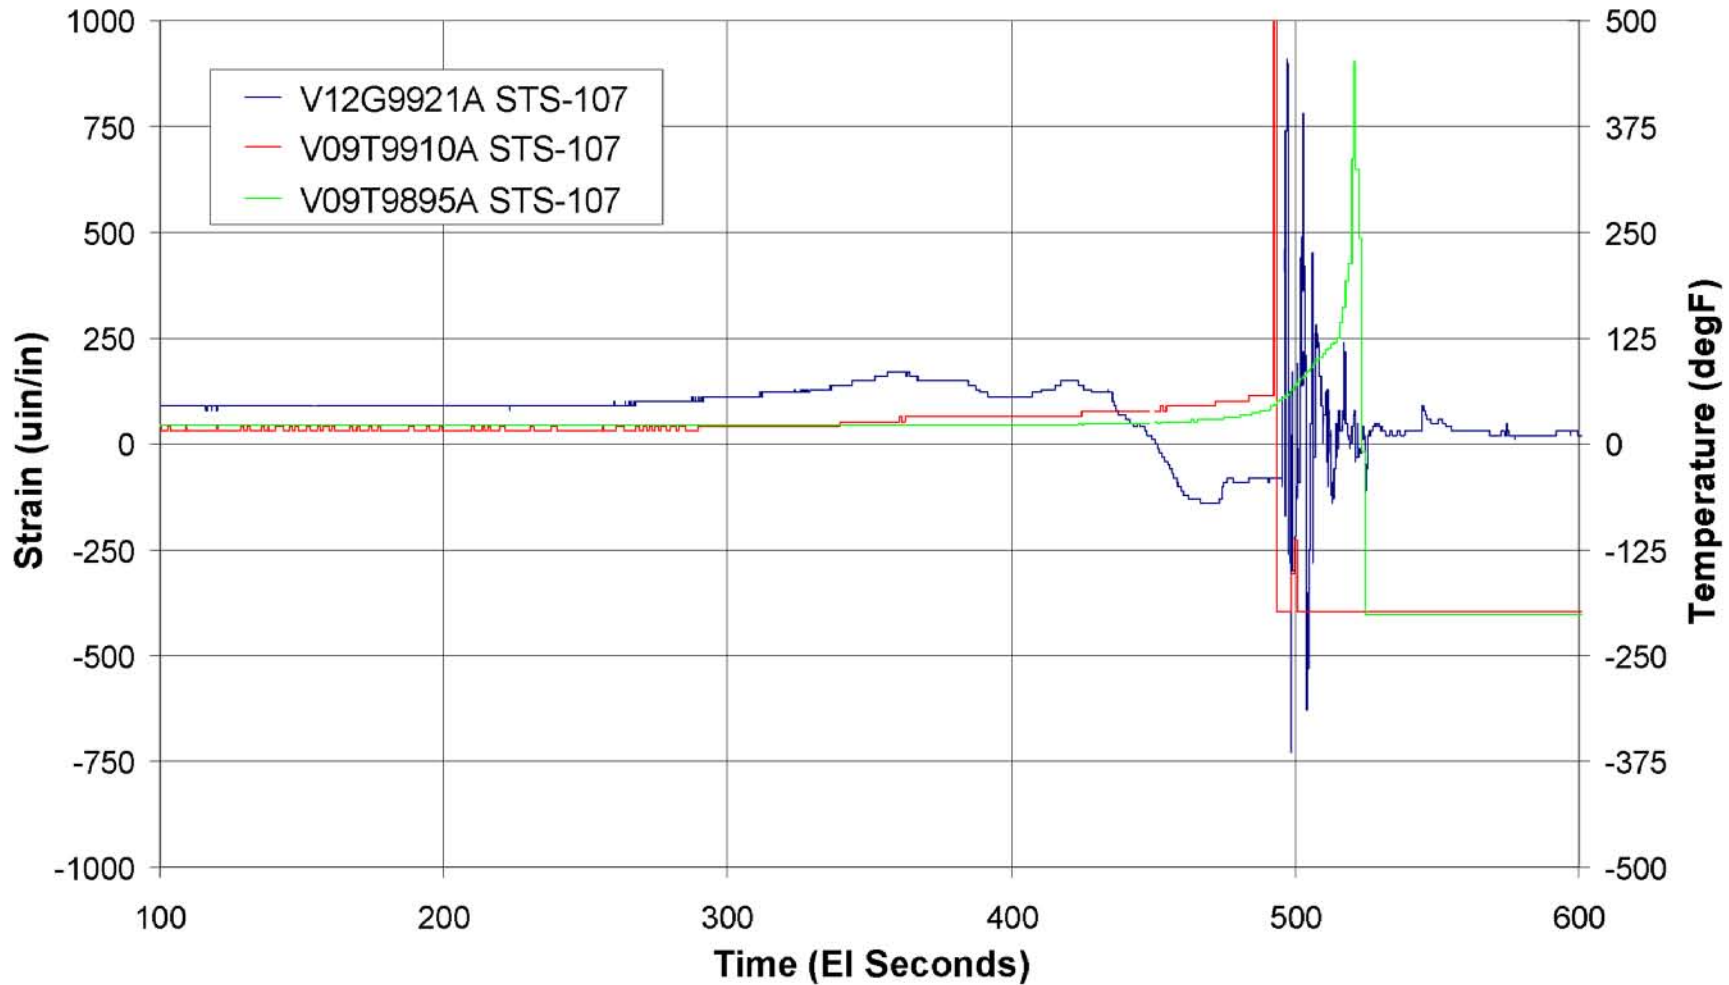
## RCC Panel 9 OEX Gages, STS-107

- Three MADS gauges of particular interest near RCC Panel 9 on the Left Wing
  - One Strain gauge, Two Temperature gauges
    - V12G9921A, V09T9910A, & V09T9895A
  - Data for these three gauges was plotted together
    - Indicates failure at approximately the same time for V12G9921A and V09T9910A (~EI +495sec)
    - Later failure for V09T9895A (~EI +515sec)
  - Continued analysis is underway for this data.

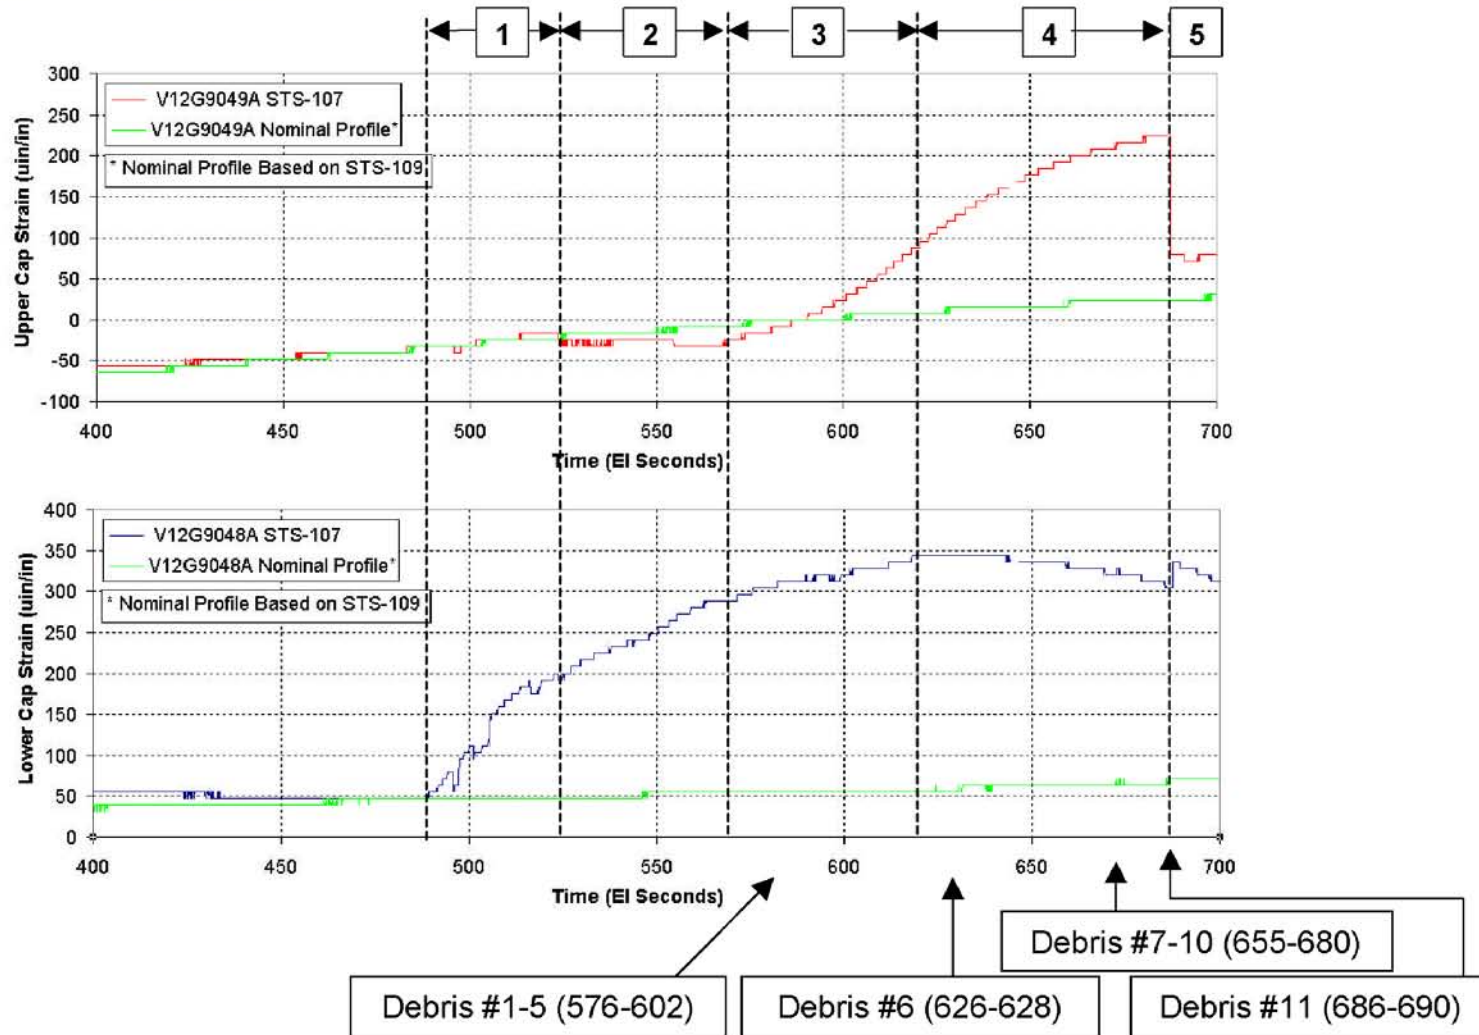
# STS-107 Reconstructed Data

- **Anomalous strain gage signatures are presumed to result from instrumentation malfunction, thermally induced strain, load redistribution, or a combination.**
  - Thermal effects are a more reasonable explanation than load redistribution scenarios.
    - Lower spar cap shows a slope sign reversal.
    - No slope changes before or after sharp data changes.
- **The current analysis uses FEM methods to assess the feasibility of thermally induced strain as a mechanism to produce the observed signatures.**
  - Analysis does not attempt to model actual structural temperatures.
    - Objective is to determine the structural response to local temperature differentials.

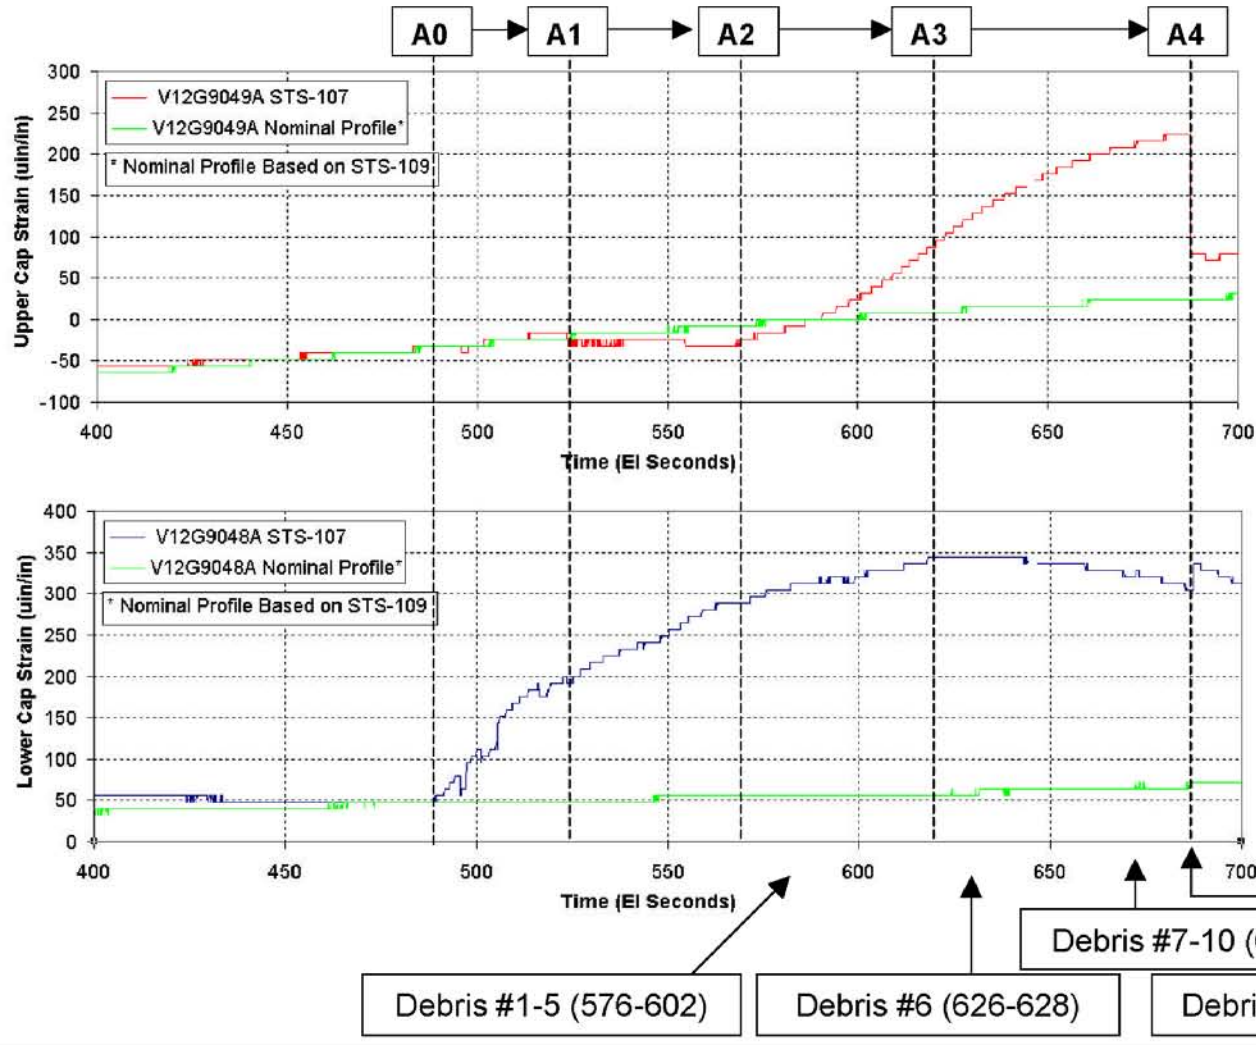
# FEM Scenario Timeline Plot

- **FEM temperature load cases may be combined in a number of ways to generate temperature profile sequences which produce the observed strains.**
  - Several profile sequences were developed, and screened versus corroborating scenario evidence to define the most likely profile that could have produced the observed strains.
- **The most rational temperature profile was selected.**
  - Combined heating of aft upper skin, spar web, upper and lower forward skins, and upper spar cap, with less heating to lower spar cap.

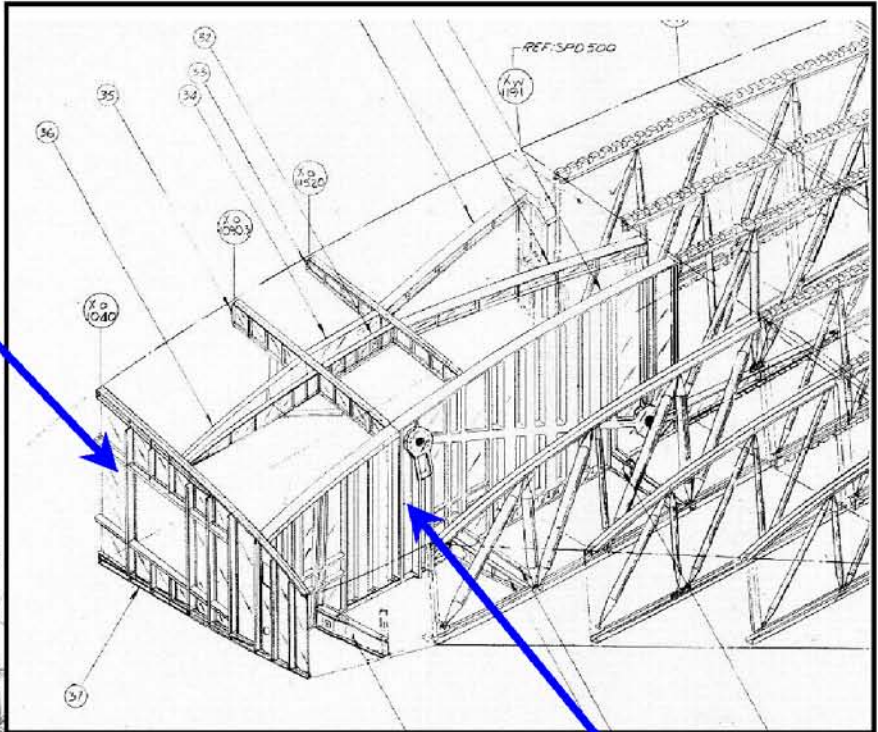
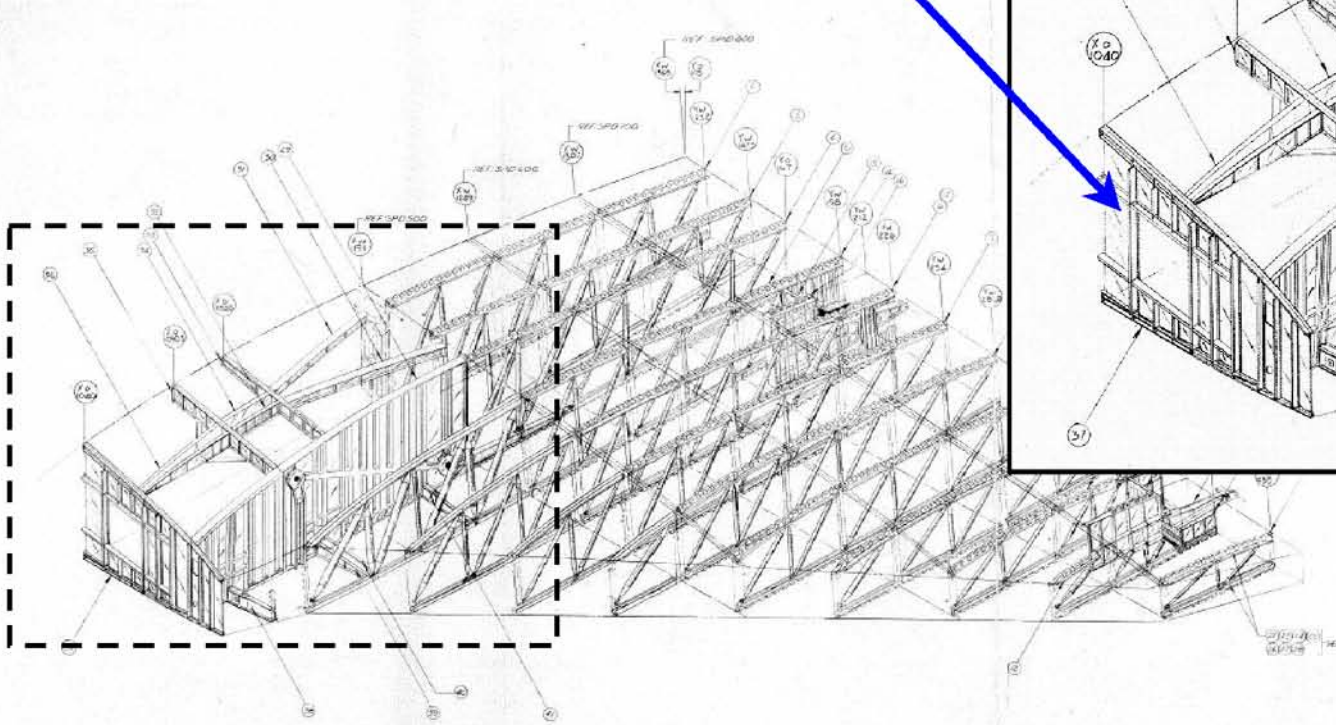
- **Local temperature gradients could potentially explain the observed Xo1040 upper and lower spar cap strains.**
- **Strain gage evidence offers some support for failure scenarios involving hot gas intrusion from the wing cavity into the glove area and/or the MLG wheel well.**
  - Timing of strain gage events has reasonable correlation with breach times of WLE and MLG well.
- **Strain gage data does not, however, conclusively indicate this scenario.**
  - Results require the critical assumption that the lower spar cap is initially exposed to less heating than the upper cap, spar web, and nearby skins.

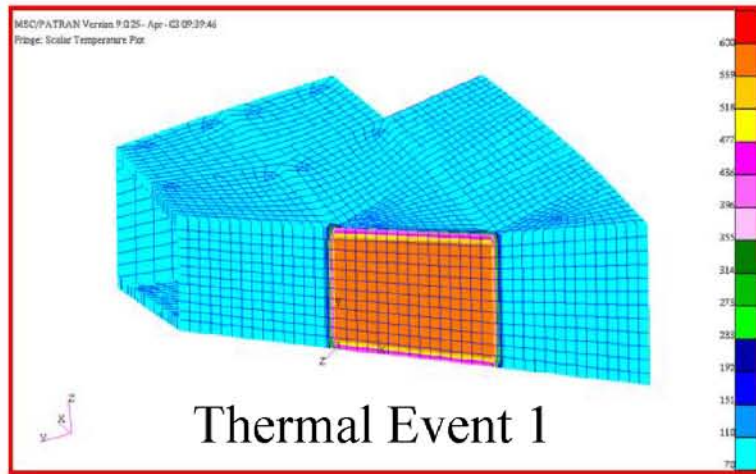
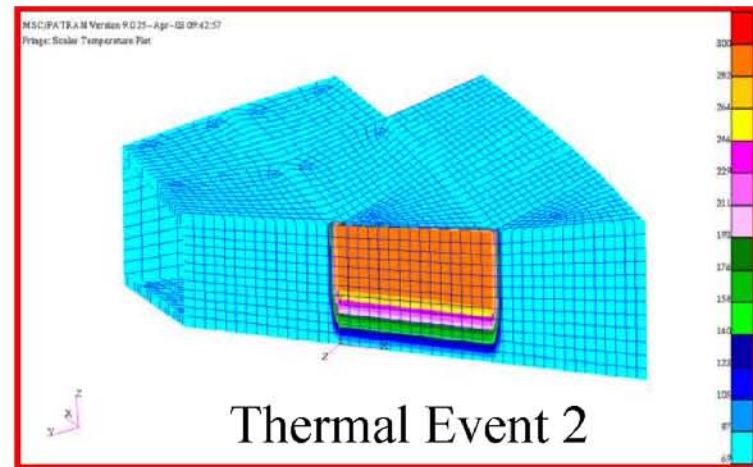
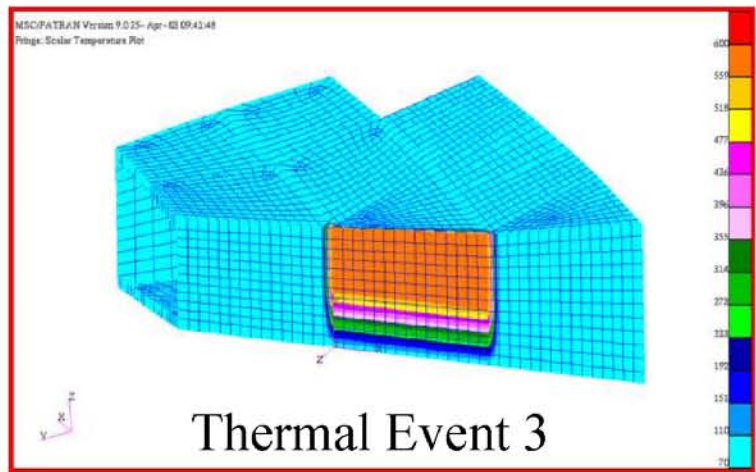
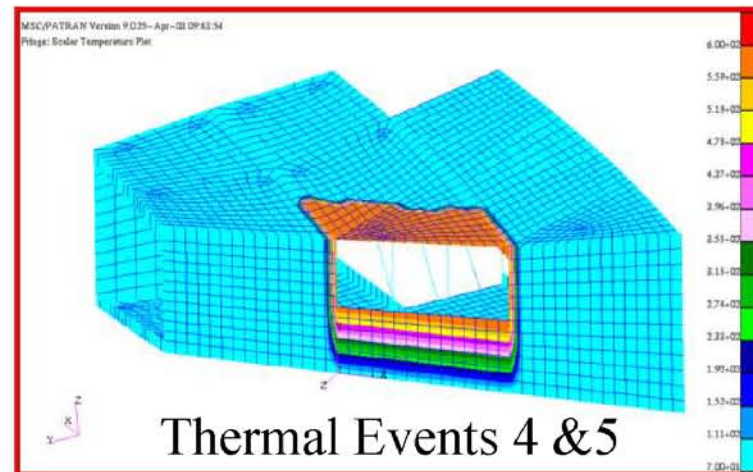
# Thermal Event Temperature Distributions

- Thermal events analyzed continued...
  4. Assume burn through on upper half WLE spar web
    - Assumed 600°F on upper WLE cap, wing skin, and wing ribs up to 16 inches from WLE
    - Assumed linear temperature distribution of 600°F to 70°F from edge of burn through (middle of WLE web) to bottom WLE cap
    - 70°F on rest of structure
  5. Assume burn through on upper half WLE spar web and spar cap
    - Assumed 600°F on upper wing skin and wing ribs up to 16 inches from WLE
    - Assumed linear temperature distribution of 600°F to 70°F from edge of burn through (middle of WLE web) to bottom WLE cap
    - 70°F on rest of structure
