# COLUMBIA

## ACCIDENT INVESTIGATION BOARD

REPORT VOLUME IV  
OCTOBER 2003

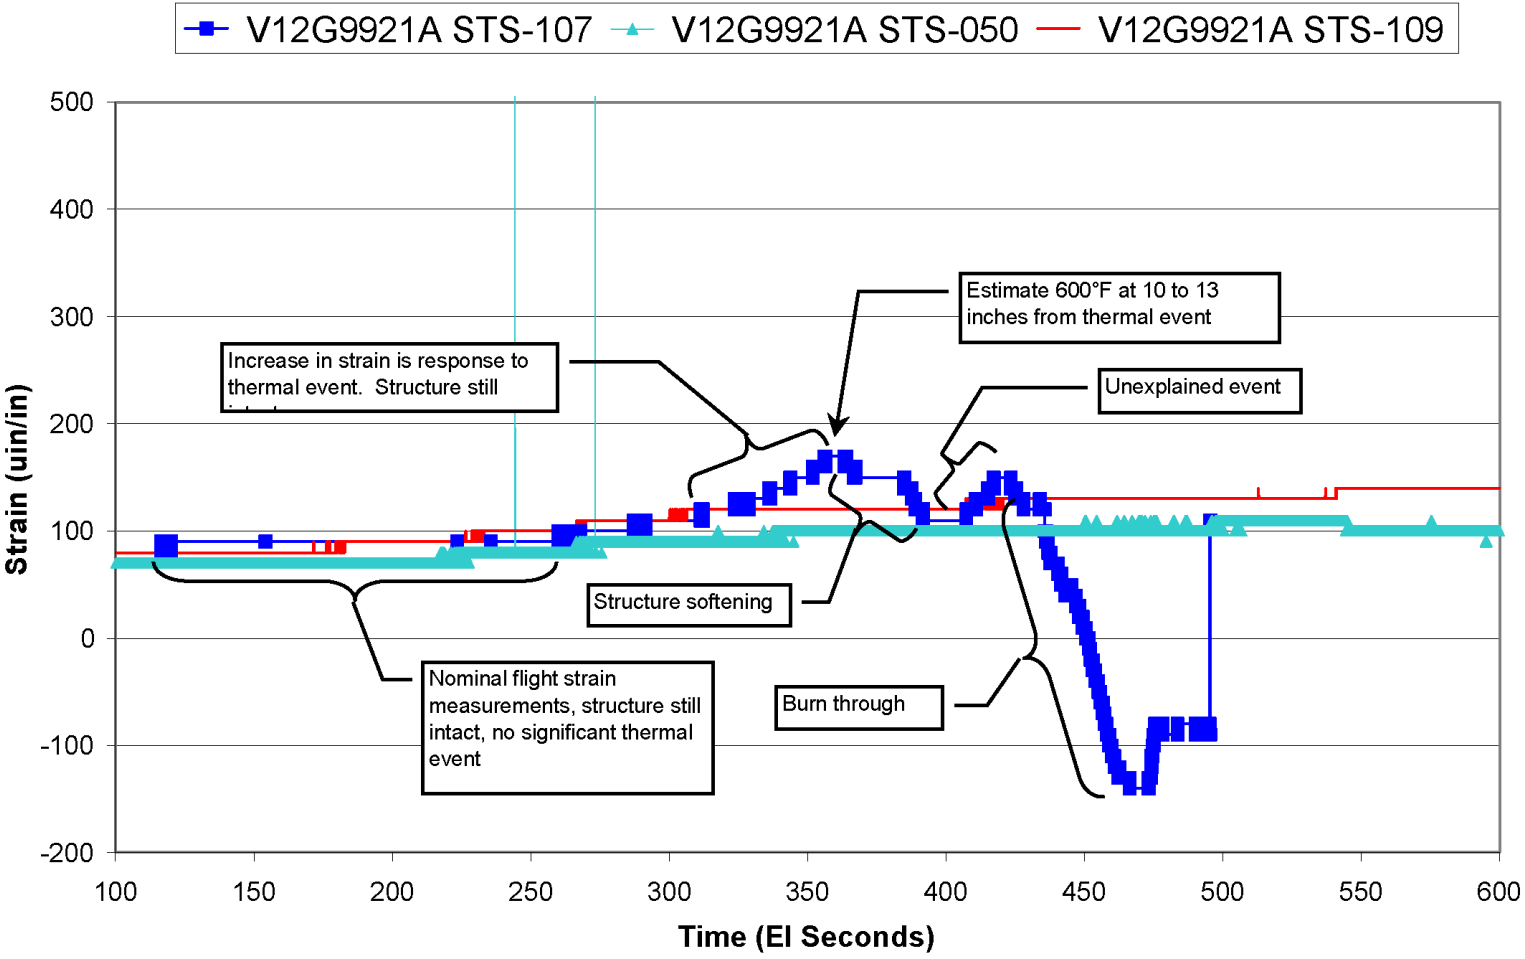
# Scenario Description Overlay With Nominal Strain Gage Data

RCC Panel 9 OEX Strain Gage 9921A STS-107 Comparison to Nominal Data

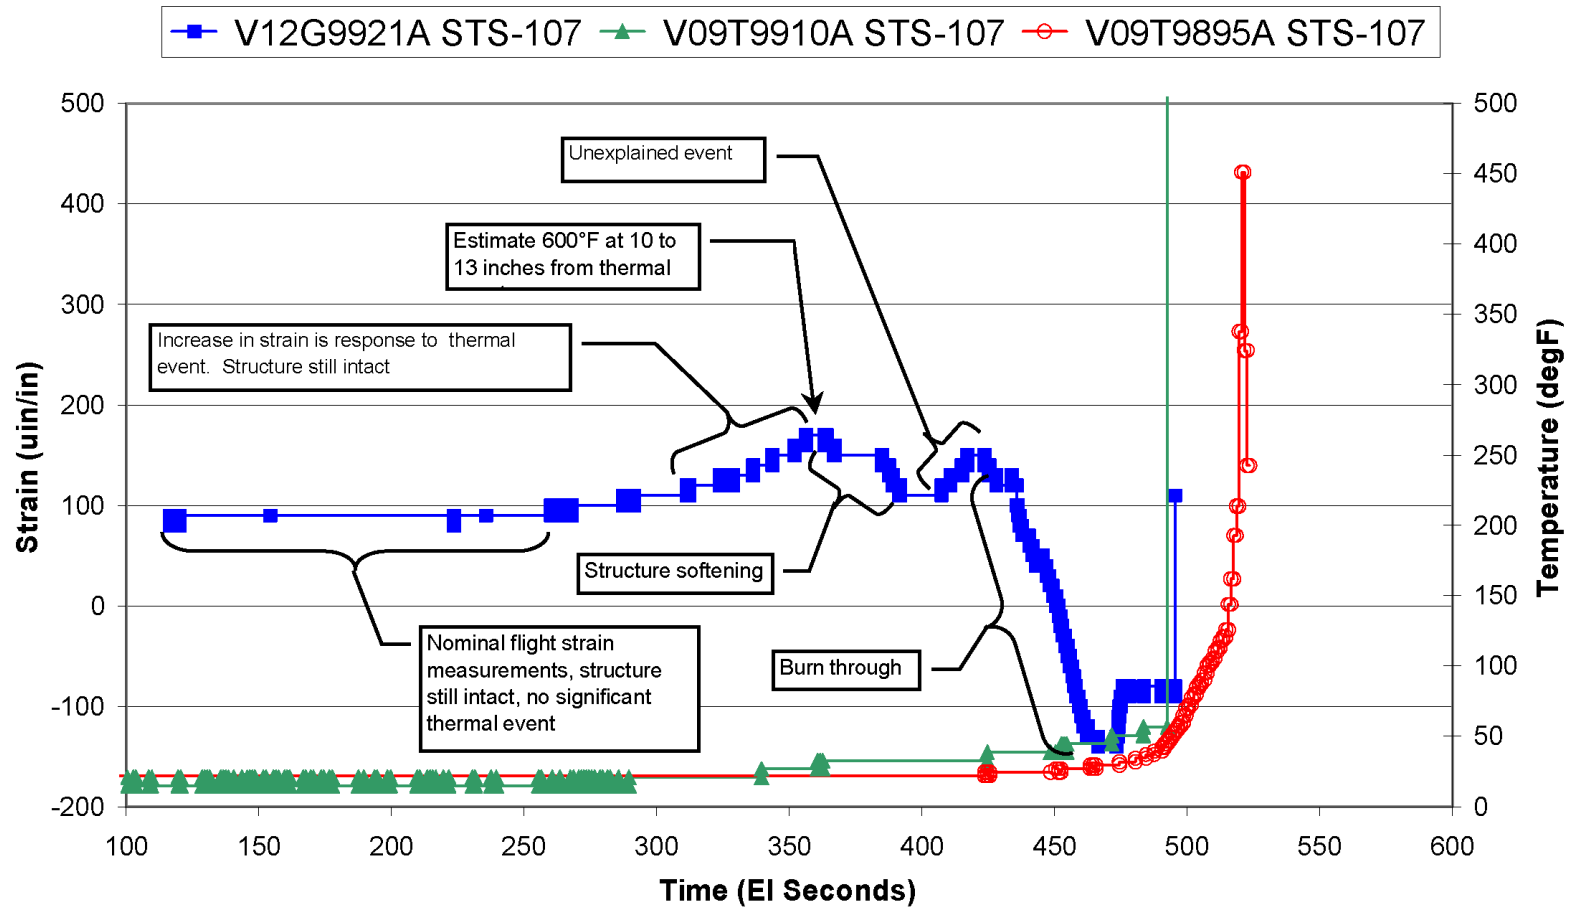
# Scenario Description Overlay With Thermal Flight Data

## RCC Panel 9 OEX Gages, STS-107

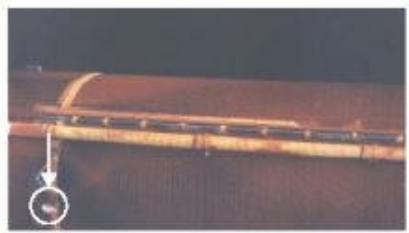
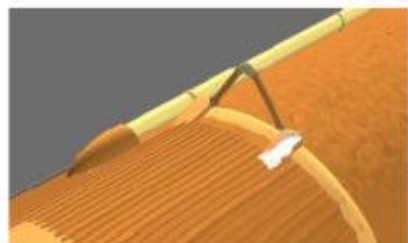
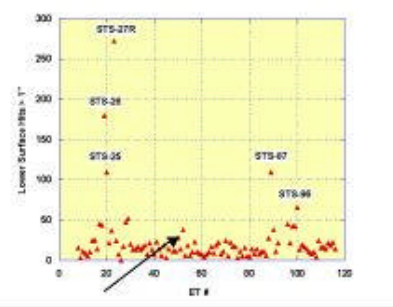
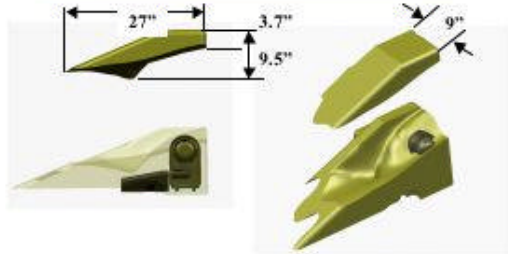
**STS-50  
ET-50**

**STS-50 28 Hits > 1"**

Vol 700.5 cu in  
Wetted Area 636.18 sq in  
Wt 0.97 lbs

<p><b>STS-50 / ET-50 (launched 06/25/92)</b></p> <ul style="list-style-type: none"> <li>• Post separation film (umbilical camera) showed – 60 percent of the –Y (LH) bipod ramp closeout was missing               <ul style="list-style-type: none"> <li>– Damage area measured approximately 26 x 10 inches in size and was deep enough to expose SLA closeout</li> </ul> </li> <li>• Lower surface Orbiter tile damage locations = 141 with 28 &gt;1"               <ul style="list-style-type: none"> <li>– Largest damage: 9" x 4.5" x 0.5" (Left wing of Orbiter, three feet outboard of the LH2 umbilical)</li> </ul> </li> </ul>

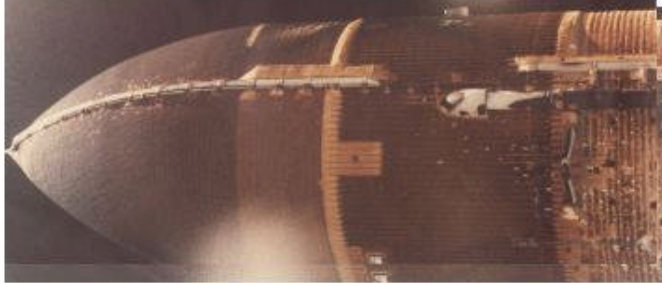
STS-7/ET-6 - All four foams CFC-11

STS-112/ET-115 - Three HCFC 141b foams with one CFC-11 foam  
STS-112/ET-115 - Foam loss on bipod - CFC-11

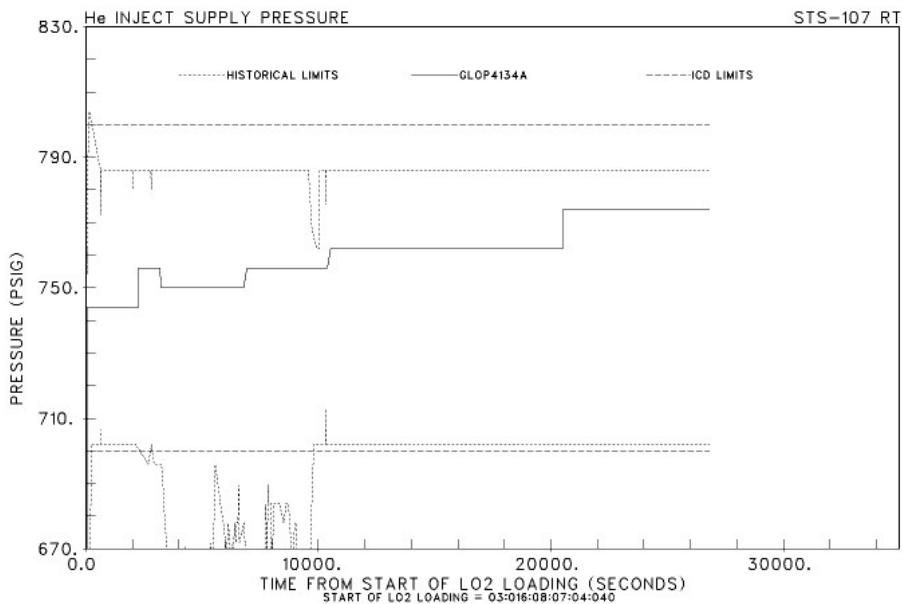
*Figure 5.3.1.2.2-1. ET LO2 Helium Inject Supply Pressure*

The EOR absolute ullage pressure was 15.49 psia (versus 15.26 psia nominal). The EOR ET LO2 propellant load was 1,382,980 lbm (990 lbm less than nominal), which is -0.07% and well within the requirement of +/-0.29%. This includes the effect of ET-93 specific LO2 tank volume.

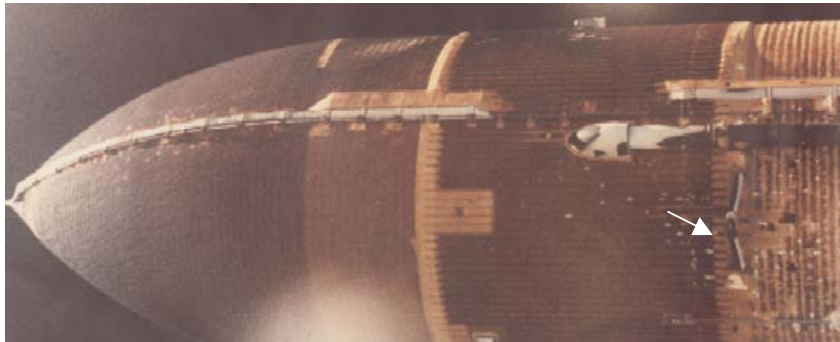
Figure 5.3.3.2-1. STS-7/ET-6

Assessment of post-flight imagery has shown five prior occurrences of bipod ramp TPS loss. All instances of ramp loss were isolated to the -Y (left hand) ramp. The first occurrence, STS-7/ET-6 (Figure 5.3.3.2-1), showed a large portion (18 in. x 12 in.) of the bipod ramp missing. The TPS area had an estimated weight of 0.6 lb. This TPS loss event was attributed to a repair in the forward edge of the ramp. Following this occurrence of TPS loss, the ramp repair criterion was limited to a maximum of 3 sq. in. on the forward face of the bipod ramp.

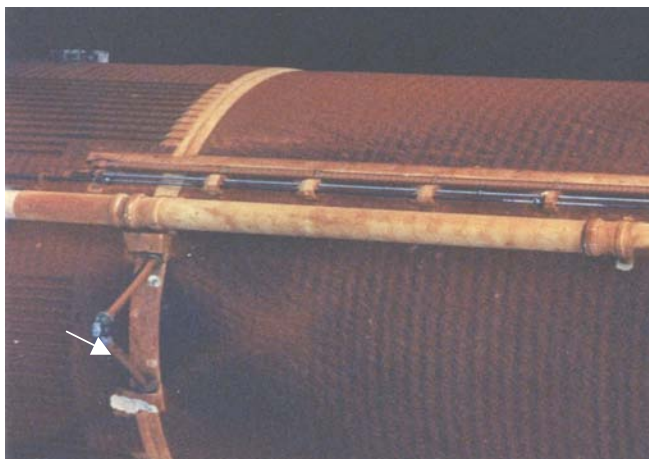
Figure 5.3.3.2-2. STS-50/ET-50

The TPS loss event on STS-50/ET-50 encompassed the majority of the bipod ramp, measuring 26 in. x 10 in. and weighing 0.98 lb (Figure 5.3.3.2-2). This loss was attributed to voids/debonds in the Isochem bond layer of the non-vented two-tone TPS area. ET-50 was the last ET built with this intertank TPS configuration.

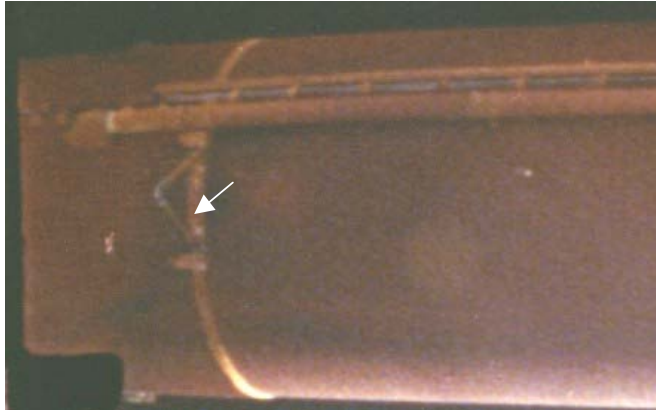
*Figure 5.3.3.2-3. STS-52/ET-55*

On STS-52/ET-55, the TPS loss was estimated to be 8 in. x 4 in., weighing 0.02 lb. (Figure 5.3.3.2-3)

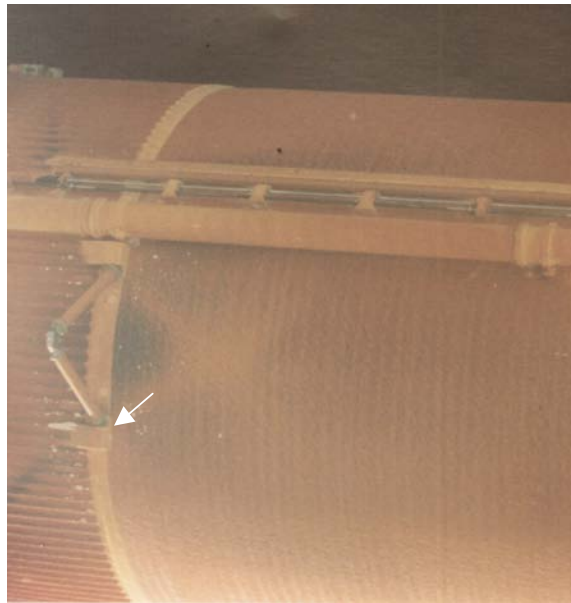
*Figure 5.3.3.2-4. STS-62/ET-62*

On STS-62/ET-62, there was a small divot in the aft face of the ramp measuring approximately 3 in. x 1 in. and weighing 0.001 lb. (Figure 5.3.3.2-4)

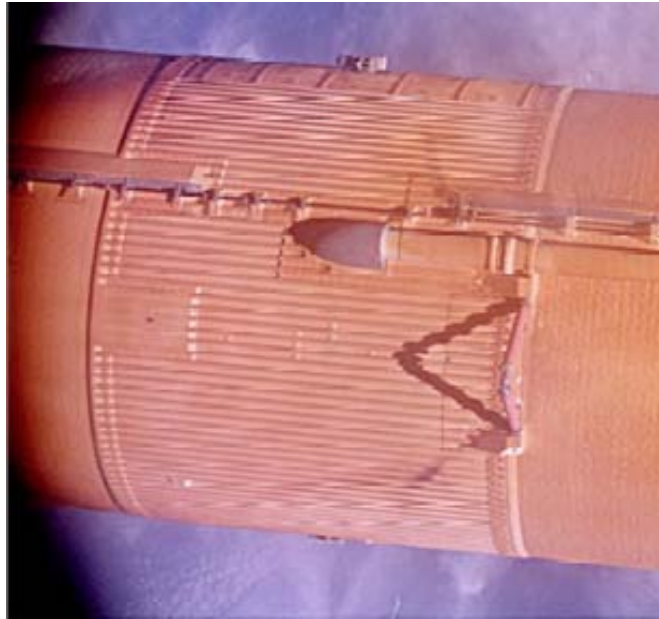
Figure 5.3.3.2-5. STS-112/ET-115

On STS-112/ET-11, the TPS loss location and shape was similar to that observed on STS-52 (Figure 5.3.3.2-5). The TPS loss on STS-112 was estimated to be 7 in. x 12 in. with a mass of 0.3 lb.

Following this occurrence of ramp loss, the ET Project initiated plans to evaluate the materials, design, and processes used for the ramps.

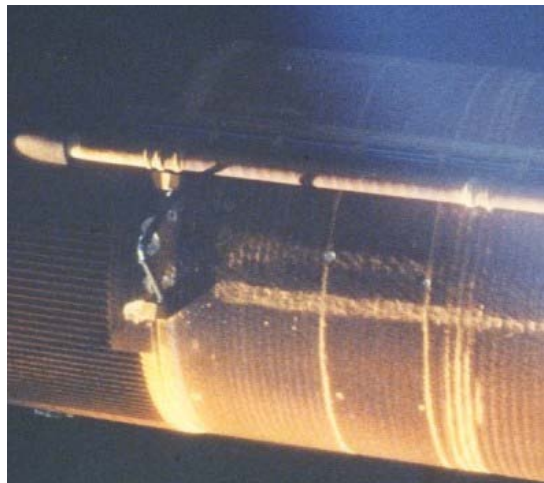
- STS-32R/ET-32 (launched January 9, 1990)  
Post-separation umbilical camera films showed several large divots in the area of the bipods. Two of the divots, measuring 12 to 14 in. in diameter, were located between the bipods just forward of the intertank-to-LH2-tank flange. A third divot, approximately 14 in. in diameter, was located between the bipod ramps and extended into the intertank-to-LH2-tank flange. The largest divot, measuring 28 in. wide, surrounded the forward part of the -Y (LH) bipod (Figure 5.3.3.5-1).

*Figure 5.3.3.5-1. STS-32R/ET-32 Post-Separation Photograph*

The most probable cause of this TPS loss was related to inadequate depth of drilled holes (venting) in this two-tone TPS location in conjunction with localized voids at the TPS CPR-488/Isochem bond layer. Following this occurrence of TPS loss, an inspection was added to the manufacturing process to verify vent hole depth. The most probable cause and corrective actions to preclude recurrence were presented/approved at the Level II Program Requirements Control Board (PRCB(PRCBD S044812A) on February 6, 1990.

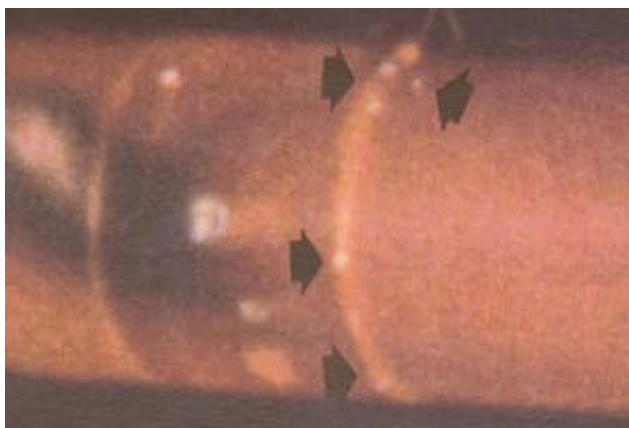
Post separation umbilical camera films showed five divots on the left side (-Y axis) of the intertank-to-LH2-tank flange closeout and five divots on the right side of the closeout (+Y axis). The largest divots ranged from 8 to 10 in. in diameter (Figure 5.3.3.5-2). Divots from this area (previously observed on other ETs) did not show a correlation with an increased level of Orbiter tile damage.

*Figure 5.3.3.5-2. STS-35/ET-35 Post-Separation Photograph*

The most probable cause of this TPS loss was localized voids behind the intertank-to-LH2-tank flange bolts. The closeout is a very complex manual two-step operation with TPS sprayed into a narrow/deep cavity and around the attach bolts. A review of the manual spray TPS technique showed that voids were a consequence of operator technique. Following this occurrence of TPS loss, an improved application technique was developed to reduce the potential for voids around the flange bolts. This process was validated and the operators were required to demonstrate their ability to perform the closeout successfully. Through the process enhancement, the number of divots was reduced but not completely eliminated.

The most probable cause and corrective actions to preclude recurrence were presented/approved at the Level II PRCB (PRCBD S044824C) on June 14, 1991.

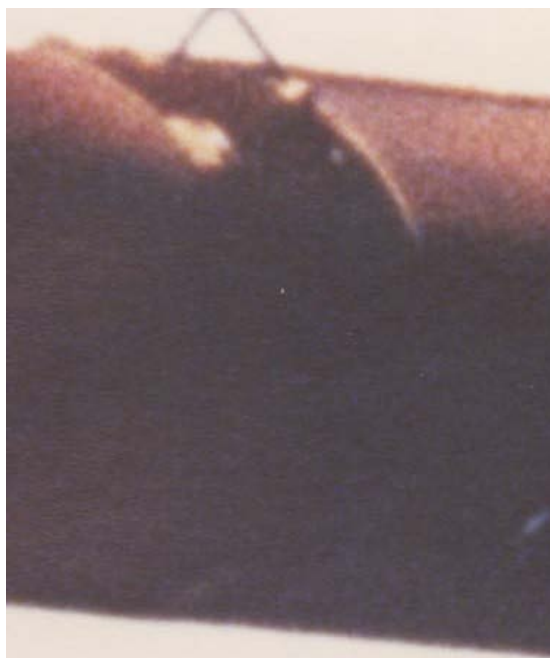
*Figure 5.3.3.5-3. STS-42/ET-52 Post-Separation Photograph*

- STS-42/ET-52 (launched January 22, 1992)  
Post-separation crew handheld camera films showed two divots on the intertank acreage. The divots were estimated to be approximately 8 to 14 in. in diameter (Figure 5.3.3.5-3).

FT analysis was used to identify the possible causes of the divots. Major areas included excessive flight environments, mechanical damage, processing or assembly anomalies, and other causes, *i.e.*, material age, BSM impingement, fluid spill.

The most probable cause of this TPS loss could not be determined. ET-52 was the second tank to fly with the revised TPS configuration and application method (replaced two-tone configuration with two-gun spray application). No corrective actions were implemented.

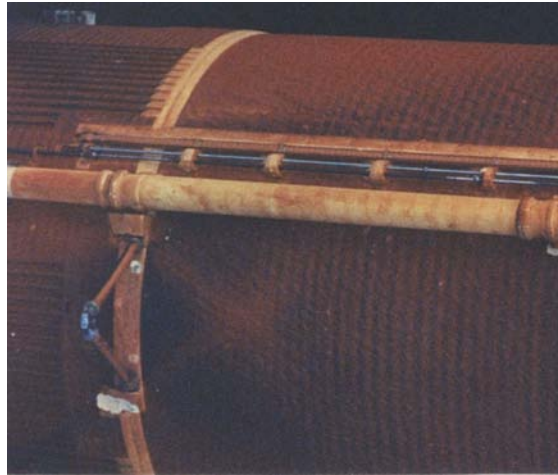
*Figure 5.3.3.5-4. STS-50/ET-50 Post-Separation Photograph*

- STS-50/ET-50 (launched June 25, 1992)  
Post-separation umbilical camera films showed two areas of TPS damage near the forward bipod area. The first showed approximately 60% of the –

Y bipod ramp was missing with a 24 in. by 8 in. divot. The second location was the +Y jack pad closeout, measuring 4.5 in. sq., located just below the right bipod strut (Figure 5.3.3.5-4). The TPS surface under the bipod ramp was the intertank two-tone TPS configuration. The jack pad is a Polymer Development Laboratories (PDL) closeout of a tooling mount used to jack the Orbiter into place for mate at KSC.

The most probable cause of the bipod ramp TPS loss was related to debonds/voids in the Isochem bond layer of the two-tone TPS configuration. This area was not vented because of proximity to the cryogenic zone. Following this occurrence of TPS loss, the vented area on remaining ETs with Intertank two-tone TPS (ET-48/STS-46, ET-49/ST-53, and ET-45/STS-47) was revised to add vent holes just forward of the ramp to acreage interface (Figure 5.3.3.5-5).

The most probable cause of the jack pad closeout was cryopumping of a subsurface void under the PDL pour TPS closeout. It was determined that loss of this TPS during ascent was not considered a flight or safety issue; therefore, it was recommended to fly the subsequent ETs with no

additional action. The only concern for the TPS loss was related to the potential to form ice during pre-launch. This concern was mitigated by the ability of the Final Inspection Team's ability to safeguard against this type of condition going undetected. This was the last of the tanks with the two-tone TPS application. Subsequent tanks incorporated the two-gun spray application, which eliminated the BX-250 and Isochem bond layer used on the two-tone configurations. The most probable cause and corrective actions to preclude recurrence were presented/approved at the Level II PRCB (PRCBD S044876C) on August 6, 1992.

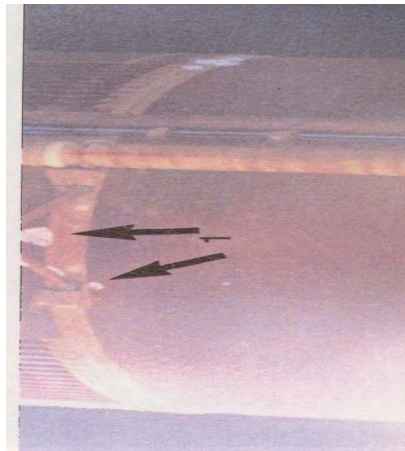
Post-separation umbilical camera films showed a divot approximately 14 to 16 in. in diameter on the intertank between the left and right bipod fittings just forward of the intertank flange closeout in the two-tone TPS area (Figure 5.3.3.5-6).

*Figure 5.3.3.5-6. STS-47/ET-45 Post-Separation Photograph*  
Minimal Orbiter tile damage was observed post-flight on OV-105 (STS-47). TPS loss of this type was not considered a safety of flight concern but one of Orbiter tile maintenance.

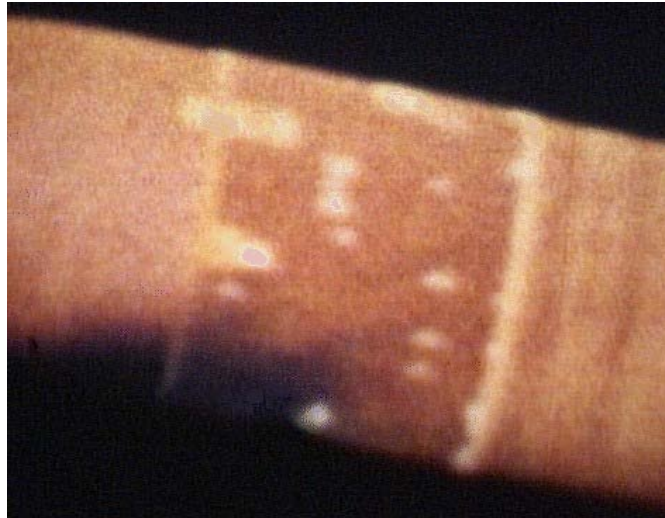
*Figure 5.3.3.5-7. STS-56/ET-54 Post-Separation Photograph*

Post separation crew handheld camera films showed 10 large, shallow divots on the -Z side of the intertank acreage (Figure 5.3.3.3-7). The divots were in a unique pattern, with two lines with 3 and 4 divots each. The magnitude of the TPS loss experienced on STS-56 was within the STS experience base.

The most probable cause of this TPS loss was not conclusively determined. The most likely scenario is rollover/crevicing anomalies in the TPS (Figure 5.3.3.5-8), and the effects in the flight environment. Differential pressure caused by aeroheating, flight loads, and panel flexure may have caused anomalies to propagate along the TPS knitlines (area between TPS spray passes), with shallow divots as the result.

No immediate corrective actions were implemented. An application process enhancement was implemented to minimize or eliminate the occurrence of rollover or crevicing. This enhancement would reduce the

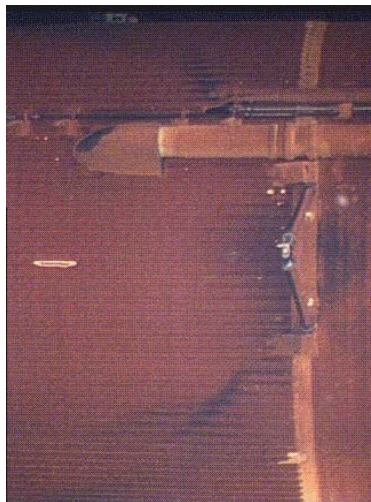
*Figure 5.3.3.5-9. STS-58/ET-57 Post-Separation Photograph*

Post-separation umbilical camera films showed three areas of TPS loss on the intertank +Z side. One divot (approximately 28 in. L x 3 in. W) was in the acreage TPS, and the other two divots were identified as the TPS from the jack pad closeouts. Exposed primer was observed in both jack pad cavities (Figure 5.3.3.5-9), Divots of this magnitude and the Orbiter tile damage were within the STS experience base.

The most probable cause of the intertank acreage divot on STS-58 is the same as suspected for the TPS loss on STS-56 – Anomalies in the TPS caused by rollover/crevicing phenomenon.

The most probable cause of the jack pad closeout was cryopumping of a subsurface void under the PDL pour TPS closeout. Following this jack pad closeout TPS loss occurrence, a tool was developed to allow spray around the holes masking the jack pad tooling holes, leaving four 1-in. diameter holes on each side of the closeout to eliminate the large closeout/repair area (6 in. x 6 in. square). The jack pad itself is now closed out in conjunction with the flange closeout.

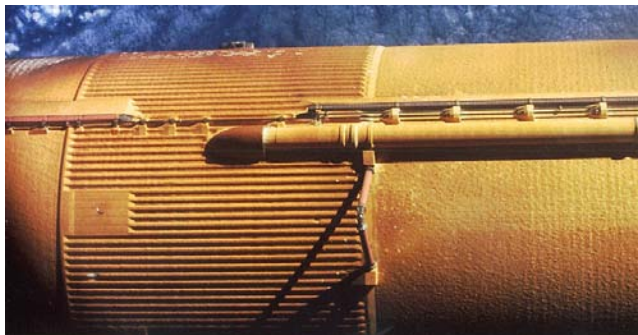
*Figure 5.3.3.5-10. STS-87/ET-89 Post-Separation Photograph*

- STS-87/ET-89 (launched November 19, 1997)  
Post-separation crew handheld camera films showed areas of missing TPS on the +Y and -Y thrust panels (Figure 5.3.3.5-10). Post-landing inspection also showed a significant increase in Orbiter tile damage: 308 damage sites on the Orbiter lower surface, with 132 sites greater than 1 in. The total number of lower surface damage site and the number of damage sites greater than 1 in. were out of family when compared to previous missions.

The most probable cause of this TPS loss was a combination of the following factors:

- Reduced mechanical properties of the TPS and its trapped gases
- Environmentally induced cell gas pressure from heating, vacuum, and moisture in the cells
- Stress concentrating geometry, especially evident on the intertank thrust panels and to a lesser extent on the skin/stringer panels.

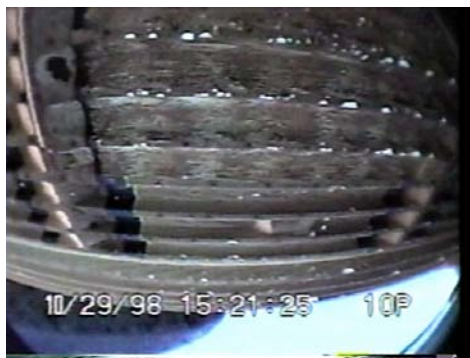
*Figure 5.3.3.5-11. STS-95/ET-98 Post-SRB-Separation Photography*

A study to gain an understanding of the TPS loss event ensued; the first data gathering exercise included the installation of a camera on one SRB of STS-95/ET-98. This camera imaged the ET intertank thrust panel during flight and provided the first opportunity to view TPS loss up close and in real time (Figure 5.3.3.5-11). The camera showed TPS loss initiating approximately 92 sec into the flight and continuing until SRB separation, at which time the view was lost.

TPS loss was seen to be most severe on the tops and sides of the thrust panel ribs but was not limited to these areas. Some material loss was also observed on the skin-stringer areas of the intertank. From a visual standpoint, the TPS loss closely resembled the phenomenon known as 'popcorning', which has been observed in thermal-vacuum testing at MSFC and MAF test facilities.

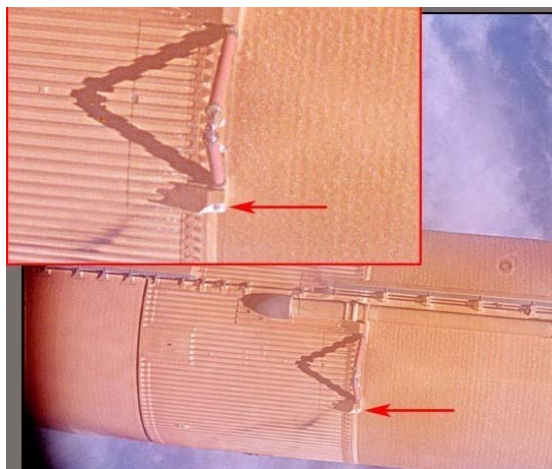
Figure 5.3.3.5-12. STS-112/ET-115 Post-Separation Photography

- STS-112/ET-115 (launched October 2, 2002)  
Post-separation crew handheld camera films showed an area of missing TPS (approximately 4 in. x 5 in. x 12 in.) on -Y bipod ramp exposing the bipod housing SLA closeout (Figure 5.3.3.5-12).

The most probable cause of this TPS loss occurrence was suspect subsurface void(s) during bipod ramp closeout coupled with launch environments. The most probable cause was presented at the SSP PRCB (S062151, Action # MSFC-ET/1-1) on December 19, 2002 and at that time, the Project identified the corrective action that was under evaluation. The proposed corrective action was to enhance the closeout configuration by eliminating the SLA under the TPS, thereby eliminating the potential for air entrapment (subsurface voids). The final corrective action was to have been presented at the SSP PRCB on February 6, 2003.

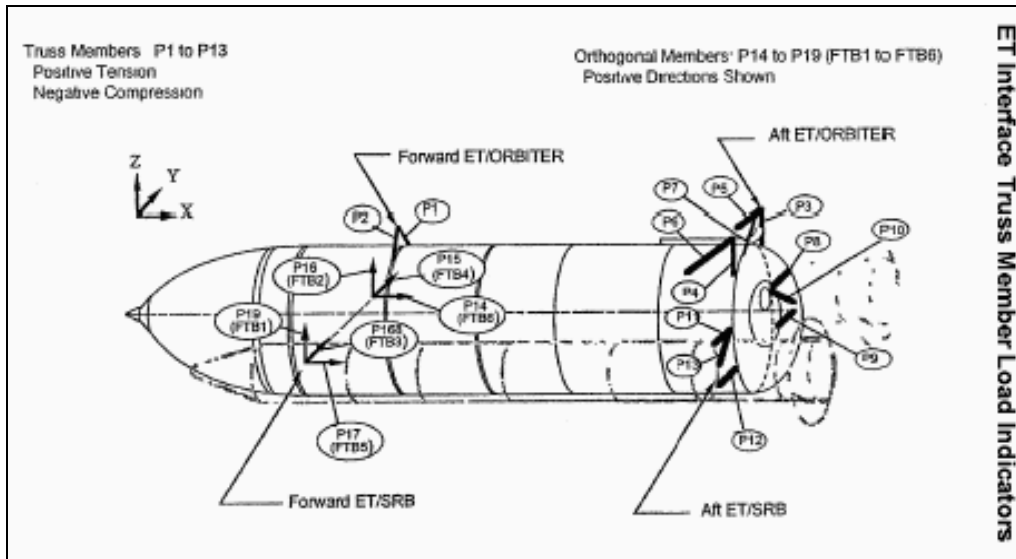
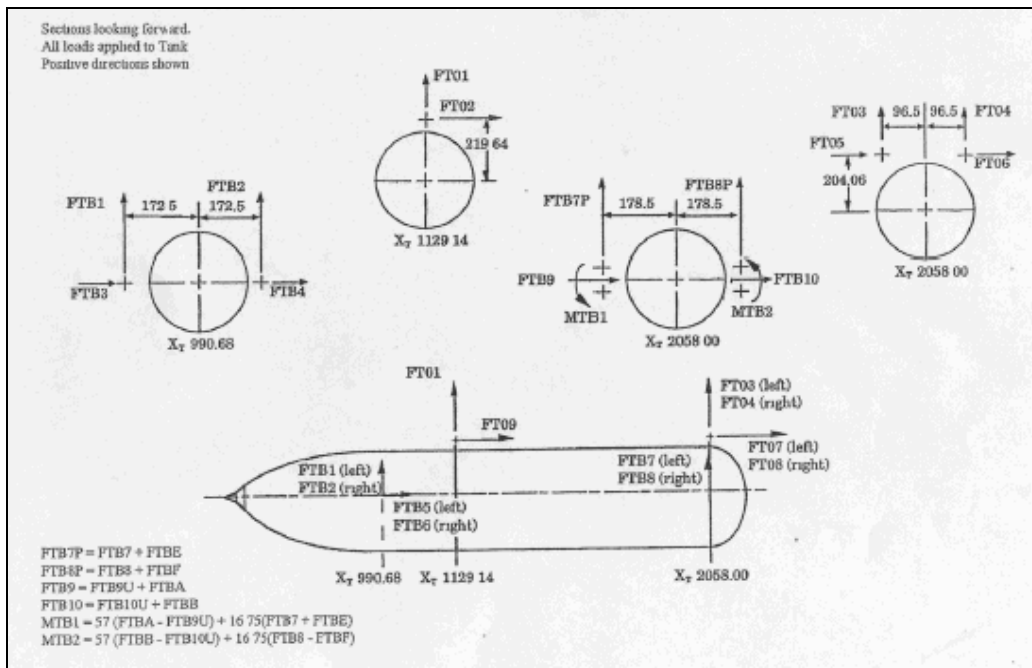
Figures 7.2.3.8.1.2-1 and 7.2.3.8.1.2-2 show the location of the load indicators evaluated with respect to the ET interfaces: truss members and interface load indicators. The Boeing analysis group, through the SSP loads board, provided the reconstructions to the Interface Team. The BET loads reconstruction was based on a rigid body analysis. In addition to the BET loads indicator sets, an additional flexible body reconstruction was provided.

No loads issues were found with any phase of operations. All indicators were well within design limits. The flex body loads reconstruction was actually less than the BET reconstruction, so they did not affect the evaluation. All of the analysis to date shows no evidence of excessive or anomalous loading.
