Restoring Redundancy to the Wilkinson Microwave Anisotropy Probe Propulsion System

NASA Goddard Space Flight Center, Greenbelt, Maryland 20771

Abstract

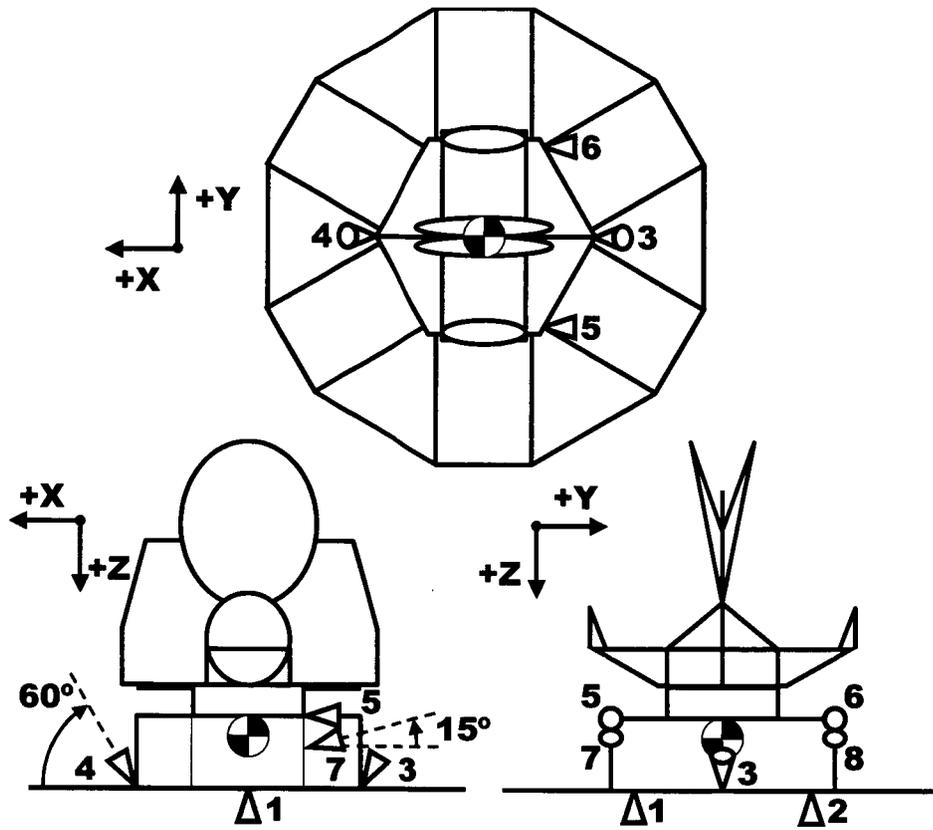
Figure 3: Original Thruster Layout

The team decided to mount the two new thrusters in a canted direction to provide functional redundancy for all three thruster pairs. In order to achieve this, thrusters 5 and 6 were moved in the $-Z$ direction with respect to the spacecraft center of mass (CM) and thrusters 7 and 8 were added on the $-X$ face of the observatory with a 15 deg cant from the XY plane to provide thrust vector in the $+X$ and $+Z$ directions, as shown in Fig. 3.

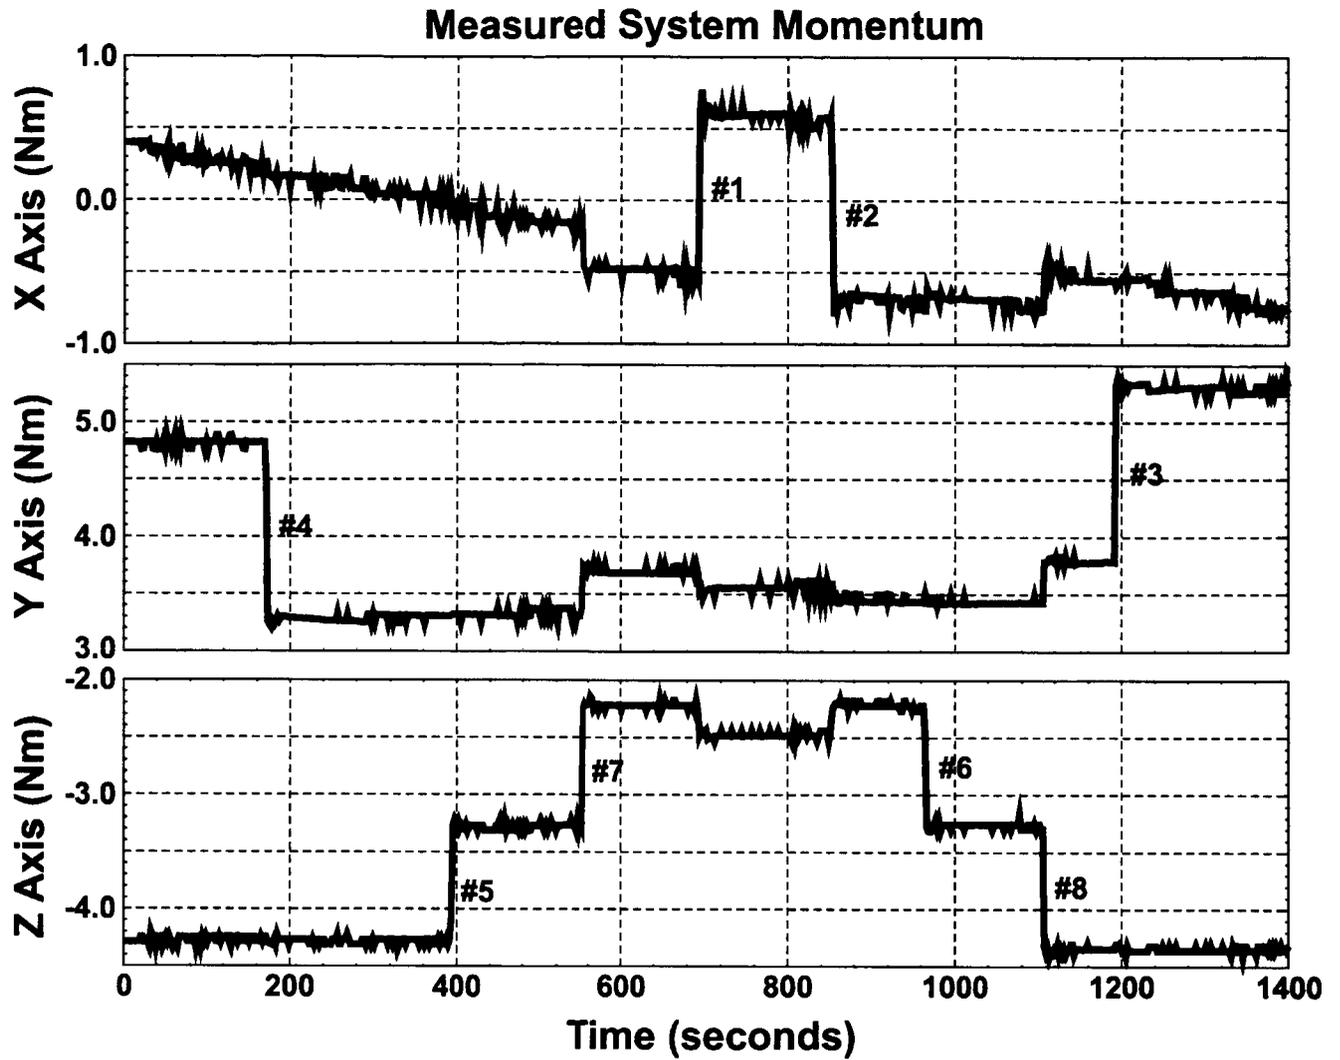
Figure 10: Thruster Pulse Check Momentum Effects

The ACS team determined a specific order for the thruster tests so that the tests would tend to decrease rather than increase the system momentum. Fig. 10 shows the system momentum magnitude difference caused by the first round of thruster one-shots. As each thruster was fired during the first round of tests, the momentum changes were only 73–82% of the expected values. The propulsion team did not find these results to be of concern, surmising the low value to be caused by the initial lack of hydrazine between the thruster seats, and that the second round of

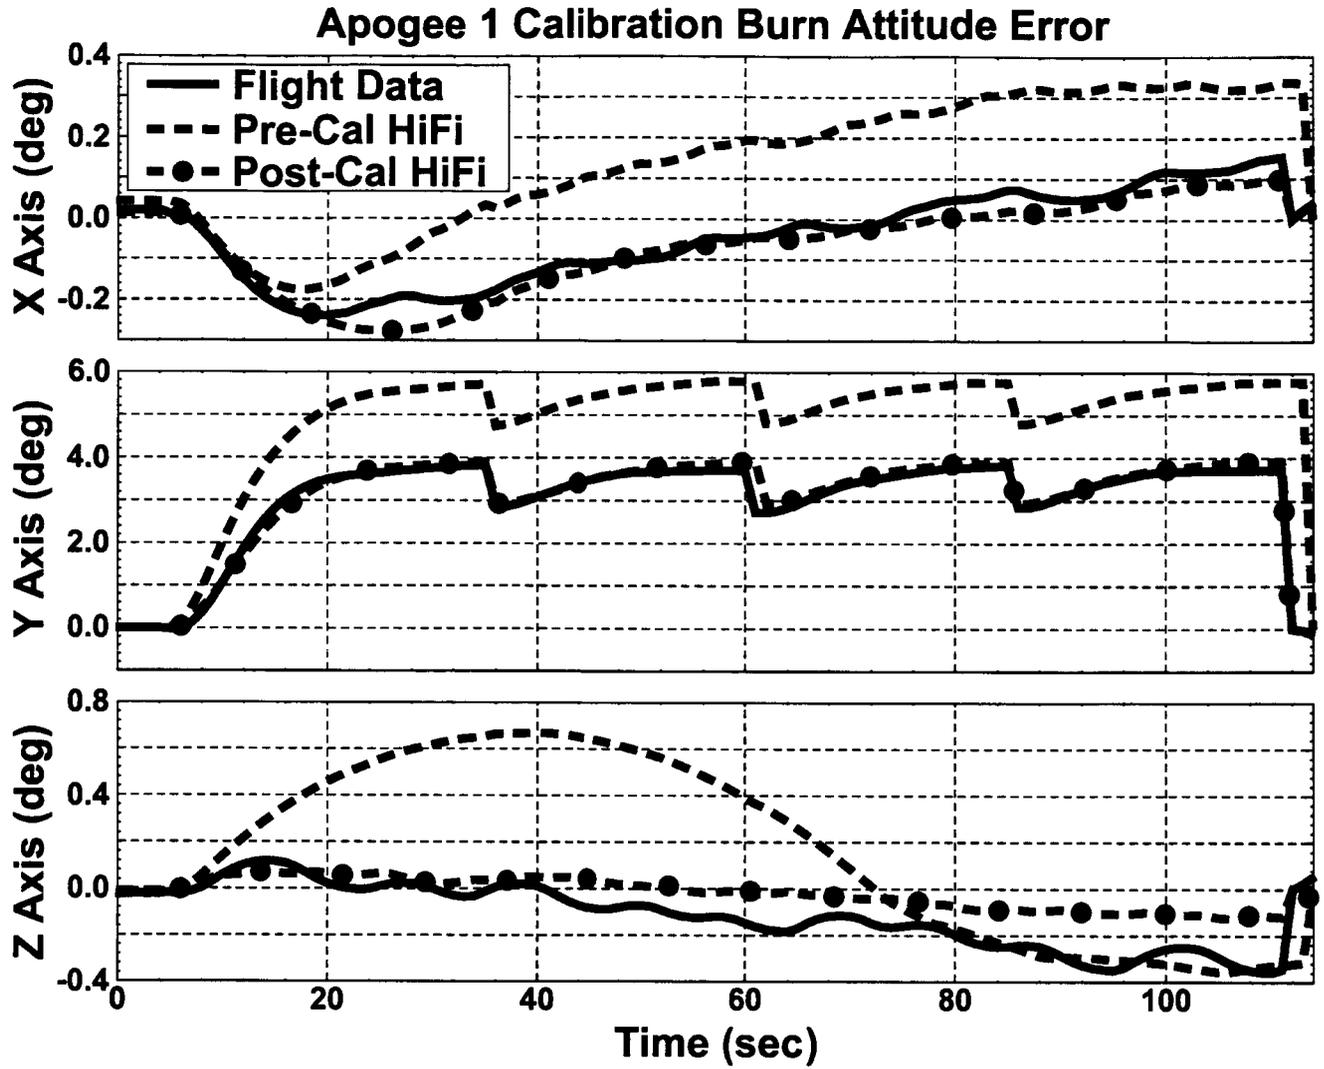
Figure 11: +X Calibration Maneuver Attitude Error

Fig. 11 shows the attitude error from the first Delta V calibration burn, along with the expected performance as determined from HiFi simulation. The performance was much better than

expected, with a thruster 4 duty cycle of 28% and a Y axis attitude error just under 4 deg. This was potentially good news—the lower duty cycle meant less fuel usage along with the smaller attitude error—as long as a viable explanation for the better performance could be found. After analysis, a CM 2.785 cm from its predicted value and thruster plume impingement torques 50% of their expected magnitudes was found to allow accurate predictions of thruster mode performance. The dashed lines in Fig. 11 show the actual vs predicted performance of the burn after before and after calibration of the simulation parameters, with much better concurrence between flight and HiFi data afterwards.

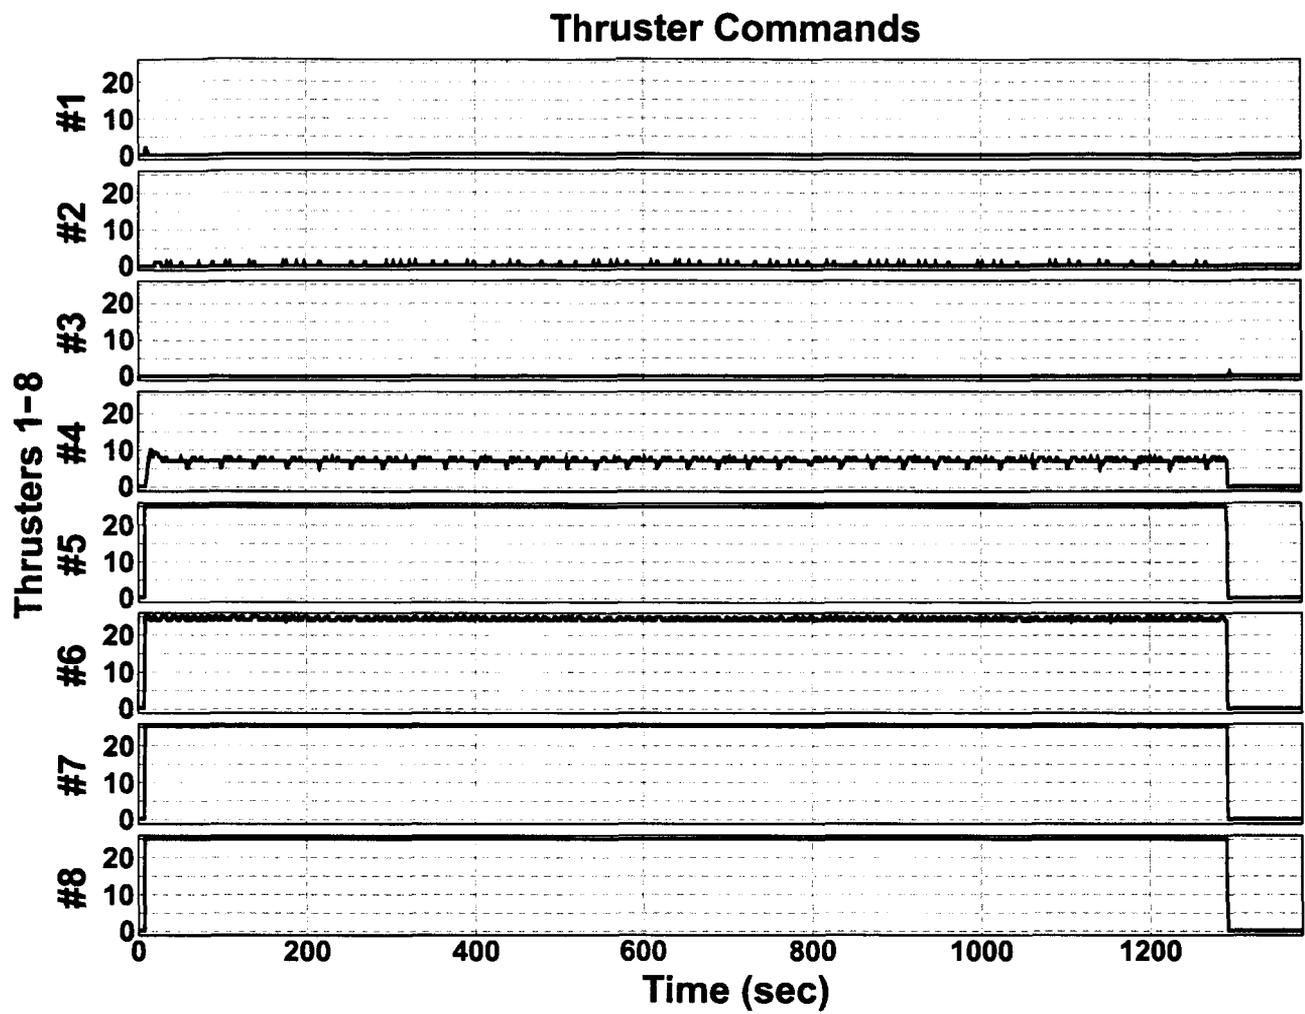
Figure 12: Perigee Maneuver 1 Thruster Commanded Counts

Fig. 12 and Fig. 13 show the thruster command profiles for the eight thrusters and attitude error flight data from the first perigee maneuver, a 20 minute burn that was the longest performed. The thruster 4 duty cycle and attitude error performance were consistent with that seen in the calibration burn. Except for some excitement due to an “anomalous force” acting on the spacecraft near perigee,¹¹ the first maneuver proceeded nominally, both from an ACS and a trajectory point of view. The remaining orbit maneuvers at the second and third perigee and the
