BEHAVIOR OF COMPRESSION-LOADED COMPOSITE PANELS WITH STRINGER TERMINATIONS AND IMPACT DAMAGE

Dawn C. Jegley
NASA Langley Research Center
Hampton, VA

AIAA Paper No. 98-1785-CP
Long Beach, California

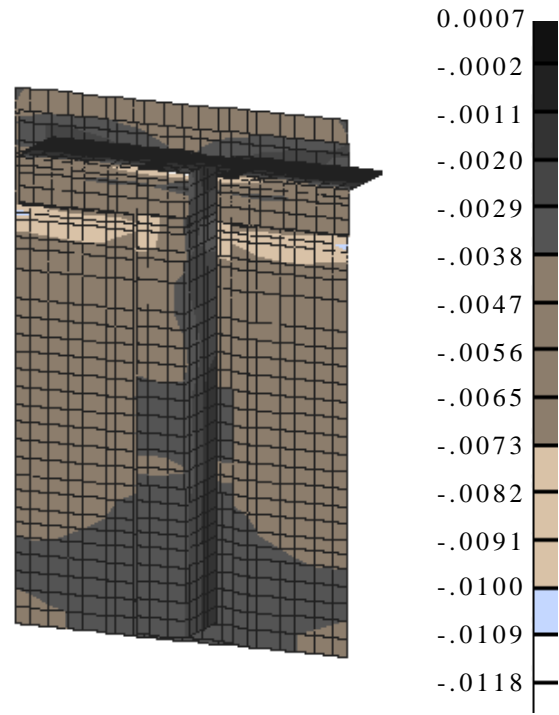
Figure 9. Axial surface strain for a load of 100,000 lb for panel U-1.

Analytically determined axial surface strains for a load of 100,000 lb are shown in figure 9. The maximum compressive axial surface strain occurs in the intercostal flange near the intercostal, but the maximum axial strain at the laminate midplane occurs in the stringer flange near the intercostal. Based on an allowable axial strain value at the laminate midplane for undamaged structure of .0093 in/in., failure should not occur due to axial strain for a load less than 108,500 lb. Lateral strains were small enough to have little effect on failure. However, the shear strain in the intercostal flange is predicted to exceed the shear strain allowable of .0126 in/in. for loads greater than 91,200 lb. Shear strain in the intercostal flange causes or contributes to failure of the panel since the panel failed at 98,200 lb.

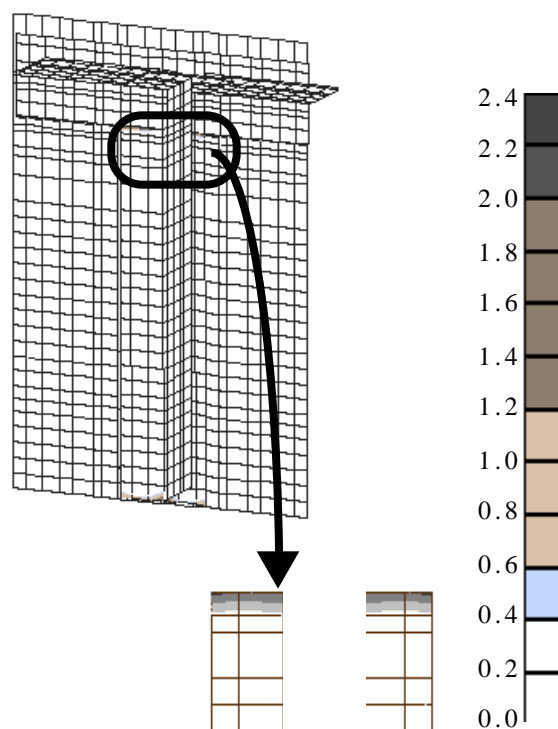
Figure 10. Normalized interlaminar stresses at skin-to-stringer flange interface for a load of 100,000 lb for panel U-1.

The maximum interlaminar stress in the stringer flange occurs at the end of the flange where it terminates at the intercostal flange. At this location the interlaminar failure parameter is approximately equal to 2.0 for a load of 100,000 lb. The maximum axial strain, shear strain and interlaminar shear strain occur in close proximity, and failure could result from a combination of strains.

Test results indicate that failure initiates at the interface between the skin and stringer flange. The separation of the stringer flange from the skin occurs immediately beneath the blade of the stringer. The analytical prediction of the location of failure agrees with the experimental results. The panel failed at 98,200 lb of load.

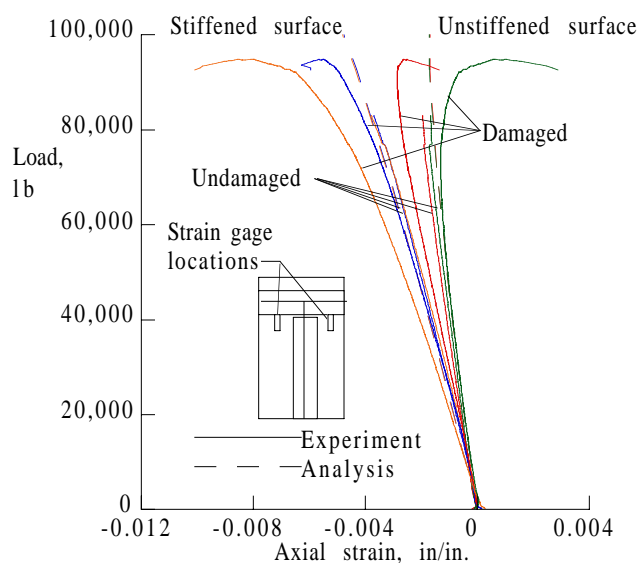
Figure 12. Axial strains near the intercostal flange in panel U-2.

After being subjected to impact damage, the panel was loaded to failure. The impact damage had little effect on the far-field behavior or on the global behavior of the panel. The local effect of the impact damage can be seen in figure 12, in which results are shown for strain gages within one inch of the impact sites. Surface damage closer than one inch from the impact site was too severe to allow strain measurements.

The allowable midplane strain for damaged structure is .0053 in/in. The analysis predicts a strain at the impact site of .0053 in/in. for a load of 147,000 lb. Failure through the impact site would not be expected for loads less than 147,000 lb. Since the failure load is significantly less than 147,000 lb, the midplane strain at the impact site cannot be used to predict failure of this panel.

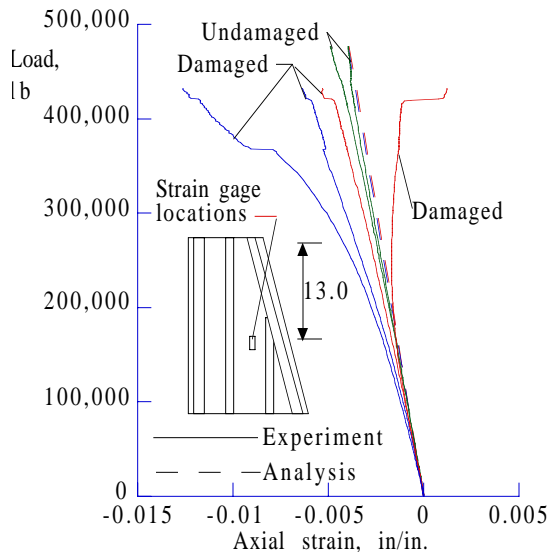
Figure 14. Axial strains in the skin at the impact site of panel L-1.

Panel L-1 was subjected to severe impact damage resulting in an indentation with a depth of 0.16 inches. The criterion of allowable strain at the reference surface of .0053 in/in. and the criterion described in reference 4

assume an indentation depth of approximately 0.1 inches. Damage to the panel is significantly more severe than appropriate for either of these methods. However, the predicted strain at the impact site exceeds the allowable axial strain for damaged structure with loads greater than 650,000 lb. By using the method described in reference 4, panel L-1 would be expected to fail at a load of 640,000 lb. The two methods produce similar results since there is little bending behavior near the impact site.

Panel L-1 failed through the impact site and the point of maximum strain in an undamaged skin with a load of 435,000 lb, and with damage 1.6 times as severe as required by the criterion. The panel failed with a stress at the impact site of 35.2 ksi, which is approximately 89 percent of the design stress. An undamaged panel would have had a strain of approximately .0037 in/in. at the impact site for the load at which the damaged panel failed. The maximum midplane strain (based on the measured surface strains) near the impact site was equal to .0052 in/in. The predicted maximum strain in the panel away from the impact site is equal to .0043 in/in., which is significantly less than the allowable strain in undamaged structure. These results indicate that failure was caused by the strain in the region of the impact site. A photograph of panel L-1 after failure is shown in figure 15.

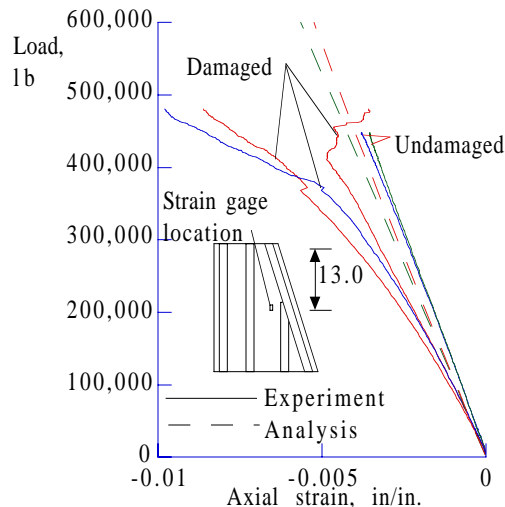
Figure 17. Axial surface strains in the skin at the impact site of panel L-2.

The panel was subjected to impact damage resulting in an indentation with a depth of 0.11 inches. The allowable strain of .0053 in/in. at the impact site is exceeded for loads greater than 580,000 lb. Applying the method of reference 4 results in a predicted failure load of 570,000 lb. The panel failed through the impact site for a load that is approximately 85 percent of that predicted by analysis. The panel failed with a stress at the impact site of 44.6 ksi, which is 113 percent of the design stress.

Test data indicate that the load at which the maximum midplane strain (based on the surface strain gages) near the impact site reached .0053 in/in. was 397,000 lb. The panel failed at a load of 484,000 lb. The maximum midplane strain in the region of the impact site was .0062 in/in., which is 1.16 times the allowable strain value. The predicted maximum strain in the panel away from the impact site is .0058 in/in., which is significantly less than the allowable strain value in undamaged structure, so failure was caused by the strain in the region of the impact.

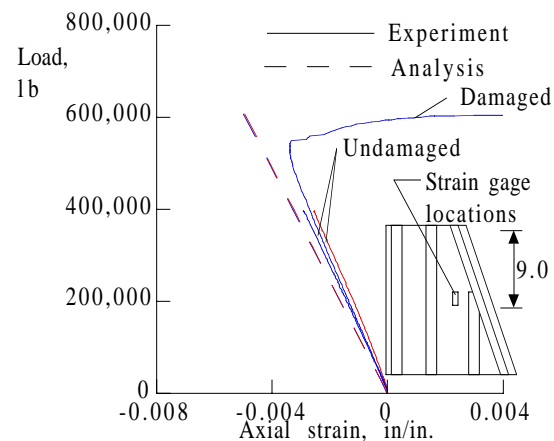
Figure 18. Axial surface strains in the skin at the impact site of panel L-3.

skin next to the tapered stiffener, but on the unstiffened side of the panel. Axial strains predicted by finite element analysis and measured during the preliminary and final loading are shown in figure 18 for strains at the impact site. Impact damage has little effect on strain at the impact site or far from the impact site. The relatively mild impact of 100 ft-lb did not disable the strain gage on the stiffened side of the panel at the impact site. Analysis accurately predicts the far field strains and strains at the impact site.

Analytically, a damage allowable strain value of .0053 in/in. at the reference surface of the skin at the impact site corresponds to a load of 648,000 lb. Applying the method described in reference 4 results in a predicted failure of 640,000 lb. The actual failure occurred through the impact site at 611,000 lb. Damage to the resin layer on the surface prevented strain from being measured at the impact site. The reference surface strain near the impact site was approximately .005 in/in. The panel failed at a strain that is slightly less than the allowable strain at the impact site. Failure prediction based on the damage allowable strain value and the analysis indicates that the panel failed at 95 percent of the prediction based on the method of reference 4 for impact damaged structure. However, that prediction is based on the assumption of a 0.1-inch-deep dent, rather than a dent depth of less than .01 inches that was applied to panel L-3. The predicted maximum strain in the panel away from the impact site is equal to .0067 in/in., which is significantly less than the allowable strain value in undamaged structure, so failure was caused by the strain in the region of the impact. The panel failed with a stress of 50.0 ksi at the impact site, which is 115 percent of the design stress.
