GT2004-53970

CERAMIC MATRIX COMPOSITE VANE SUBELEMENT TESTING IN A GAS TURBINE ENVIRONMENT

Michael Verrilli and Anthony Calomino
NASA Glenn Research Center, Cleveland, Ohio, USA

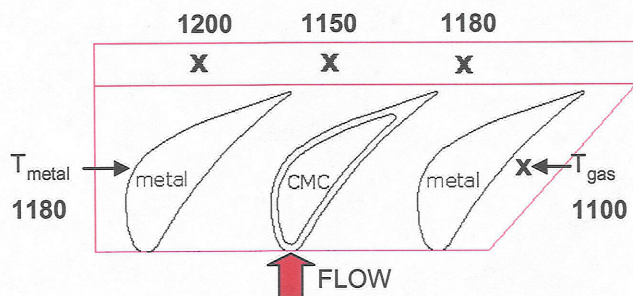
Typical temperature measurements obtained during rig testing of the vane are shown in Figure 9. Data shown here was obtained during the 18th hour of steady state testing. The gas temperature adjacent to one of the superalloy vanes reached 1100 °C and the surface temperature of the other superalloy vane peaked at 1180 °C. Gas temperatures of 1150 to 1200 °C were measured downstream of the vanes. After completion of 20 hours of testing, the SiC/SiC vane subelement had no visual degradation, whereas the superalloy vanes and other superalloy rig hardware had visually identifiable cracks.

Figure 9 – Temperatures (°C) measured during steady state testing of SiC/SiC vane subelement.

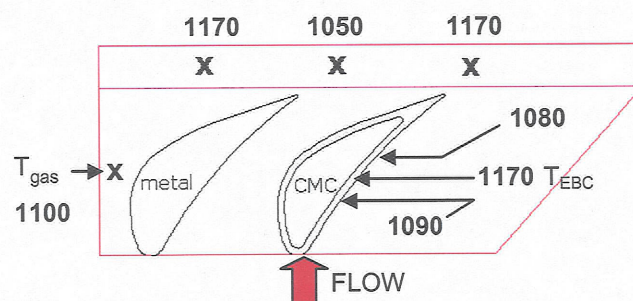
To allow measurement of the SiC/SiC vane temperature using optical pyrometry, one superalloy vane was removed to permit a proper sight line and testing was continued. As shown in Figure 10, the peak surface (EBC) temperature of the SiC/SiC vane subelement was 1170 °C. For both the two-vane and three-vane test configurations, rig operating conditions were held constant and similar gas temperatures were obtained (the exception was the cooler downstream temperature at the

Figure 10 – Temperatures (°C) measured during steady state testing of SiC/SiC vane subelement. One superalloy vane was removed to enable measurement of SiC/SiC vane temperature.

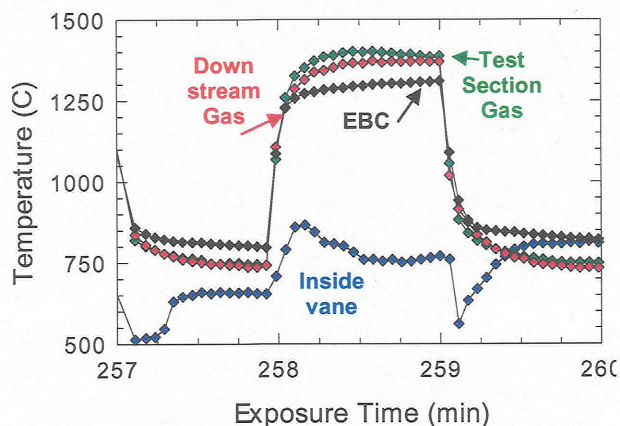
Considerably higher gas and material temperatures were reached during the cyclic peaks than had been obtained during the steady state testing (Figure 12). The EBC surface temperature reached 1320 °C and the maximum test section gas temperature for this cycle was 1400 °C.

Figure 12 – Temperatures measured during cycle 100.
