# THE ROSSI X-RAY TIMING EXPLORER (XTE) SOLAR ARRAY ANOMALY

Edward M. Gaddy, Robert Kichak, and Lee Niemeyer  
Goddard Space Flight Center, Greenbelt, MD 20771

## ABSTRACT

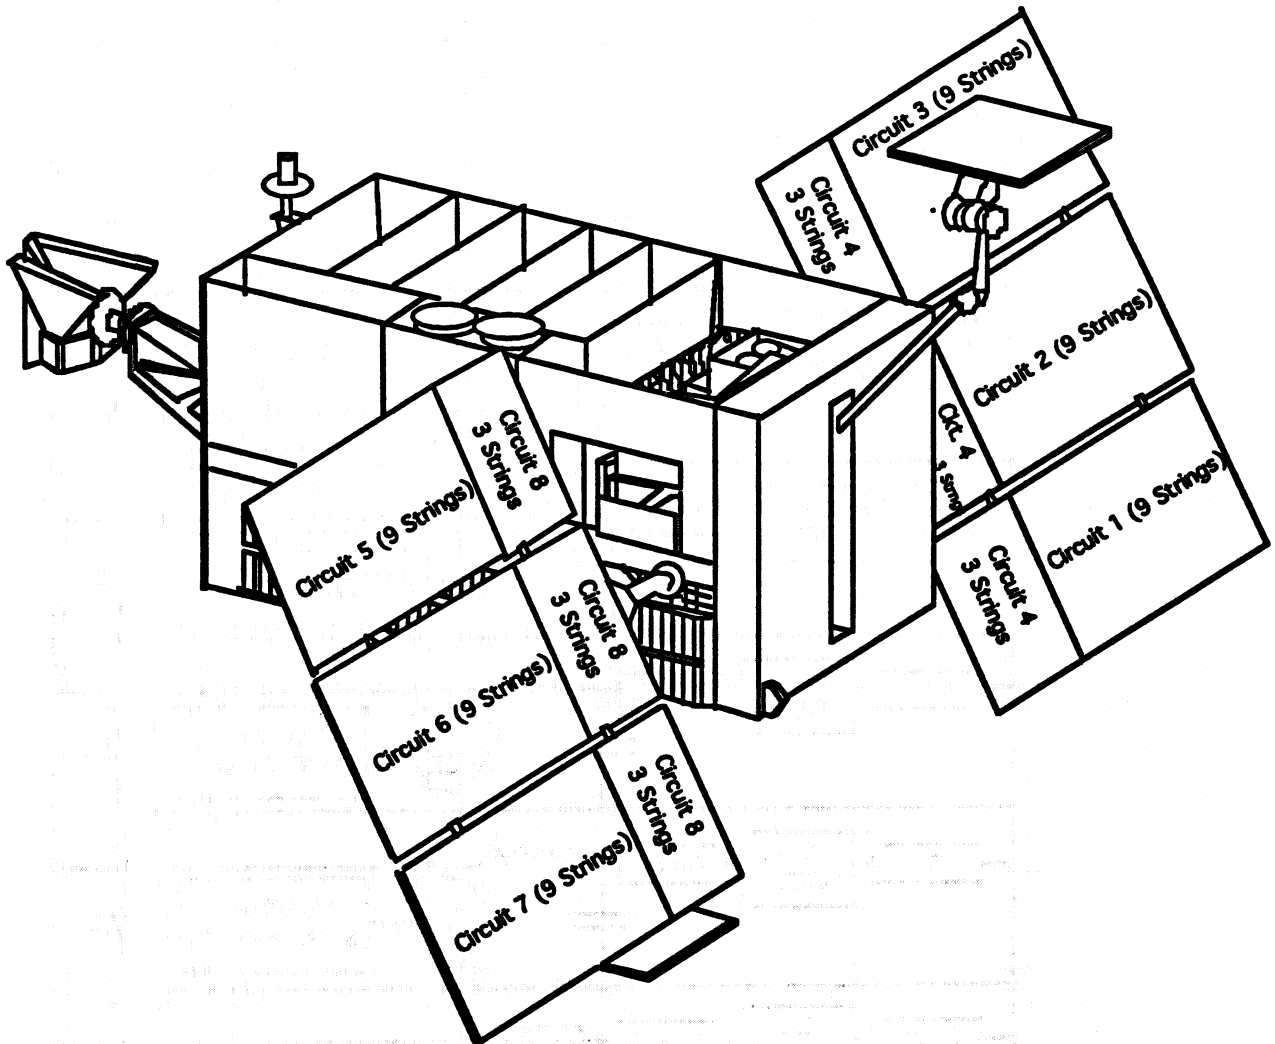
**Figure 1**  
*The XTE Spacecraft and Solar Panels*

The XTE's solar array is such that it is always oriented to the sun except when the spacecraft is slewing from one "target" to another. Figure 1 shows that the XTE solar array is divided into eight circuits. Six of these circuits are each contained completely on a single solar panel. The other two, circuits four and eight, are each divided on three panels. Each circuit is further subdivided into nine strings of silicon solar cells. Six of these strings have 100 cells in series and three have 103 cells in series. The strings comprising each circuit are paralleled at the most positive and negative cell. Each cell's size is 3.92 centimeters by 5.70 centimeters. The cells are fixed to aluminum face sheet substrates with CV 2568. The circuits are wired into the spacecraft as depicted in Figure 2; and, their voltages and currents are monitored as shown.

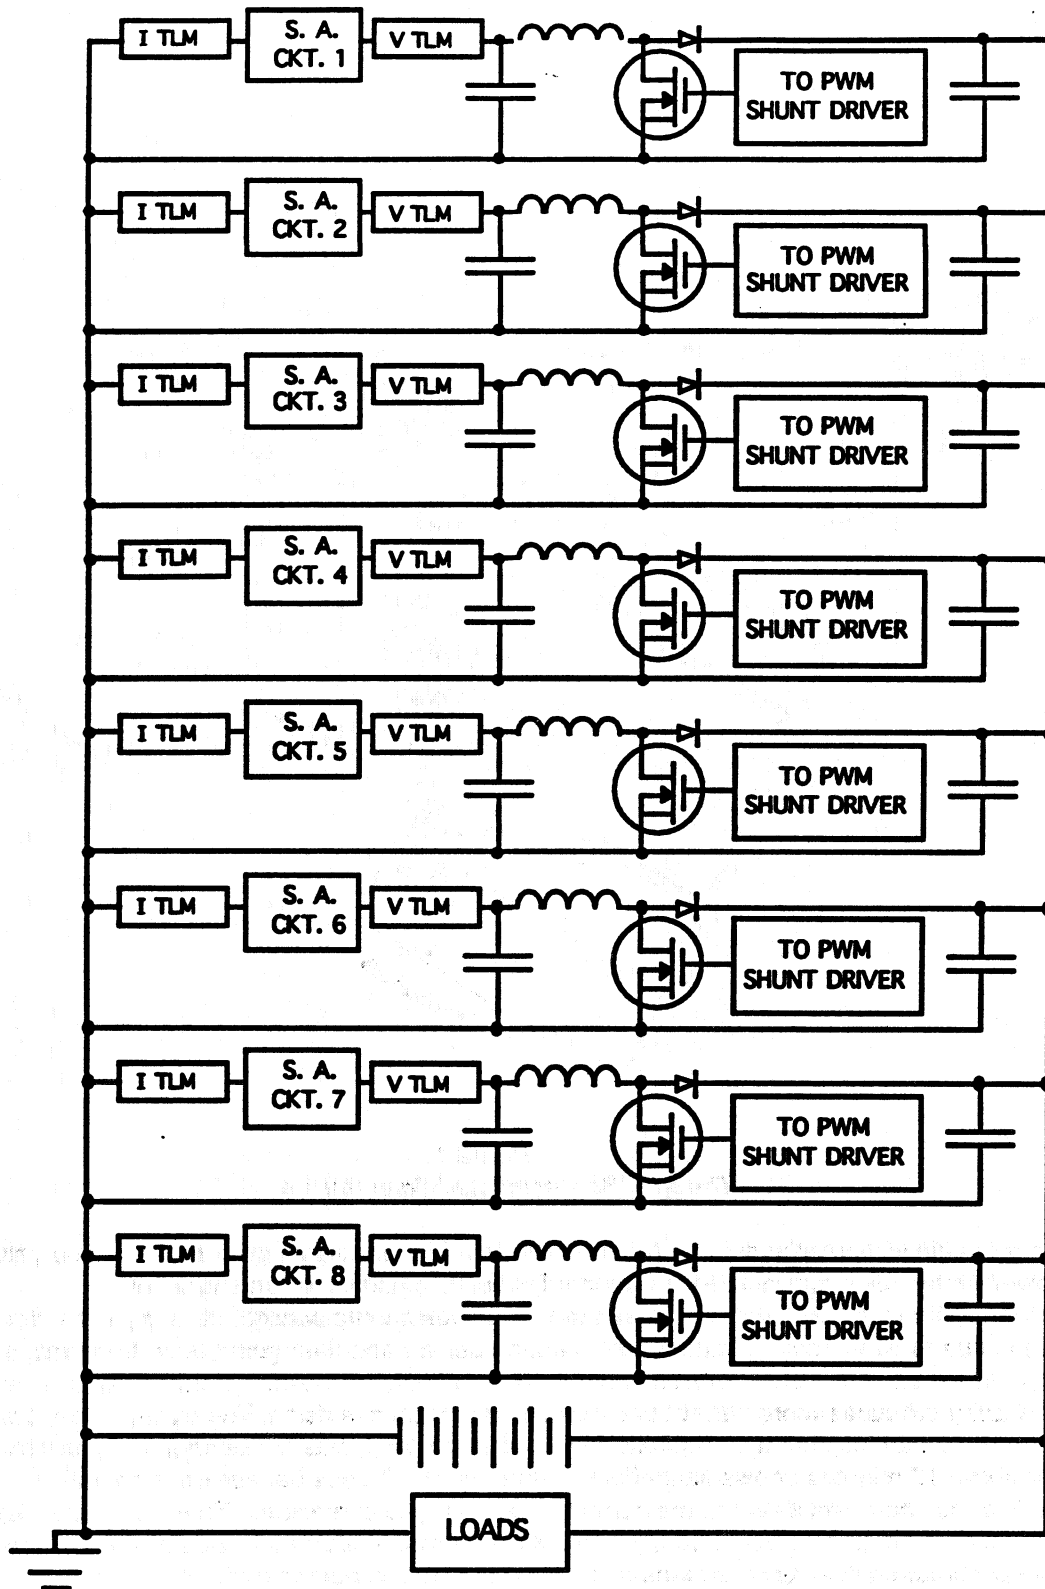
Figure 2  
Simplified Schematic of the XTE Power System

Figure 2 shows that each of the eight circuits feeds into the spacecraft independently. As the battery charges during the sunlit portion of the orbit, the spacecraft needs less current. This current control is accomplished by partially and then sequentially completely shorting out one circuit after another, with circuit eight shorting first. For example, soon after coming into sunlight circuit eight is shorted, circuit seven is partially shorted, and the remaining circuits are fully on line. Sometime thereafter circuits eight, and seven are shorted, circuit six is partially shorted and the other circuits are fully on line; etc.

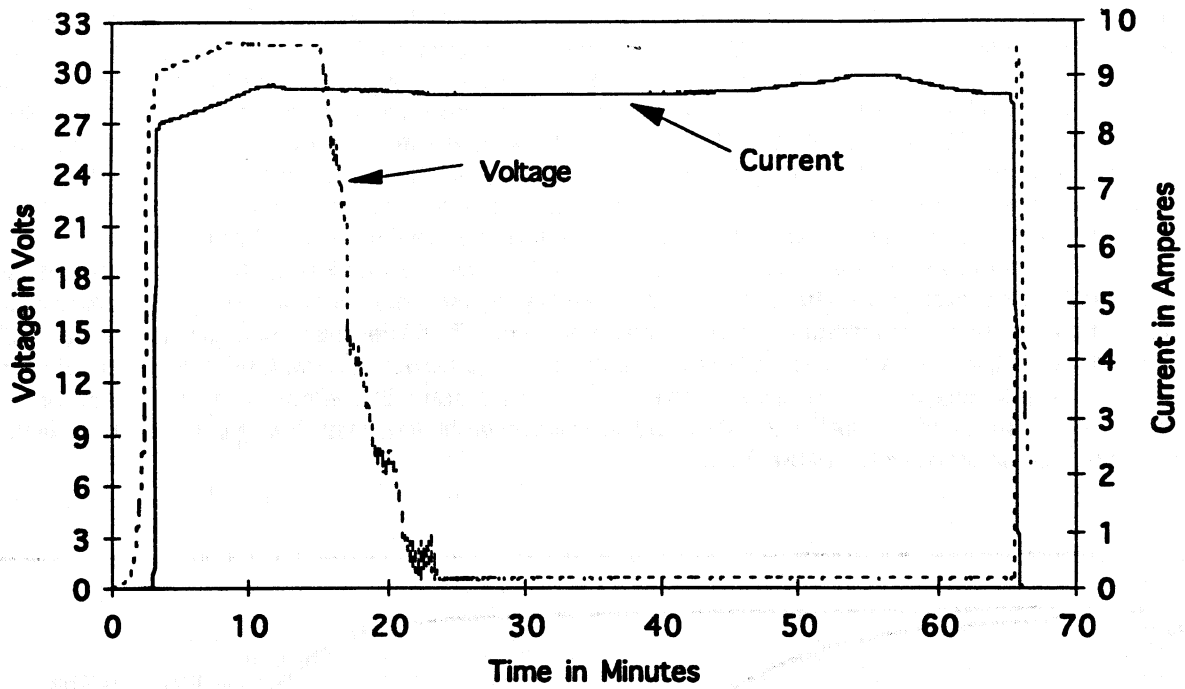
**Figure 3**  
**Module Five Voltage and Current Versus Time for Orbit Five**

Figures 3 and 4 respectively show the voltage across and the current produced by circuits five and four during the sunlit portion of orbit five. The performance of circuit five is normal in all respects. The voltage rises rapidly across the circuit when it comes into sunlight. It then reaches the battery voltage and is clamped to battery voltage through the diode. The voltage rise continues at a slower rate as the battery is charged. The rise in voltage stops when the battery hits its voltage limit. The voltage then holds steady for about seven minutes. Subsequently, it decreases suddenly. This is due to the power system shorting out the circuit which is no longer needed to maintain the battery at constant voltage. The circuit voltage stays at about 0.6 volt until

The current from circuit five rises rapidly as the circuit comes into sunlight. It then rises more slowly. This second rise is due to two effects. First the array is approaching and then going over the terminator about ten minutes into the orbit. This event corresponds to an increase in the array current due to earth albedo. Second, the array produces more current because its temperature is rising. The current then drops and rises again as the spacecraft crosses the terminator again at about 55 minutes. The shorting of the circuit to about 0.6 volts at about 17 minutes shows little effect on the current. This is because the operating voltage of the circuit is well to the short circuit side of the current versus voltage curve knee. There is nonetheless an effect. It cannot be seen in Figure 3, but a barely perceptible increase in current occurs every time the circuit is shorted. We will contrast the increase to the increase in the malfunctioning circuit four later.
