# **ACOUSTIC EMISSION DETECTION OF IMPACT DAMAGE ON SPACE SHUTTLE STRUCTURES**

WILLIAM PROSSER<sup>1)</sup>, MICHAEL GORMAN<sup>2)</sup> and ERIC MADARAS<sup>1)</sup>

1) Nondestructive Evaluation Sciences Branch, NASA Langley Research Center,  
MS 231, 3 E. Taylor St., Hampton, VA 23681, USA

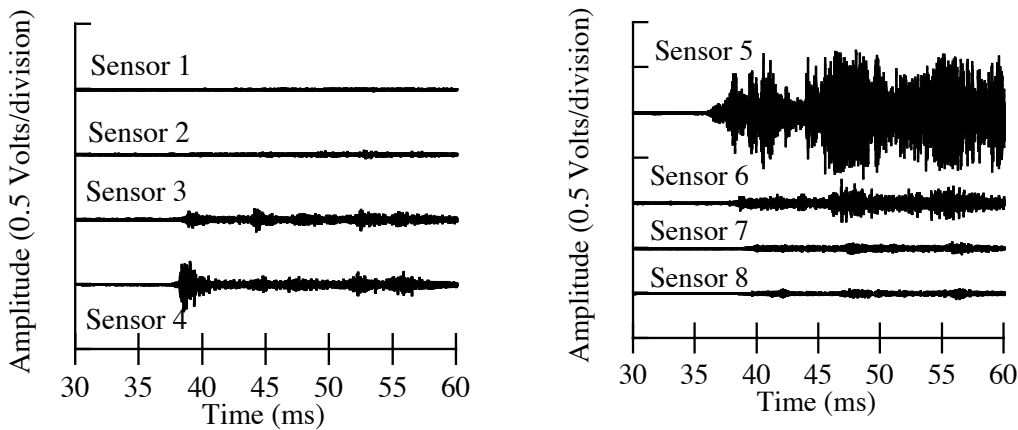
For the defining test of the investigation, a foam block weighing 1.67 lbs. was launched at a velocity of 237 m/sec, striking panel 8 as indicated in Figure 1. This impact produced a significant hole in the RCC panel providing conclusive evidence for the Columbia Accident Investigation Board in determining the cause of the accident [4]. The AE signals that were detected from this foam impact event are shown in Figure 2. Only 6 dB of gain was applied to the signals from the AE sensors. As would be expected, the largest signal, arriving earliest in time was that from sensor 5, which was nearest the impact site. Decreasing arrival times and amplitudes of signals from sensors located further away from the impact point were observed. Although not noticeable in this figure as all signals are plotted on the same scale, signals were detected all the way down to the location of sensor 1, suggesting that impact events can be detected by sensors mounted several RCC panels away, a distance of more than 1 m. Examination of the arrival times for signals from sensors 7 and

Figure 2. AE signals from foam impact on Shuttle RCC wing leading edge.

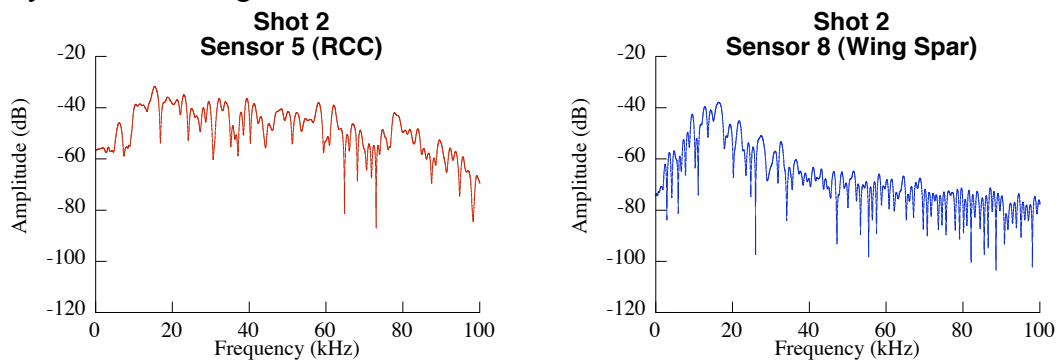
Additional foam impact tests were performed on RCC panels over a range of projectile sizes and impact velocities. These impact tests were performed on different panels on the LESS test article, as well as on the T-35 test article, which represented a more outboard section of the wing. This test article allow impact tests on panels 16 and 17 and further provided the opportunity to evaluate the effect of differing impact locations on measured signals. Signals from small projectiles and/or low impact velocities producing impact energies below the threshold of damage were still readily detected. Variations in the signal amplitude correlated with the impact energy. In addition to sensors on the spar, sensors were also placed on the RCC panel of the T-35 test article to measure the transfer function response from the RCC panel to the spar. The frequency response plots in Figure 3 show the significant loss in high frequency signal content that occurs as the signal propagates from the RCC to the wing spar of Columbia construction. Preliminary testing on test articles with the wing spar construction of the remaining Shuttle fleet suggests that this high frequency attenuation might not be as severe.

Figure 3. Frequency content of foam impact signals for sensors on RCC panel and wing spar.

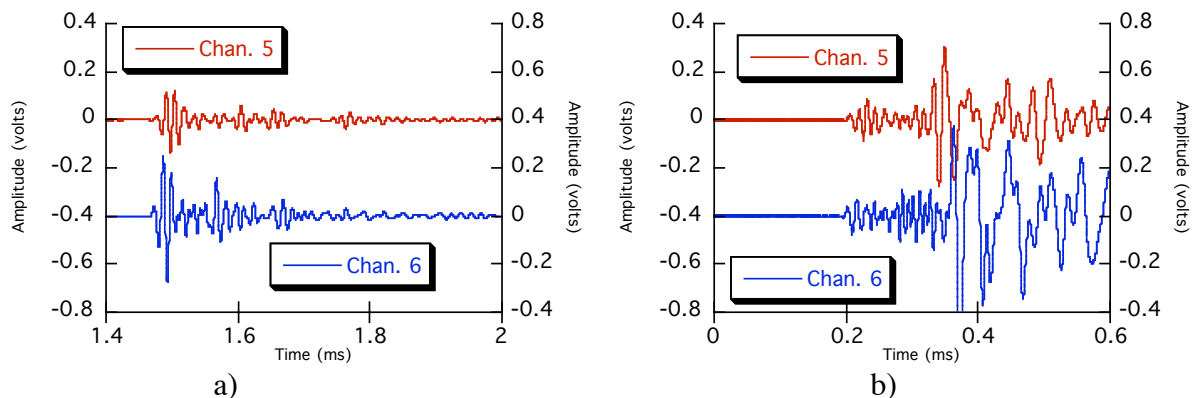
Figure 6. AE signals produced by a) hypervelocity impact and b) pencil lead break.

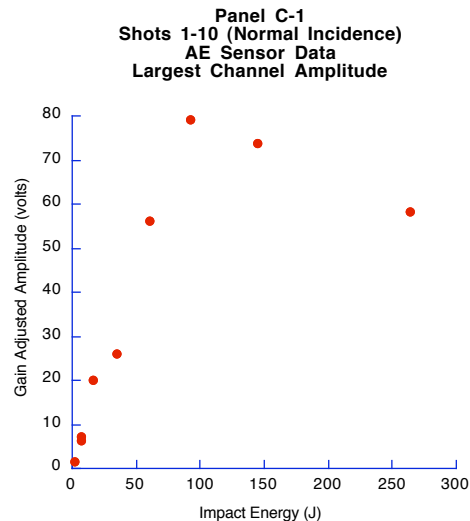
Figure 7. AE signal amplitude versus impact energy

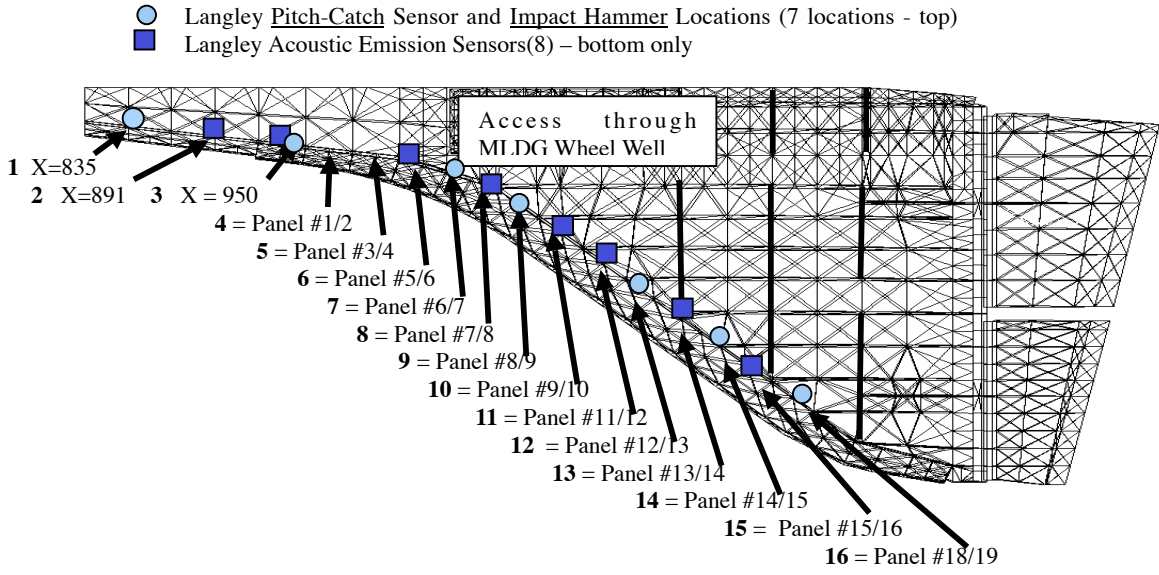
Impact hammer and pulse-receive ultrasonic measurements were made on the wing spar of the Shuttle Endeavor to investigate the effects on wave propagation due to differences in wing spar construction. As noted previously, the LESS and T-35 test articles represented the Columbia wing spar construction which is different from the remainder of the fleet. Transducers were attached to the leading edge of the Shuttle's wing, as indicated in Figure 8. At various locations, ultrasonic signals between 10 to 150 KHz were introduced and recorded on the fixed transducers. In addition, a series of low energy, instrumented hammer impacts (20, 60, 150 and 250 lbs) were performed on the wing's leading edge. Similar experiments were performed on the LESS and T-35 test articles to develop a correlation between the different structures. Figure 9 shows the frequency response of AE sensors to a hammer impact on the Shuttle Endeavor wing spar as well as on the LESS test article. Although the overall peak amplitudes of the time domain signal are similar, the frequency response shows that the peak amplitude is at a much lower frequency with much higher frequency attenuation for the LESS as compared to the Shuttle. These differences are significant in that they indicate that higher frequency signal components may propagate from impacts on the Shuttle to and along the spar. Such higher frequencies may enable improved signal to noise for detection as the background noise is expected to decrease with increasing frequencies. However, no database exists for measurements of the background noise for ultrasonic frequencies on the Shuttle. A flight experiment to obtain this information is being planned to enable optimized sensor frequency selection for a planned upgrade to the Shuttle impact sensing system.

Figure 8. Layout of transducer locations inside the Shuttle Endeavor's wing.

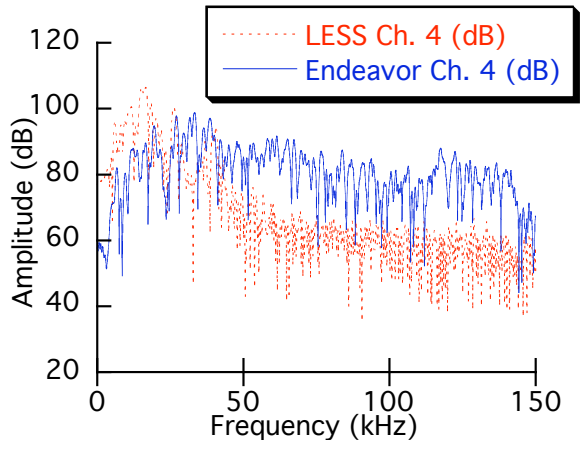
Figure 9. Frequency response for 150 lb hammer impact on Shuttle Endeavor wing spar and Leading Edge Structural System (LESS) test article.
