Report of the Seasat Failure Review Board

DECEMBER 21, 1978

REPORT OF THE SEASAT
FAILURE REVIEW BOARD

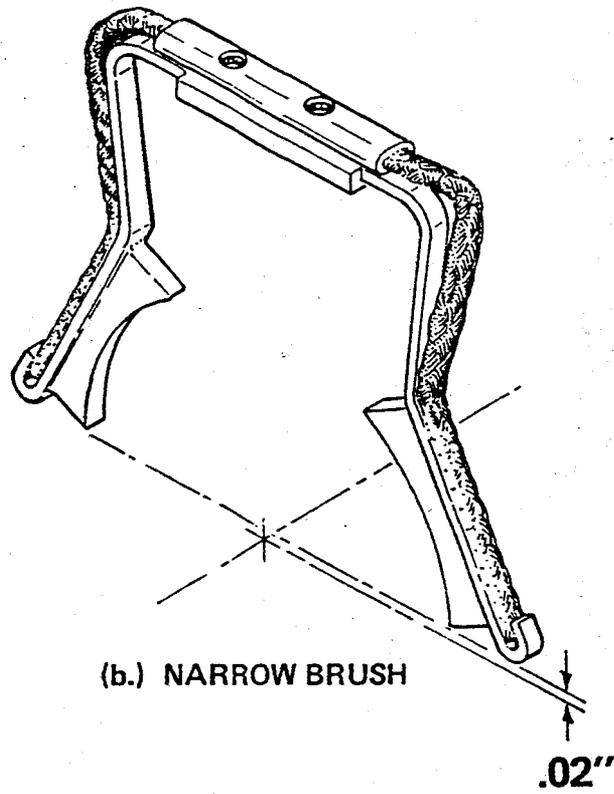
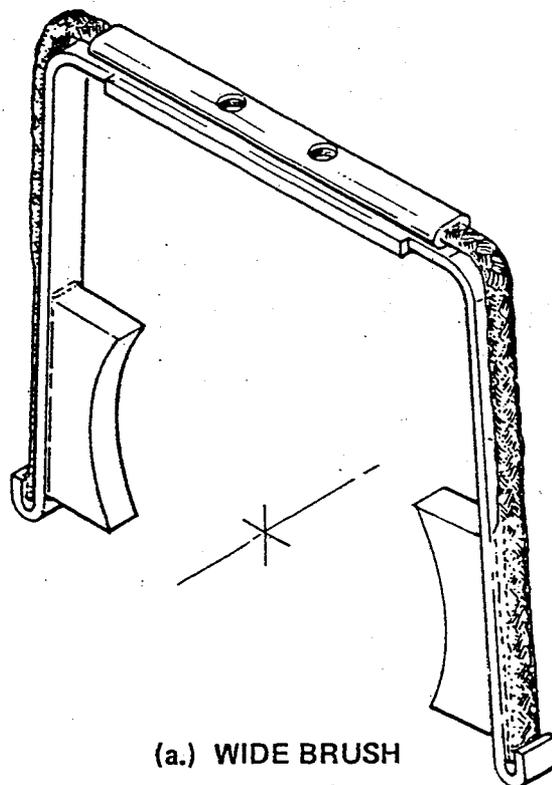
Figure 5-13. Slip Ring Brush and Spring Assemblies

The slip ring rotor assembly consisted of individual slip rings on a fluted shaft, held in place by a potting compound that provided structural support and positioning to the rings and their soldered leads as well as dielectric insulation. The two types of brush and spring assemblies in the design flown on Seasat are shown in detail in Figure 5-13 (a and b). From these figures it is clear that the wide brush assembly, when mounted, straddled the slip ring assembly in a manner to bear on its mating slip ring from opposite sides. This resulted in having essentially a full overlap between the interleaving wide brush assemblies that were mounted alternately from the top and bottom brush holders in the slip ring assembly. The narrow brushes shown in Figure 5-13b sprung out when placed over the rotor so that a vertical gap of 0.04 inch typically resulted at assembly between the tips of narrow brushes. An appreciation of brush spacings when fully assembled may be seen by the photographs in Figure 5-14.

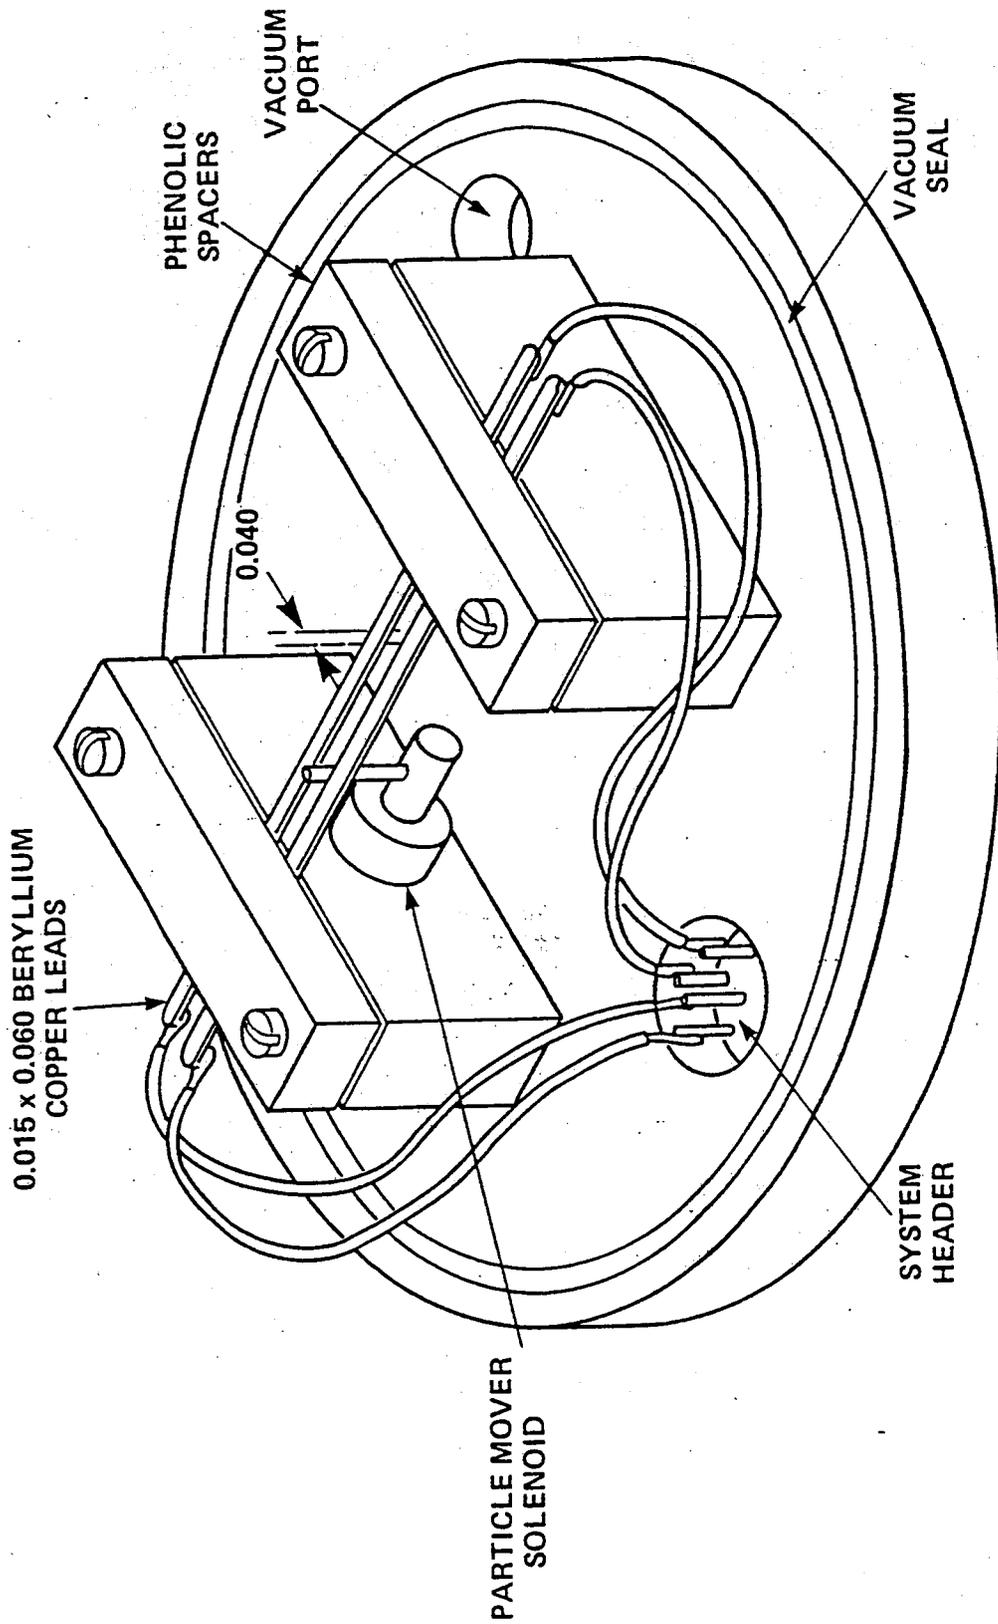
Figure 8-5. Simulation Fixture for Debris Tests

Sperry Flight Systems¹, Phoenix, Arizona, who has used slip rings with the same brush material, brush spring material, and similar brush-to-brush clearances has conducted an investigation of a failure mechanism that can be initiated by contaminants. Tests were run in a fixture containing simulated slip ring brush assembly springs, with clearances similar to the Seasat flight hardware (Figure 8-5). The purpose of tests conducted with this apparatus was to determine the nature and extent of arcing shorts that might be initiated by debris.

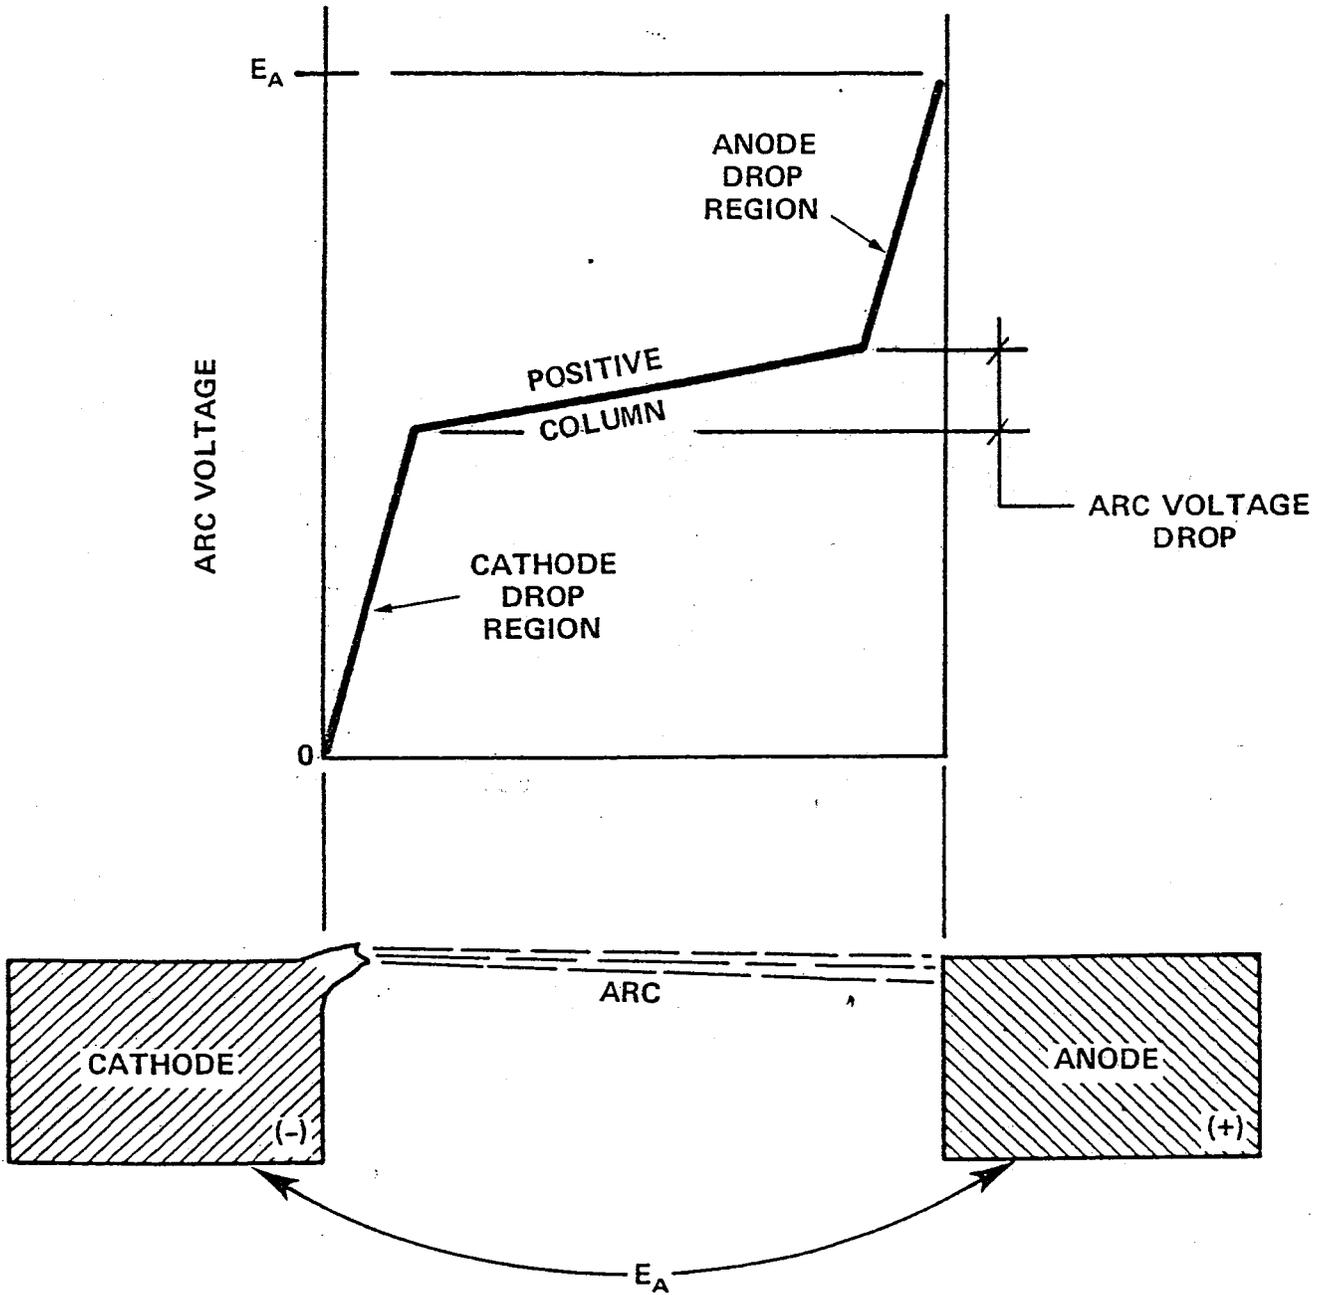
Figure 8-8. Voltage Within Cathode - Anode Arc

Test No.	Arc ΔV volts-DC	Arc Current amps	Peak Current amps	Arc Duration ms	Power Dissipation watts	Lead Material Loss inches
1	-	-	65	400	950	0.6
2	14	50	62	85	570	0.5
3	14	50	64	275	700	-
4	10	50	96	600	600	totally consumed
Seasat Flight Data	10	60	not known	600	600	not known
