## COMPLIANT FOIL SEAL INVESTIGATIONS

Margaret P. Proctor  
National Aeronautics and Space Administration  
Glenn Research Center  
Cleveland, Ohio

2003 NASA Seal/Secondary Air System Workshop  
November 5-6, 2003

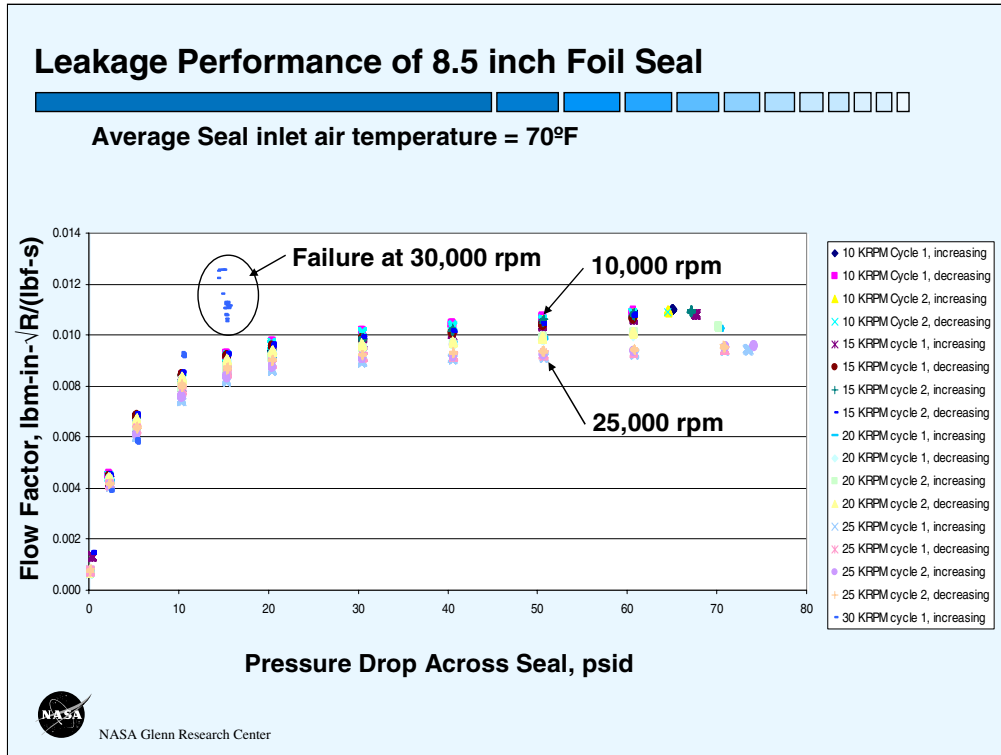
This is a plot of the seal leakage flow factor versus pressure drop across the seal obtained during the performance test. For all speeds the flow factor increases with increasing pressure differential until about 25-30 psid where it levels off indicating that the flow is choked. The flow factor decreases as speed increases due to reduced clearance cause by centrifugal growth of the rotor. During the failure event at 30,000 rpm and 15 psid the flow factor increased substantially and rapidly. This sudden increase in flow factor indicates an opening of the seal clearance caused by either loss of the seal coating or wear of the seal top foil.

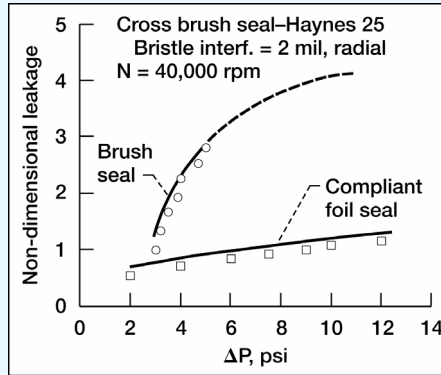
### Foil Seal and Brush Seal Leakage Data 2.84 in. Dia. Journal; 68 °F SBIR Phase 1

From the previous chart we see that the flow factor for the 8.5 inch foil seal leveled out between 0.009 and 0.011.

Previous testing at NASA has shown that finger and brush seals have flow factors of 0.004 to 0.006.

MiTi previously tested a 2.84 inch foil seal and found its leakage performance to be much better than a brush seal.

The leakage performance of the 8.5 inch foil seal is about twice that of a brush or finger seal. Since this is counter to previous findings at smaller diameter seals, it is concluded that there are some scale up issues that need to be addressed.

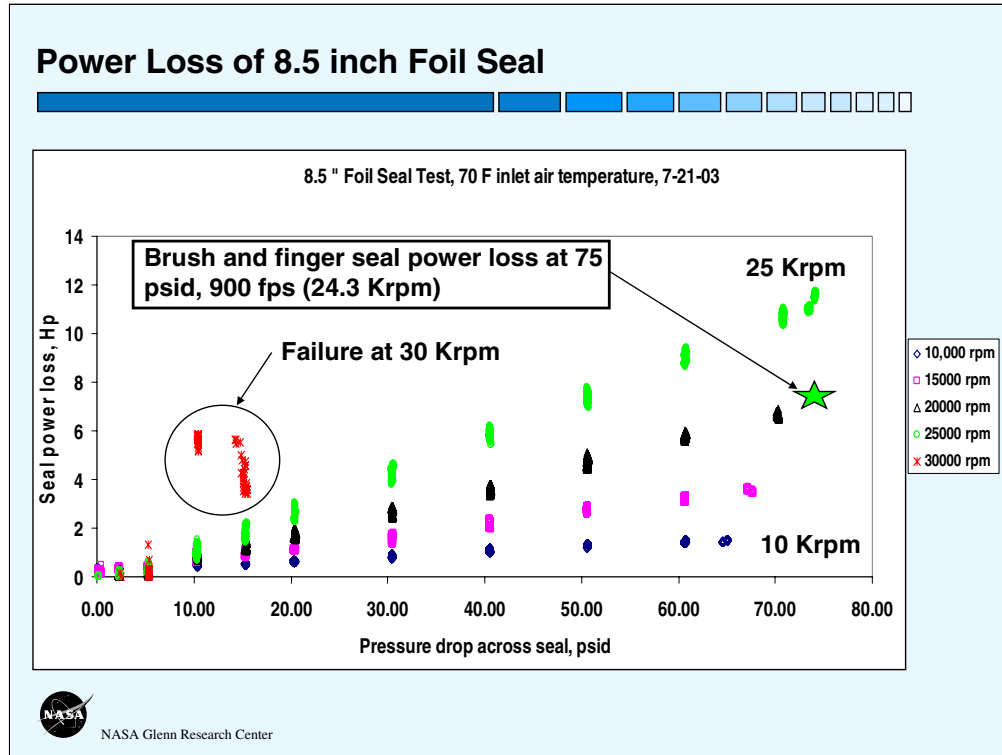
## Power Loss of 8.5 inch Foil Seal

This is a plot of the measured 8.5 inch foil seal power loss versus pressure drop across the seal for each speed tested. A torquemeter was used to measure the total torque of the seal test rig with the seal installed. The tare torque of the seal test rig without a test seal installed is subtracted from the total torque to derive the seal torque. The seal power loss is computed as the seal torque multiplied by speed. The seal power loss increases with speed and with pressure differential.

Noting that the seal power loss of the 8.5 inch foil seal at 25,000 rpm or 927 ft/s and 75 psid is 11-12 Hp and comparing it to previously published data for the finger and brush seal at 1200 F inlet air temperature, 900 ft/s and 75 psid which had a seal power loss of 7.5 to 8 Hp, it is concluded that the 8.5 inch foil seal tested has a higher power loss than a brush or finger seal.
