Failure Analysis of Discrete Damaged Tailored Extension-Shear-Coupled Stiffened Composite Panels

Donald J. Baker*

Vehicle Technology Directorate – ARL, NASA Langley Research Center, Hampton, VA 23681

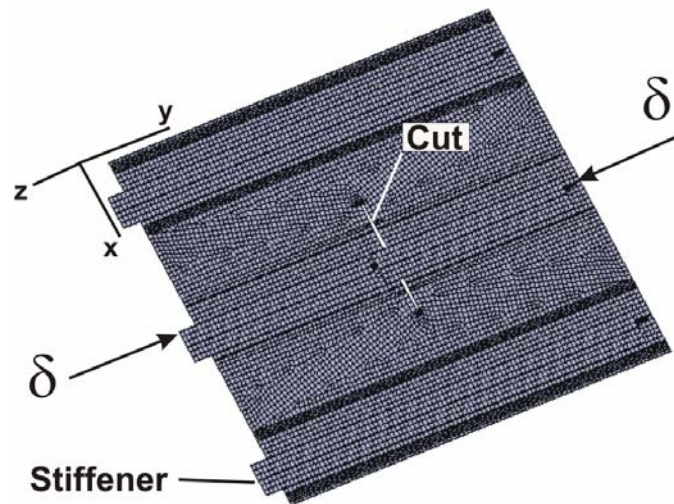
Figure 5. Finite element model of *Horizontal cut* panel.

The STAGS finite element model for the *Horizontal cut* panels is shown in Fig. 5. The model contains 12,771 quad elements (element 410 in the STAGS element library) and 12,494 nodes. A progressive failure analysis of the *Horizontal cut* panel was performed with the STAGS finite element model by applying an incremental axial displacement to load the specimen to simulate the loading in a test machine. The material properties used in the analysis are typical IM6/3501 carbon-epoxy properties and are shown in Table 1. The material property values shown in Table 1 are typical vendor supplied data and the property distributions were unknown. It was necessary to estimate some of the properties not available in the literature. The predicted initial failure occurred at a load of $N_y = 4.84$ kips/in. The initial failure, shown in Fig. 6, started at each end of the machined slot and started to turn to the right in the top detail and to the left in the bottom detail. The elements that failed indicate that 30 percent to 80 percent of the plies have failed. Increasing the axial displacement until a maximum load was achieved resulted in the predicted failure load for the specimen to be $N_y = 7.87$ kips/in. The progression of failure to the maximum load is shown in Fig. 7. The predicted failure progressed from the initial failure down across the skin at a 35° angle to the panel centerline and stops at the edge of the skin. More than 60% of the plies have failed in the elements that indicated failure. The predicted failure progressed up at a 35° angle to the centerline and has turned into the transition to the stringer pad up. The predicted in-plane (v) and out-of-plane displacements (w) at the maximum load are shown in Fig. 8. The out-of-plane displacements (Fig. 8) predict a skewed pattern resulting from the anisotropic properties of the skin. An increased area of out-of-plane displacement is predicted at the skin failure area. The slot in the central stringer and skin combined with the skin fractures eliminate most of the in-plane coupling. By increasing the axial displacement, the resulting load carrying capacity of the specimen is reduced and the failure line can be predicted. After approximately 100 displacements steps, the failure progresses across one stringer as shown in Fig. 9 and the load carrying capacity is reduced to $N_y = 5.78$ kips/in. As indicated in Fig. 9, the stringer is predicted to be completely severed. Increasing the displacement steps completes the failure line across the entire panel as shown Fig.10 and the load capacity has fallen to $N_y = 2.74$ kips/in. The predicted panel end shortening and transverse in-plane displacement as a function of load are shown in Fig.11. A least squares best fit to the axial displacement between 0 and 5 kips/in. of load is also shown as a dashed line in Fig. 11. The slope of the line is 111.92 kips/in/in. At an applied load of 4.84 kips/in. the predicted in-plane displacement is 15.8 percent of the axial displacement. The axial displacement curve is linear until over 5 kips/in (past the initial failure) and then slightly nonlinear to failure. The remainder of the curve reflects the load reduction indicated previously as different elements of the panel fail.

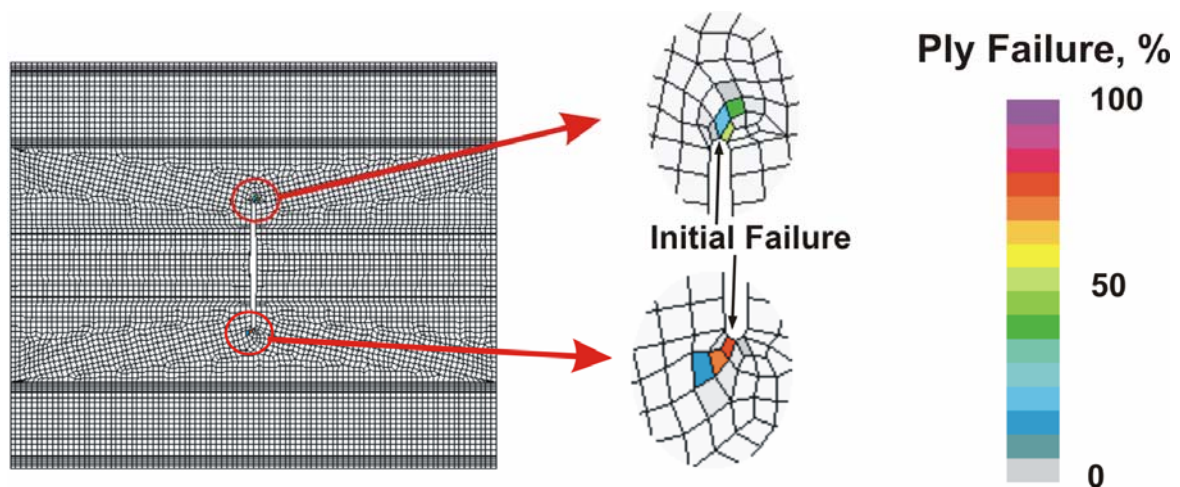
Figure 6. Initial failure in *Horizontal cut* panel, $N_y = 4.84$ kips/in.

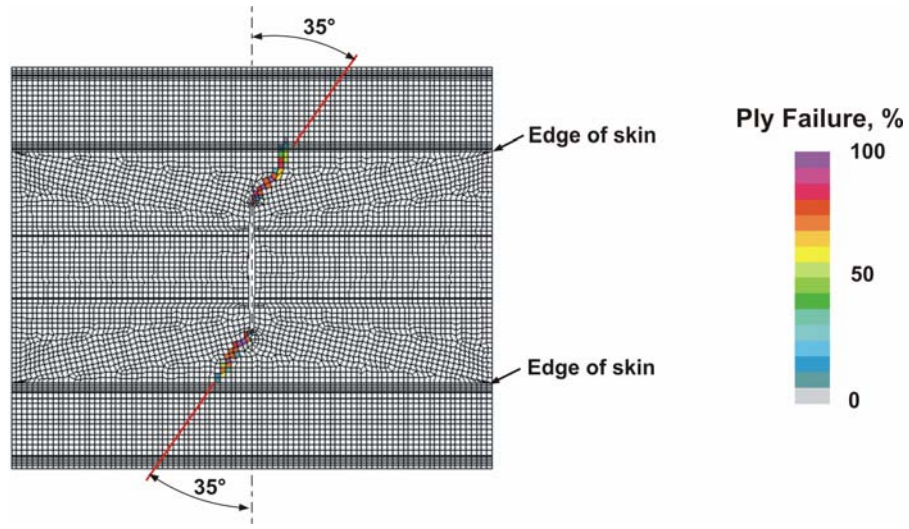
Figure 7. Predicted failure in *Horizontal cut* panel at maximum load, $N_y = 7.87$ kips/in.

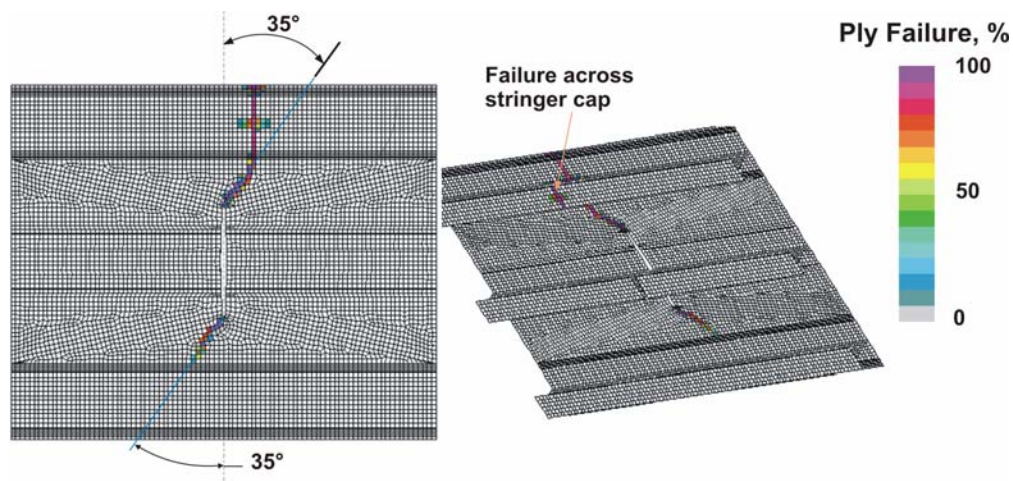
Figure 9. Predicted failure path in *Horizontal cut* panel at $N_y = 5.78$ kips/in.

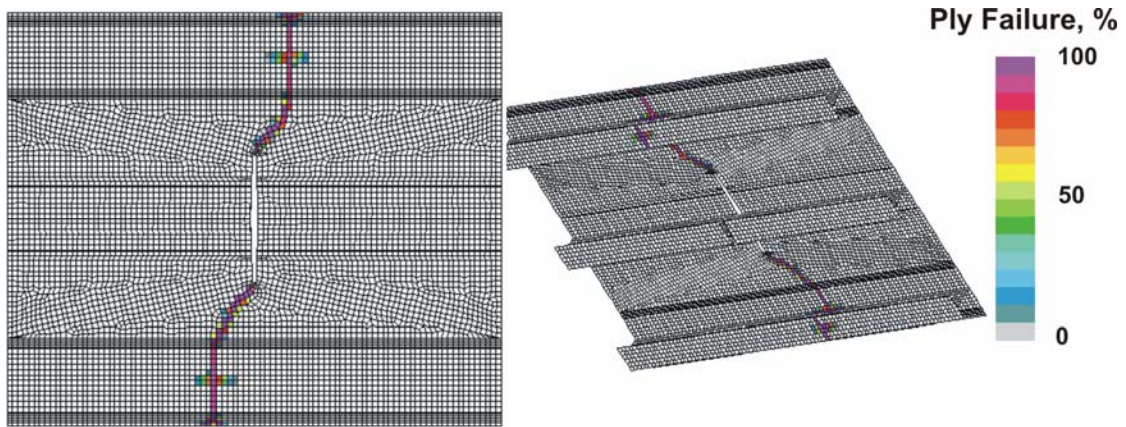
Figure 10. Predicted panel failure in *Horizontal cut* panel at $N_y = 2.74$ kips/in.

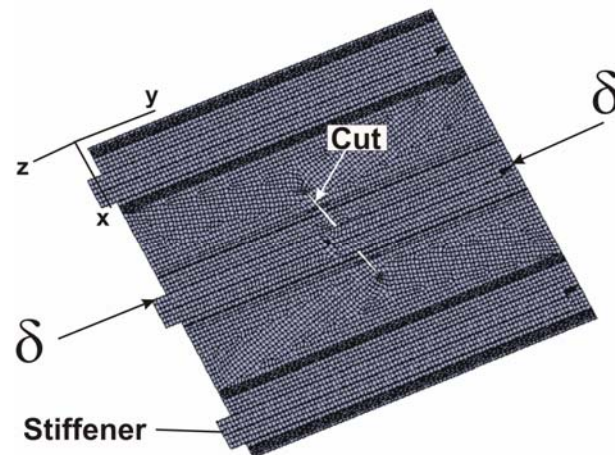
Figure 12. Finite element model of *Inclined cut* panel.

The STAGS finite element model of the specimen with the inclined cut is shown in Figure 12. This model contains 12,702 quad elements and 12,429 nodes. A progressive failure analysis of the *Inclined cut* panel was performed with the STAGS finite element model by applying an incremental axial displacement to load the specimen to simulate the loading in a test machine. The material properties used in the analysis are typical IM6/3501 carbon-epoxy properties and are shown in Table 1. The predicted initial failure occurred at $N_y = 3.8$ kips/in. as shown in Fig. 13 and started at each end of the slot. The failed element at the bottom of the slot as shown in Fig. 13 indicated approximately 25 percent of the plies had failed while the failed element at the top of the slot indicated approximately 40 percent of the plies had failed. Increasing the axial displacement until a maximum load was achieved resulted in the predicted failure load for the specimen to be $N_y = 8.53$ kips/in. The failure progressed down and to the left at a 50° angle from the panel centerline with increasing load as shown in Fig. 14. The failure progressed into the edge of the transition area on the lower side of Fig. 14 while only a few elements indicate damage on the upper side of the slot. Information shown in Figures 14 and 15 are at a load of $N_y = 8.43$ kips/in which is on the unload phase after the maximum load has been achieved. The out-of-plane displacements shown in Fig. 15a predicts a positive 'w' displacement at the top end of the slot while a negative out-of-plane displacement is predicted along the lower part of the slot but not at the tip of the slot. The skin failure can be seen in the in-plane displacements (Fig. 15b). The load continues to drop as the displacement of the test machine platens is increased. The failure progresses to the edge of the panel as shown in Fig 16. At this point only the skin has failed. The stringer cap and web has not failed. A very few additional elements indicated failure at the top of the slot. Increasing the axial displacement for approximately 20 steps the load is maintained at approximately $N_y = 5.7$ kips/in. Then the loads increased as the axial displacement increases resulting in more elements failing and the lower stringer failing in the web and started to fail in the cap. The predicted axial strains in the skin for $N_y = 6.31$ kips/in are shown in Fig. 17. Strain in the bottom of the panel as shown in Fig. 17 is nearly zero. The fracture area is indicated by the strain in excess of 3 percent. Most of the strain is in the top of the panel where the stringer is still

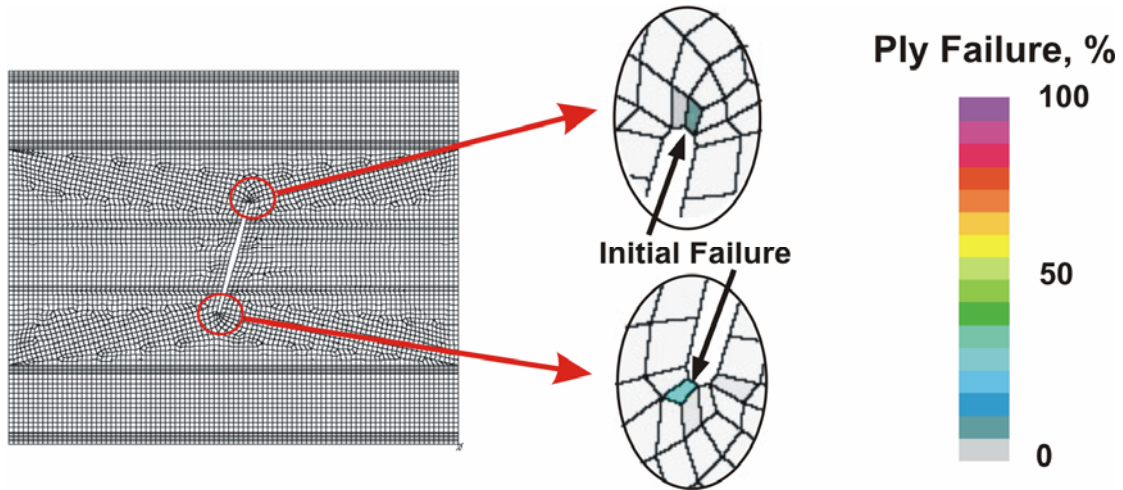
Figure 13. Predicted initial failure in the *Inclined cut* panel, $N_y = 3.8$ kips/in.

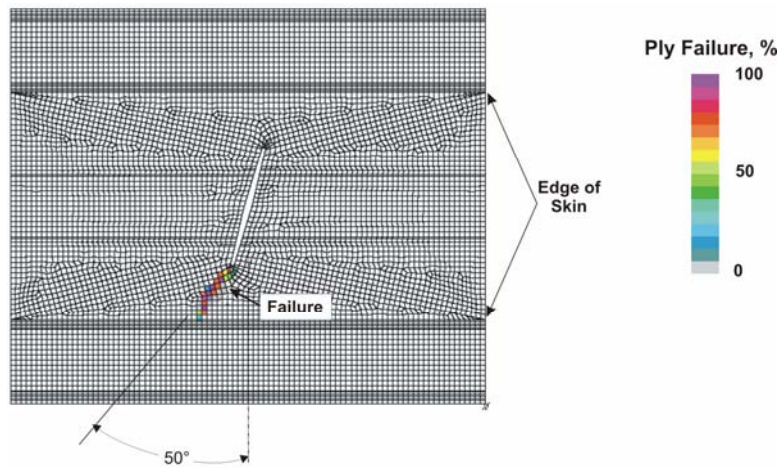
in the load. Increasing the axial displacement resulted in the damage progressing to and into the stiffeners as shown in Fig. 33 which is the last image before panel failure. Comparing Fig. 33 with the predicted failure direction shown in Fig. 14 indicates the failure direction is the same, down to the right for one end of the slot.

Figure 14. Predicted failure in *Inclined cut* panel $N_y = 8.43$ kips/in.

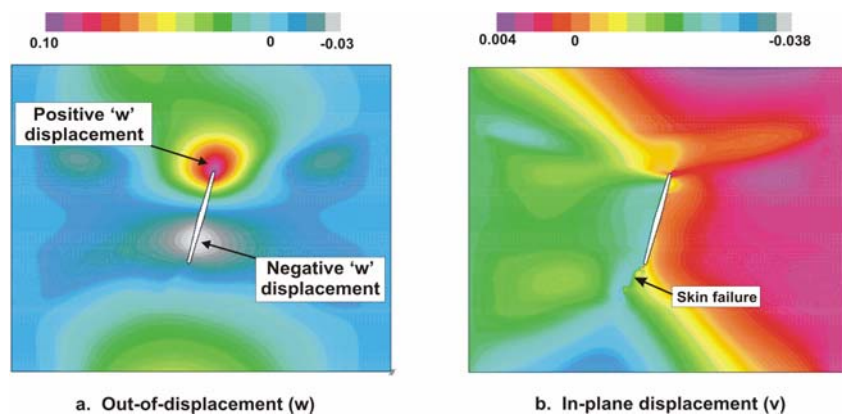
An intermediate result from the VIC-3D system at $N_y = 6.32$ kips/in is shown in Fig. 31 and indicates that the panel is bulging as indicated by the concentric displacement contours around the slot. This out-of-plane deflections is different from the predicted displacement shown in Fig. 15 where one end of the slot deflects in one direction with the opposite slot end deflecting in the opposite direction. The local area image indicates a delamination at the corner of the slot. The delamination shown in Fig. 31 first appeared at $N_y = 5.32$ kips/in. and increased in size until $N_y = 6.32$ kips/in. Damage started to show up in both ends of the slot as shown in Fig. 32 after a very small perturbation

Figure 15. Predicted in-plane and out-of-plane displacements in *Inclined cut* panel, $N_y = 8.43$ kips/in.

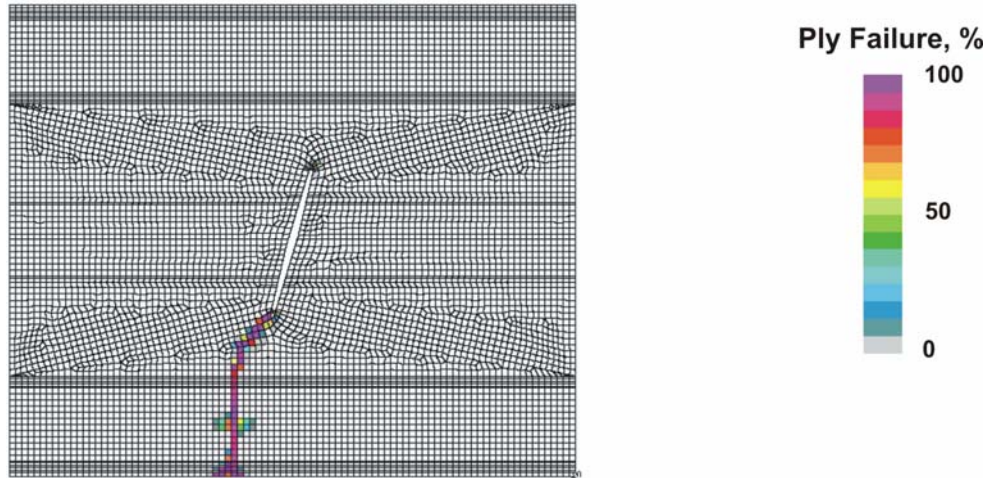
Figure 16. Progression of failure in *Inclined* cut panel at $N_y = 5.69$ kips/in.

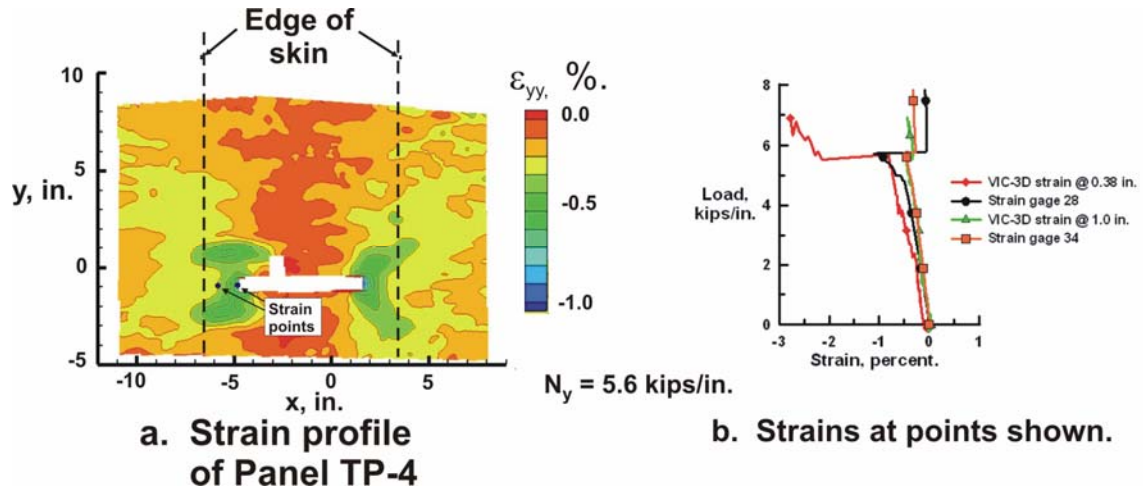
Figure 25. Measured axial strains (ϵ_{yy}) on panel TP-4..

As indicated previously in this paper, strain can be computed from the u, v, and w displacements determined from the VIC-3D images. The axial strain (ϵ_{yy}) profile for the panel TP-4 image area, which covers approximately 60 % of the skin surface is shown in Fig. 25a for an applied load of $N_y = 5.6$ kips/in. which is the load just prior to

initial failure. This load was selected to have a flat surface to compute the strain in lieu of a load after initial failure where the surface is not flat due to the outer layers delaminating and buckling away from the surface. A non-flat surface would not allow a good strain computation. The anisotropic skin appears to have an effect on the shape of the strain contours at the end of the slot. Two points located at 0.38-inches and 1.0-inches from the left end of the slot have been selected to determine the strain as a function of load. The strain, at these selected points, has been extracted from the VIC-3D images and is shown in Fig. 25b. Strains from gages 28 and 34 which are on the opposite side to the selected points on panel TP-4 are also shown in Fig. 25b. The VIC-3D strain, shown in Fig. 25b, from the point at 0.38-inches from the slot would not be reliable above the load of $N_y = 5.6$ kips/in due to the delamination and buckling from the initial failure. The strain at the point at 1.0-inch from the slot would be more reliable since this location is on the edge of the buckled lamina. There is a good correlation between the strains up to a load of 5.6 kips/in. Strain results from panel TP-7 are shown in Fig. 26 which is plotted to the same scale as Fig. 25. Comparing the Fig. 25 and Fig. 26 indicates that the response of panel TP-7 is similar to the response of panel TP-4. The predicted axial strains (ϵ_{yy}) contours for the *Horizontal cut* panels is shown in Fig. 27 for an applied load of 5.58 kips/in. Comparing Figures 27, 26 and 25 the following can be observed: a) all figures have an area through the center of the panel of near zero axial strain, b) the shape of the strain distributions at the end of the slots are very similar, c) the magnitude of the strains along the side of the panels are similar.

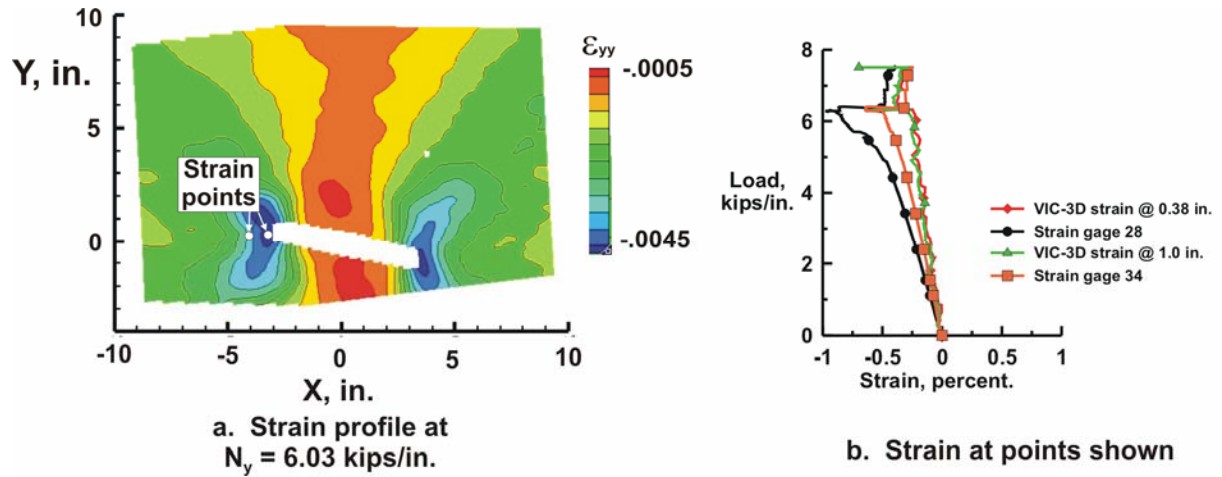
Figure 34, Axial strains in *Inclined cut* panel as determined by VIC-3D and strain gages.

The VIC-3D axial strain (ϵ_{yy}) profile for the *Inclined cut* panel is shown in Fig. 34a for $N_y = 6.03$ kips/in. Two points located at 0.38-inches and 1.0-inches from the left end of the slot have been selected to determine the strain as a function of load. The strains at these selected points has been extracted from the VIC-3D images and are shown in Fig. 34b. Strains from gages 28 and 34 which are on the opposite side to the selected points on the *Inclined cut* panel are also shown in Fig. 34b. There is good correlation between the strain gages and strain extracted from the VIC-3D images until the skin started to deflect out-of-plane or approximately 4.0 kips/in. The predicted axial strains (ϵ_{yy}) contours for the *Inclined cut* panel is shown in Fig. 35 for an applied load of 6.07 kips/in. The anisotropic skin appears to have an effect on the shape of the strain contours at the end of the slot. Comparing Figures 34 and 35 the following can be observed: a) both figures have an area through the center of the panel of near zero axial strain, b) the shape of the strain distribution at the left end of the slot is similar while the right end of the slot is different, the magnitudes of the strain along the sides of the panel are similar.
