Combustion Device Failures During Space Shuttle Main Engine Development

Otto K. Goetz
NASA

5th International Symposium on Liquid Space Propulsion
Long Life Combustion Devices Technology

Chattanooga, Tennessee
October 27-30, 2003

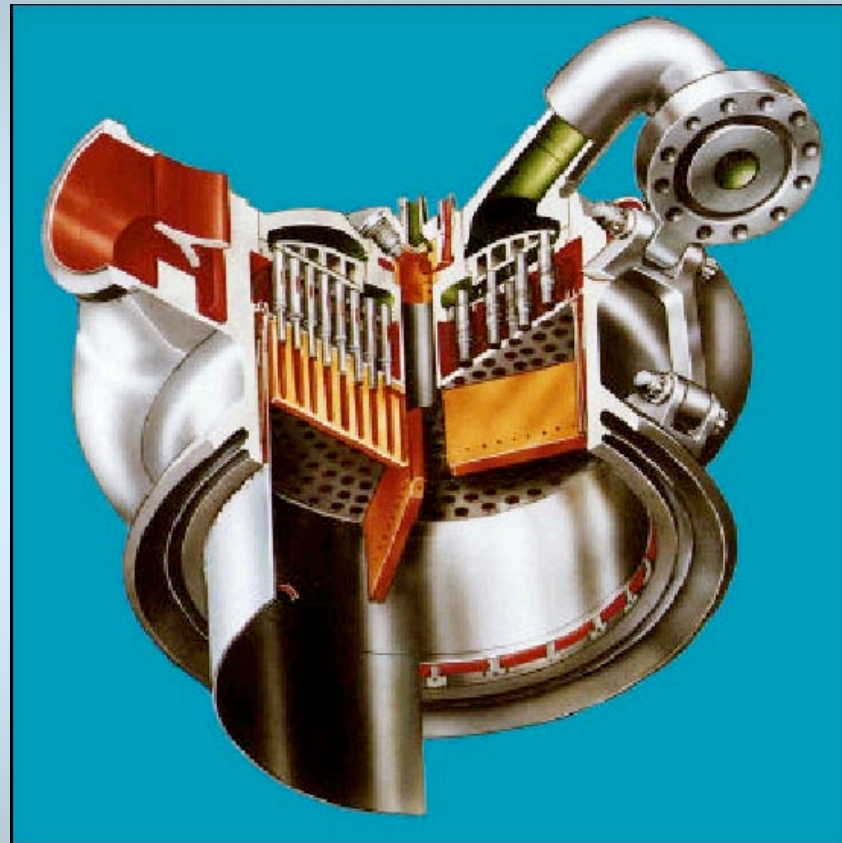
Engine 0523, Test 902772, June 6, 1997

Failure: Fuel Preburner Fuel Manifold Contamination

Incident Description: Test 902772 was prematurely terminated at 5.18 seconds when the HPFTP Turbine Discharge Temperature redline was exceeded. Posttest inspection of the engine revealed FPB liner erosion; MCC hot gas wall forward end had flame spray, slag, and numerous dings and dents; and the HPFTP turbine sustained erosion damage to the turbine housing, struts and blades.

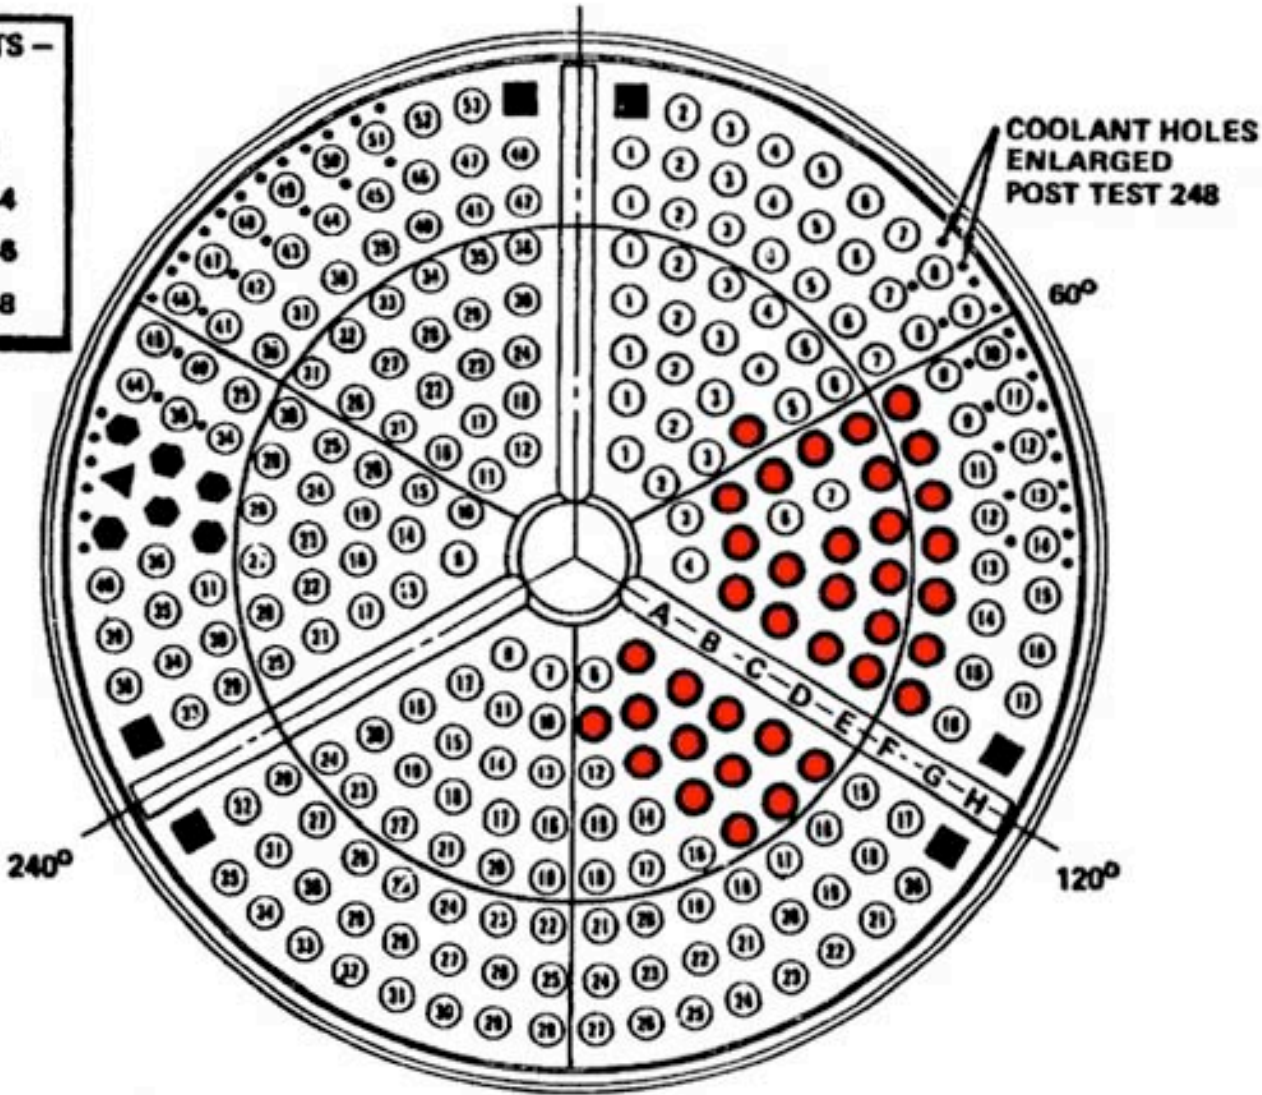
**PINNED LOX POSTS –
LEGEND**

Cause: FPB injector face had experienced damage during a prior test and had been repaired by plugging several oxidizer posts in one quadrant resulting in a circumferential temperature gradient in the preburner. Localized high temperature streaking caused disbonding of the first stage turbine tip seals; excessive rubbing of the blades caused blade failure, sudden rotor speed decay and resulting HPFTP inlet volute rupture and Lox rich shutdown.

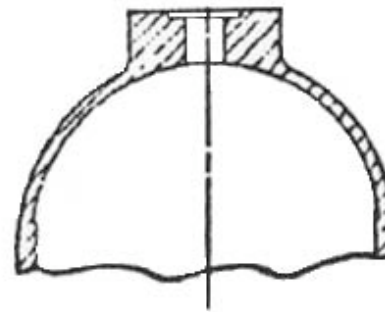
Integrally Machined Bosses

Failure: FPB Instrumentation Boss Crack

Incident Description: Test 901468 was prematurely terminated at 203.86 seconds when the external powerhead temperature redline was exceeded. Visual inspection revealed a crack in the weld forward of the stub to the joint flange.

Cause: High cycle fatigue of welded in port. Not flight configuration and only power head in service with welded in instrumentation ports.

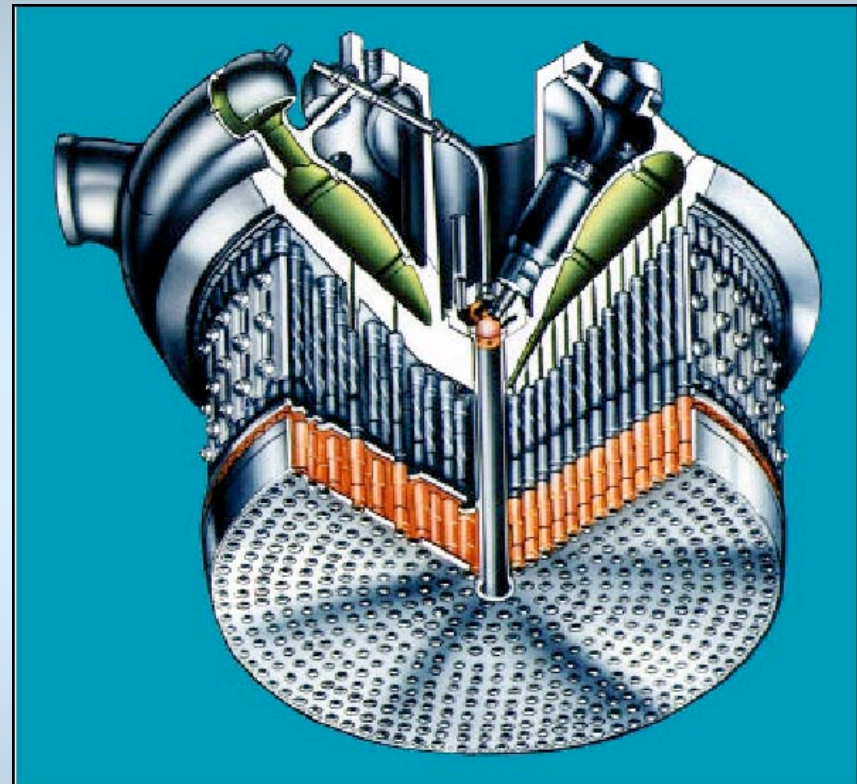
Engine 2108 Test 901331, July 15, 1981

Failure: Lox injector post crack

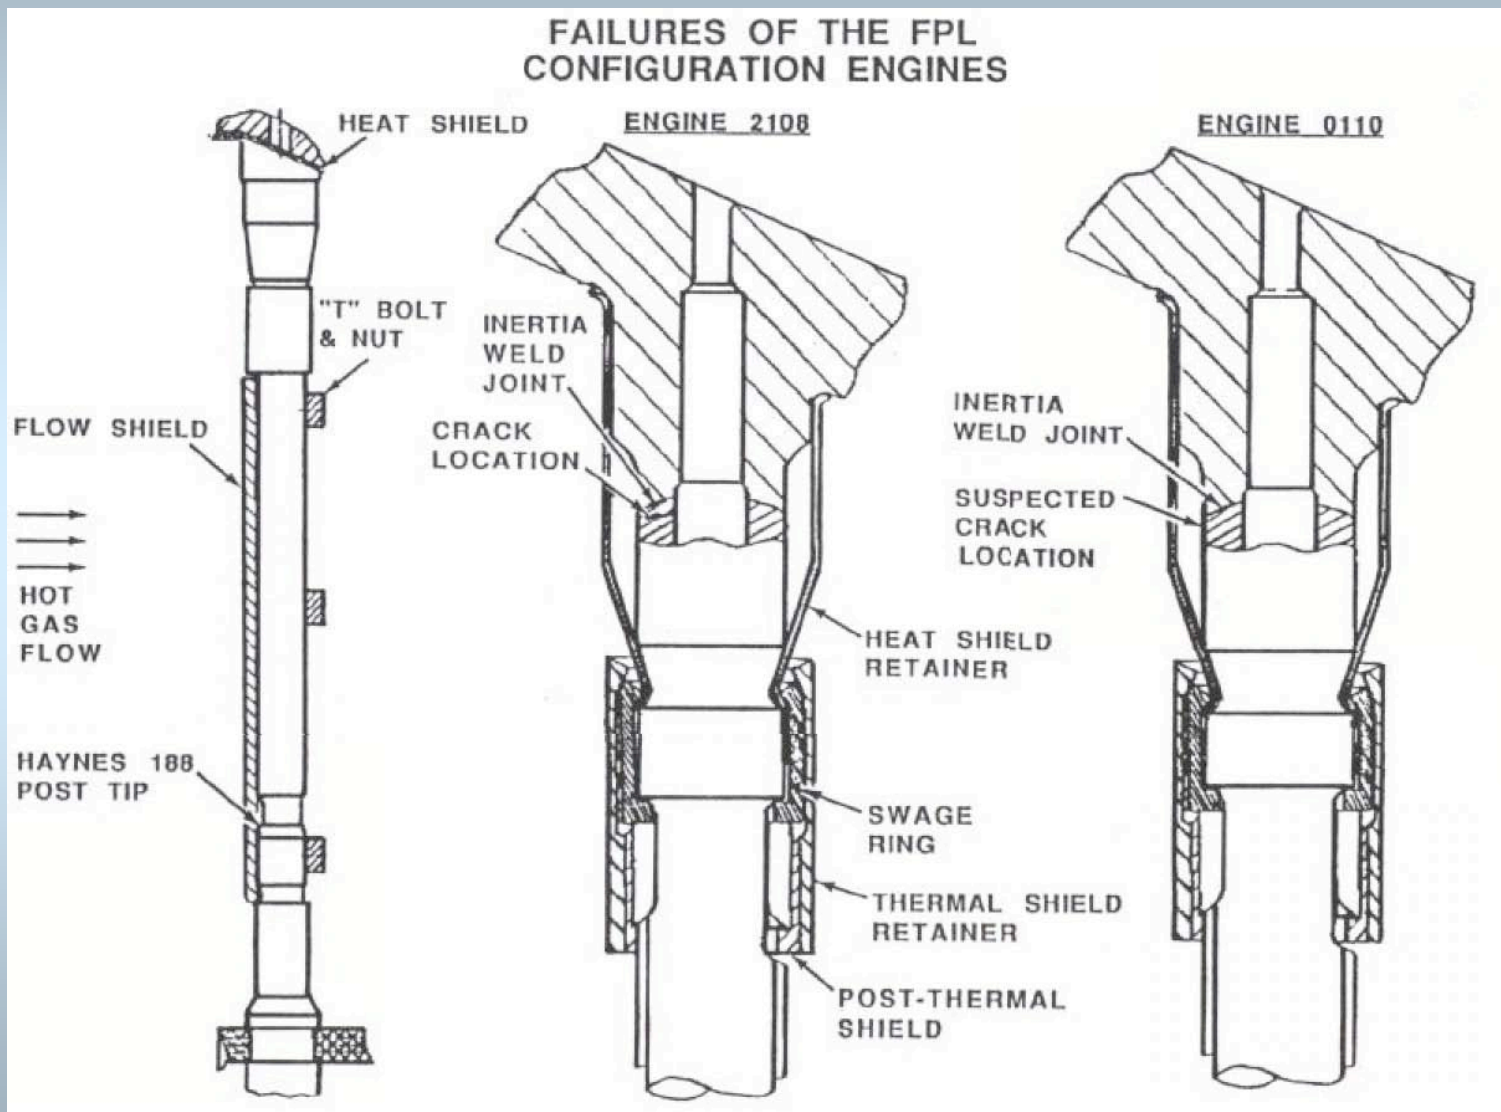
Cause: Lox post number 79 in row 13 failed in the 316L material at the inertial weld (which joins a 316L post to an INC0718 interpropellant plate stub) . The post failure was caused by high cycle fatigue. There was a much larger increase in flow induced vibration in going from RPL to FPL; than had been estimated in life calculations. Furthermore, the modifications which had been made in the high pressure fuel pump to adapt it to FPL operation increased the severity of the flow induced vibrations at all power levels.

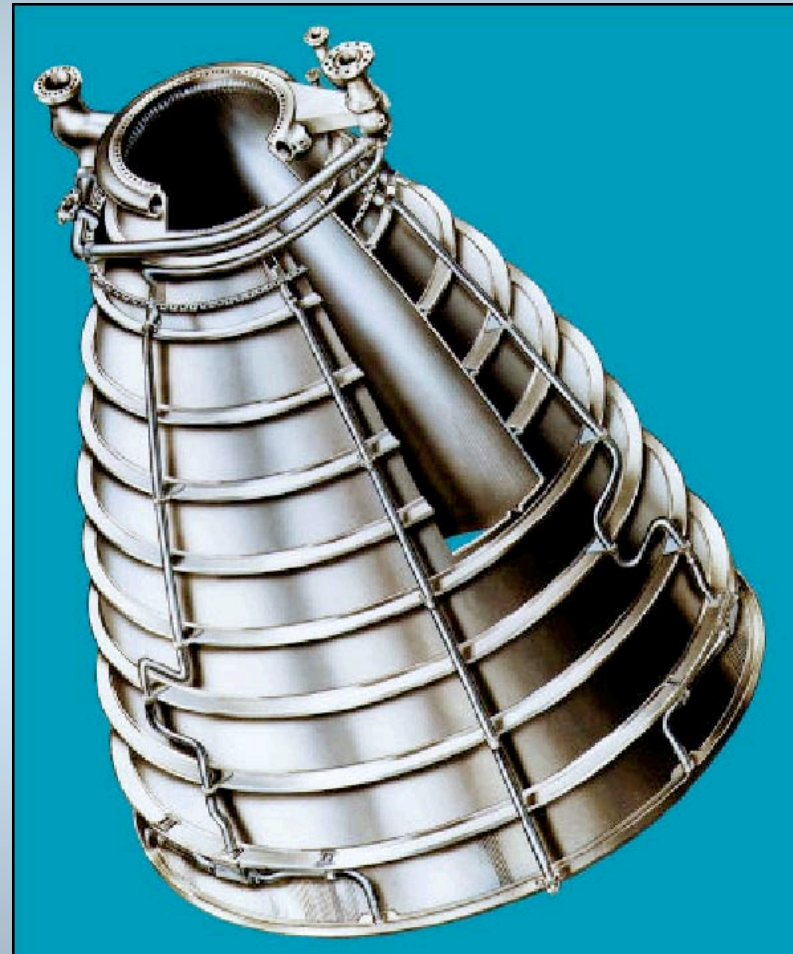
Engine 0524, Test 902933, August 27, 1997

Failure: Nozzle coolant tube rupture

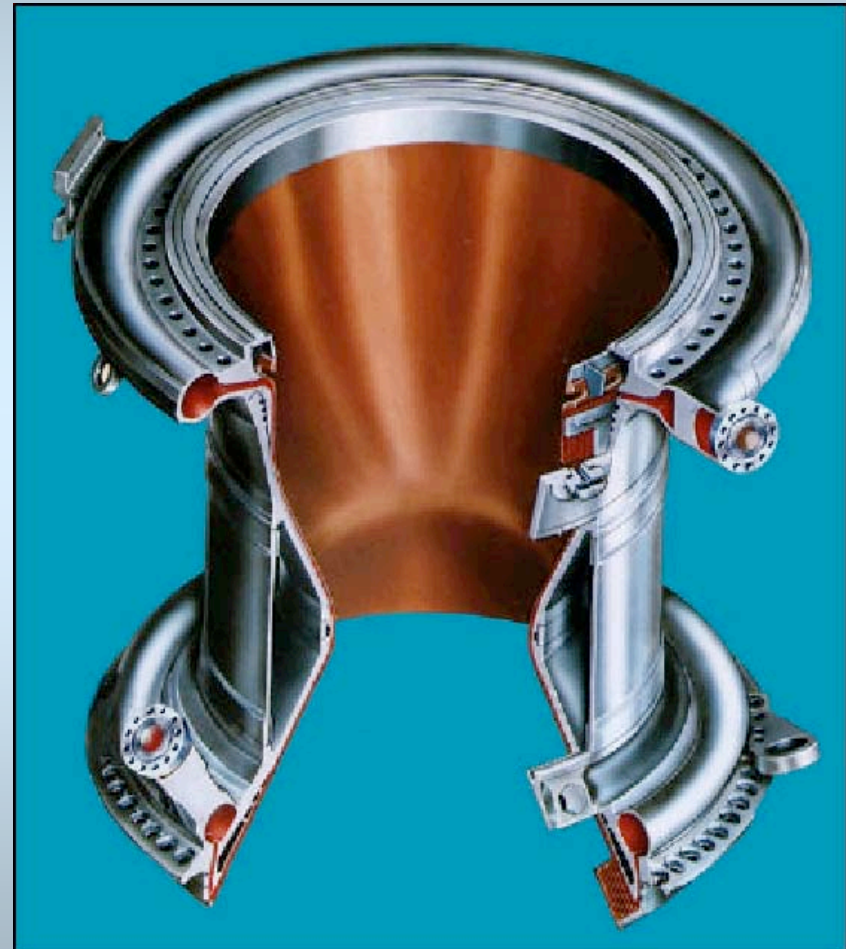
Engine 2308, Test 750259, March 27, 1985

Failure: Failure: Outlet neck rupture

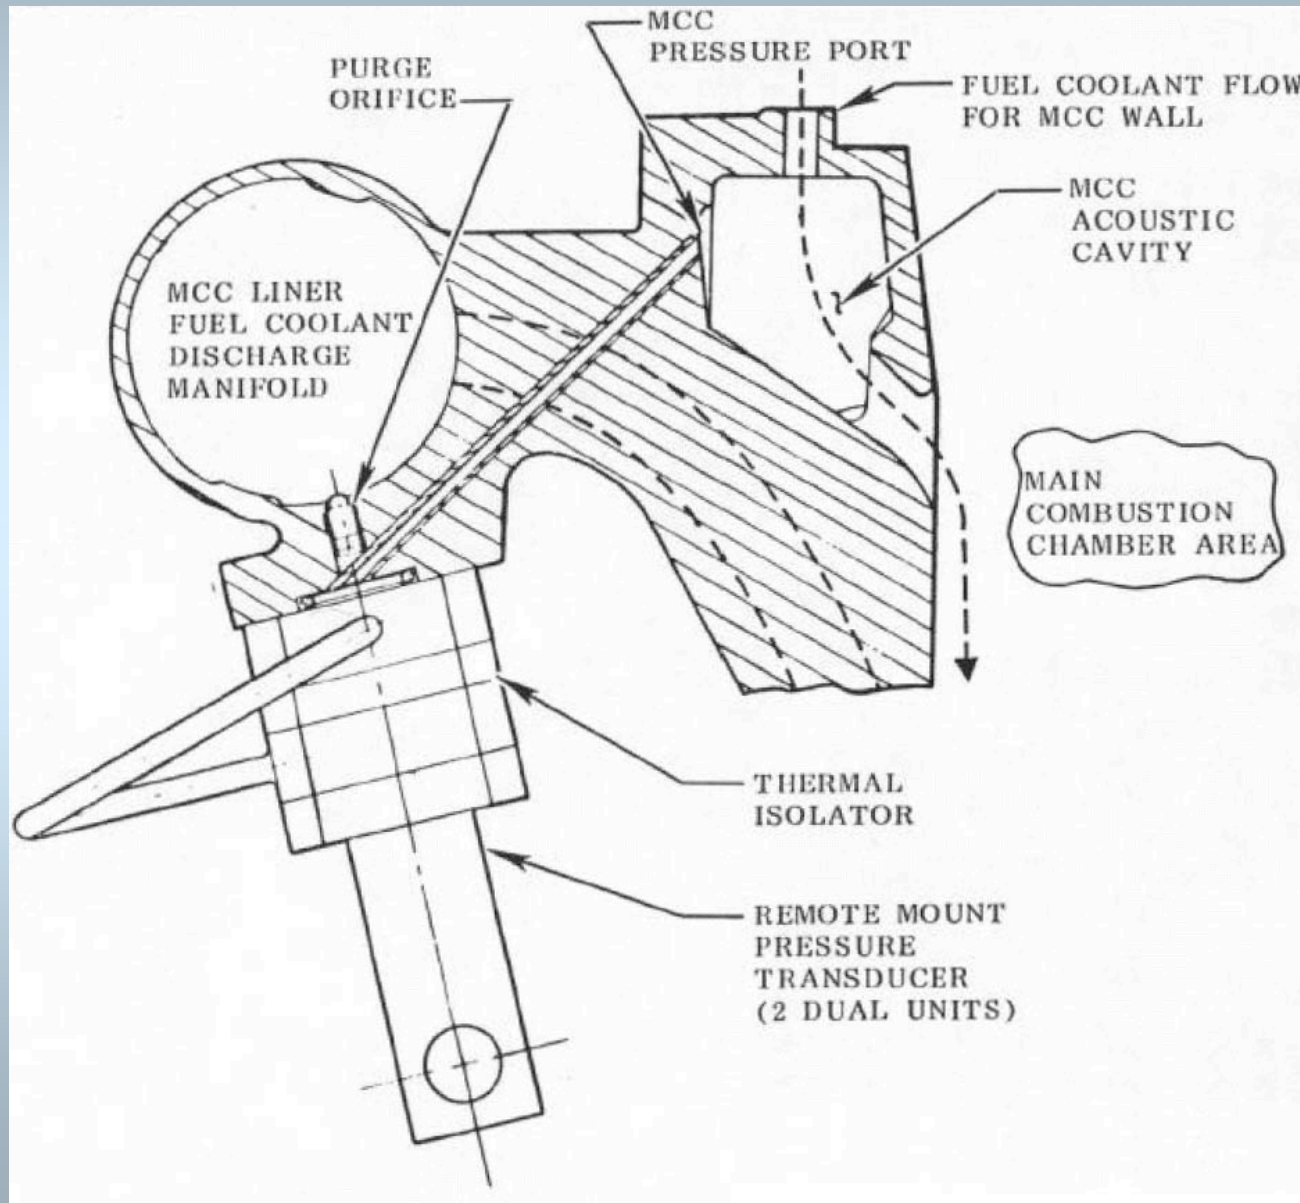
Engine 0010, Test 901284, July 30, 1980

Cause: Two unrelated events caused this failure to prorogate to a catastrophic failure. First, Channel B of the Engine Controller cut itself off at 3.25 seconds because of failure of electronic components in the facility power supply. Secondly, at 3.9 seconds, the Lee Jet orifice, used to purge the Channel A Pc transducer passage, became dislodged and caused the Pc transducer to sense MCC coolant flow pressure instead of Pc. The reason for the Lee Jet orifice dislodging was a poorly machined Lee Jet housing that went undetected. It was out of specification and should have been noted.
