**Development of Non Destructive Evaluation Techniques for the In-Situ Inspection
of the Orbiter's Thermal Protection System**

José M. Hernández
NASA – Johnson Space Center
Houston, Texas

**IEEE Symposium
Guadalajara, Mexico**

**Jose M. Hernandez
NASA - Johnson Space Center
April 2, 2004**

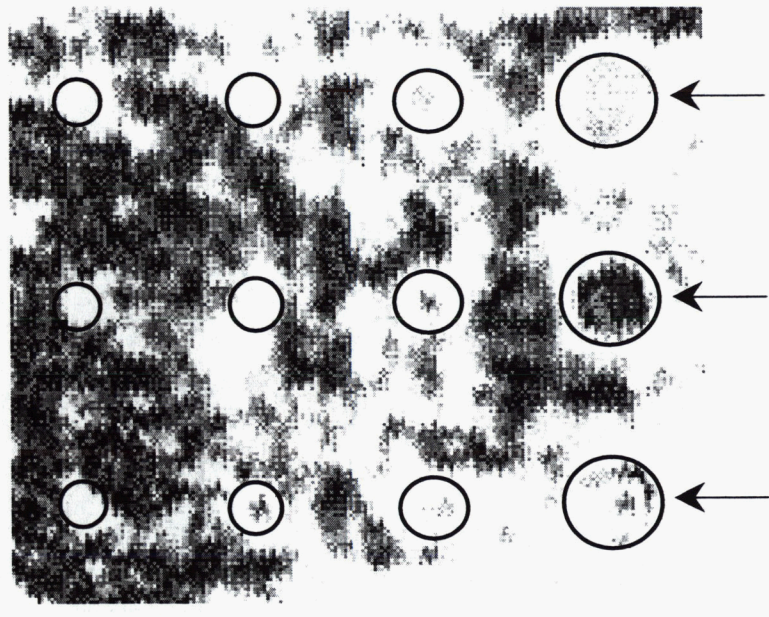
P-E UT Optimum Coupling

Back Side 0.4" Mid 0.22" Front Side 0.04"

0.44" Thickness Sample

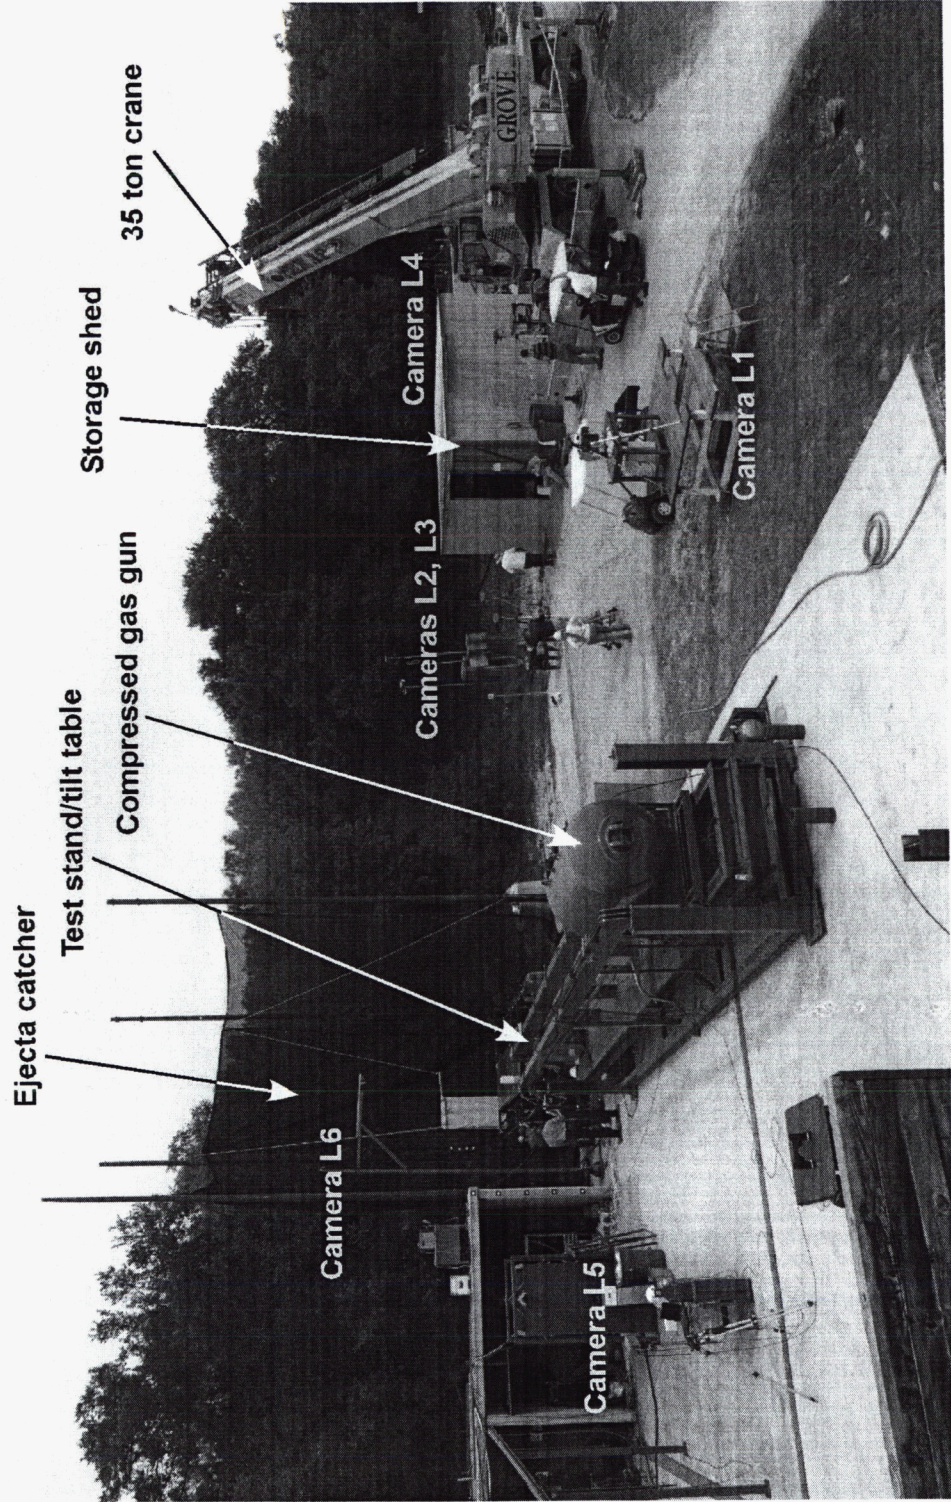
NASA Took Advantage of Foam Impact Tests conducted at SwRI

- Panel 6
 - Material: BX 250 foam
 - Dimensions: 5.63" x 11.56" x 21.38"
 - Mass: 763.8 g (1.68 lb)
 - Actual launch velocity: 768 ft/sec
 - CG angle of impact: 20.6°
 - 5½" long through thickness crack
 - Located on the lock side approximately 6" below the stagnation
 - Transverses the entire rib width, extends through the lock side channel and onto panel lower face.
 - Approximate 3/4" crack on the lower face
 - T-seal crack 2.5" long on rib
