NASA/TM—2005-214021

Analysis of Carbon/Carbon Fragments From the Columbia Tragedy

David R. Tallant and Regina L. Simpson
Sandia National Laboratories, Albuquerque, New Mexico

Nathan S. Jacobson
Glenn Research Center, Cleveland, Ohio

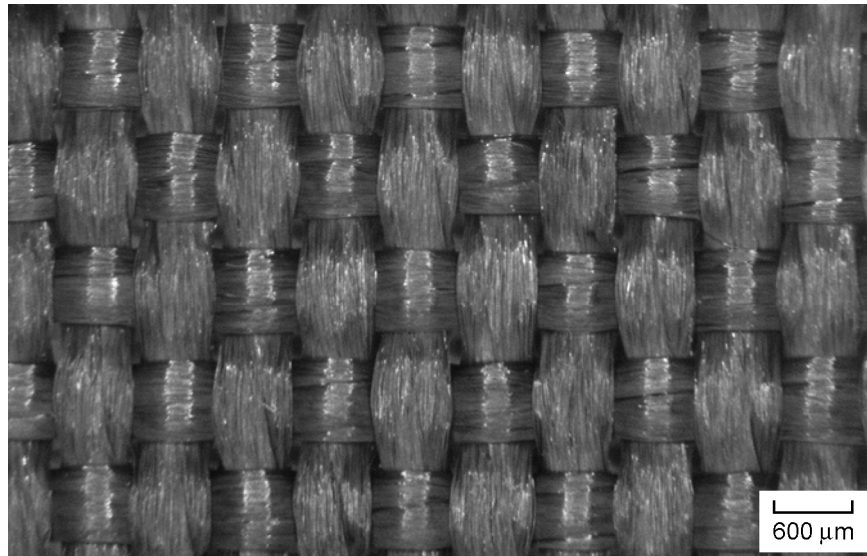
Figure 9.—Photograph of the as-fabricated RCC (Avtex) cloth used in RCC.

Figure 9 is an optical micrograph of the as-fabricated carbon/carbon cloth. This is made of rayon-derived carbon fibers by Avtex (Formerly of Front Royal, VA). Raman spectra for this cloth are given in Figures 10(a) and (b) with illumination along the edge of the fiber and at the end of the fiber, respectively. Note that when illumination is at the fiber ends (versus along the length of the fibers), the 1350 cm⁻¹ band is enhanced in intensity because the ends of graphene planes are sampled, where symmetry results in a larger Raman cross-section for the vibrational mode resulting in the 1350 cm⁻¹ band. Therefore, care is necessary in interpreting Raman spectra from highly oriented assemblages of carbon, as in high-temperature-processed fibers.
