JPL Publication 2005-2

Genesis Failure Investigation Report

JPL Failure Review Board, Avionics Sub-team

July 2004

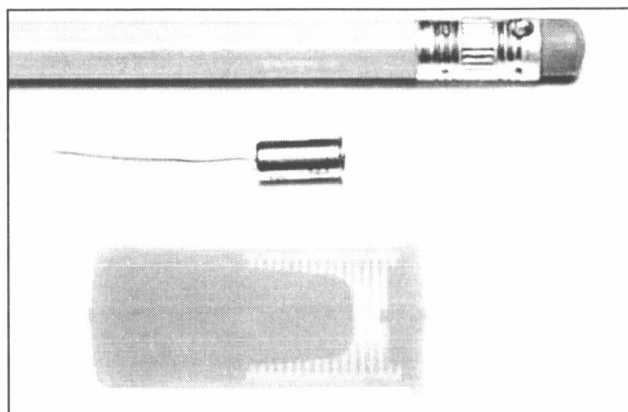
- *Power (including control and power for motors, battery depassivation, and final battery operation; see Figures 2-8 and 2-9).* The Relay module was responsible for SRC power, conditioning the LiSO_2 battery before SRC separation, and then sending commands to switch power to SRC batteries. Note that although the G-switch sensors were located on the Relay module, their functionality was closely related to the Event Sequence Timer (EST) module. Contacts on the G-switches went directly to the backplane and were passed to pins on the EST module. An X-ray of the G-switch clearly shows the proof mass and the spring that determined the sensitivity of the switch. The direction of applied force required to close the switch is also easily discernible (Figure 2-10).

Figure 2-10. G-switch views; X-ray shows mass and spring

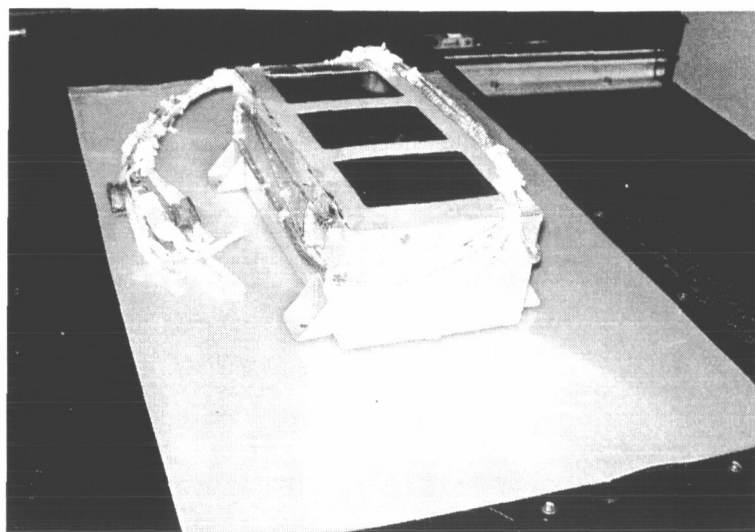
A thorough inspection of the battery was performed at JPL, including dimensions, weight, and some electrical measurements at the battery level. Peripheral devices such as the four temperature sensors and the three heater strips were also measured. All measurements were also done on the ATLO battery for comparison. The outer appearance of the battery looked very clean and indicated minimal damage from the hard landing. Figure B-2 shows the battery during initial inspection at JPL.

Figure B-2. SRC battery, pre-flight

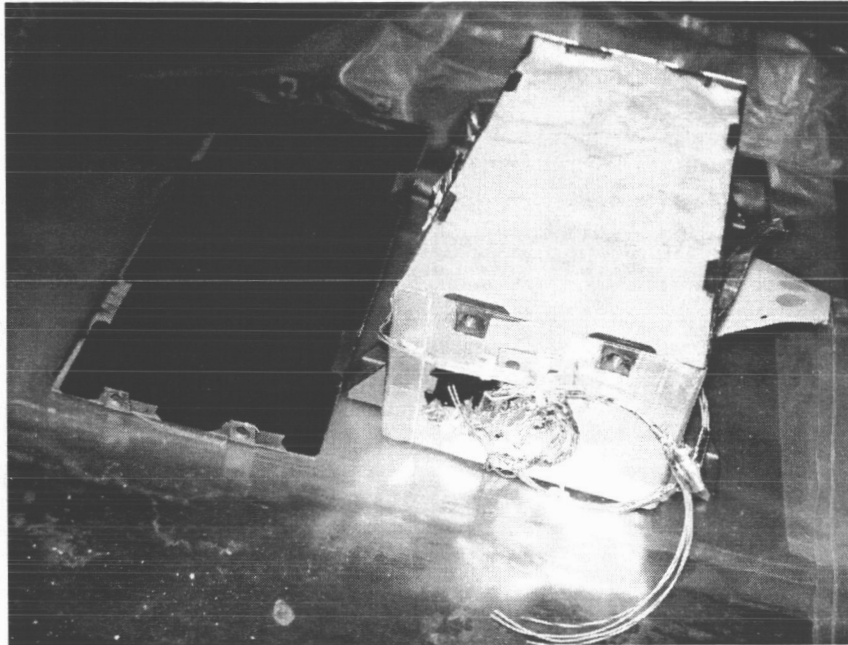
The ATLO battery (i.e., one that had not been exposed to a flight environment) was opened first for comparison purposes. Figure B-6 shows the top of the ATLO battery underneath the cover and Kapton layers. The Eccofoam insulation looks pristine and has a pinkish color. By contrast, when the SRC battery top cover was removed, there was significant discoloration of the Eccofoam insulation, indicating exposure to excessively high temperatures (Figure B-7). The worst discoloration, almost black, was localized over the nickel cell interconnect tabs. This condition is consistent with high-rate discharge over a significant duration.

Figure B-6. ATLO battery showing pristine Eccofoam insulation

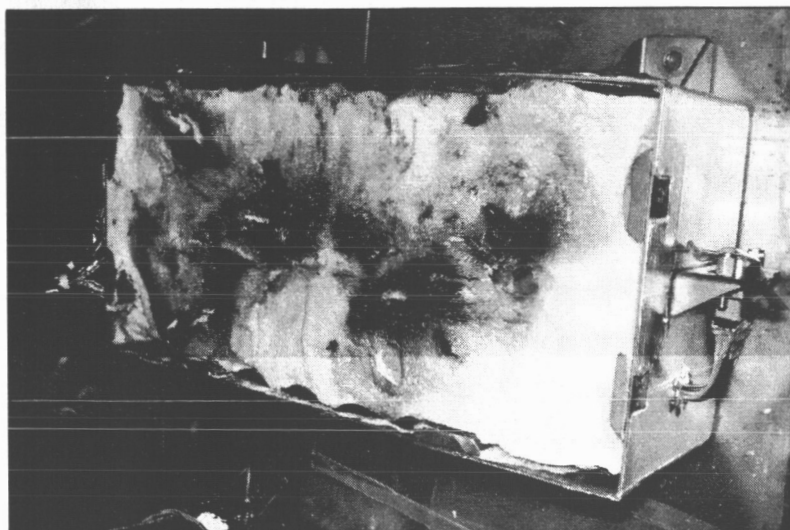
Figure B-7. SRC battery Eccofoam insulation

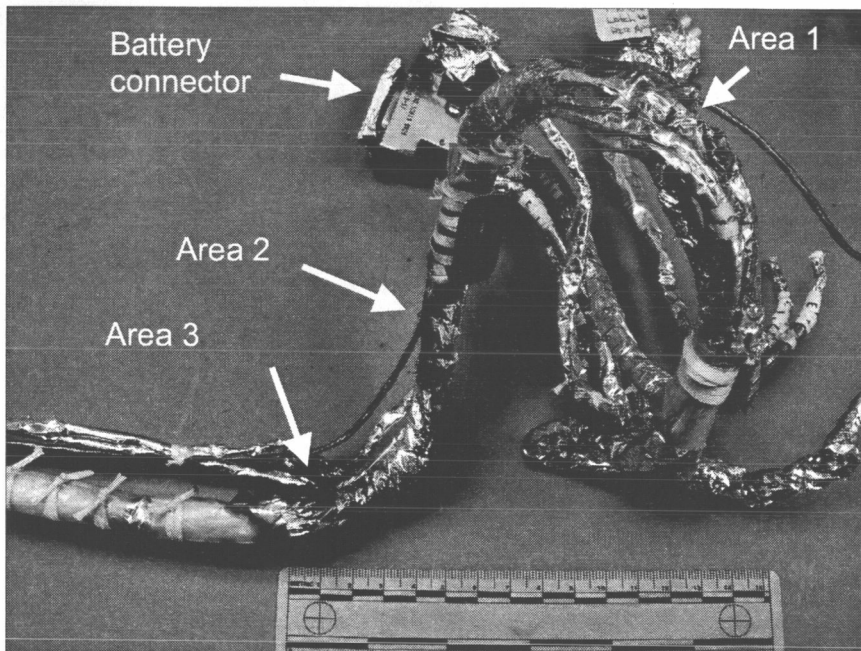
Image No.:0411A00202, Project No.: 2004110004

Figure 2. Another view of the harness at areas 1 to 3 with the packaging material removed.

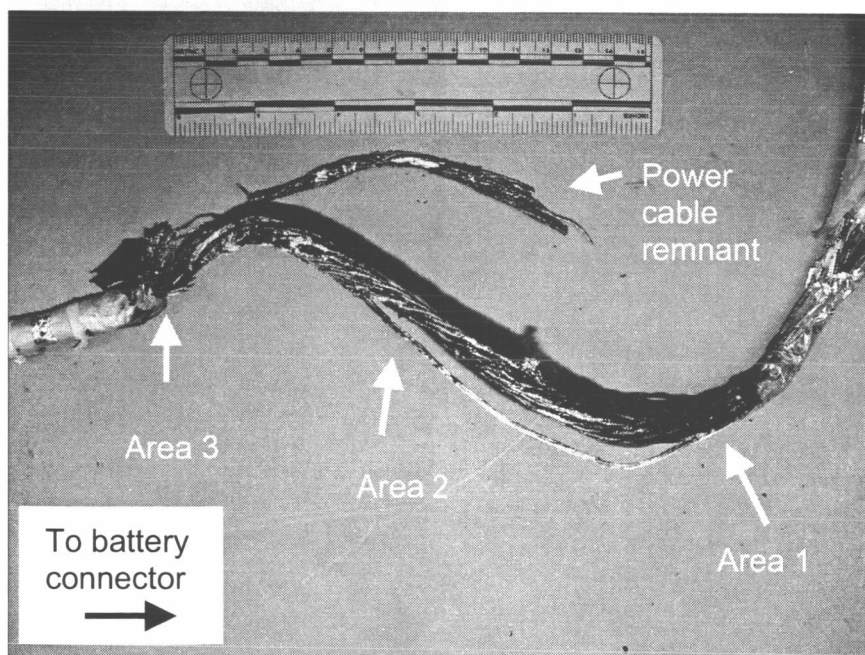
Image No.:0411A00290, Project No.: 2004110004

As the aluminized Mylar was removed further, charred and separated remnants of the power cable were exposed in the section between Areas 1 and 3. A view of the harness in this area with the largest of the exposed power cable remnants is shown in figure 10.

Figure 10. View of the harness between Areas 1 and 3 after removal of the outer aluminized Mylar wrap.

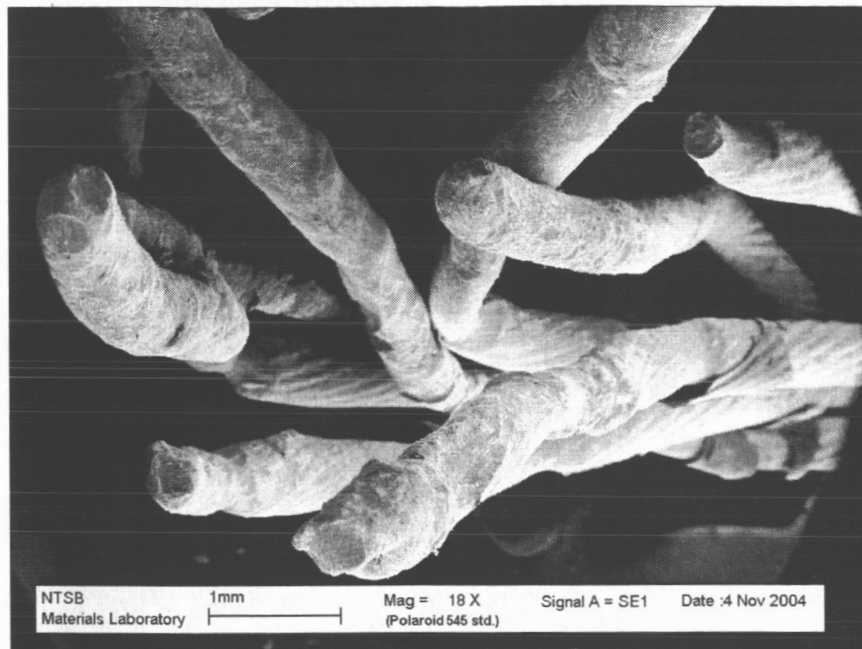
Image No.:0411A00663, Project No.: 2004110004

Figure 13. Strands from the power cable near Area 1 as viewed using SEM.

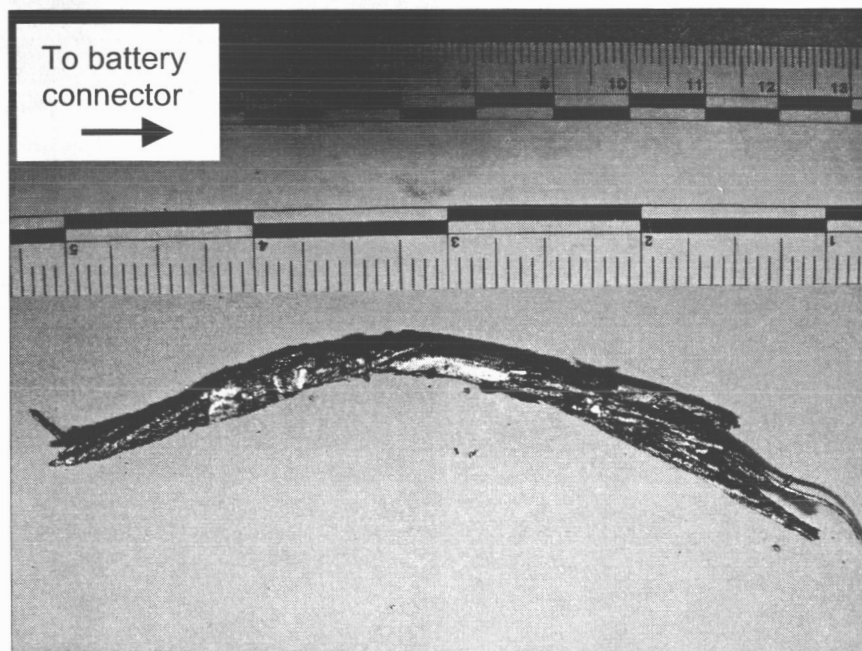
Image No.:0411A00291, Project No.: 2004110004

the power cable in this area remained relatively intact as shown in figure 14. This section was held together by the aluminized mylar wrap.

A view of the harness at Area 3 after removal of the shrink tubing, aluminized Mylar, and aluminized Kapton is shown in figure 14. The power cable Kapton film showed charring and heat damage within 0.2 to 0.3 inches of the fractured or melted ends of the power cable strands. Also, two of the adjacent strands with white insulation showed heat damage and slight charring within 0.2 inches of their fractured ends. Black fibrous deposits also were observed throughout the area, visible in many of the close views of strands in this section.

Figure 14. Closer view of the power cable remnant from between areas 1 and 3 (also shown in figure 10).

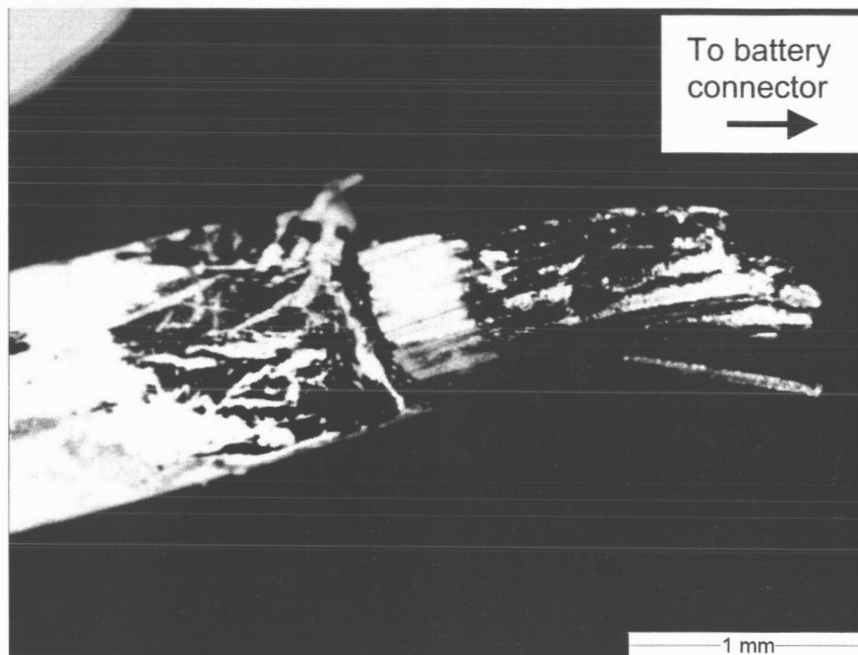
Image No.:0411A00569, Project No.: 2004110004

The fractured ends of white strands 1 and 2 are shown in figures 17 to 20. Approximately 0.06 inch of bare wire was exposed on each strand. The fractured ends of the strands were bent and flattened, and individual wires were sheared consistent with contact with another object. On white strand 1, several wires were inadvertently bent outward during disassembly of the aluminized Mylar and aluminized Kapton. On both strands, the adjacent insulator was charred. Black deposits were observed on the strand. In areas where the deposits were not present, the wires had a light brown color. Using energy dispersive x-ray spectroscopy (EDS), a typical spectrum of the white strand insulator material was obtained and is shown in figure 21. The spectrum showed a high peak of fluorine and much smaller peaks of titanium and carbon. A typical EDS spectrum for the black deposits on the bare end of white strand 2 is shown in figure 22. The deposits had a high peak of carbon with smaller peaks of oxygen, fluorine, and silicon. A silver peak also was observed, consistent with the coating on the underlying wire material.

Figure 18. Close view of white strand 2 in Area 3.

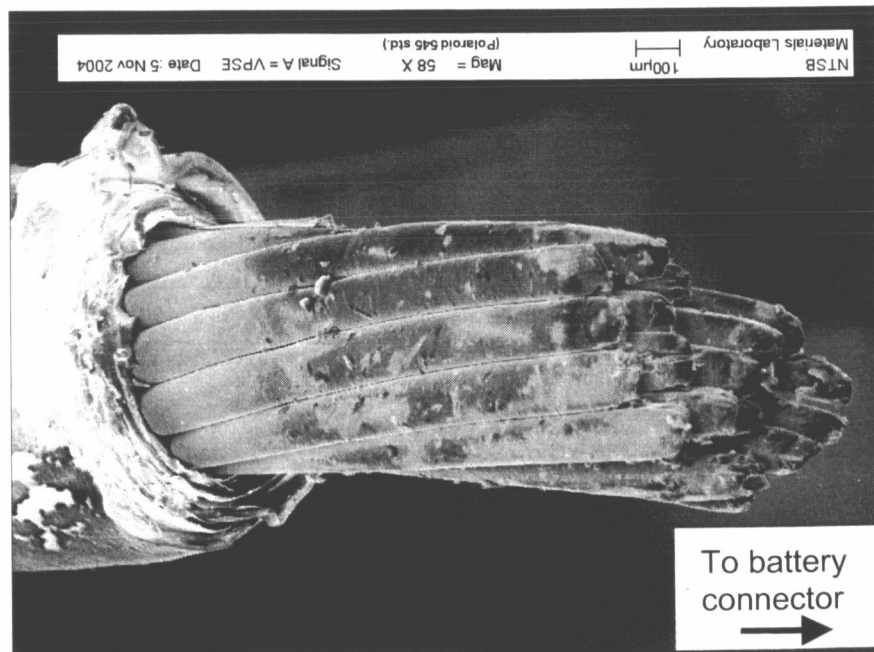
Figure 19. SEM view of white strand 1 at Area 3.

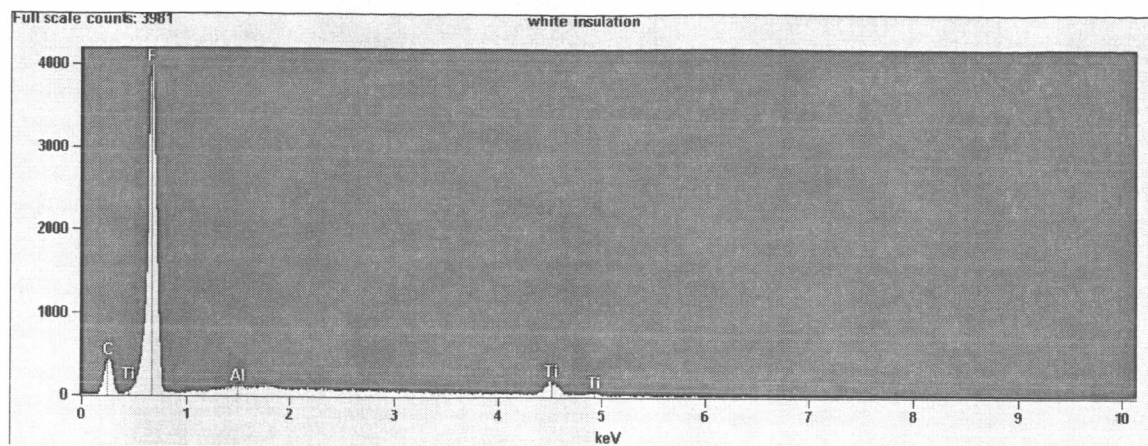
Figure 21. EDS spectrum for the white strand insulator adjacent to the power cable.

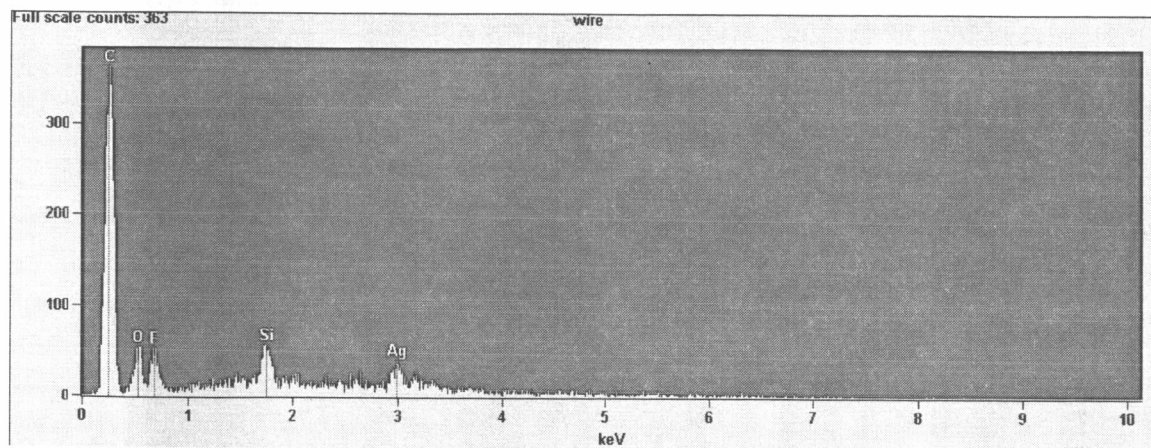
Figure 22. EDS spectrum for black deposits on the exposed white strand at Area 3.

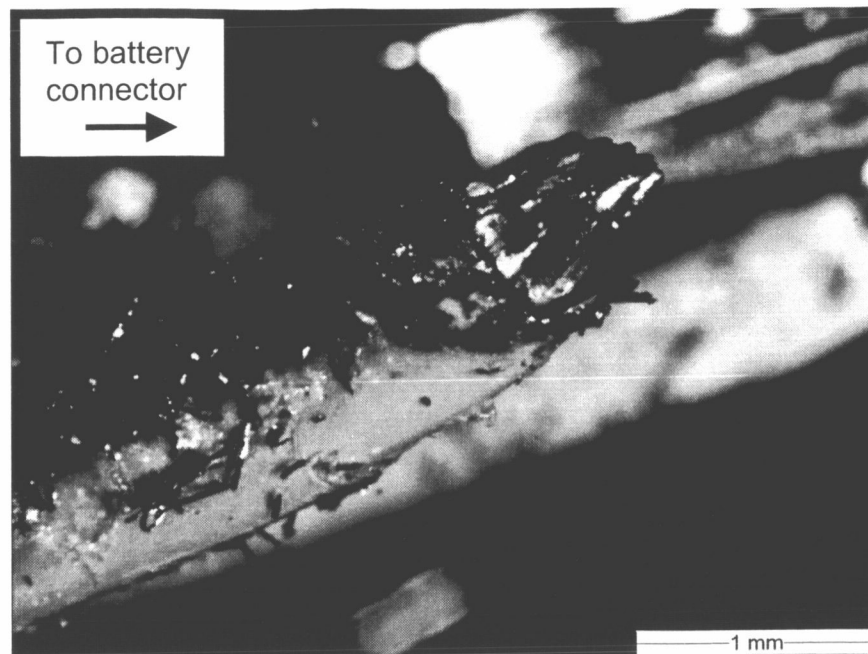
Figure 23. Close view of power cable strand 1 in Area 3.

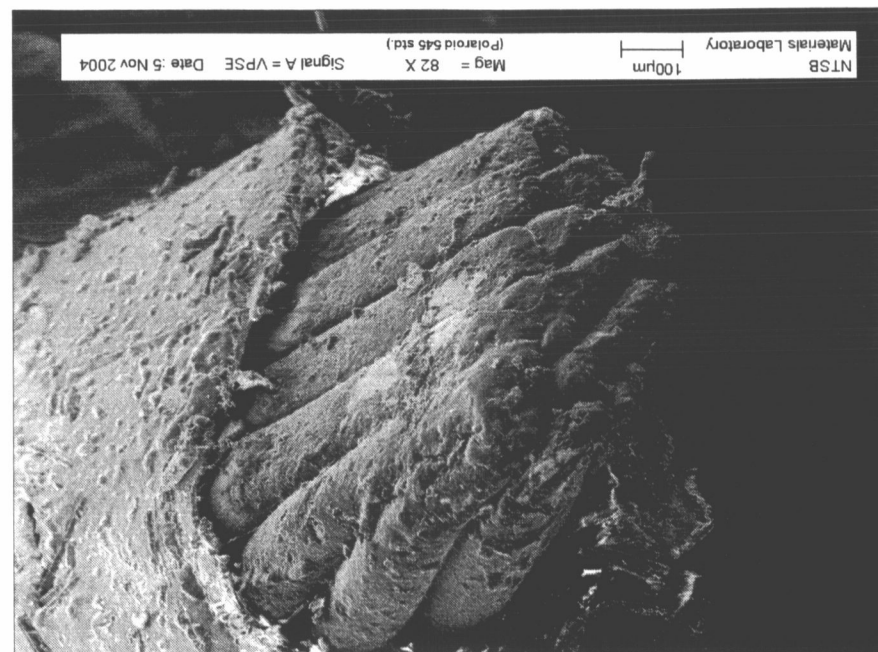
Figure 24. SEM view of power cable strand 1 at Area 3.

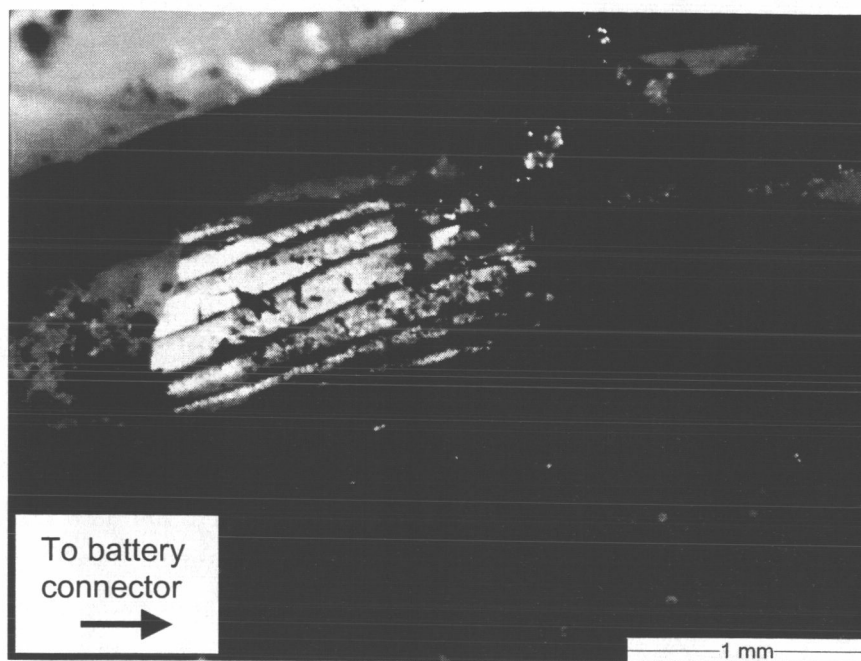
Figure 25. Close view of power cable strand 2 in area 3.

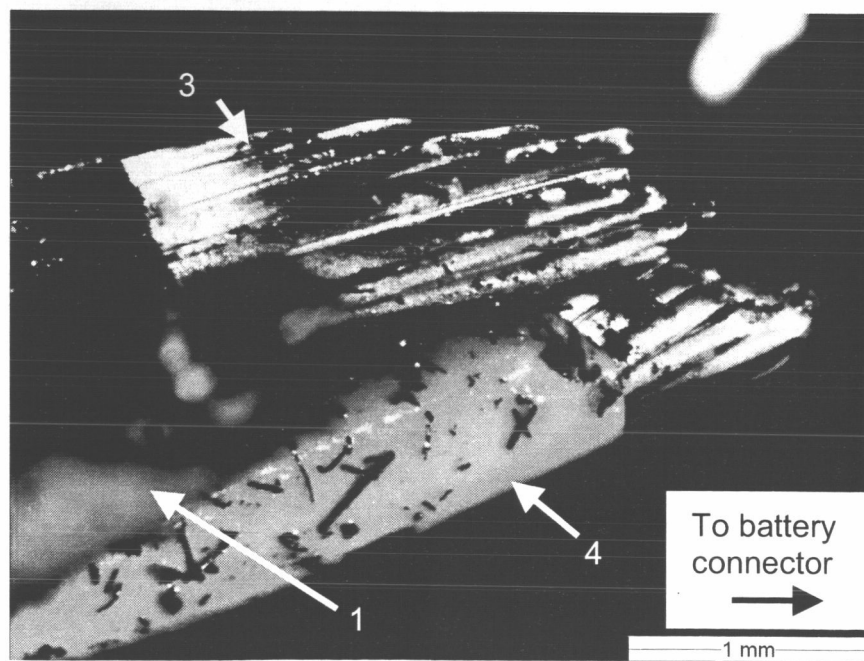
Views of power cable strand 3 are shown in figures 26 and 27. The strand was fractured with some wires sheared and others showing necking consistent with overstress fracture in tension. The ends of the exposed bare strand had black deposits, and in areas where the black deposits were not present, the ends appeared light brown. The strand had a more shiny silver appearance adjacent to the insulator. The insulator adjacent to the bare strand was charred. Black fibrous deposits also were observed in the area.

Views of power cable strand 4 are shown in figures 26 and 28. The strand end was bent and individual wires were sheared, consistent with contact with another object. Some charring was observed on the insulator adjacent to the bare strand, and where the insulator was charred, the exposed strand was tinted slightly brown mixed with some black deposits.

Figure 26. Close view of power cable strands 3 and 4 in Area 3.

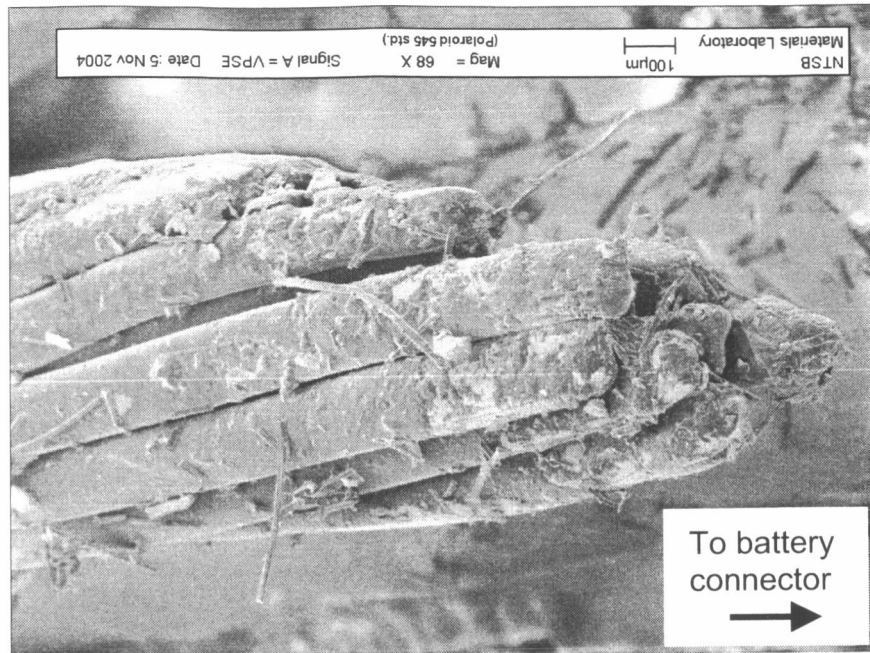
Figure 27. SEM view of power cable strand 3 at Area 3.

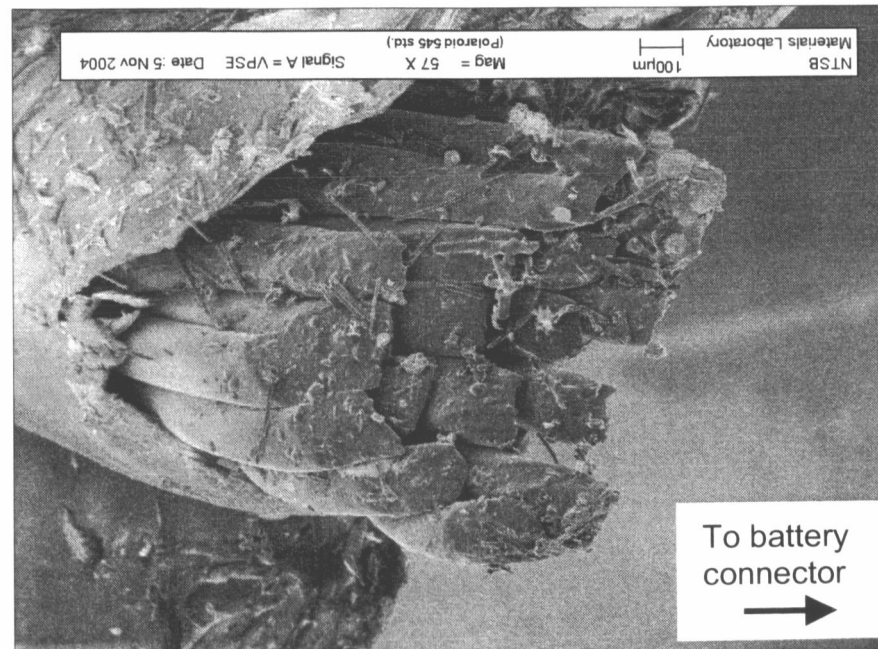
Figure 28. SEM view of power cable strand 4 at Area 3.

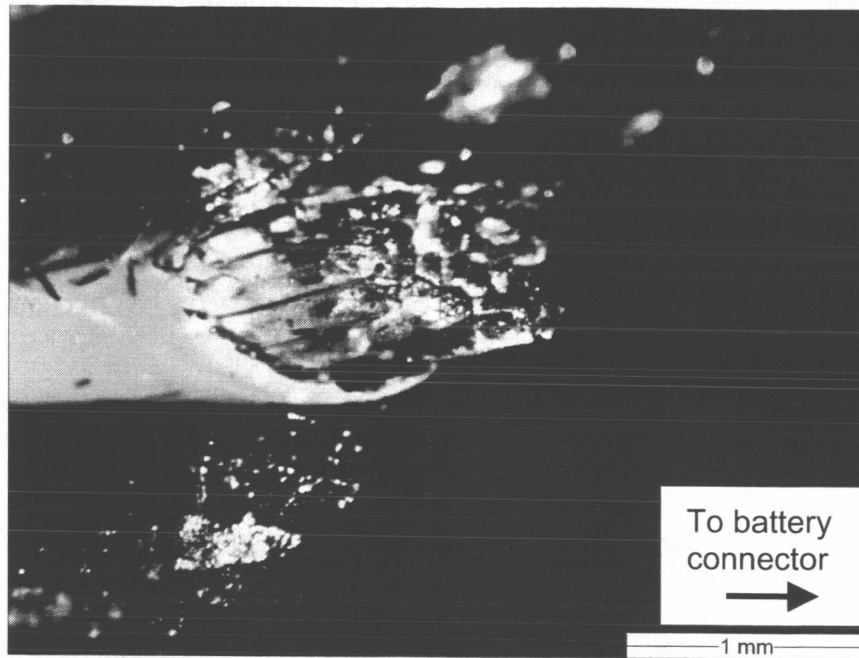
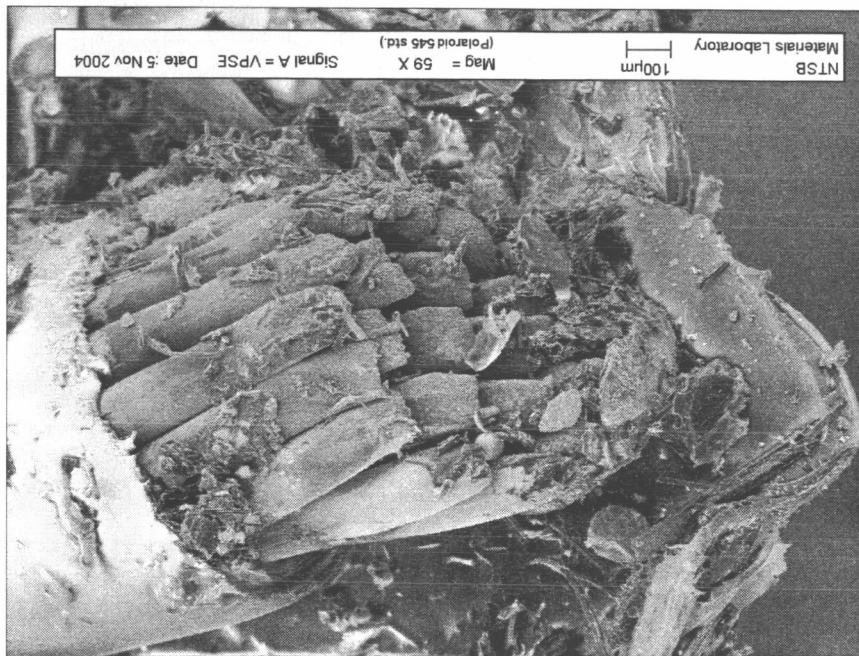
Views of power cable strand 5 are shown in figures 29 and 30. The strand end was bent and individual wires were sheared, consistent with contact with another object. Black deposits were observed on the fractured ends, and where deposits were not present, the strands had a light brown color. The insulator adjacent to the exposed bare strand was charred. Black fibrous deposits also were observed in the area.

Figure 29. View of power cable strand 5 in Area 3.

Figure 30. SEM view of power cable strand 5 at Area 3.

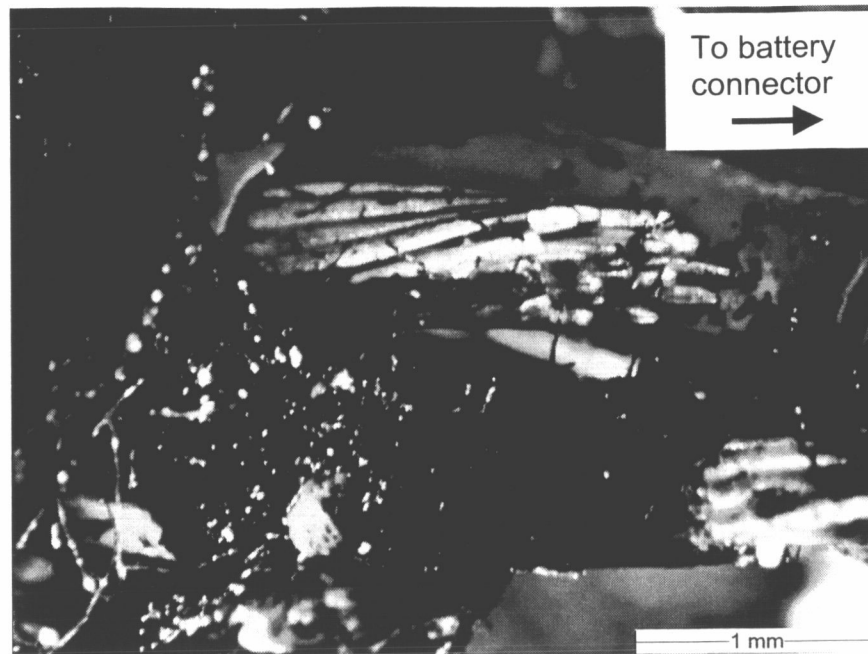
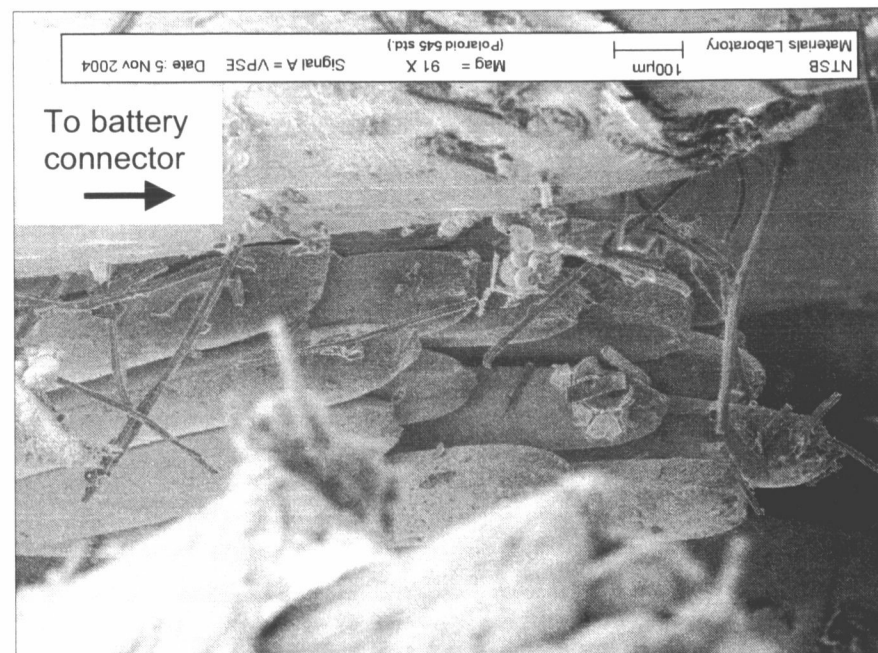
Views of power cable strand 6 are shown in figures 31 and 32. The wires of the strand end were flattened, bent, and sheared, consistent with contact with another object. The insulator adjacent to the bare strand was discolored slightly brown.

Figure 31. Close view of power cable strand 6 in Area 3.

Figure 32. SEM view of power cable strand 6 at Area 3.

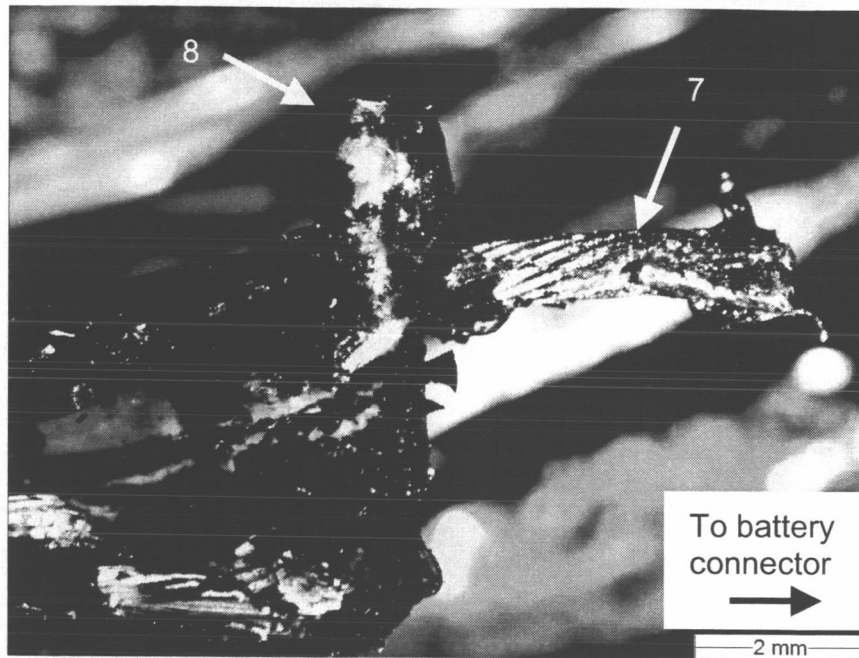
Views of power cable strand 7 are shown in figures 33 and 34. Several wires at the end of this strand were melted into a ball and the ball was oriented at an angle relative to the strand. Several other wires were melted together with an irregular melt shape. The insulator adjacent to the bare strand was charred.

Views of the power cable strand 8 are shown in figures 33 and 35. Individual wires were fused into a single melt ball and the melt ball was oriented at an angle relative to the strand in approximately the same direction as the melt ball of strand 7. The insulator adjacent to the bare strand was charred.

Figure 33. Close view of power cable strands 7 and 8 in Area 3.

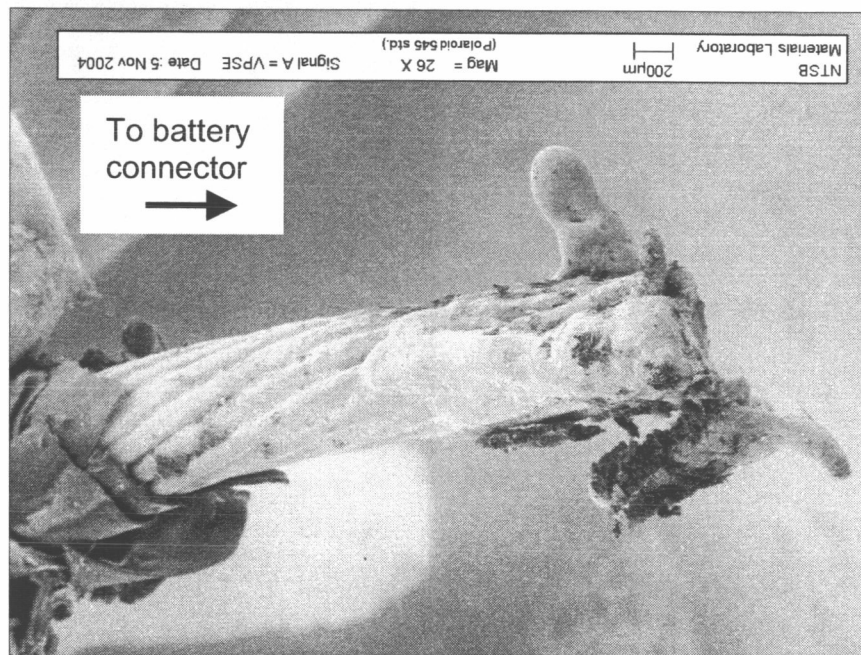
Figure 34. SEM view of power cable strand 7 at Area 3.

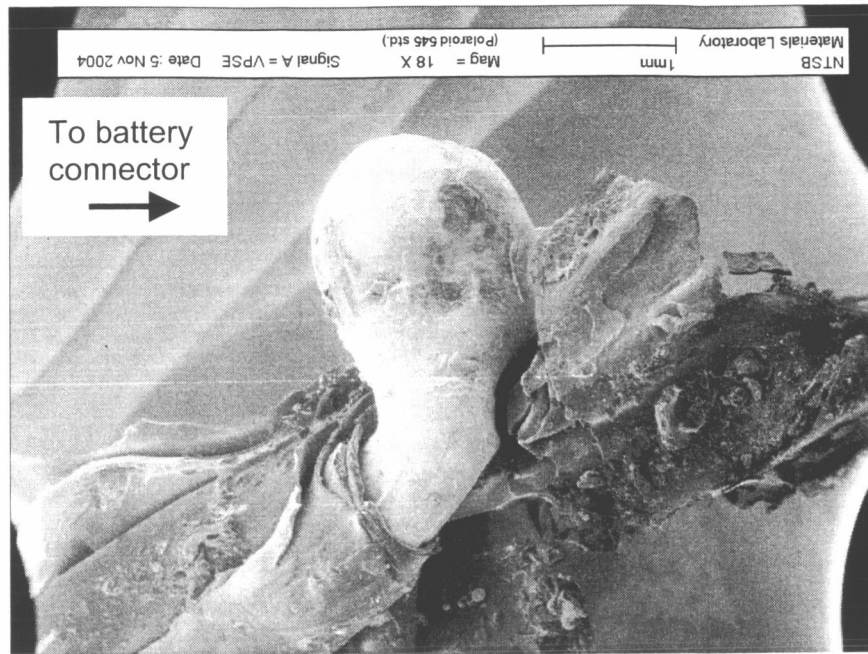
Figure 35. SEM view of power cable strand 8 at Area 3.

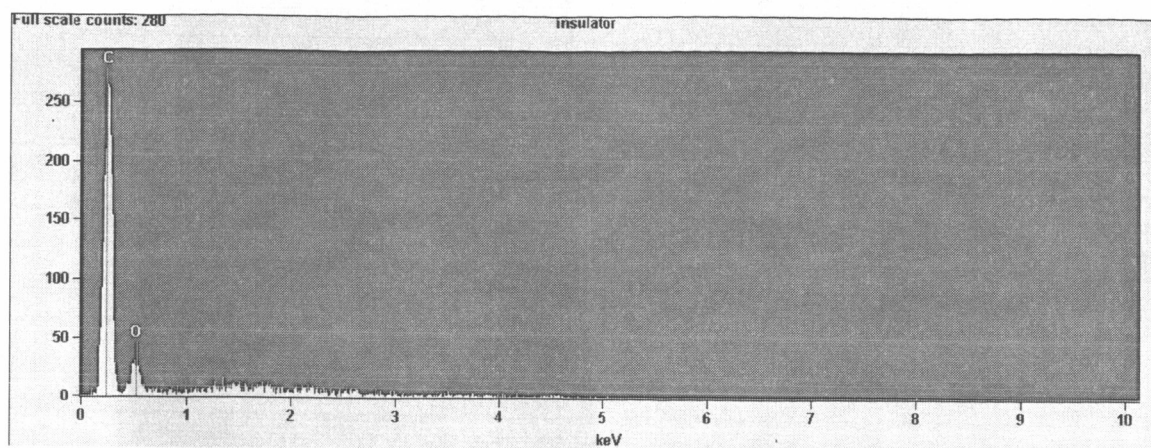
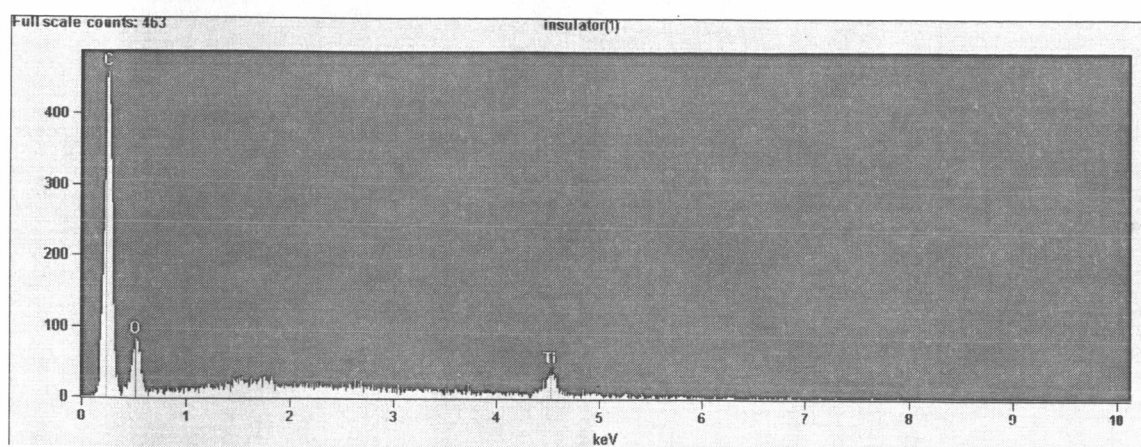
The EDS spectra for the green and yellow power cable strand insulators are shown in figure 36. Both insulator colors had a high peak of carbon and a smaller peak of oxygen. One color also had a peak of titanium.

Figure 36. EDS spectra for the yellow and green power cable strand insulators.

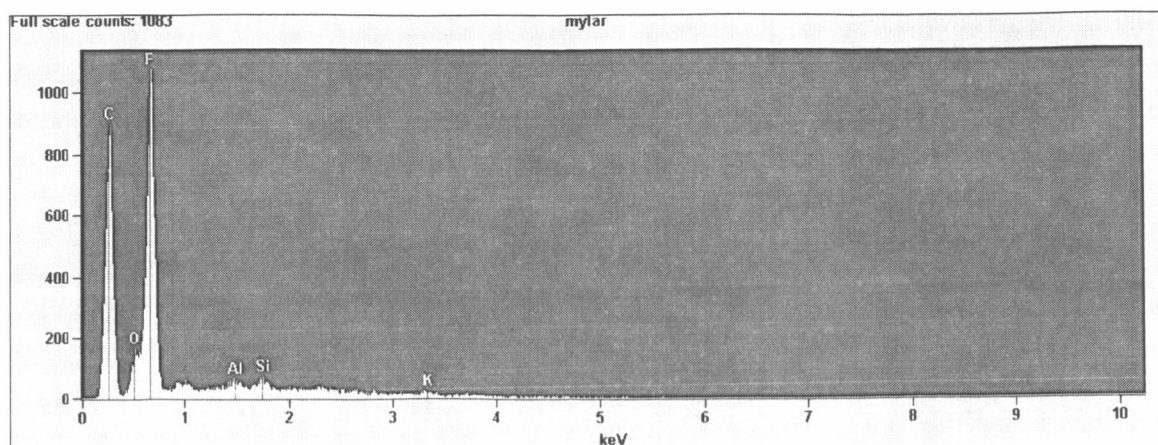
An EDS spectrum for undamaged shrink tubing is shown in figure 37. High peaks of carbon and fluorine were observed with smaller peaks of oxygen, aluminum, silicon, and potassium. A black portion of the charred shrink tubing located at Area 3 also was examined using EDS, and the resulting spectrum is shown in figure 38. Peaks of carbon and oxygen were observed in similar ratios to that of the undamaged shrink tubing, but the fluorine peak was substantially smaller.

Figure 37. EDS spectrum for undamaged shrink tubing.

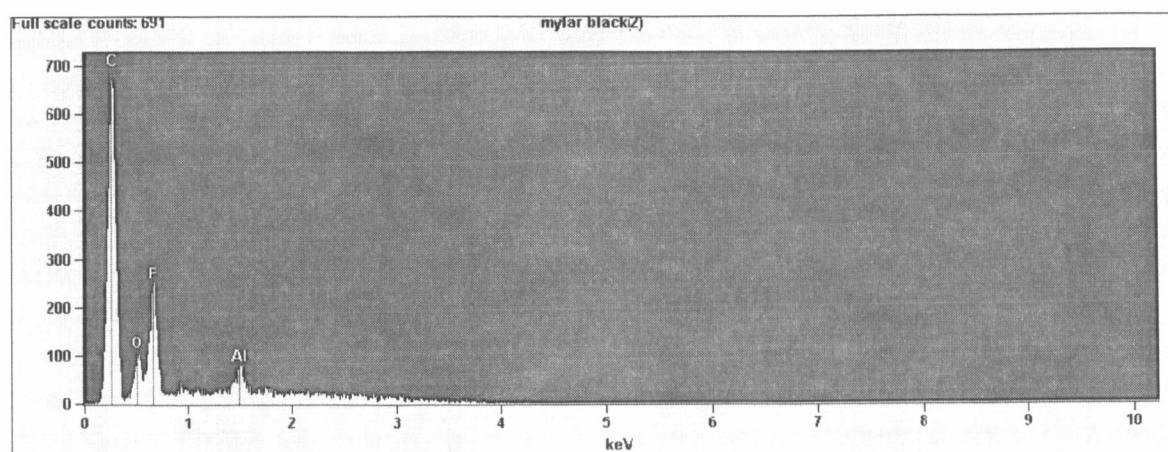
Figure 38. EDS spectrum for a blackened area of shrink tubing.

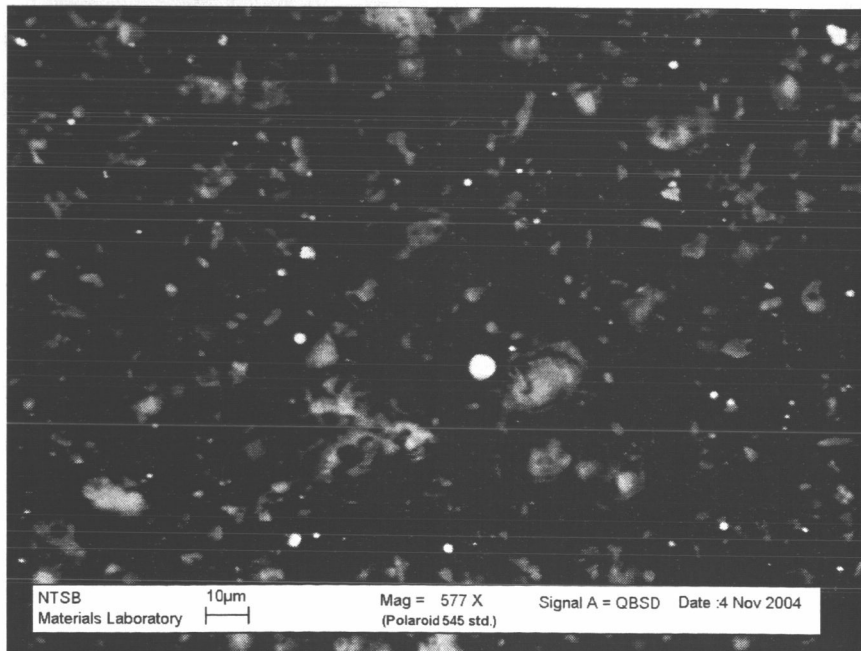
The deposits on the bolt catcher were examined using SEM and EDS. An SEM view using backscattered electrons is shown in figure 40. The deposits appeared mostly darker than the underlying bolt catcher material, but some areas appeared brighter. Most of the brighter areas were round with diameters ranging from less than a micrometer to several micrometers.

Figure 40. SEM view of deposits on the bolt catcher as viewed using backscattered electrons.

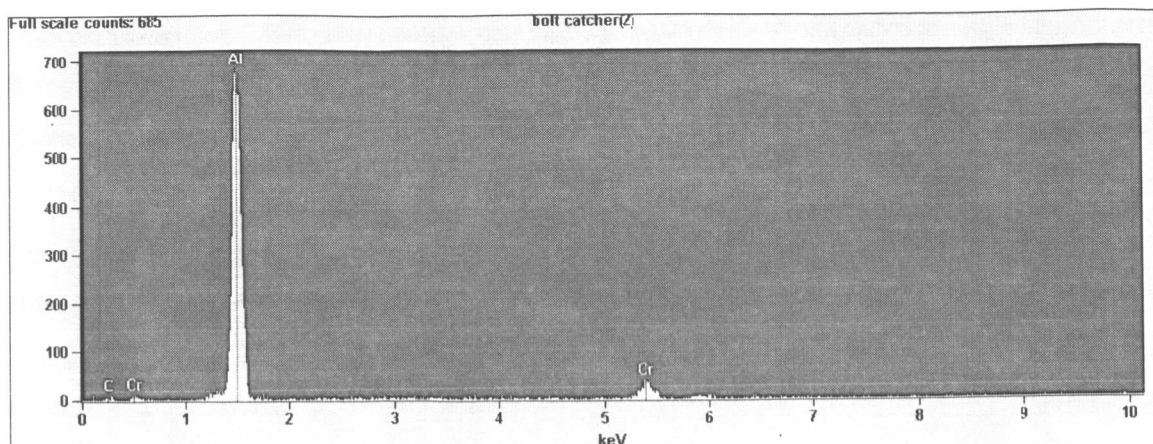
An EDS spectrum of the bolt catcher is shown in figure 41. The bolt catcher had a high peak of aluminum and much smaller peaks of chromium and carbon.

Figure 41. EDS spectrum of the bolt catcher.

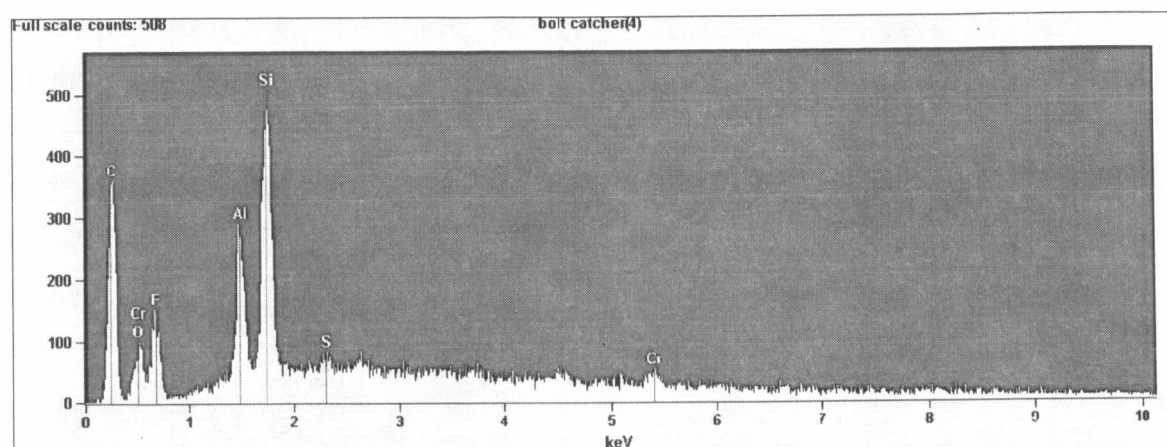
An EDS spectrum of the black deposits on the bolt catcher is shown in figure 42. This spectrum had high peaks of silicon, carbon, and aluminum with smaller peaks of fluorine and oxygen and much smaller peaks of sulfur and chromium.

Figure 42. EDS spectrum of black deposits on the bolt catcher.

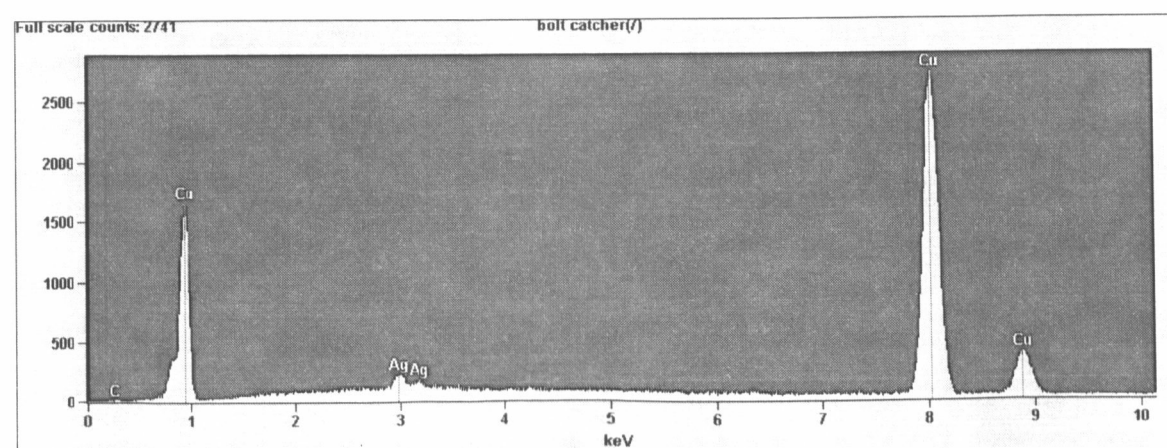
An EDS spectrum of the deposits appearing round and white in figure 40 is shown in figure 43. The spectrum had high peaks of copper with much smaller peaks of silver and carbon.

Figure 43. EDS spectrum of deposits appearing round and white using SEM with backscattered electrons.

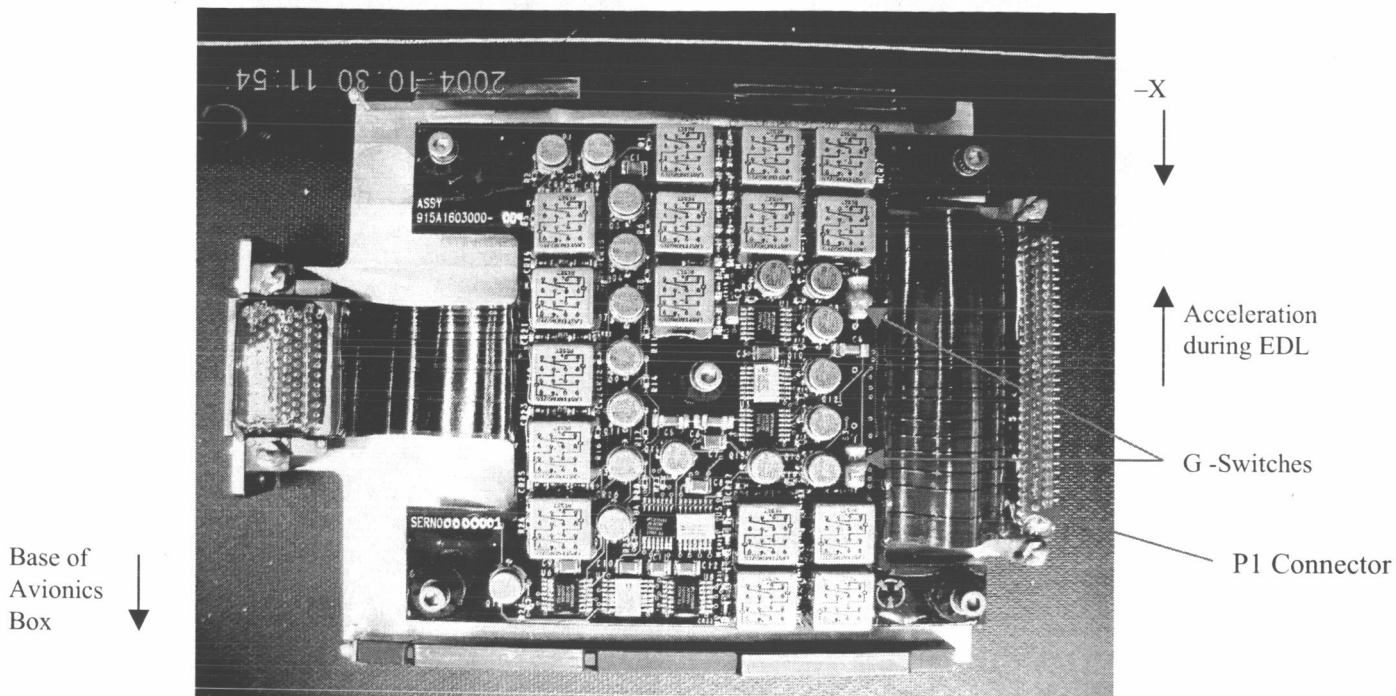
Figure G-1. Avionics Box A Relay Card SN 001

A card-level continuity test was performed. Continuity was measured from power-to-ground and power-to-power for each primary and secondary power net. There were no shorts.

Continuity was also measured at the card level from each separate pyro output-to-ground and from each separate pyro output-to-pyro output. There were no shorts.

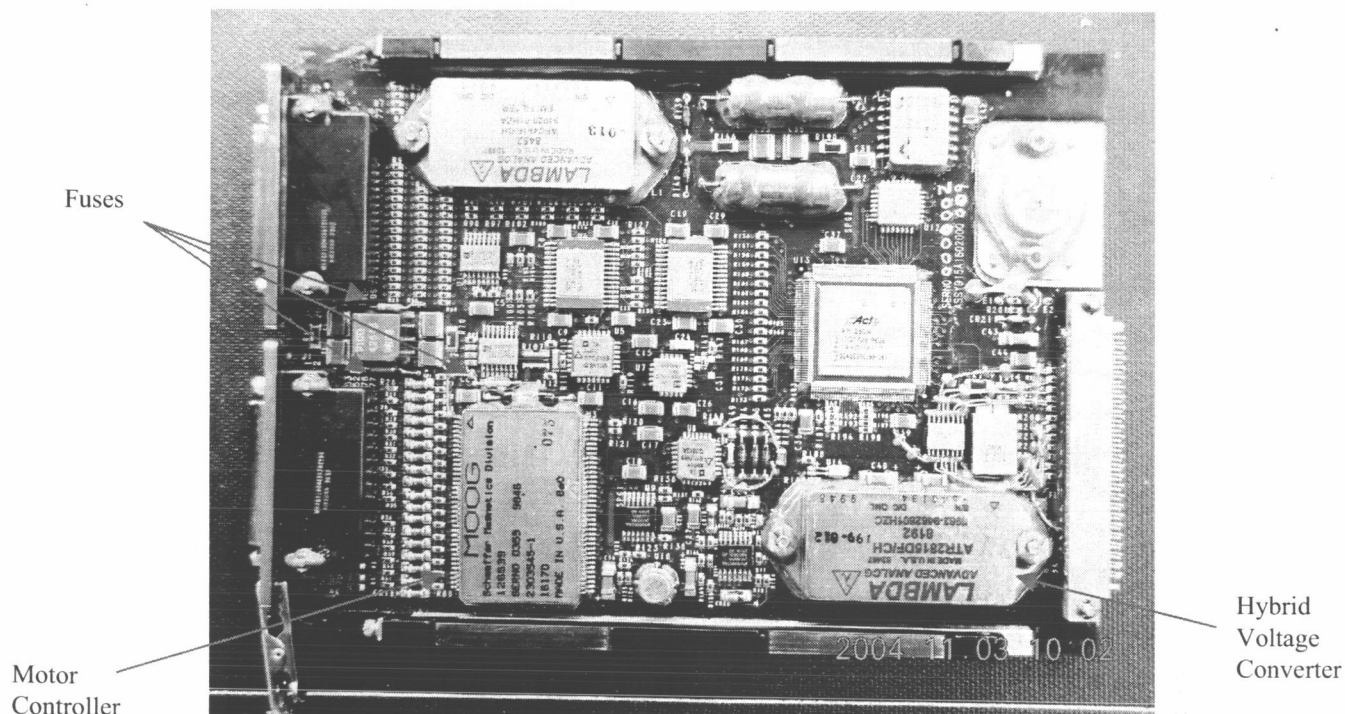
Figure G-4. Avionics Box A MDE Card SN 002

MDE Card S/N 002. The MDE card was in very good condition (Figure G-4). A slight deformation of the board was observed, less than the EST. The two 5-A 28-V spacecraft power fuses appeared normal with no visible evidence of damage or overstress. Continuity tests verified the integrity of the fuses. The hybrid DC/DC secondary voltage converter appeared normal with no evidence of damage or overstress.
