JPL Publication 2005-2

Genesis Failure Investigation Report

JPL Failure Review Board, Avionics Sub-team

July 2004

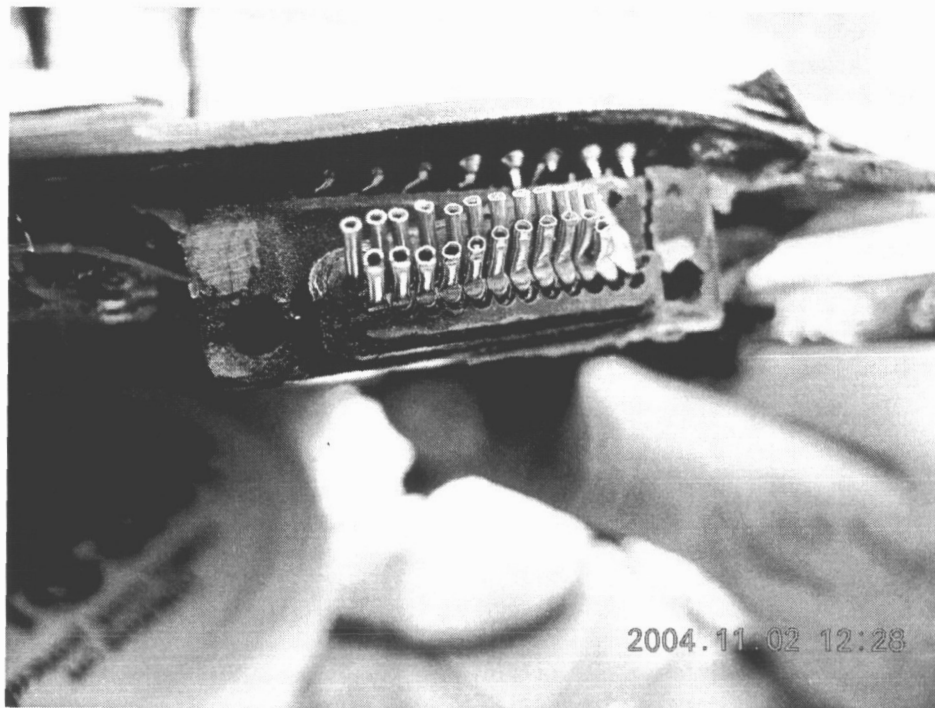
Figure G-8. EST SN 002 J2 Connector

Damage to the connectors prevented their use for card-level continuity tests; therefore, testing was performed by probing board solder joints through the conformal coating. Primary and secondary ground nets were shorted to ground and to each other. Pins touching each other on the smashed connector may have been responsible for the shorts (Figure G-8). If these shorts had occurred while the circuit was powered, there would have been considerable heat generated. However, the lack of visual evidence such as discoloration, burning, or melting of the PCB suggests the power-to-ground shorting of the EST card was due to crash damage and not an in-flight failure.

Pyro output continuity testing could not be performed because of connector damage.

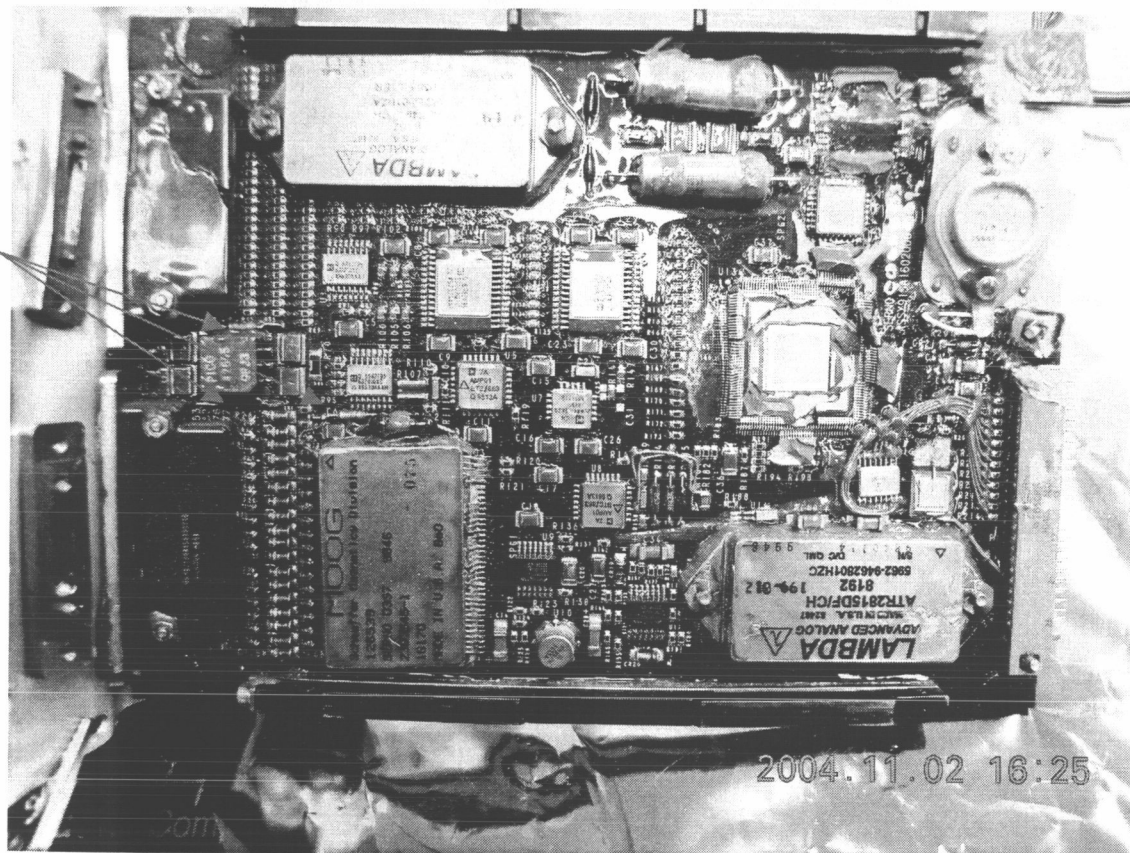
Figure 9. Avionics Box B MDE Card SN 003

MDE Card S/N 003. The MDE card was in bad condition, with extensive damage to the components and board near the P1 connector (Figure G-9). However, the two 5-A 28-V spacecraft power fuses escaped damage and appeared normal, with no visible evidence of damage or overstress. Continuity tests verified the integrity of the fuses.
