# **Debris/Ice/TPS Assessment and Integrated Photographic Analysis of Shuttle mission STS-109**

Armando Oliu  
Process Engineering/Mechanical System Division/ET-SRB Branch,  
Kennedy Space Center, Florida

**March 1, 2002**

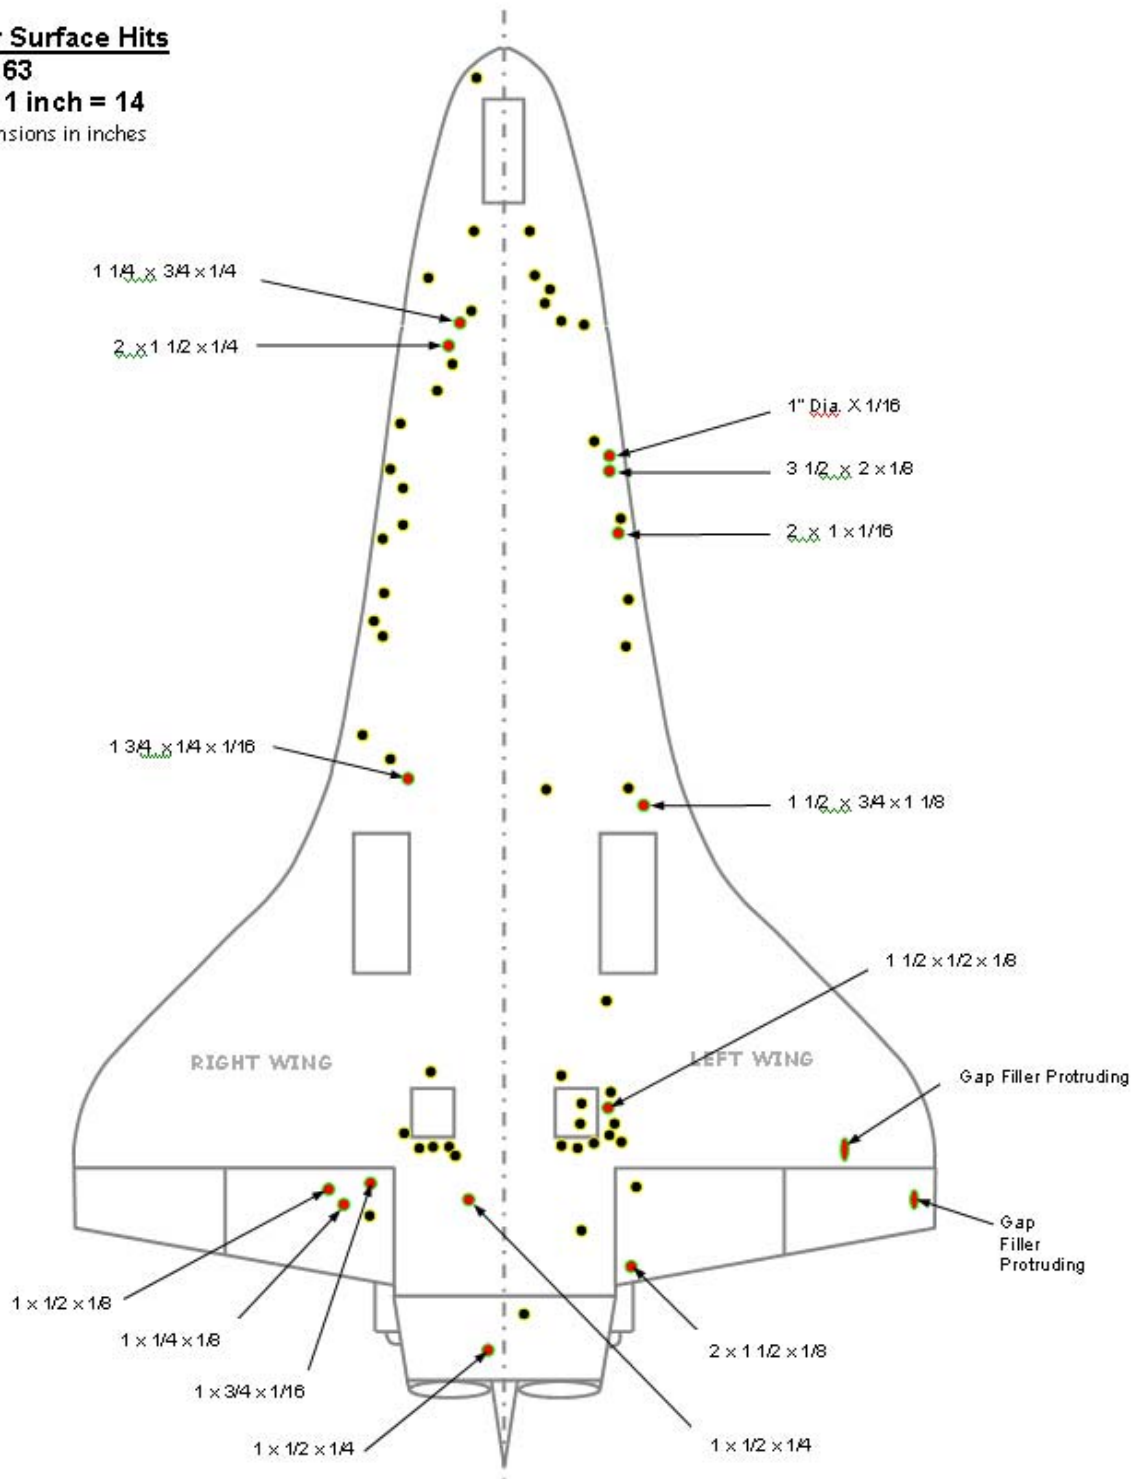
**Figure 1: Orbiter Lower Surface Debris Damage Map**

Post landing inspection of Orbiter tiles showed a total of 98 hits, of which 18 had a major dimension of 1-inch or larger. The Orbiter lower surface sustained 63 total hits, of which 14 had a major dimension of 1-inch or larger. The majority of the hits (34 total with 7 having a dimension larger than 1-inch) were located in the area from the nose landing gear to the main landing gear wheel wells. Approximately 13 of the total lower surface hits were around the LH2 and LO2 umbilical areas. Most of the damage sites around the ET/ORB umbilical were most likely caused by pieces of the umbilical baggie flailing in the airstream and contacting tiles before pulling loose and falling aft.

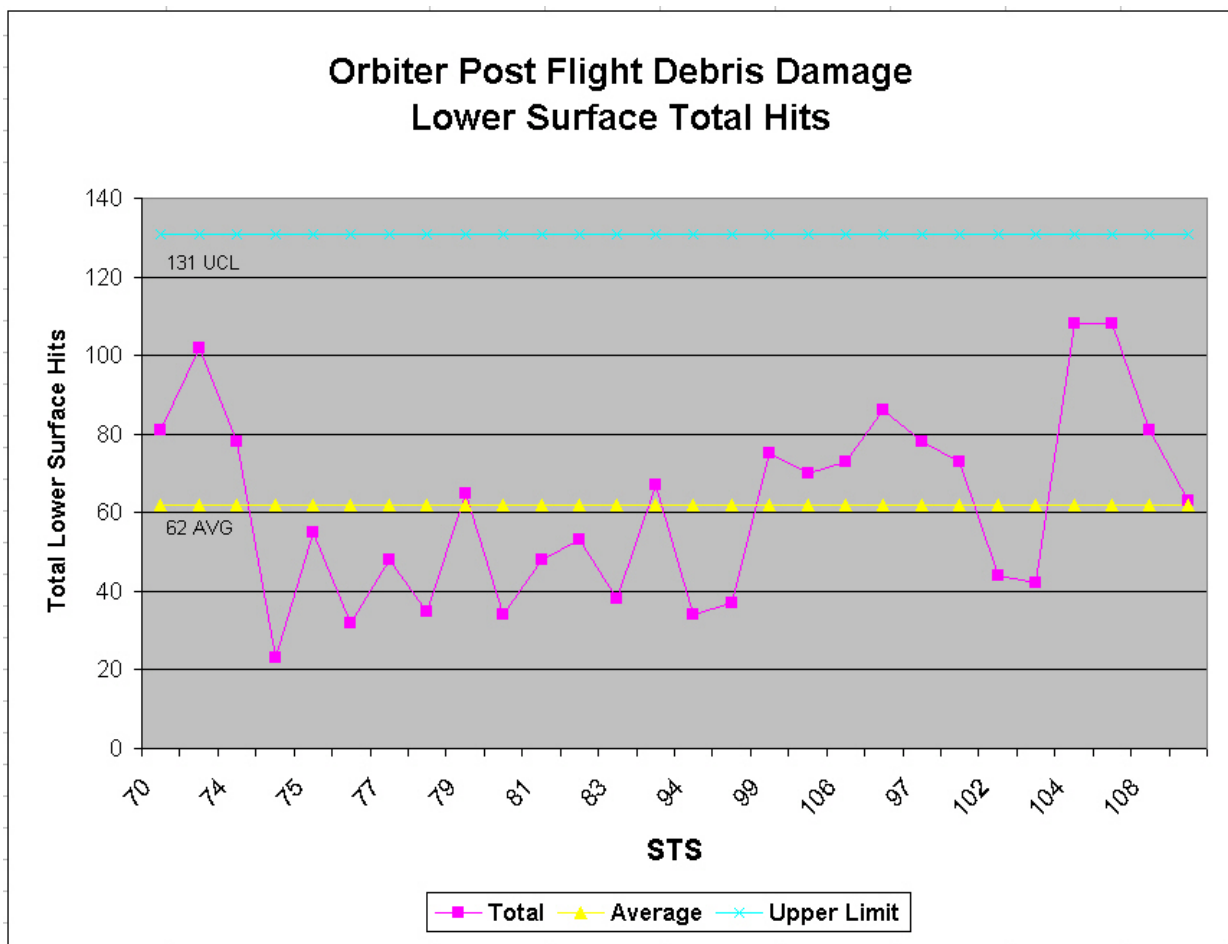
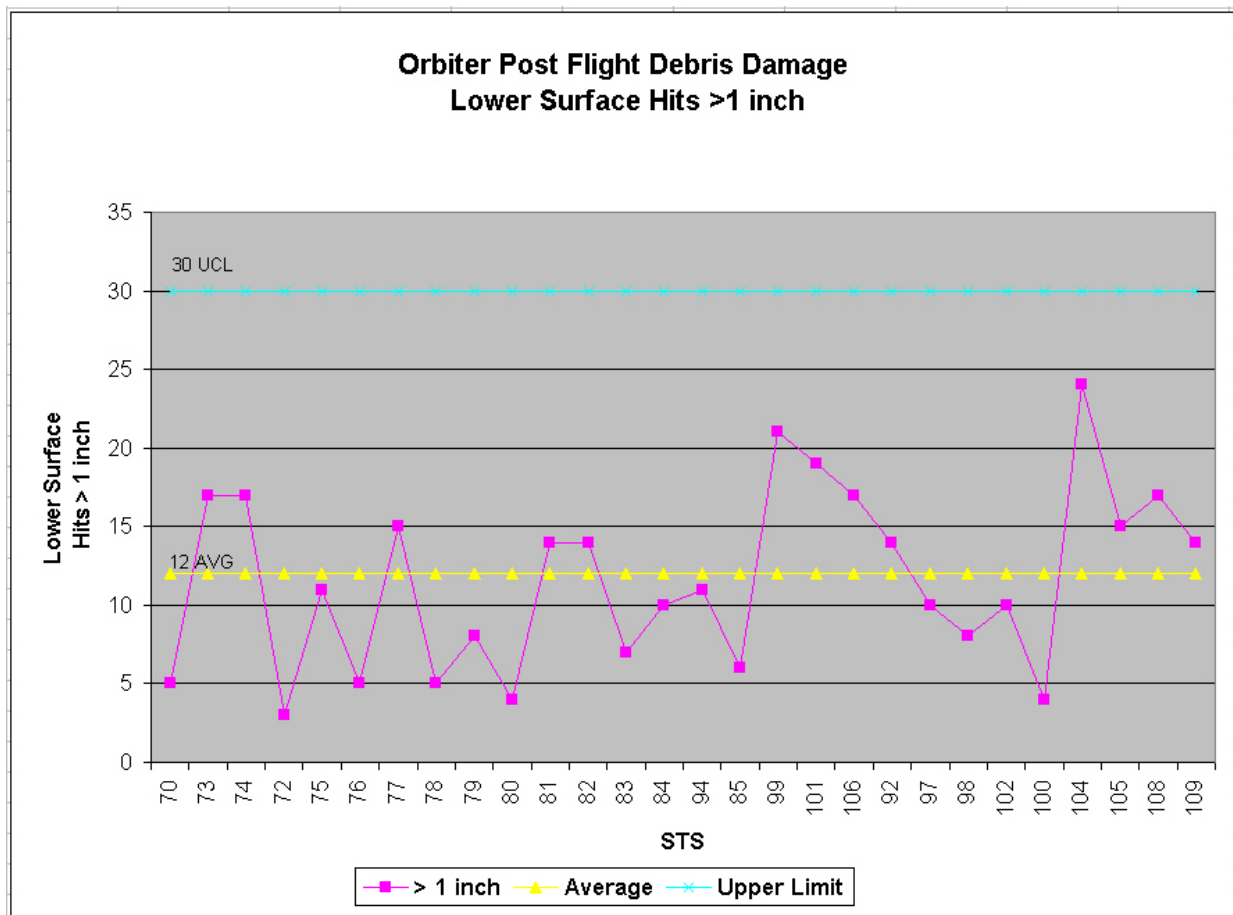
**Figure 5: Control Limits for Lower Surface Hits**

In summary, both the total number of Orbiter TPS debris hits and the number of hits 1-inch or larger were somewhat less than the family average. ET TPS venting modifications continue to have a reducing effect on the quantity and size of the damage sites

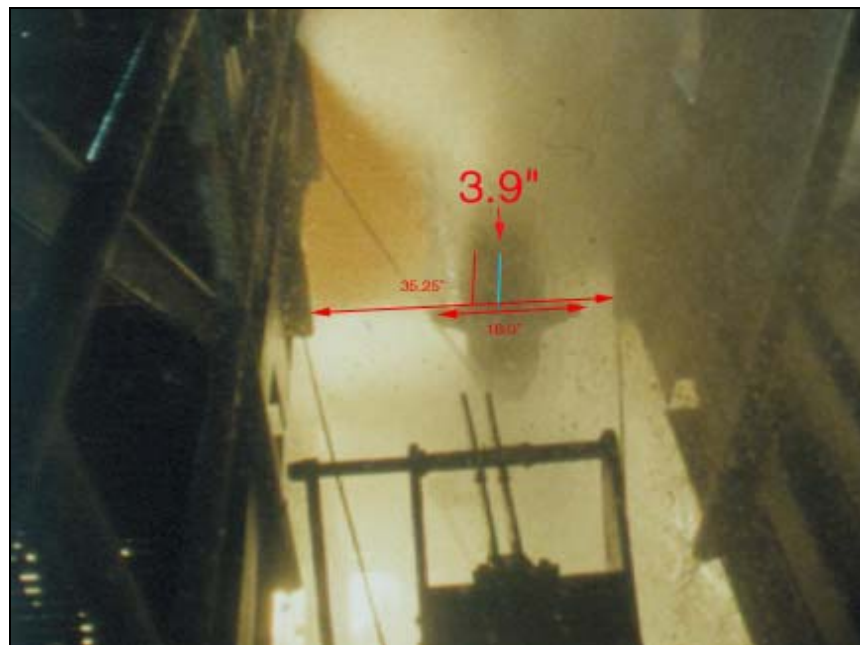
**Figure 2.2 GH2 Vent Arm South of Center Contact with the Deceleration Cable During Latchback (Camera E39)**

One special interest observation was noted that involved similar hardware to an anomalous event seen previously on the STS-108 mission.

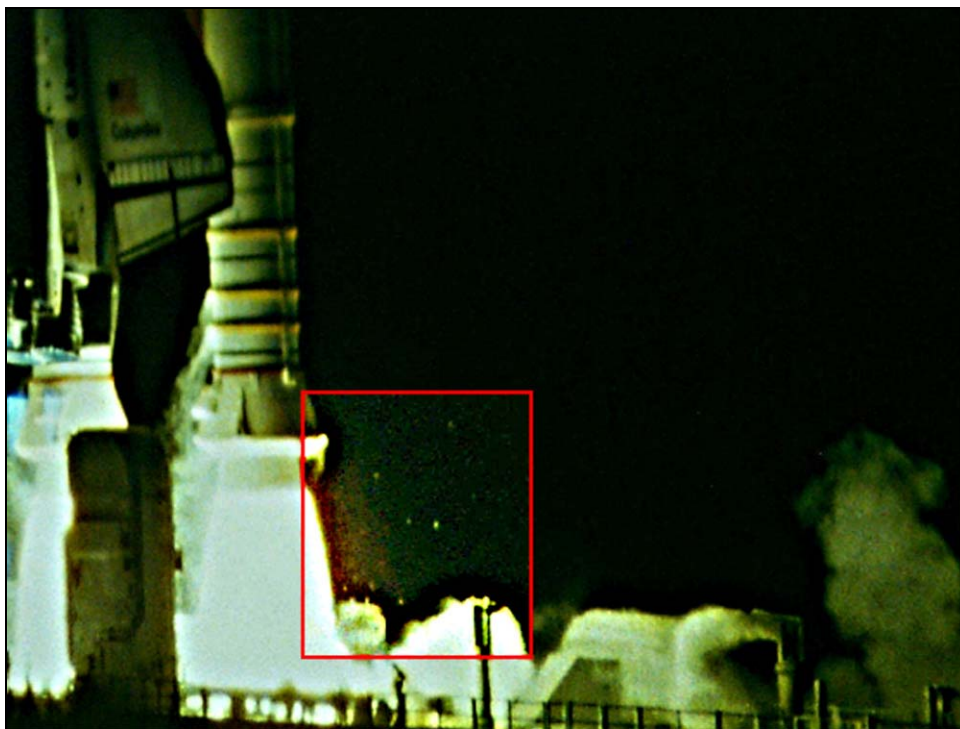
**Figure 2.3.1 (C) Debris Seen North of MLP During Liftoff (Camera E1)**

Multiple pieces of SRB throat plug and/or SRB flame duct debris were seen near the right and left SRBs during liftoff. None of this debris was seen to contact the launch vehicle. See Figure 2.3.1 (C) and Table 2.3.1. (Cameras E1, E5, E17, E19, E41, E52, E63, E76, E222)

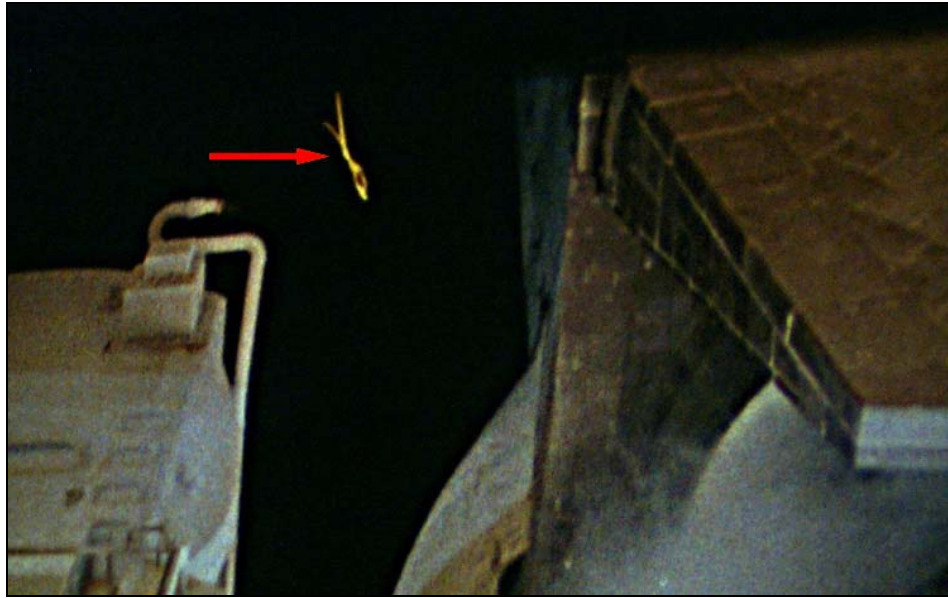
**Figure 2.3.1 (D) Unidentified Debris seen above LO2 TSM (Camera E17)**

A long, unidentified, linear-shaped debris object (with a fork-shaped appearance on one end) appeared to be above the LO2 TSM (in the image view) and traveled toward the +Y edge of the body flap before falling aft during liftoff (11:22:02.905 UTC). See Figure 2.3.1 (D). (Camera E17)

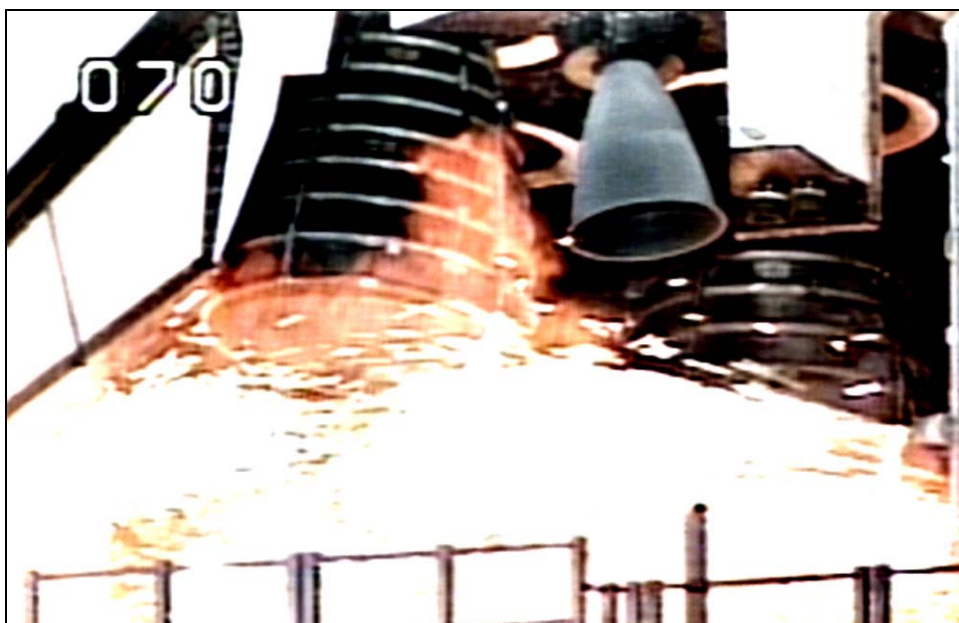
**Figure 2.3.3 (A) Orange Vapor Seen Above SSME Rims Prior to Liftoff (Camera OTV070)**

Orange vapor (possibly free burning hydrogen) was seen forward of the base of the vertical stabilizer, near the base heat shield, forward of the trailing edge of the OMS pods, and on the -Z side of the body flap during SSME ignition (11:21:56.471 UTC). See Figure 2.3.3 (A). Orange vapor forward of the aft end of the Orbiter during SSME ignition has been seen on previous mission films and videos. (Cameras OTV070, E1, E2, E5, E18, E19, E20, E52, E63, E76)

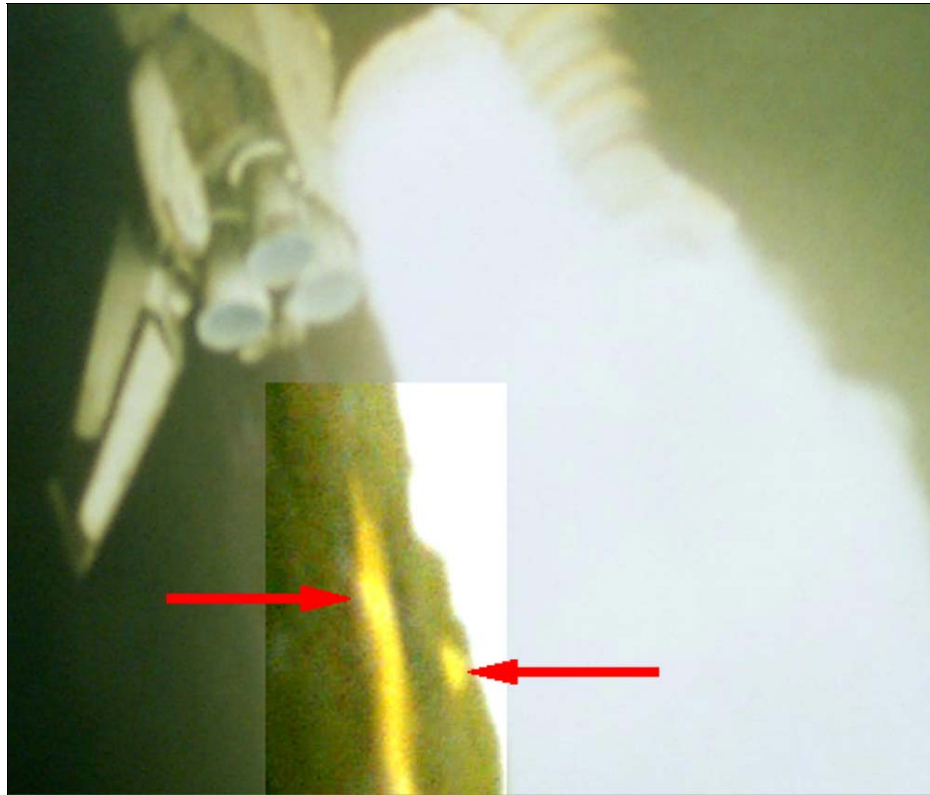
**Figure 2.3.4 Flares Seen in SSME Exhaust Plume (Camera E223)**

Multiple light-orange-colored flares (possibly debris induced) were noted in the SSME exhaust plume during ascent on the long range tracking camera films. See Figure 2.3.4. Often on previous mission imagery, debris has been seen contacting the SSME exhaust plume resulting in visible flares. Usually this debris was RCS paper. (On STS-26 and STS-101, debris that resulted in very large orange-colored flares was determined to have been tile material.) Examples of flares seen on STS-109 can be seen in Table 2.3.4.

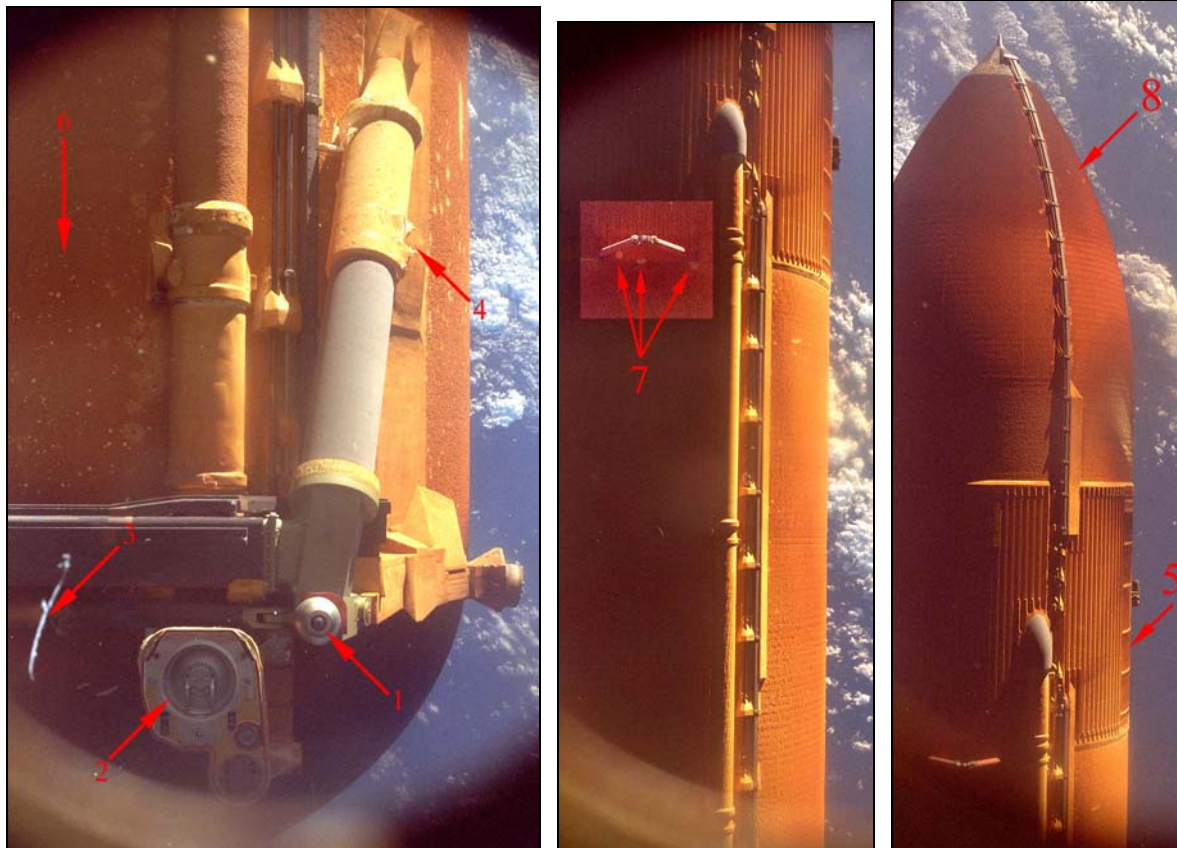
**Figure 2.4.1 35mm Images of the External Tank during Separation**

The separation bolt between the ET and the aft end of the Orbiter (EO-3 fitting near the liquid oxygen umbilical) appeared to be flush or, at the most, very slightly protruded. See Figure 2.4.1, annotation 1. (A Shuttle Program investigation of the STS-106 bolt extension was previously conducted in October, 2000). The red-colored purge seal on the EO-3 ball joint fitting was in place.

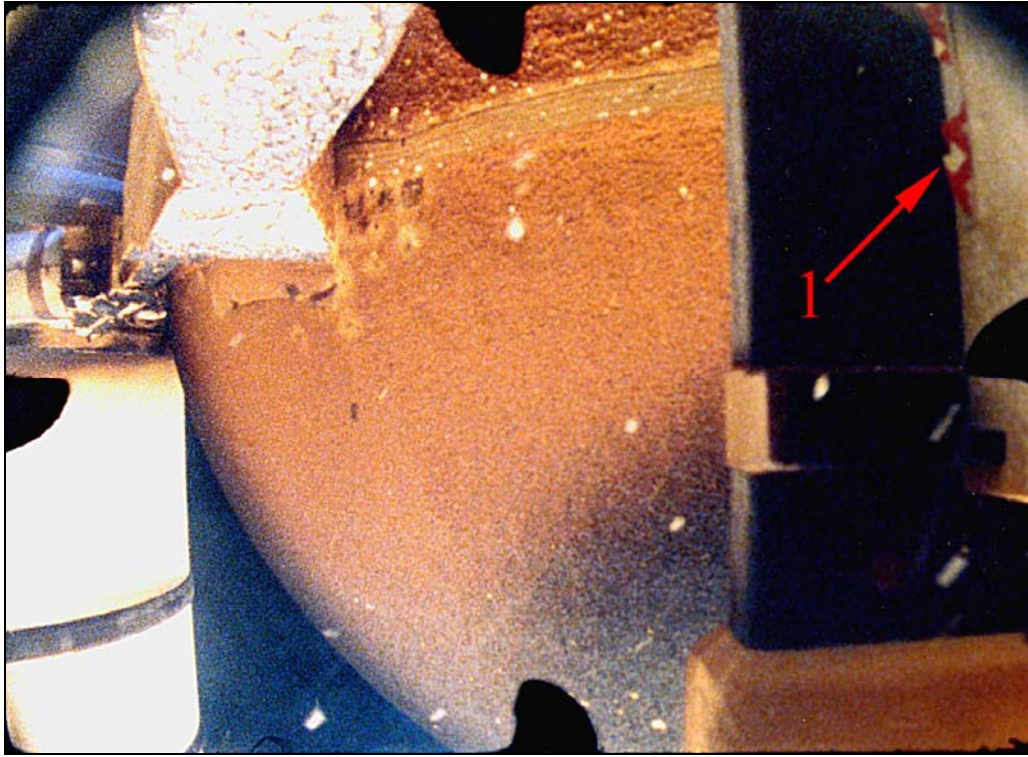
**Figure 2.4.2 (A) 16mm Umbilical Well Camera Imagery**

The LSRB separation appeared normal on the 16 mm umbilical well camera films (recorded through the 5mm and 10 mm lenses).

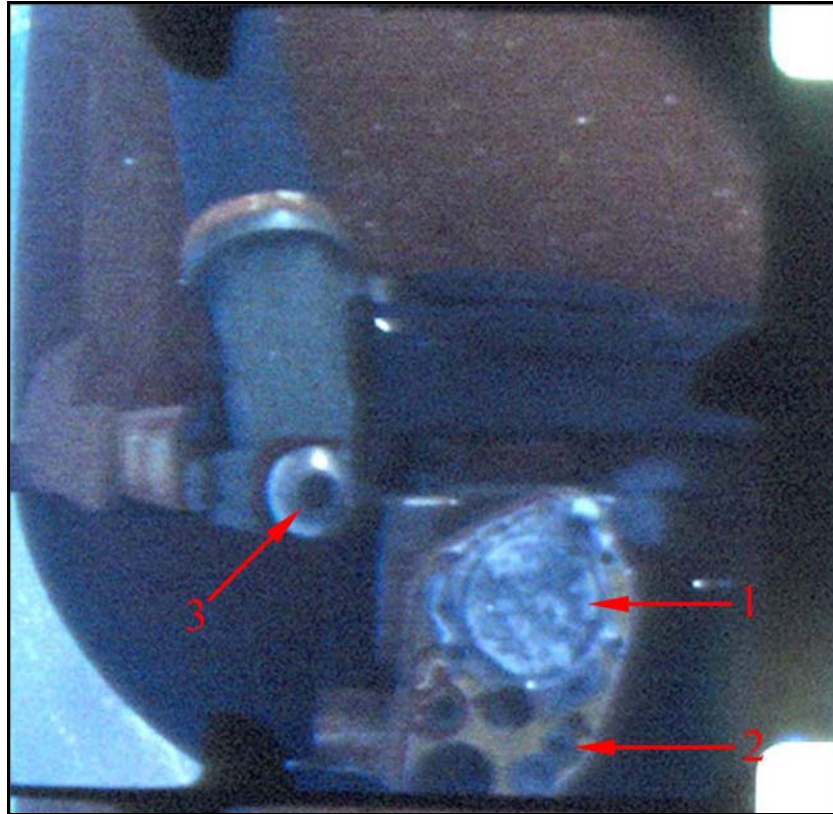
**Figure 2.4.2 (B) 16mm Umbilical Well Camera Imagery**

Typical vapor and multiple light-colored pieces of debris were seen after the umbilical separation. No anomalies were noted on the face of the LH2 umbilical after ET separation. As typically seen on previous missions, frozen hydrogen was visible on the orifice of the LH2 17 inch connect. See Figure 2.4.2 (B), annotation 1. A white-colored, linear, S- shaped, object seen on the -Y side of the LH2 17 inch orifice was probably a piece of frozen hydrogen. Frozen hydrogen was visible between the 1 o'clock position of the LH2 umbilical and the -Y end of the ET cross beam.

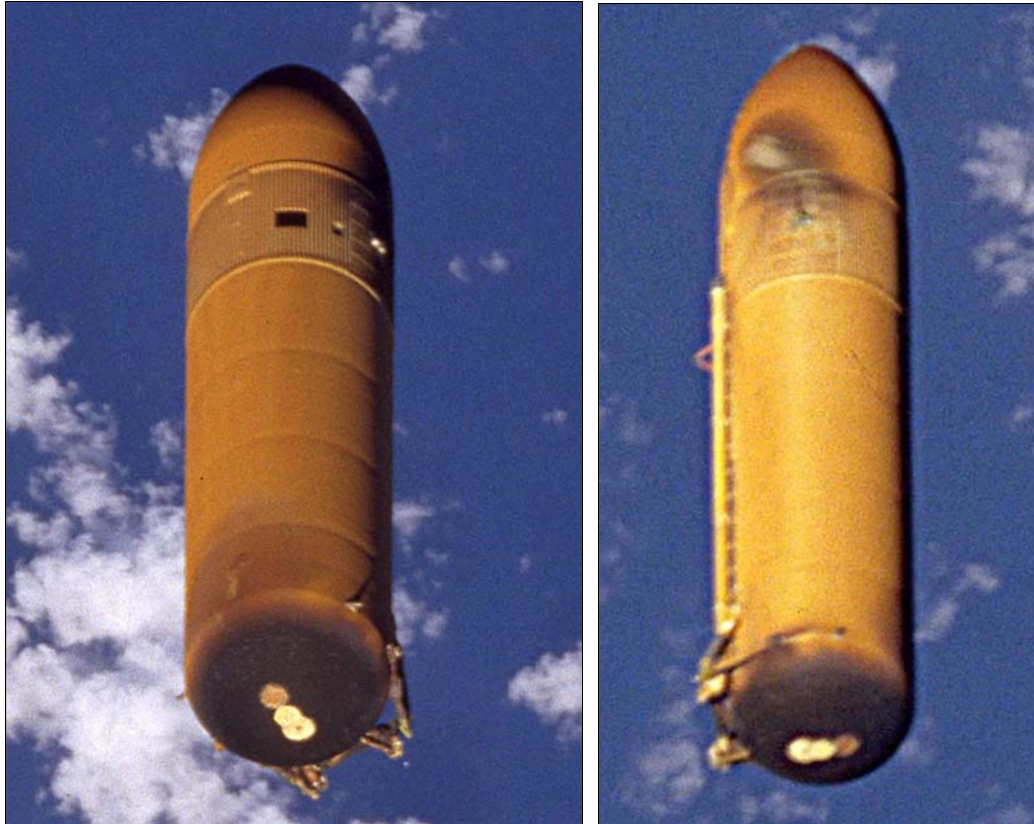
**Figure 2.4.3 Handheld images of the External Tank (Frames 1 and 11)**

No anomalous or unusual observations were noted on the handheld film views. Excellent quality views of all sides of the ET, the ET aft dome, and ET nose were acquired. See Figure 2.4.3. The +Y and -Y thrust panels appeared to be in good condition on the hand held film views.

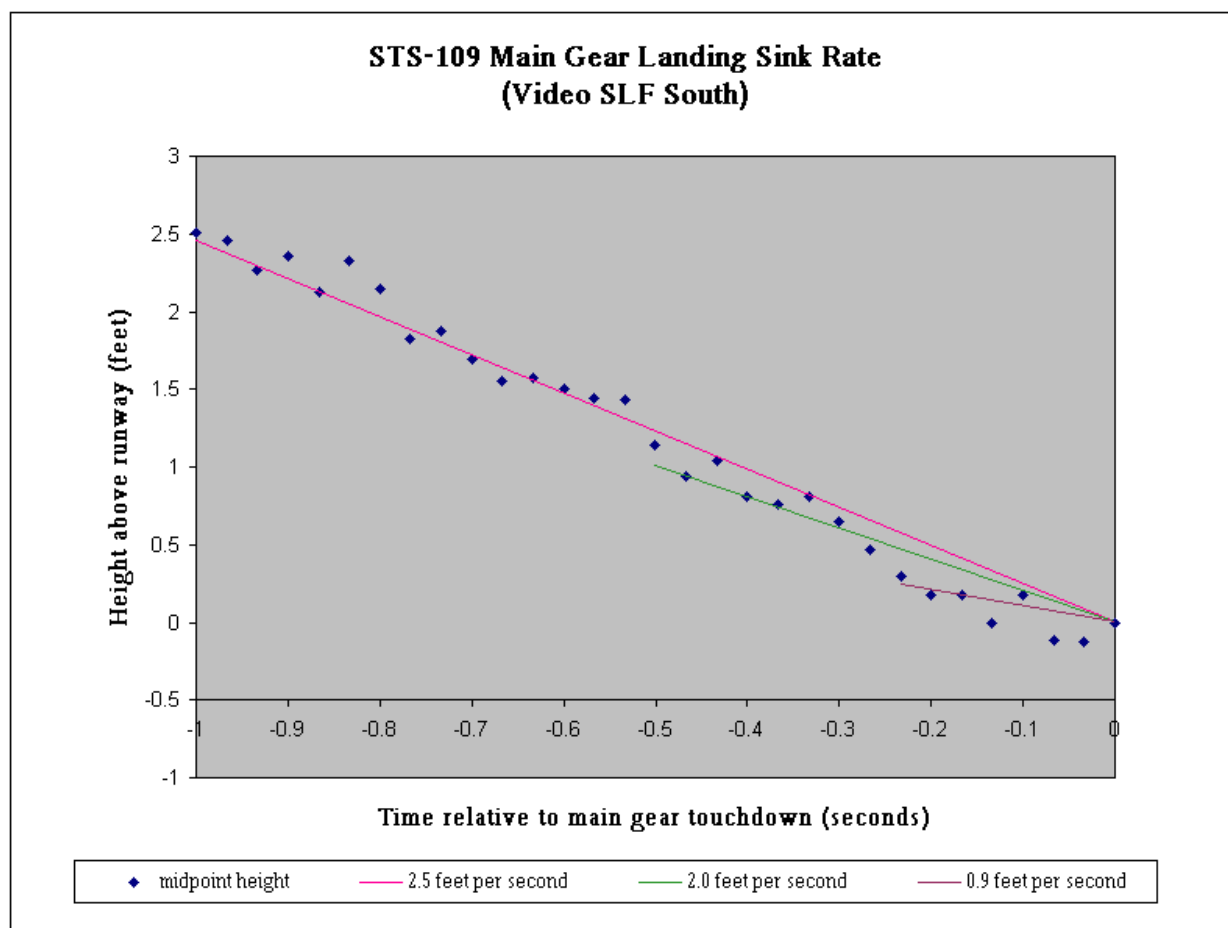
**Figure 2.6 Main Gear Midpoint Landing Sink Rate**

The main gear sink rate for the STS-109 landing at one second, at half a second, and at a one quarter of a second are provided in Table 2.6. The trends for the main gear sink rate for these same times are shown in Figure 2.6.

The maximum allowable main gear sink rate values are 9.6 feet / second for a 212,000 lb. vehicle and 6.0 feet/second for a 240,000 lb. vehicle. The landing weight of the STS-109 vehicle was reported to be 222,160 lbs.

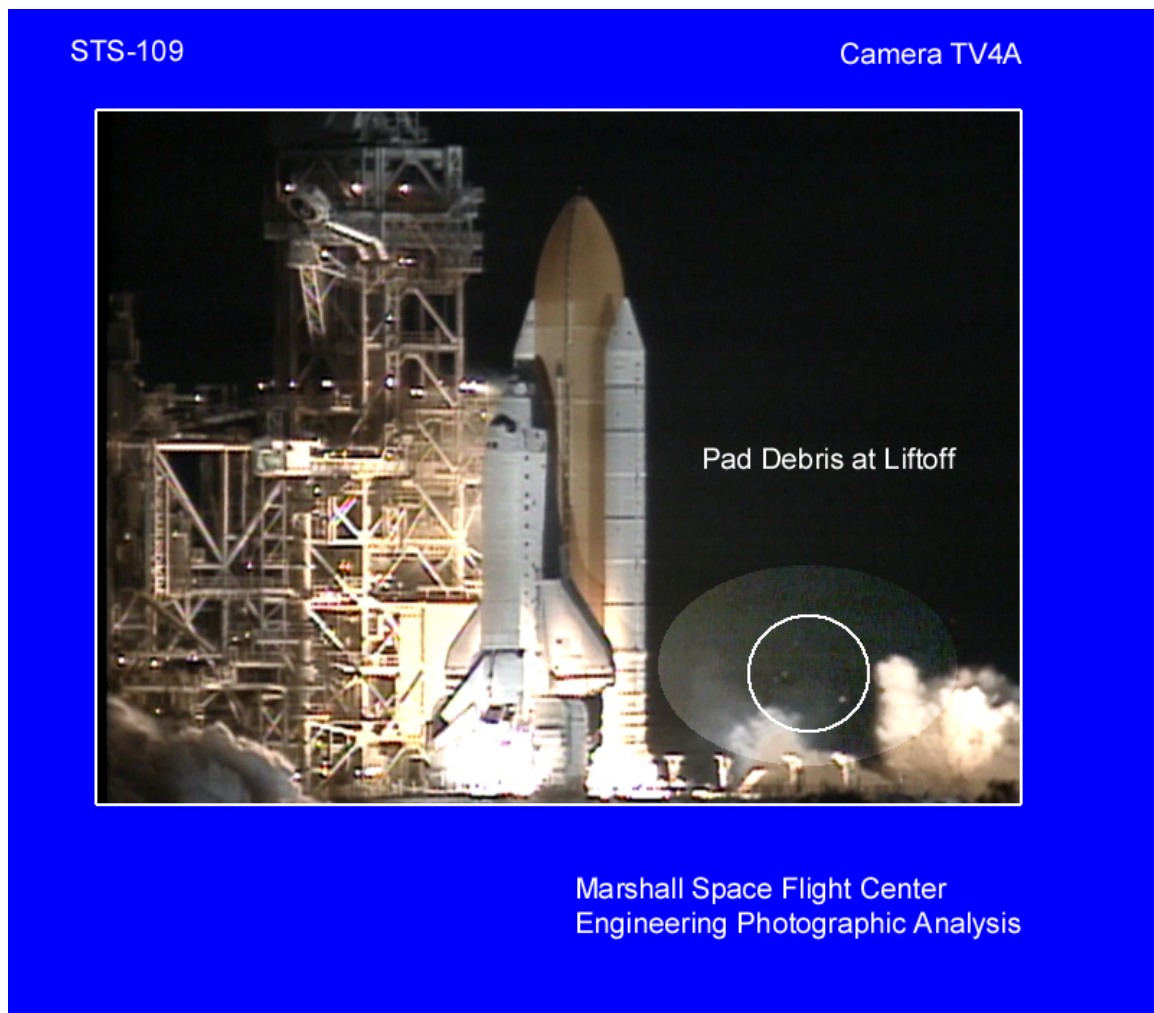
**Figure 9. Video Camera TV4A: Pad Debris at Liftoff**

Typical pad debris was observed at liftoff.

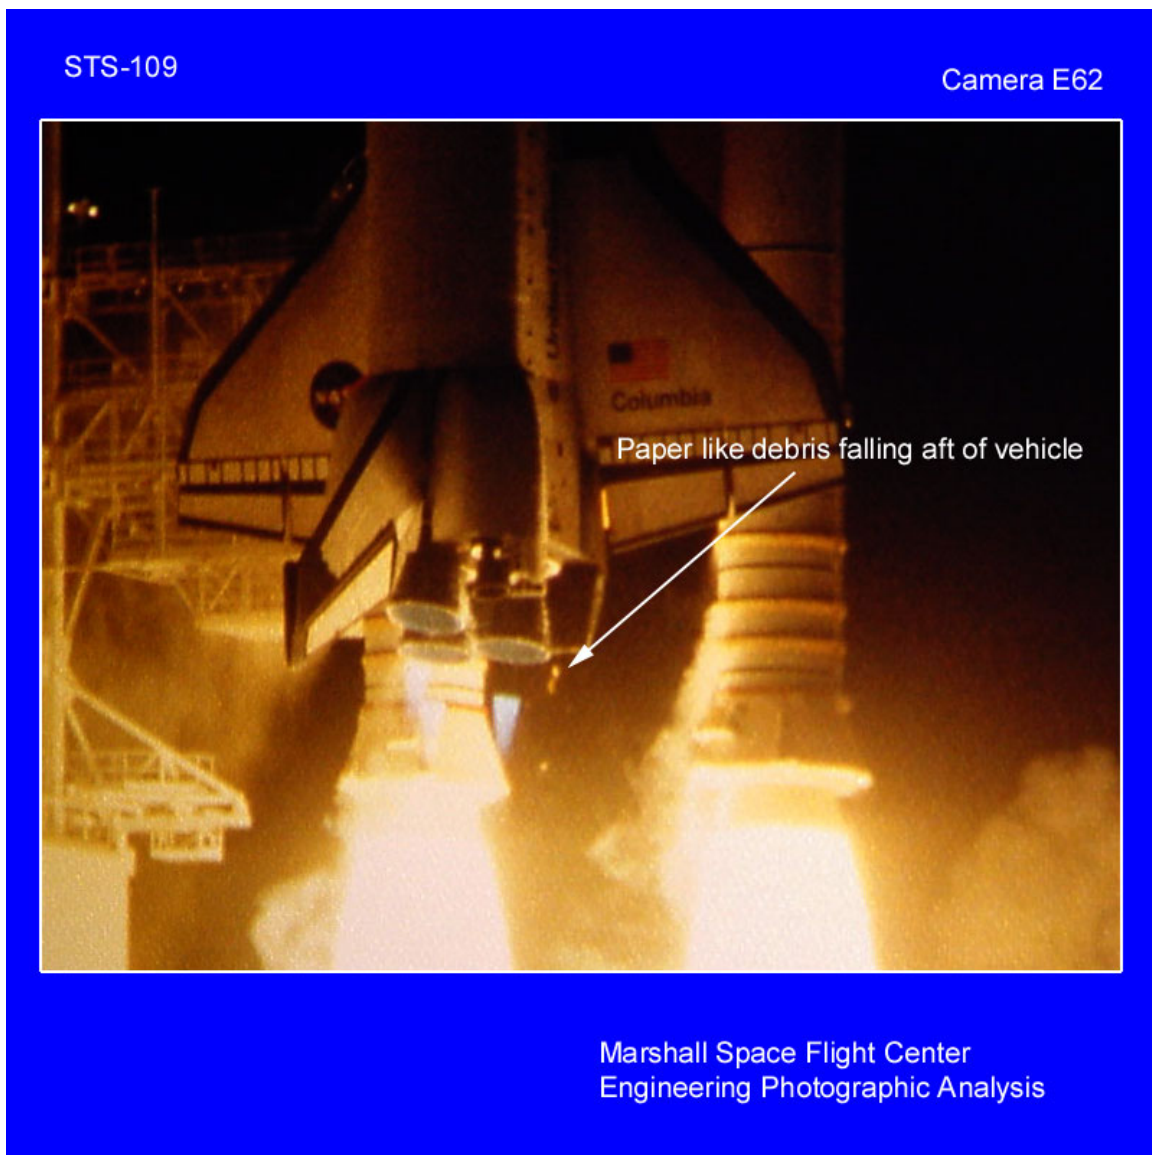
**Figure 13. Film Camera E62: Debris Falling Aft**

Debris falling aft of vehicle was noted during liftoff. This debris was probably purge barrier material. Other views of this debris was obtained from Film Camera 223, Figure 12, and Film Camera E62, Figure 13.

Another view of the debris object noted in Figure 12.

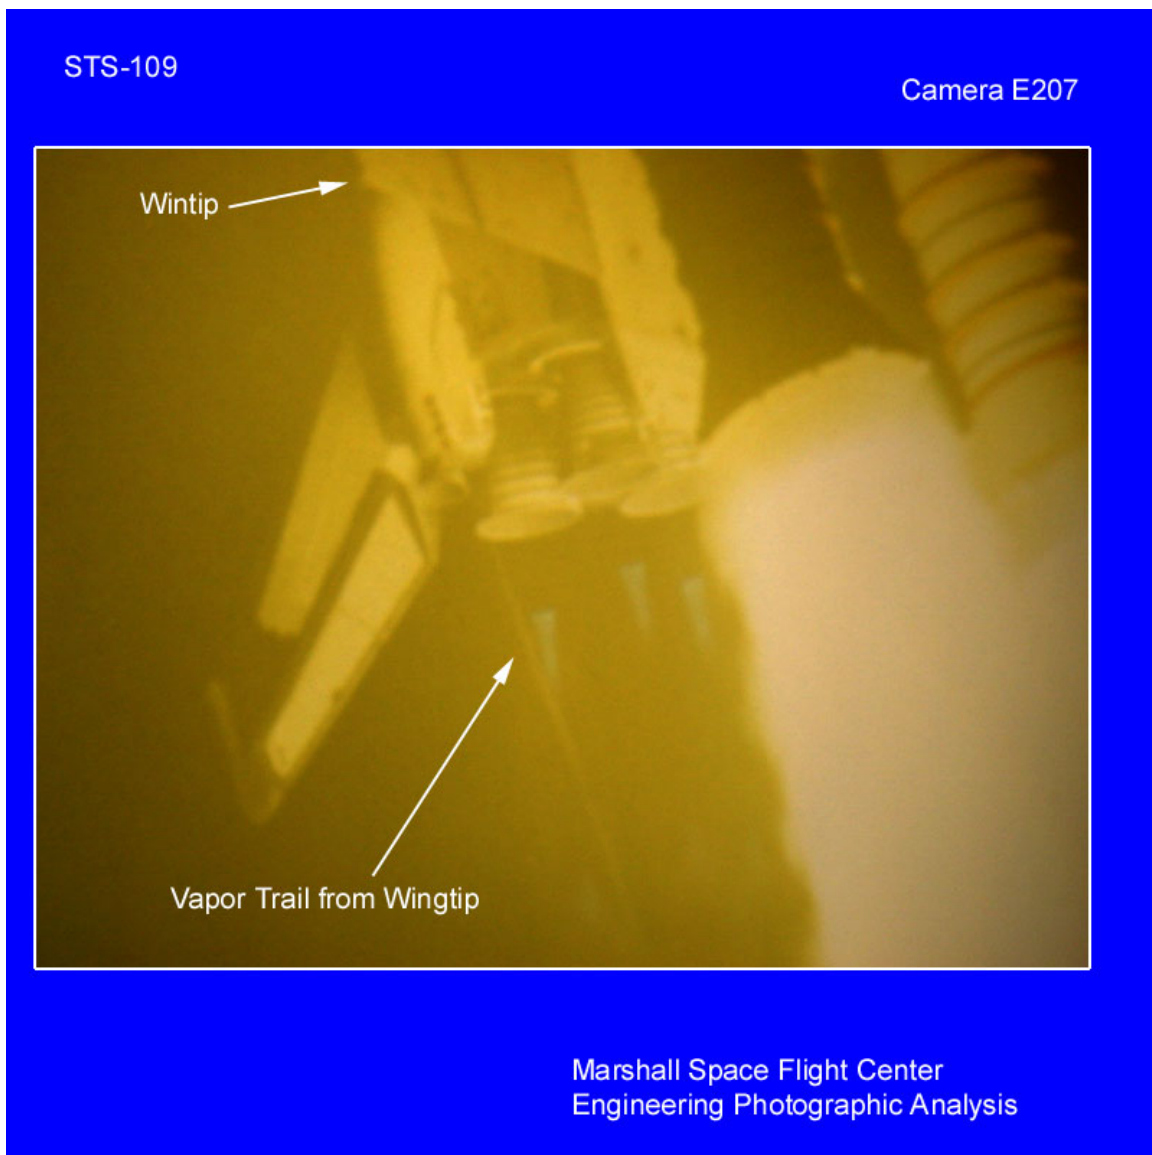
**Figure 14. Film Camera E207: Vapors off Orbiter Wingtips**

Vapors were noted off the Orbiter wingtips during ascent.

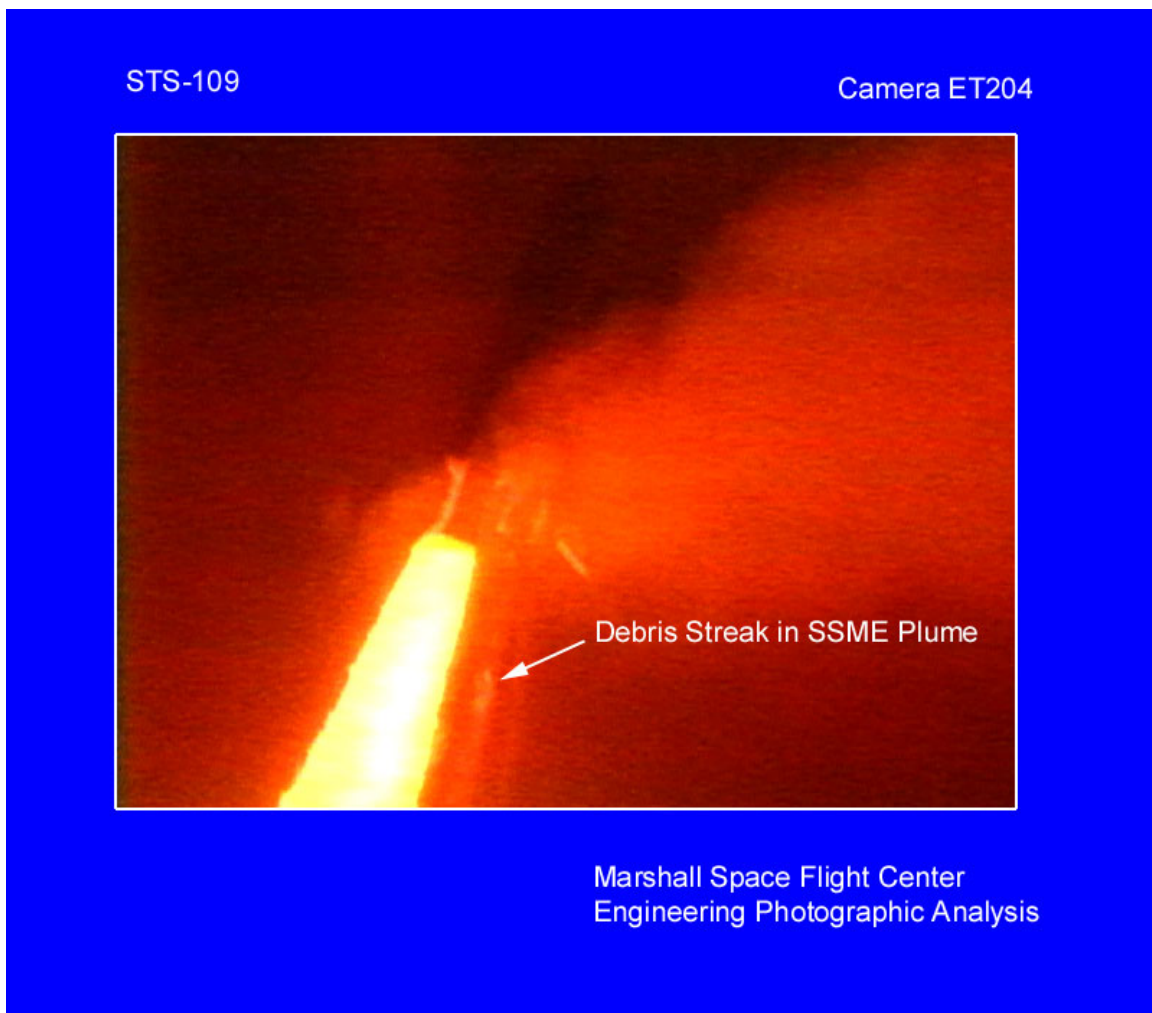
**Figure 15. Film Camera ET204: Streak in SSME Plumes**

Debris induced streaks were observed in SSME plumes during ascent.

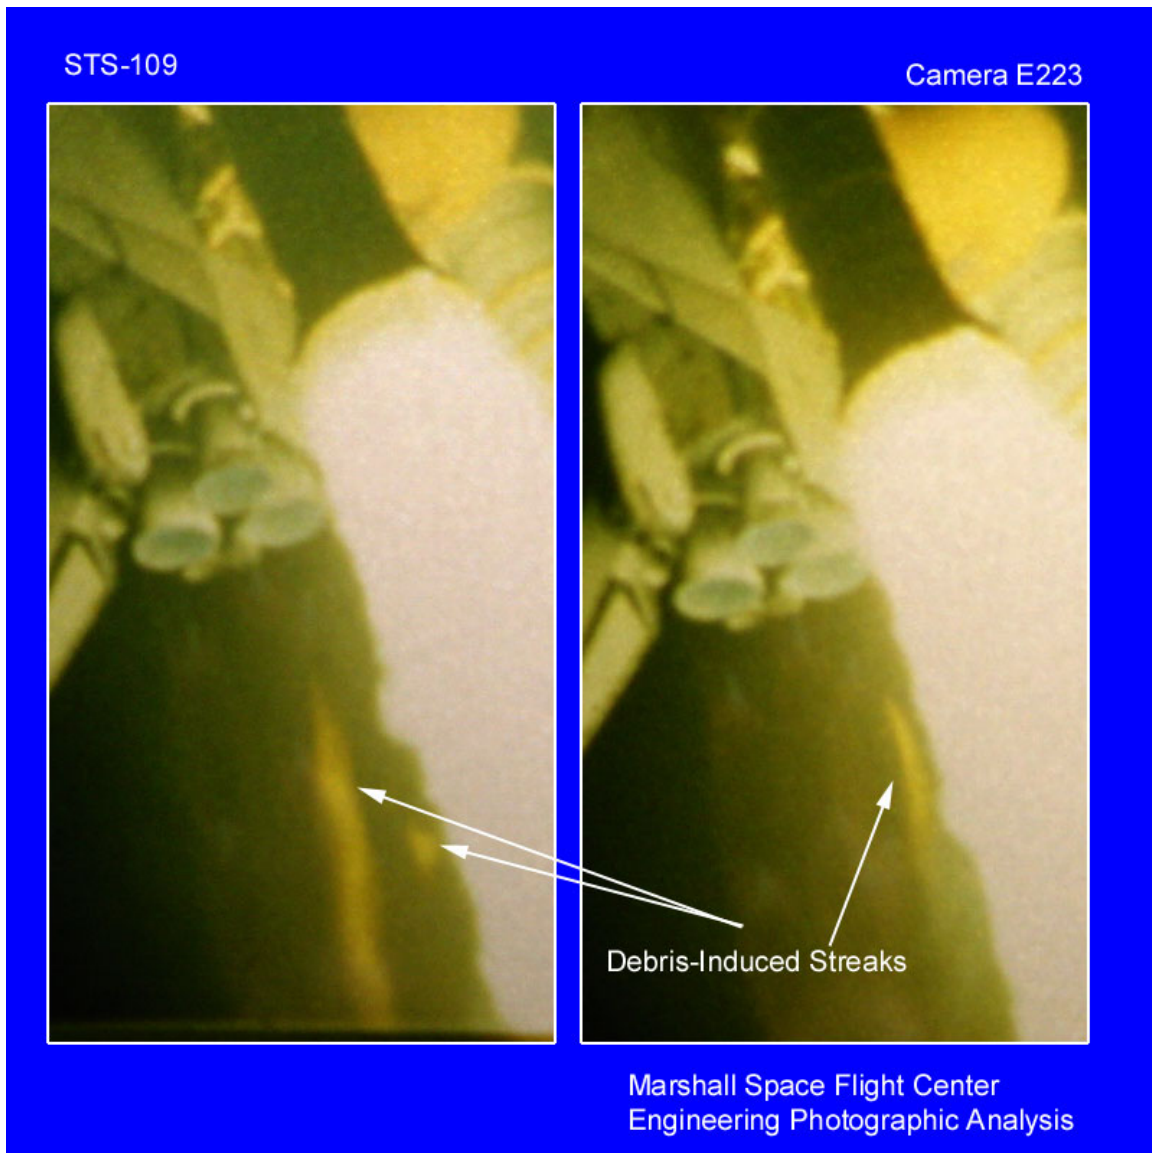
**Figure 16. Film Camera E223: Streak in SSME Plumes**

Another view of the streaks in the SSME plumes shown in Figure 15.

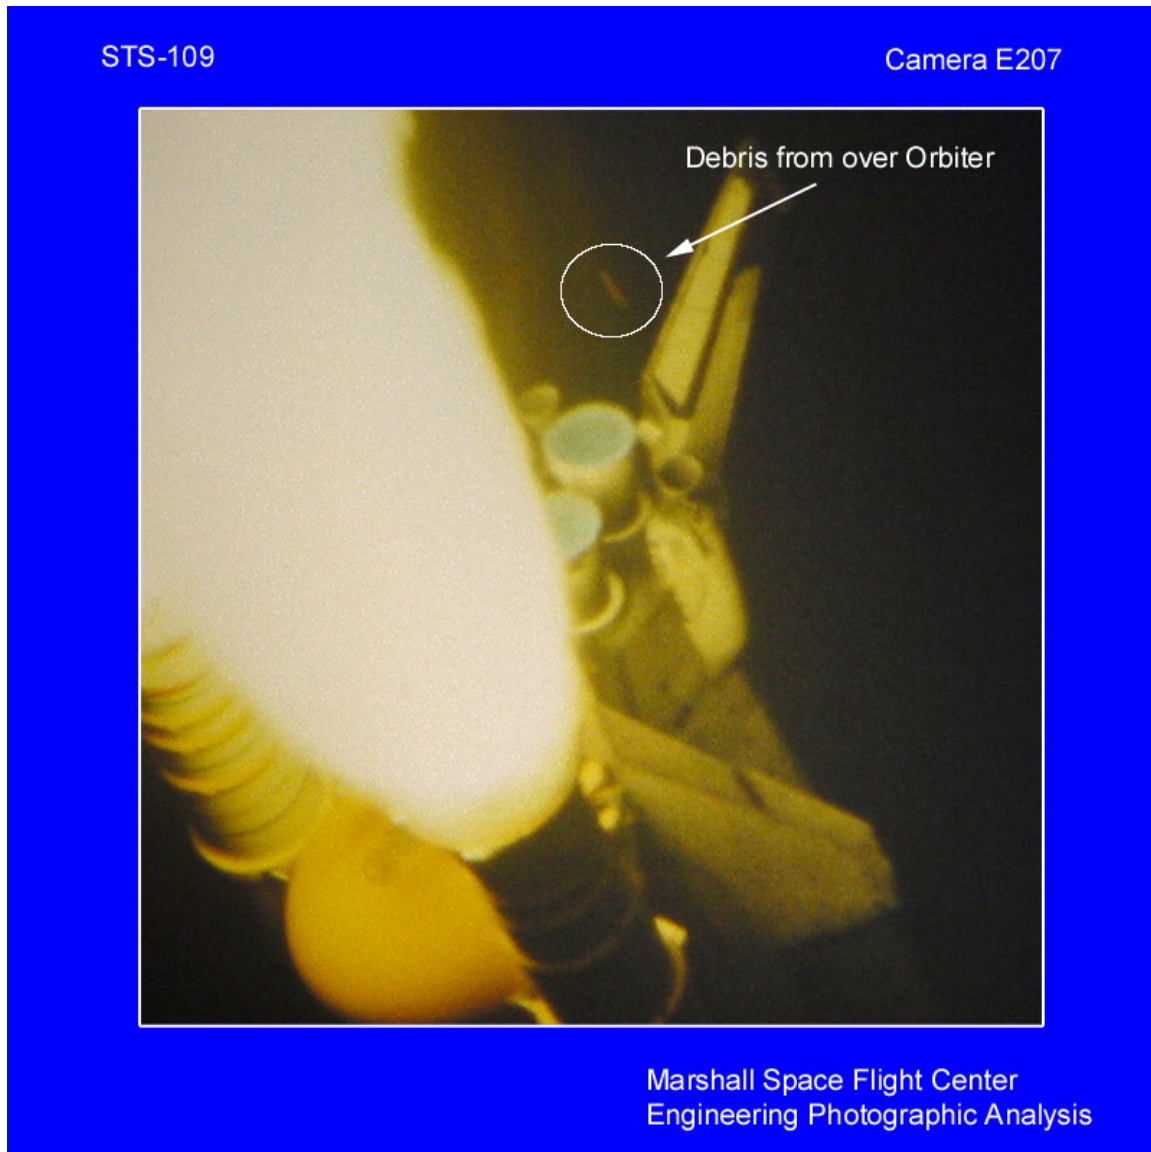
**Figure 17. Film Camera E207: Debris Falling Aft**

A view of typical debris falling aft of the vehicle during ascent. This debris is probably RCS paper from forward on the Orbiter.

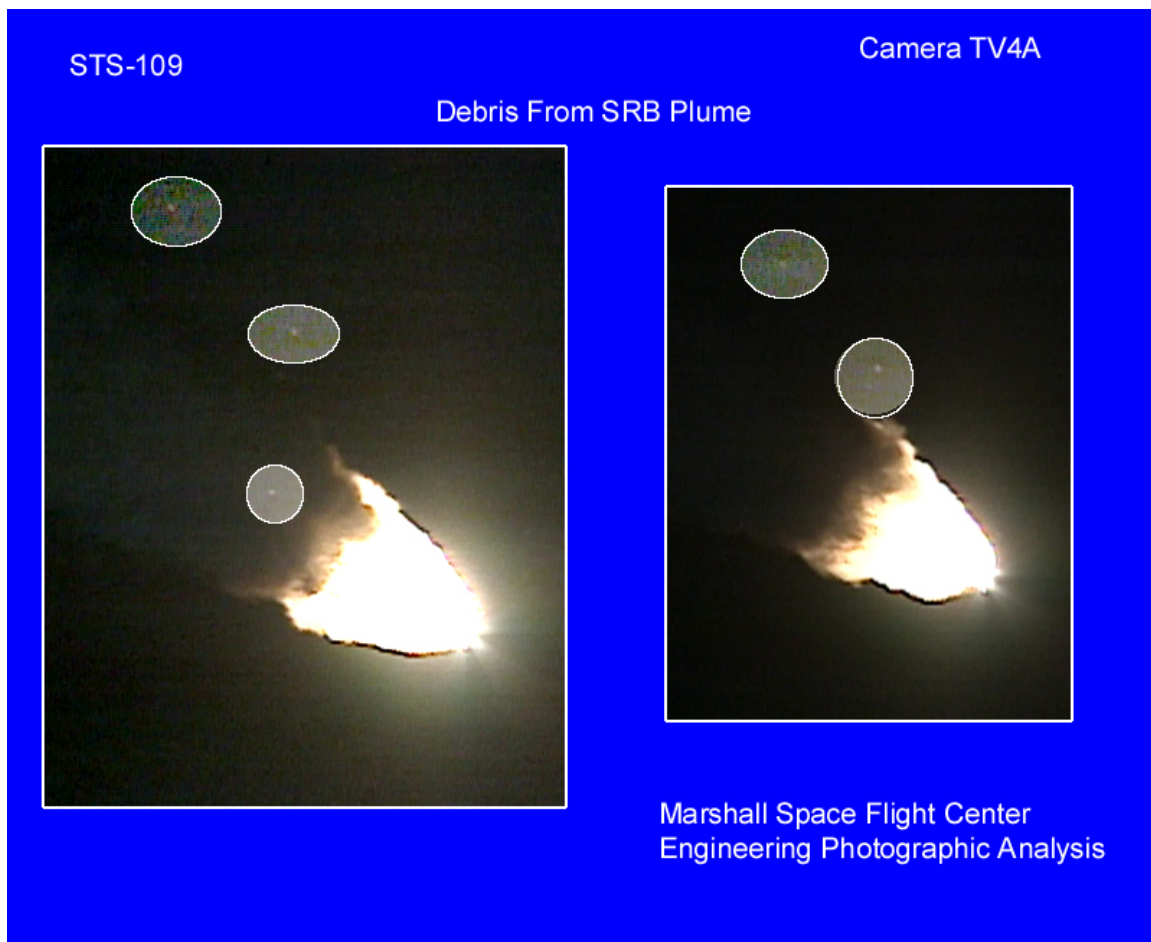
**Figure 18. Video Camera TV4A: Debris Ejected from SRB Plumes**

Typical debris ejected from the SRB plumes during ascent.
