# **Debris/Ice/TPS Assessment and Integrated Photographic Analysis of Shuttle mission STS-109**

Armando Oliu  
Process Engineering/Mechanical System Division/ET-SRB Branch,  
Kennedy Space Center, Florida

**March 1, 2002**

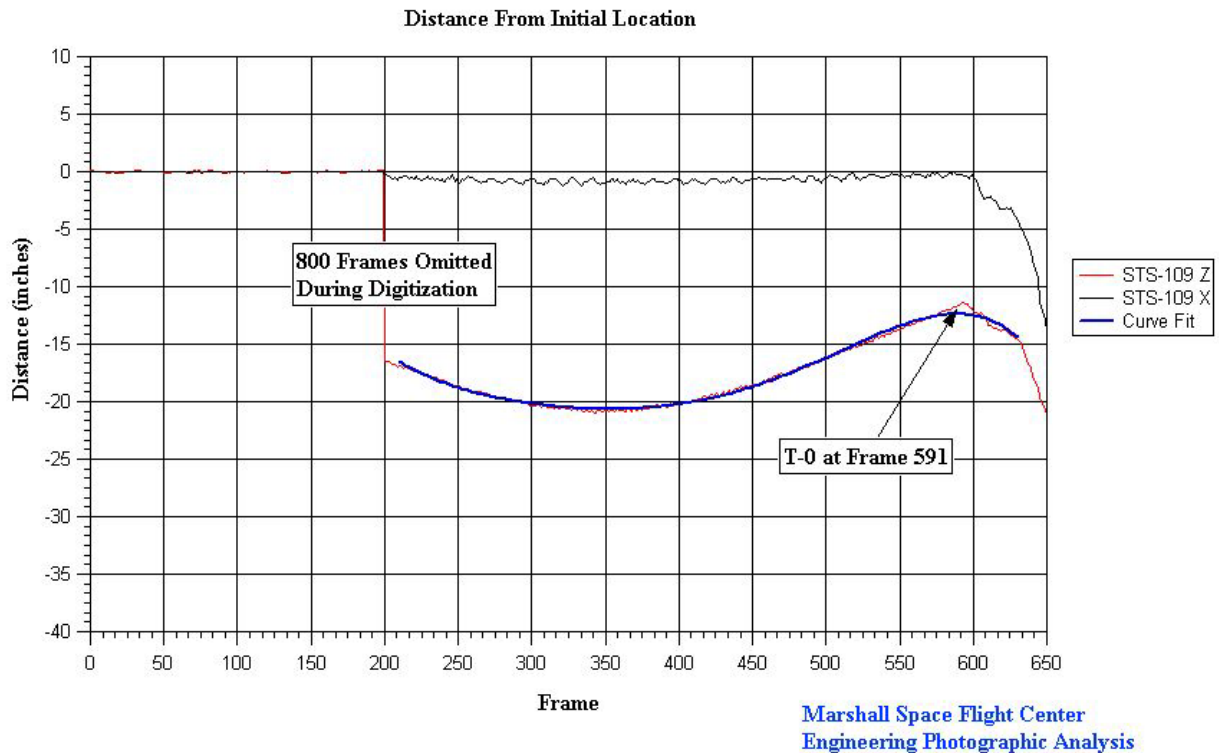
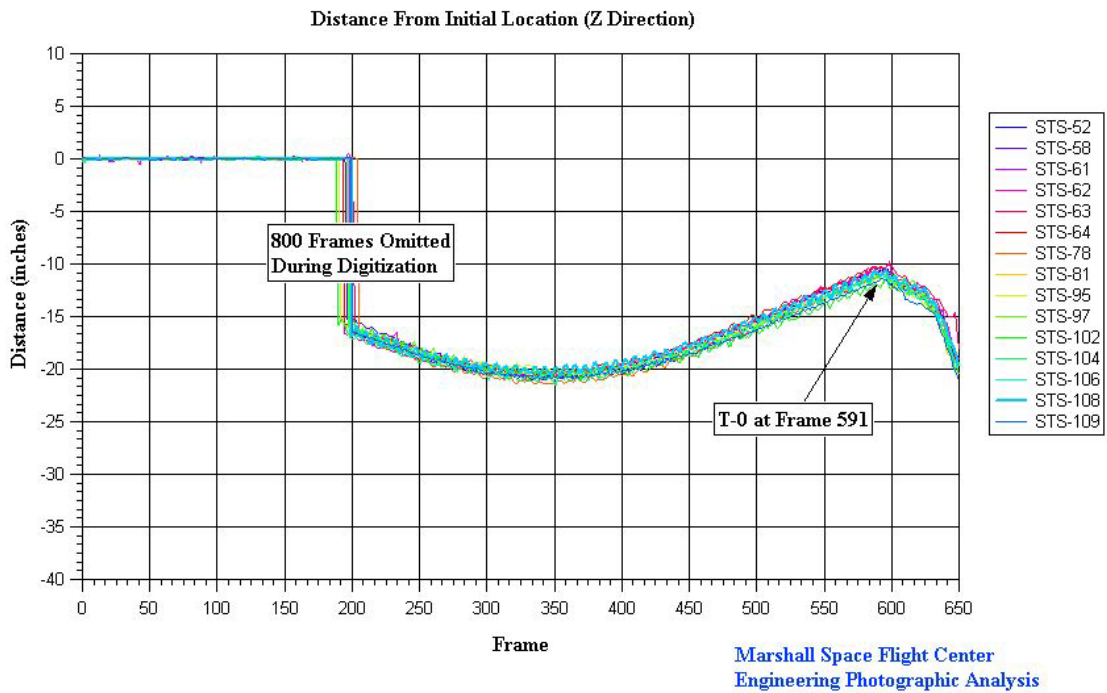
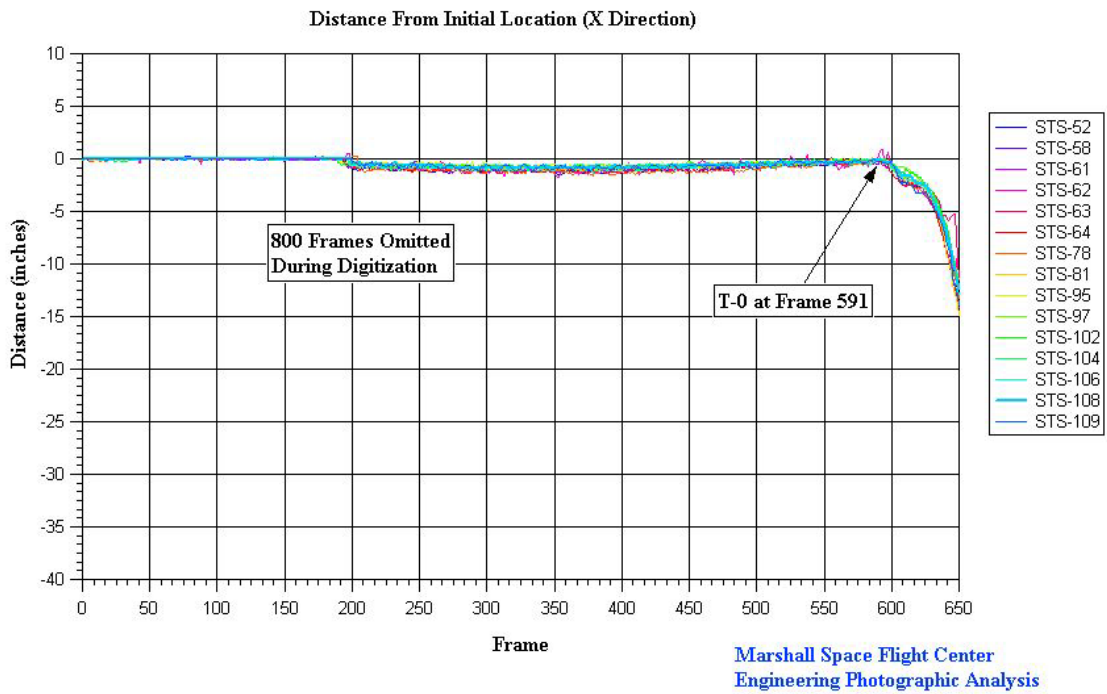
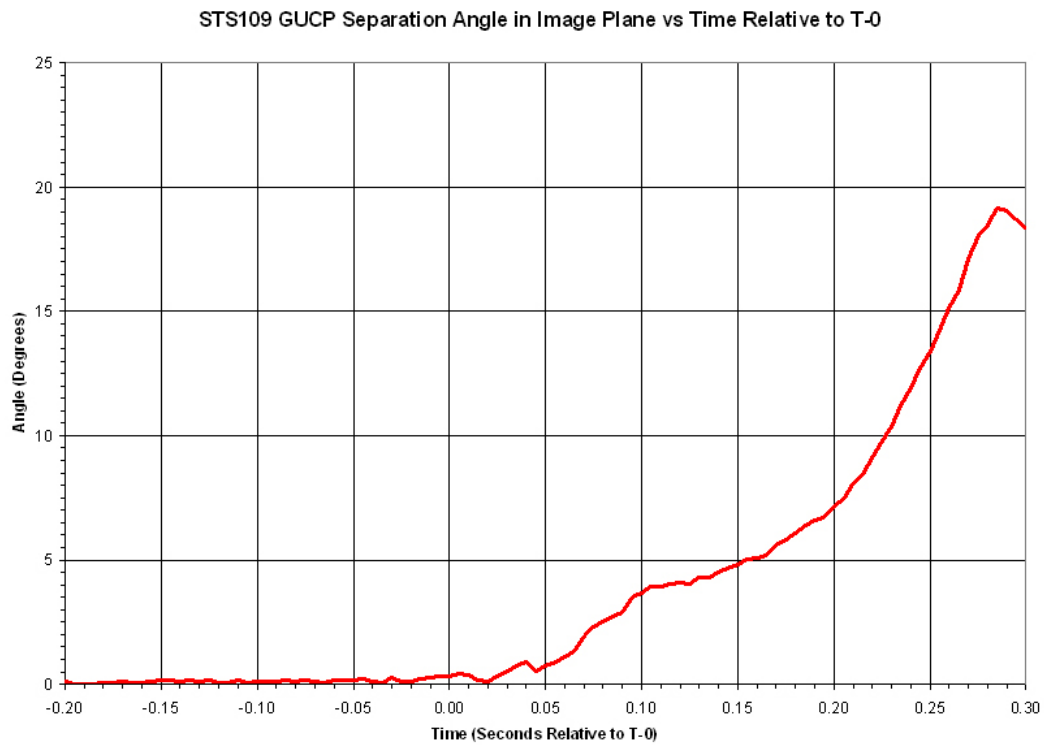
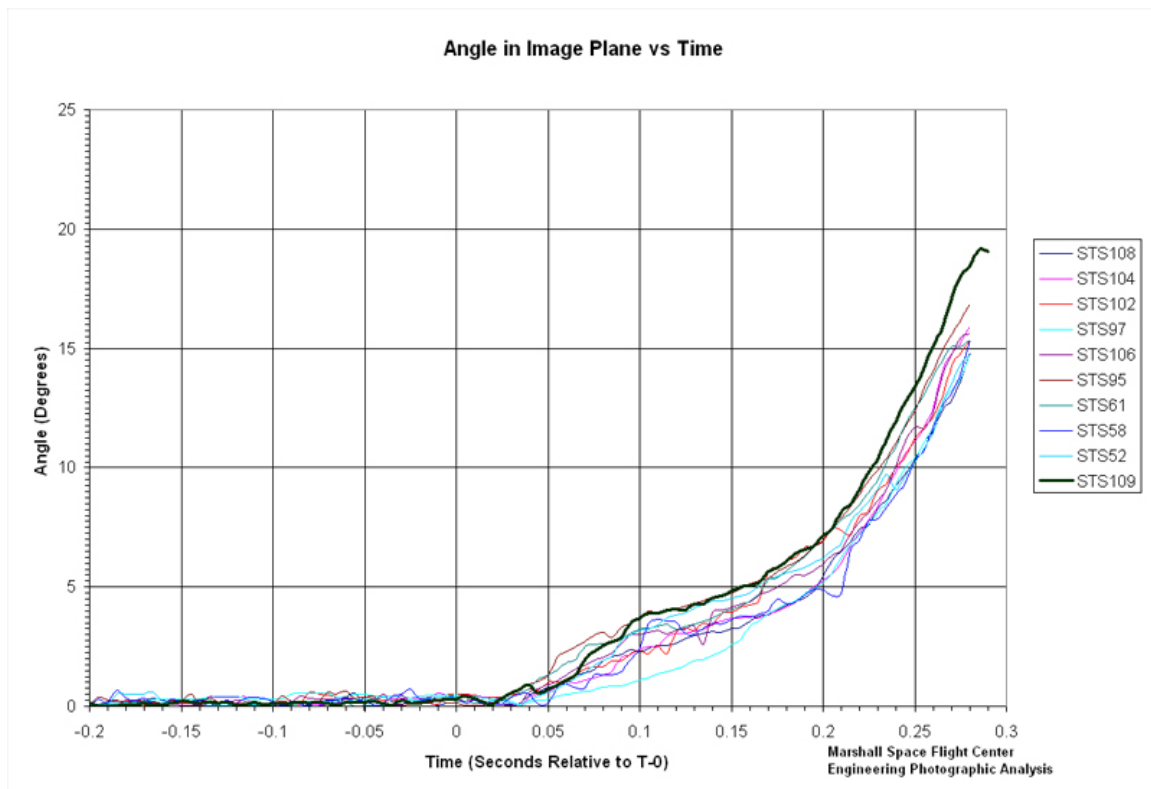
Work continued for the GH2 Vent Arm analysis for mission STS109. Analysis indicates that the GH2 Vent Arm motion in the XZ plane was similar to motion experienced by previous missions, Figure 27, Figure 28, and Figure 29. The 2D separation angle, as measured directly from the image, for the GUCP fall-away from the ET surface also appeared in-family, Figure 30. There are differences between Pad A, mission STS109, and Pad B, all other analyzed missions, which may account for the apparent steeper separation angle noted in the comparison with other missions, Figure 31.
