Screening Li-Ion Batteries for Internal Shorts

Eric Darcy
NASA-Johnson Space Center
Houston, TX USA

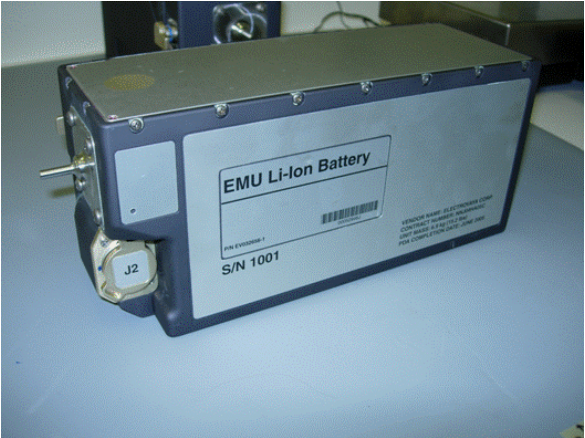
This 20V, 37 Ah spacesuit battery (Fig. 1) consists of 5 cell modules connected in series through a printed circuit board and housed in an aluminum box. This battery has two capped external connectors, J1, which connects to spacesuit electrical bus, and J2, which connects to an external charger, that can rebalance the state of charge (SoC) of each cell module (Fig. 2). Each cell module consists of 5 pouch cells (7.4 Ah) whose tabs are welded to a pair of terminal blocks. This places the 5 cells in parallel electrically (Fig. 3). Each cell is roughly 100x75x9mm, and its electrochemistry consists of graphite, cobaltate, and LiPF_6 salt (Fig. 4). The cell design consists of a single anode and cathode, and two layers of separator laminated together as a $\sim 1\text{m} \times \sim 100\text{mm}$ cell. The substrate foil for the anode and cathode is laminated with active material only on one side. The laminated cell assembly is then z-folded 15 times into a $\sim 9\text{mm}$ thick cell stack. The cell stack is then sealed in a plastic-aluminum laminate pouch material. The five cells are stacked and sealed in a similar plastic-aluminum laminate outer pouch. The fragile assembly is then placed in a mold to be potted with urethane foam to become a solid 37Ah cell module brick. The entire battery assembly, including the cells, is designed and manufactured at ElectroVaya Corp., in Mississauga, Canada. The cell and cell module acceptance is also performed by them, while the majority of the battery acceptance testing is done at NASA-JSC.

Figure 1. Lithium Ion Battery for the Spacesuit.
