Mars Exploration Rover Potentiometer Problems, Failures and Lessons Learned

Mark Balzer*

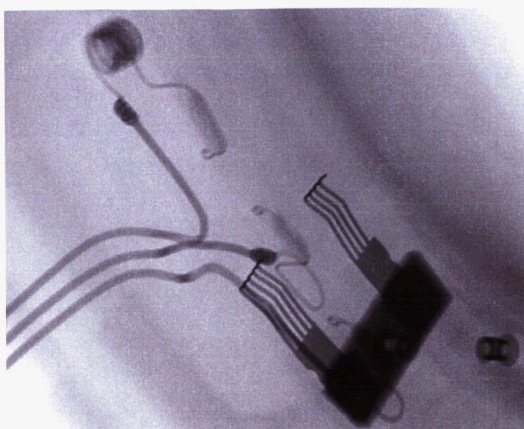
S/N 1017 was still a flight pot, so I was in no rush to tear it apart. Besides, FeinFocus X-ray images of S/N 1017 revealed no internal damage.

Instead I elected to do more testing. The pot was powered with 1.0 VDC across the input wires and the wiper voltage was measured and recorded as the rotor was rotated through 360 degrees in 5 degree increments. The wiper voltage was indeed the required linear function of rotor angle. Next the total resistance was measured and recorded as the rotor was rotated through 360 degrees in 5 degree increments. The total resistance was a smoothly decreasing function of rotor angle (Figure 9).

Figure 9. X-ray image of undamaged wiper and slip ring brushes in HGAG pot
