ISS Internal Active Thermal Control System (IATCS) Coolant Remediation Project - 2006 Update

Russell H. Morrison
The Boeing Company

Mike Holt
NASA Marshall Space Flight Center

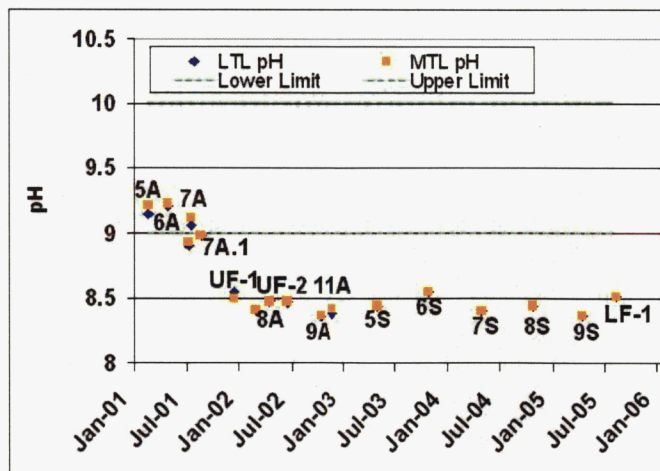
The Teflon flexhoses are permeable to CO₂. The elevated CO₂ levels in the on-orbit atmosphere have caused increases in total inorganic carbon (TIC) to levels on the order of 200 ppm in the coolant. The CO₂ has also caused a reduction in coolant pH, Figure 1. The pH has been fairly stable in the range of 8.4 to 8.5 since flight 8A in 2002.

Figure 1. Coolant pH as measured in coolant samples returned from ISS for ground analysis

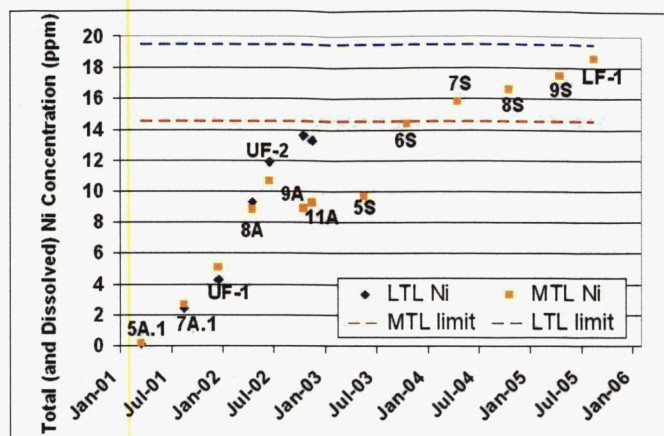
The decrease in pH has been accompanied by an increase in dissolved nickel ions within the coolant as illustrated in Figure 2. Nickel concentration in the coolant has increased at a rate of roughly 2.3 ppm per year since late 2003.

Figure 2. Total (approximately equal to dissolved) nickel concentration as measured in ISS coolant samples returned to ground for analysis

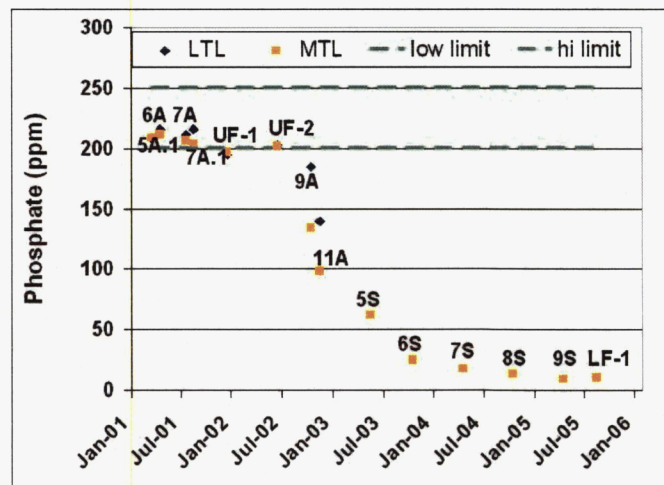
As the pH decreased and the nickel ion concentration increased, the point was finally reached when the phosphate in the coolant began to combine with the nickel to precipitate as nickel phosphate. The falling phosphate concentration is illustrated in Figure 3. It has been fairly stable since bottoming out at about 10 ppm in early 2005.

Figure 3. Phosphate concentration as measured in ISS coolant samples returned to ground for analysis

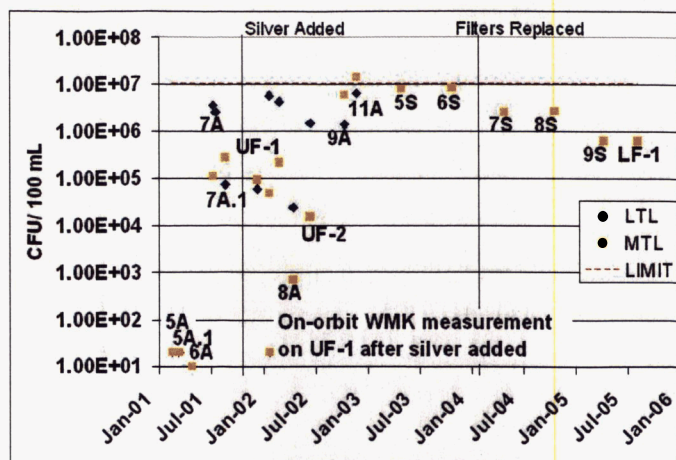
The planktonic microbial population, as measured in coolant samples returned from orbit, has been elevated since flight 7A in July 2001, Figure 4. Counts as high as 1.4E+07 colony forming units (CFU) per 100 milliliters (ml) were measured on flight 11A. There has been a steady slow decline in the counts measured in coolant samples since flight 5S to the current level of 6.3E+05 CFU/ml.

Figure 4. Planktonic microbial heterotrophic plate counts on R2A Agar as measured in ISS coolant samples returned to ground for analysis

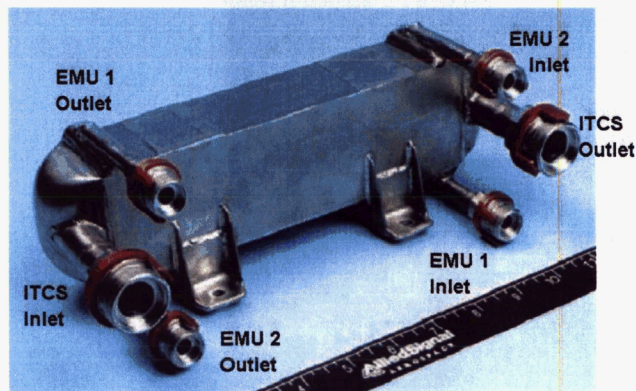
There are many components in the IATCS that contain nickel braze, but only a few represent potential catastrophic hazards. One is the SPCU HX that is installed in the USOS Airlock, Figure 16. This provides cooling for the Extravehicular Maneuvering Unit (EMU) when the crew is in the airlock. On the IATCS side of that HX, the pressure is normally 40 to 60 psia but can be as high as 115 psia. The maximum allowable pressure on the EMU side is about 30 psia. The EMU side is not protected by a relief function at this time and, should it over-pressurize, the likely failure point is in the liquid cooled undergarment worn by the crewmember underneath the Extravehicular Activity (EVA) suit. There are times in the normal procedures when the crewmember is attached to the EMU side of the SPCU HX while suited up and at vacuum. A rupture of the undergarment at that time could result in up to one gallon of IATCS coolant spilling into the suit. The risk then is that the crewmember will inhale the coolant and drown. The corrosion study team predicted that the nickel braze layer in a normal SPCU HX can be penetrated in about 4 years at pH 8.3 [5]. For that reason, the Airlock SPCU HX was replaced on March 15, 2005 with a spare unit that had undergone a second braze cycle and was expected to have a life in excess of 50 years.

Figure 16. SPCU HX

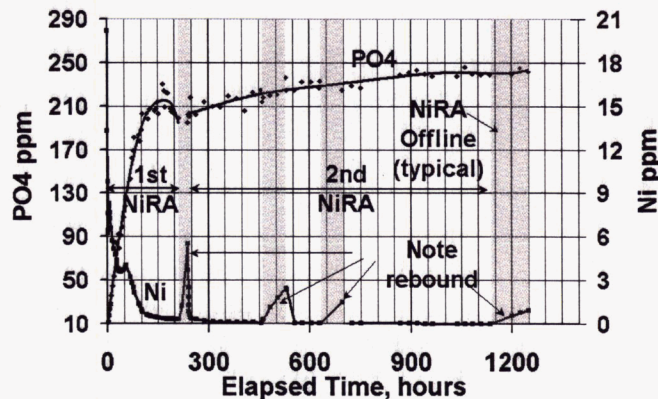
The IATCS coolant working group has performed extensive experimentation and perfected the application of a chelating resin produced by DOW Chemical for the removal of nickel ions from the IATCS coolant. A recirculating bench test of the NiRA performed in 2003/4 demonstrated its effectiveness at reducing nickel concentration, Figure 21. As the nickel concentration drops, nickel phosphate crystals distributed throughout the test bed were observed to re-dissolve and phosphate concentrations returned to their pre-precipitated levels. Subsequent bench testing proved the effectiveness of additional resin treatments for maintaining a constant pH during NiRA implementation. Ground NiRA units have been produced for experimentation and to support nickel

Figure 21. Recirculating bench test results of NiRA showing nickel removal (green) and phosphate re-dissolution (orange)

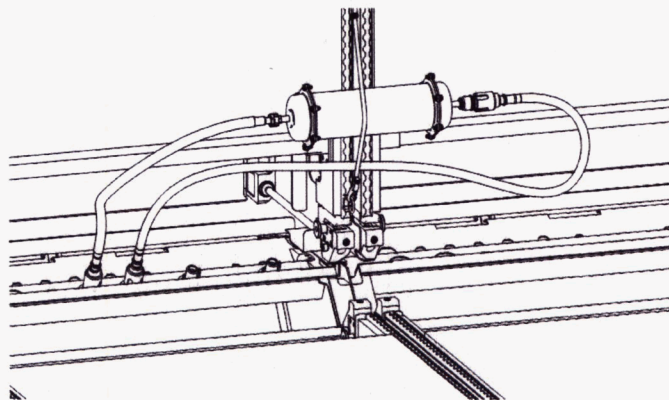
Figure 22. NiRA canister installed in US Lab

ion removal from the Node 2 cooling systems while it is processed at the NASA Kennedy Space Center (KSC). Flight units have been delivered to NASA KSC and are scheduled to be carried to orbit on flight 12A.1, Figure 22.

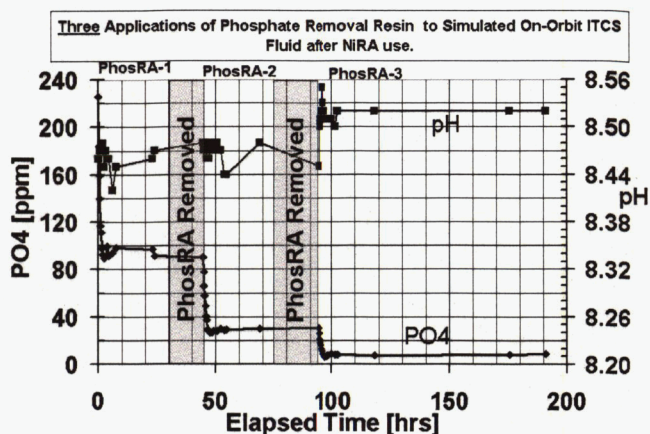
Phosphate was added to the coolant primarily as a corrosion inhibitor for the stainless steels in the system. Corrosion testing has shown that this is unnecessary at the pH levels the coolant is experiencing. Its propensity for forming nickel phosphate at the equilibrium pH of the on-orbit coolant has provided motivation to eliminate it. Future elements of the IATCS will be launched with coolant that has no phosphate. In order that payload racks may be freely moved between the US Lab and other on-orbit elements, and to preclude future nickel phosphate formation, it will be necessary to remove the phosphate from the US Lab coolant. To that end, the program has completed an extensive development program to adapt a DOWEX ion exchange resin to this application. Figure 23 illustrates its effectiveness at the bench level for phosphate removal without perturbing pH. Two flight units of the PhosRA, based on the NiRA

Figure 23. Bench scale testing of PhosRA resin showing phosphate removal effectiveness and ability to maintain a relatively constant pH

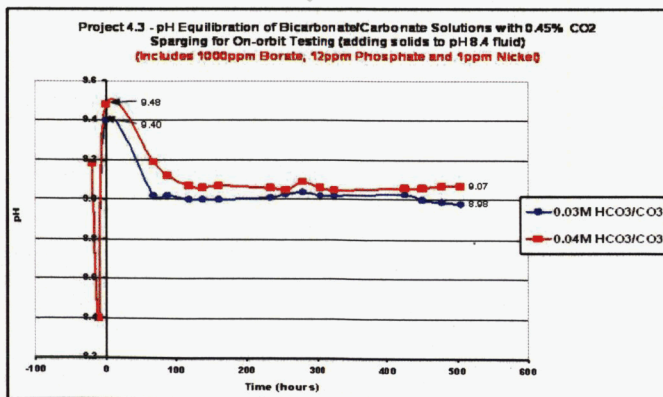
Laboratory testing has shown that addition of 0.04 equimolar carbonate / bicarbonate buffer to the 1000 ppm borate buffer already in the on-orbit US Lab coolant after pre-treatment with NiRA and PhosRA will raise the pH to about 9.5. Equilibration of the coolant with the CO₂ in the US Lab atmosphere will lower the pH to between 9 and 9.1, Figure 24.

Figure 24. 0.04 molar carbonate / bicarbonate (red) pH vs time while being sparged with air/CO₂ at US Lab concentrations

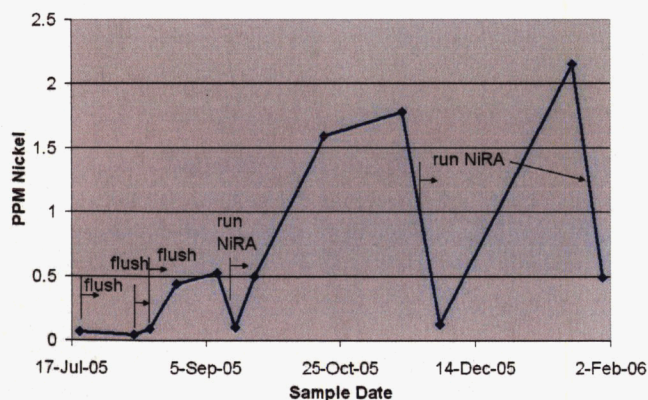
It was decided to fill Node 2 with SSP 30573 Rev. B fluid modified to delete the silver and phosphate and lower pH to 8.4 by sparging with CO₂ in April 2005. Glutaraldehyde at 200 ppm was added for microbial control. This coolant is circulated through the Node 2 loops 5 days per week, 8 hours per day using ground support equipment pumps as ground operations allow. Ground NiRA units are installed to remove nickel. The intent is to remove as much intermetallic nickel from Node 2 on the ground as possible, so as to minimize the necessity to use NiRAs in Node 2 on orbit. All hardware life predictions for Node 2 are based on this chemistry and are not an issue. Figures 27 and 28 show the nickel concentrations in the Node 2 loops since this coolant has been added. These demonstrate the effectiveness of the NiRA for controlling nickel in actual flight hardware loops at the on-orbit pH conditions.

Figure 27. Node 2 LTL Nickel

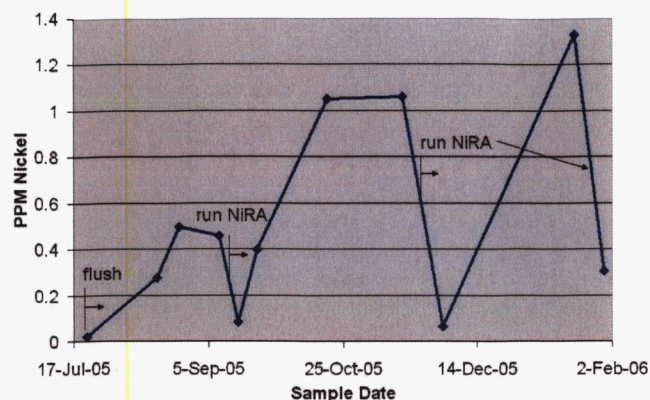
Figure 28. Node 2 MTL Nickel
