GT2006-90833

CERAMIC MATRIX COMPOSITE VANE SUBELEMENT BURST TESTING

ABSTRACT

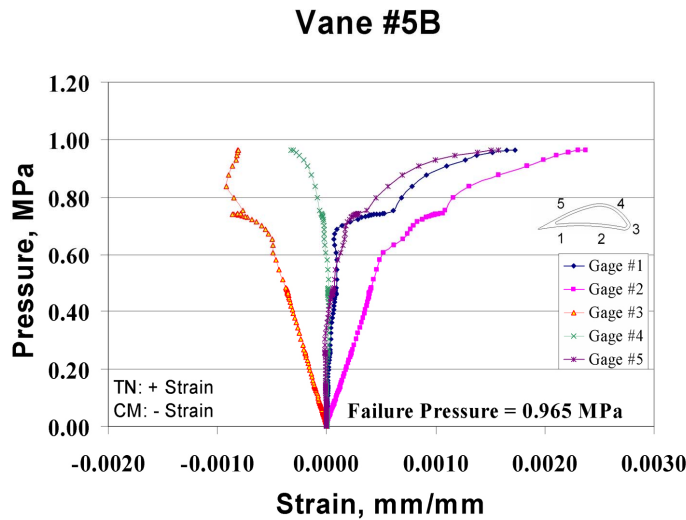
Figure 9 – Typical Pressure vs Strain, 5Gage Specimen

Typical pressure versus strain plots appear in Figure 9, for five strain gage specimens, and Figure 10, for two strain gage specimens. All specimens exhibited linear or near linear behavior during initial loading. Generally, deviation from

linear response occurred either as a softening of stiffness or in the form of a jump with decreased stiffness between strains of 0.0004 and 0.001. Non-linear behavior continued, as a combination of these two mechanisms, until failure.
