Pitting and Repair of the Space Shuttle's Inconel[®] Honeycomb Conical Seal Panel

During return to flight servicing of the rudder speed brake (RSB) for each Space Shuttle Orbiter, inspectors discovered numerous small pits on the surface of the #4 right hand side honeycomb panel that covers the rudder speed brake actuators. Shortly after detection of the problem, concurrent investigations were initiated to determine the extent of damage, the root cause, and to develop a repair plan, since fabrication of a replacement panel is impractical for cost, schedule, and sourcing considerations. This paper describes the approach, findings, conclusions and recommendations associated with the investigation of the conical seal pitting. It documents the cause and contributing factors of the pitting, the means used to isolate each contributor, and the supporting evidence for the primary cause of the pitting. Finally, the selection, development and verification of the repair procedure used to restore the conical seal panel is described with supporting process and metallurgical rationale for selection.

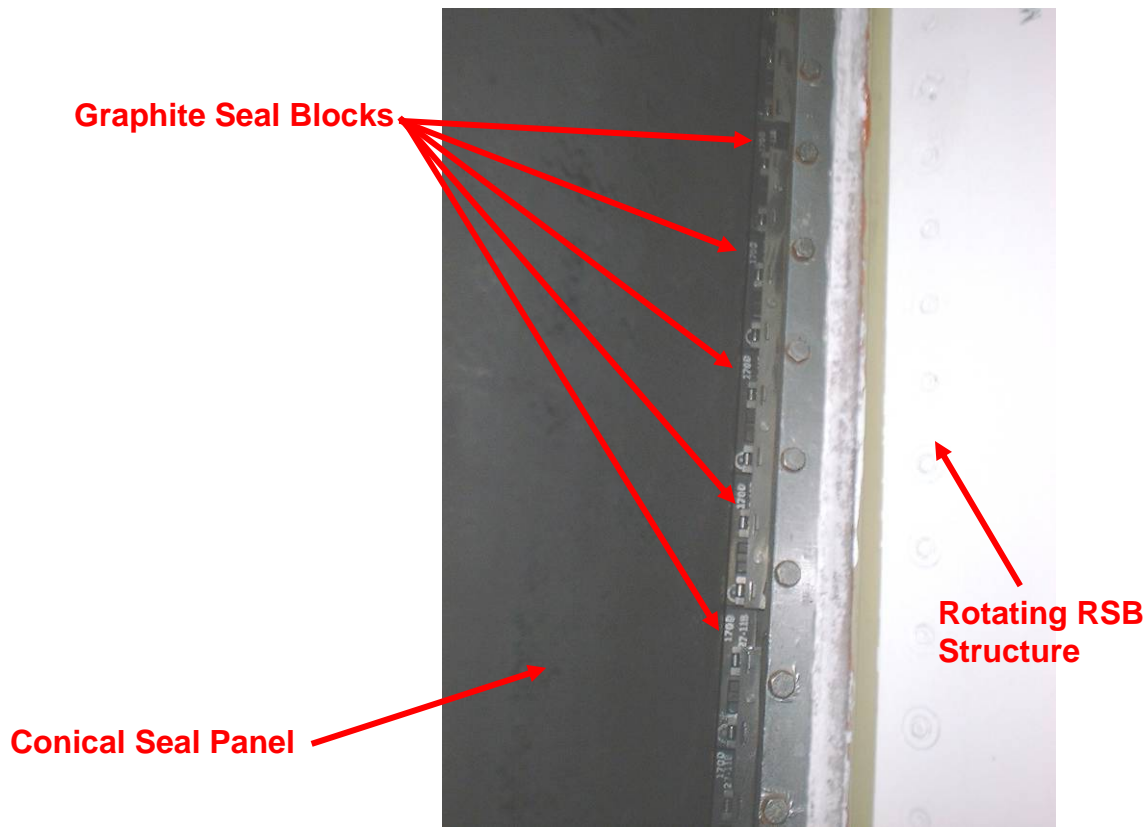
Figure 5. Photograph of Interior of OV-103 RSB graphite seal block assembly.

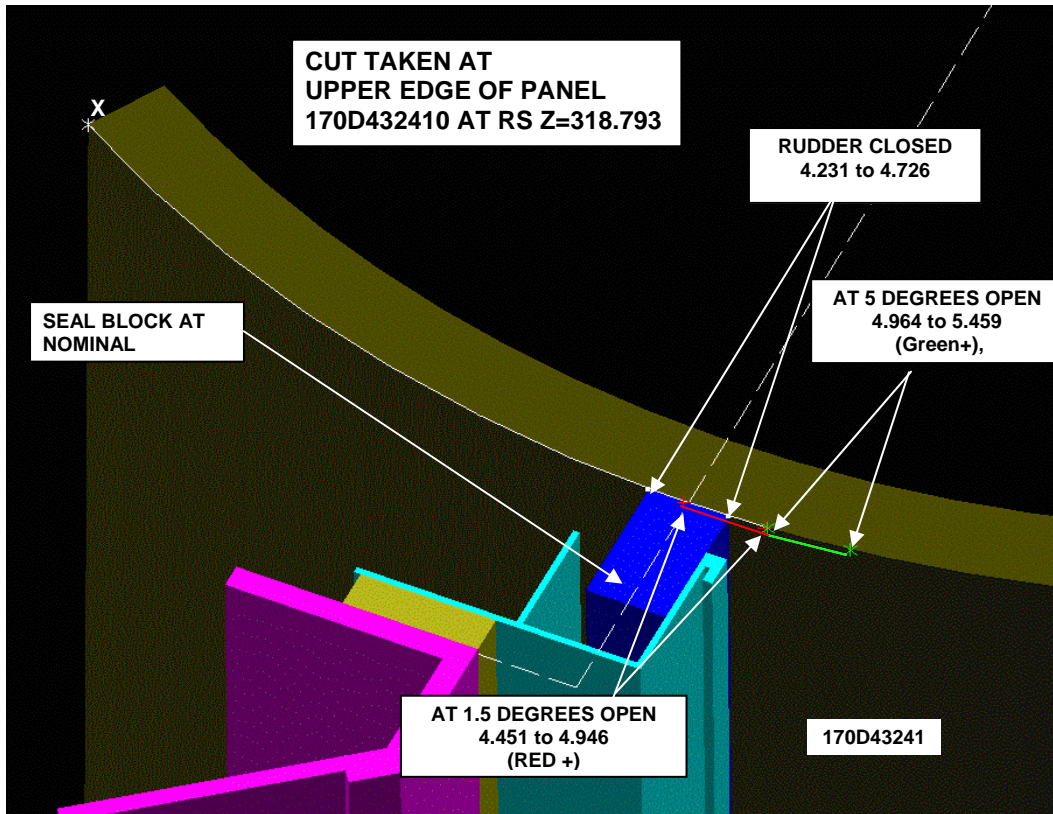
The project reviewed the ground history and the flight protocol to determine the location of the graphite seal blocks on the conical seal as a function of time. The evaluation of the ground operations concluded that the RSB was at the nominal 5 degree open position 65 percent of the time, at the nominal 1.5 degree open position 20 percent of the time, and the nominal 98 degree position 15 percent of the time. The RSB remains in the trail/parked, nominal 1.5 degree, position throughout a majority of the flight cycle. The placement of the graphite seal block for the nominal 1.5 and 5 degree positions can be seen in Fig. 6. The worst case (measured depth) pitting corresponds to the area where the graphite seal blocks are in contact with the conical seal at the nominal 1.5 degree trail/parked position.

Figure 6. Computer generated drawing of RSB seal position as a function of RSB position.
