# The Mars Climate Sounder In-Flight Positioning Anomaly

Bruno M. Jau\* and David Kass\*

## Abstract

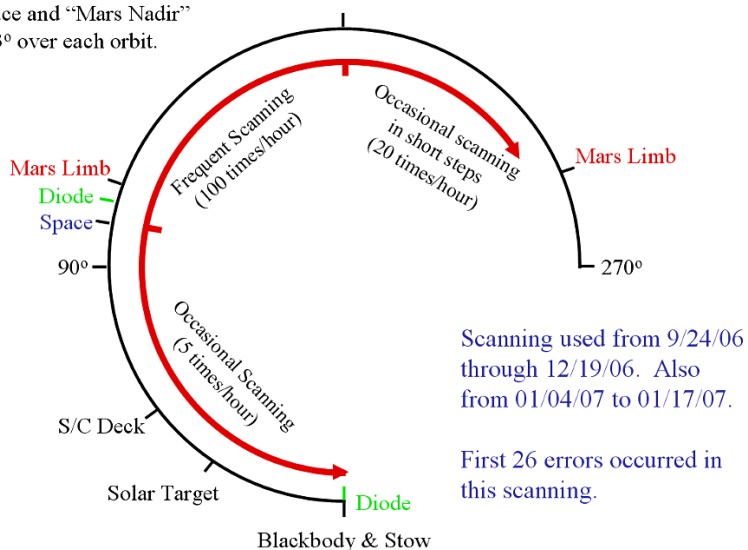
**Figure 1: Range of Elevation Actuator Operation**

The scanning is described in detail in [4], but a few locations played a key role in understanding the anomaly. A graphical representation of the range and frequency of scanning is shown in Fig. 1. The first position is the stow position. This is with both actuators pointing at 0°. This is a sun safe position that is used when the instrument is powered off, since even a momentary exposure of the telescopes will destroy the focal plane. It is also used when the instrument is standing down from normal operations.

When the elevation is at 0°, the telescopes are staring at the built-in black body, one of three calibration views. The second calibration target, the solar target, is at an elevation of 37°. The standard MCS scan observes the blackbody about five times per hour and the solar target once an hour.

Limb, Space and “Mars Nadir” drift by ~3° over each orbit.

Most of the time, MCS is pointed at the limb (or horizon) of Mars to acquire the key observations of the Martian atmosphere. The location of the limb varies by ~2° due to the elliptical nature of the MRO orbit, but is centered on the elevation actuator position of 111.2°. Tied to the limb location is the space view (the third calibration point). It is 8.4° above the limb (or a nominal elevation angle of 102.8°).

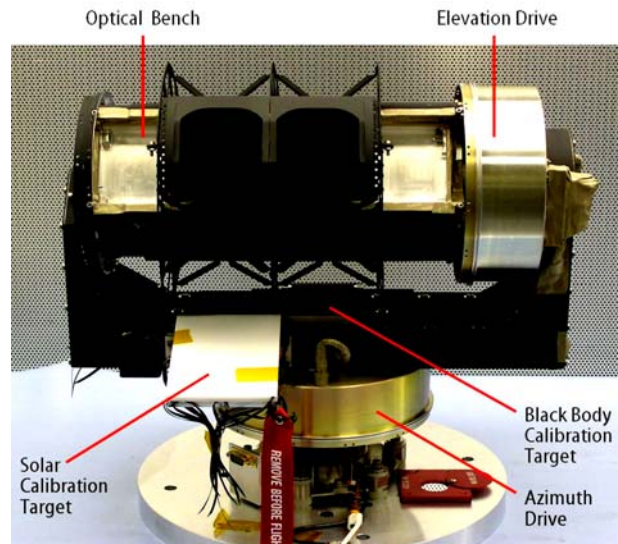
**Figure 3: Instrument without Blankets**

Figure 3 shows the instrument without its thermal blankets. It consists of an optical bench assembly, two rotational drives that provide azimuth and elevation scanning capabilities, and a yoke-like structure that serves as structural support for the upper part of the instrument. All motor control electronics resides on three individual electronics boards located inside the yoke structure.

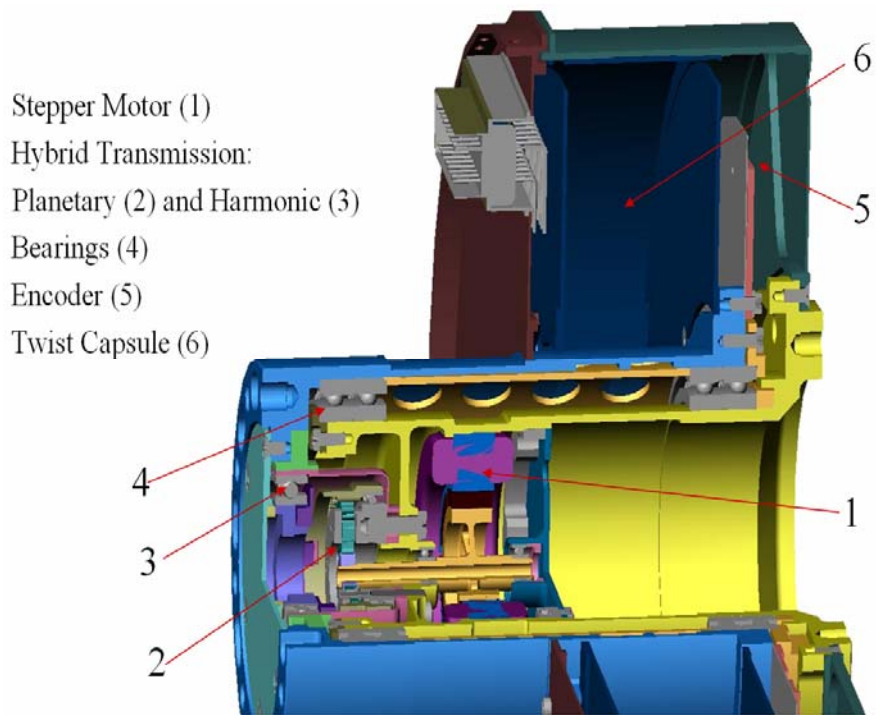
**Figure 6: The Azimuth Actuator/Twist Cap**

A disk (near item 5 in Fig. 6) normally blocks the light path between the light emitting diode (LED) and the phototransistor. The disk has one slot, allowing diode light to pass through when the slot passes a sensor. The slot size had to be made quite large (approx. 1-1/2mm) for sufficient light from the diode to pass through. Therefore, the sensor is triggered for up to six steps during each diode passage.

If the actual joint position does not correspond to the commanded position (due to whatever causes the anomaly), the position error has to be at least 3 steps away from the commanded position to be detected by this sensor system, having a 6 step diode trigger window. A sensed error reading is recorded but not reported immediately, thus complicating the error analysis (see "Error Discussion" below) Error cancellation is also possible if a subsequent error is in the opposite direction. However, if the flight software detects an error, it will reinitialize (see below), even if a subsequent error (hysteresis effect), should cancel it out.
