Failure of the Trailing Umbilical System Disconnect Actuator on the International Space Station

Abstract

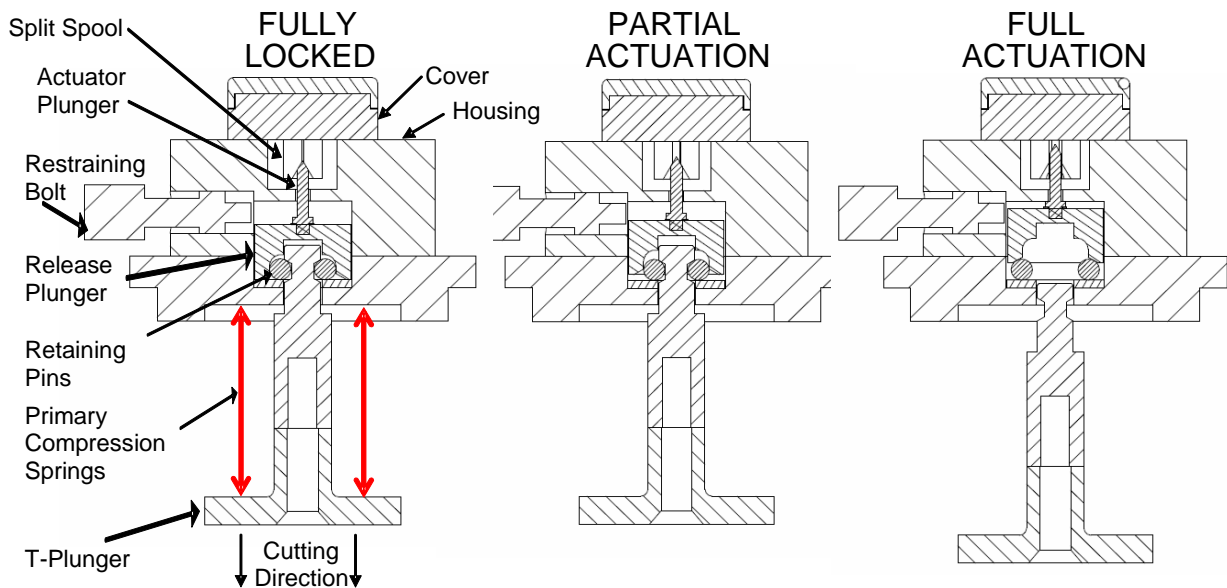
Figure 3. Actuation of the TUS Disconnect Actuator

The Restraining Bolt is used to prevent inadvertent actuation during launch vibration. In Figure 3, the crew interface is on the left side of the Restraining Bolt, and the shaft to the right of the threads blocks the Release Plunger if the TDA is actuated inadvertently. By design, a small gap is intended between the fully engaged Restraining Bolt and the Release Plunger. This ensures that the Split Spool locks the mechanism and the Restraining Bolt is truly a redundant feature. During initial on-orbit activation, the Restraining Bolt is removed, which arms the TDA. The "Fully Locked" view of Figure 3 shows the TDA armed with the Restraining Bolt backed out from the launch position.

This movement was confirmed on-orbit when the Restraining Bolt required higher than expected torque during removal due to the load being applied to the bolt from the Release Plunger. This was seen again when the Restraining Bolt would not re-engage during failure troubleshooting years later, since the Release Plunger had shifted and created interference. When the gap is closed, the TDA is placed into a partially actuated state that changes the load path within the mechanism. After the failed TDA was returned to the ground, a CAD model was created using the as-flown component dimensions. This model further illustrated the gap and clearly showed a discrepancy in the design assembly drawing.

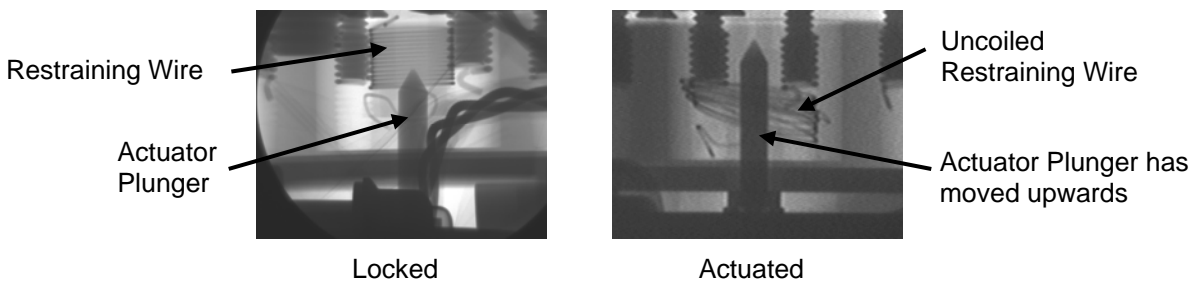
Figure 4. TDA X-Rays

To actuate the mechanism, current is passed through the fuse wire, causing it to weaken and break under load. The Restraining Wire is then free to uncoil; thus it quickly unwinds from the Split Spool (see Figure 4). With the Restraining Wire out of the load path, the spring under the Release Plunger pushes the Actuator Plunger, splitting the two halves of the Split Spool apart as the Actuator Plunger moves upwards. With the Release Plunger clear, the Retaining Pins are forced outward by the T-plunger. Without the Retaining Pins in the load path, the Primary Compression Springs are able to release their stored energy, pushing the T-plunger through the assembly, and driving the cutting blade into the TUS cable. See the actuation sequence in Figure 3.
