Space Shuttle Orbiter Atlantis Liquid Oxygen Prevalve Detent Roller Cracking Investigation

Abstract

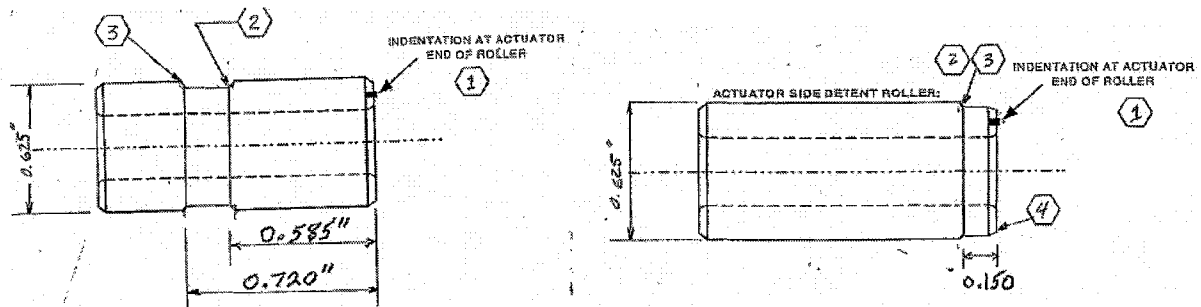
Figure 7 Drawings showing how these rollers are machined to avoid discrepant areas on valve visors

Some rollers within the fleet are specially machine to have a smaller diameter in specific locations. The purpose of this process is to reduce the effect of rough or high spots on that specific valve's visor. During inspections after the initial flights of the OV-103 and OV-104, several rollers in the LH₂ and LO₂ systems were found with rough gouges at specific distances along their lengths. Borescope and visual inspections concluded these instances of damage were due to wear associated with the high spots on each visor. Two rollers showing this type of damage are shown in Figure 6. Examples of specially machined rollers with gaps to avoid a high spot on a discrepant visor are shown in Figure 7.
