NASA/TM—2009—000000

# Mitigation of EMU Glove Cut Hazard by MMOD Impact Craters on Exposed ISS Handrails

*Shannon Ryan  
Lunar and Planetary Institute  
Johnson Space Center, Houston, Texas*

*Eric L. Christiansen  
Johnson Space Center, Houston, Texas*

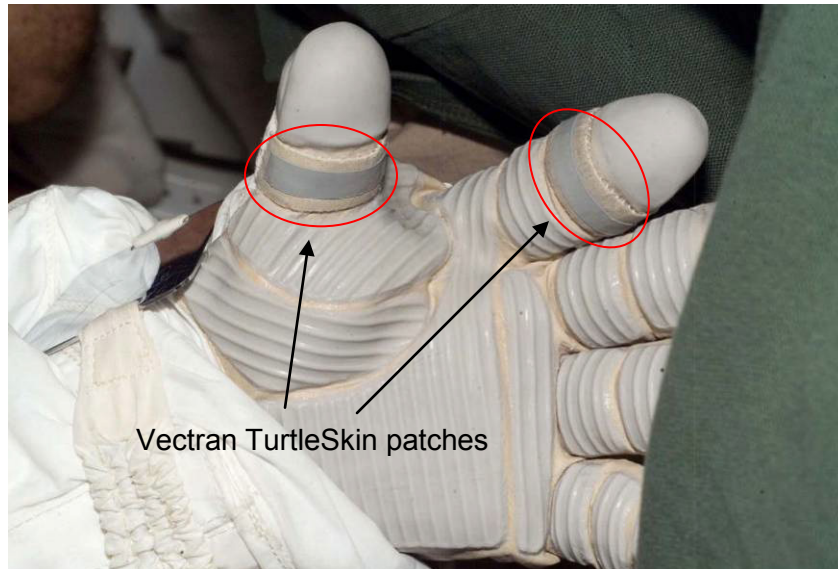
Redesign efforts are currently underway to increase the resilience of EMU gloves. For example, during STS-124 a modified EMU glove was used that incorporated Vectran TurtleSkin® patches on areas of high wear (lower part of thumb and upper part of index finger). TurtleSkin is a protective fabric material commonly used in protective vests for knife protection given its extremely tight weave, providing superior protection against cuts and penetration than common woven fabrics. The modified glove is shown in Figure 4. Preliminary analysis of glove damage suggested that the modification was successful in reducing glove damage.

**Figure 4:** Vectran TurtleSkin reinforcement patches added to index finger and thumb of the Phase VI EMU glove for STS-124.

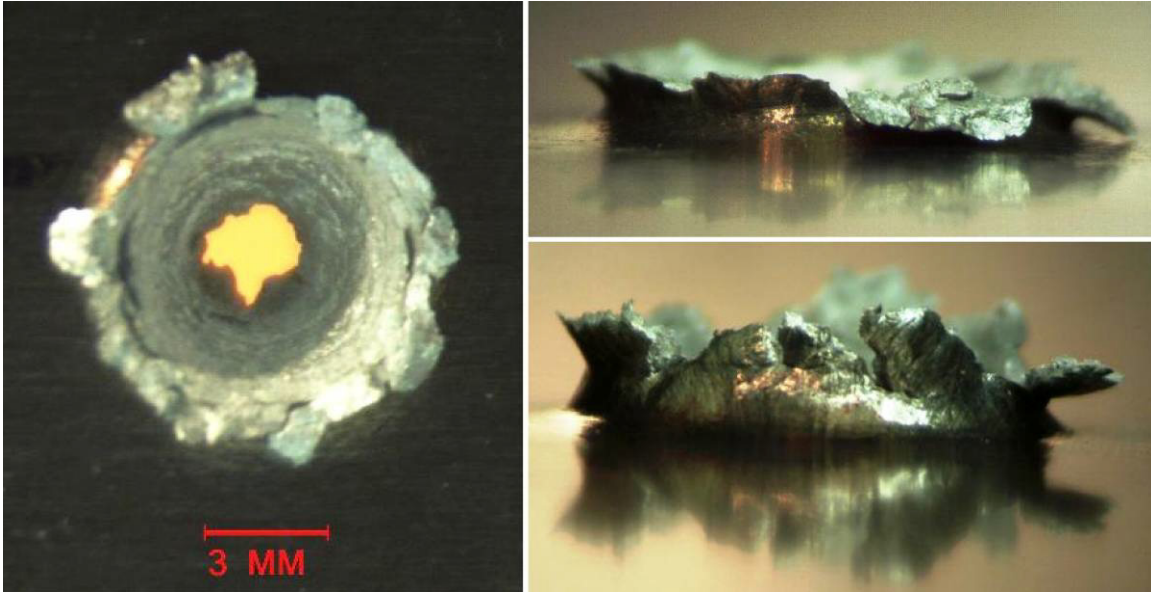
Previous studies [4][5] have investigated the formation of sharp edged crater lips induced by the impact of MMOD particles on International Space Station (ISS) handrails as a possible source of glove damage. In [4] hypervelocity impact tests were performed on metal plates representative of materials and thicknesses used for ISS handrails. Crater lip profiles were evaluated for impacts using 1 mm diameter spherical projectiles at ~7 km/s with varying angles of obliquity (0°-75°). For non-penetrating impacts, the authors recorded crater lip heights of 0.1-1.4 mm. For penetrating impacts, front and rear-side crater lip heights of up to 1.4 mm and 3.1 mm respectively were measured. Sharp-edges were observed on the crater lips in both non-penetrating and penetrating impacts, an example of which is shown in Figure 5.

**Figure 5:** Crater formation in a 0.48 cm thick Al6061-T6 plate impacted at normal incidence ( $0^\circ$ ) by a 0.15 cm diameter Al2017-T4 sphere at 6.86 km/s. Left: front view; Right: side view of entry (upper) and exit (lower) crater lips.

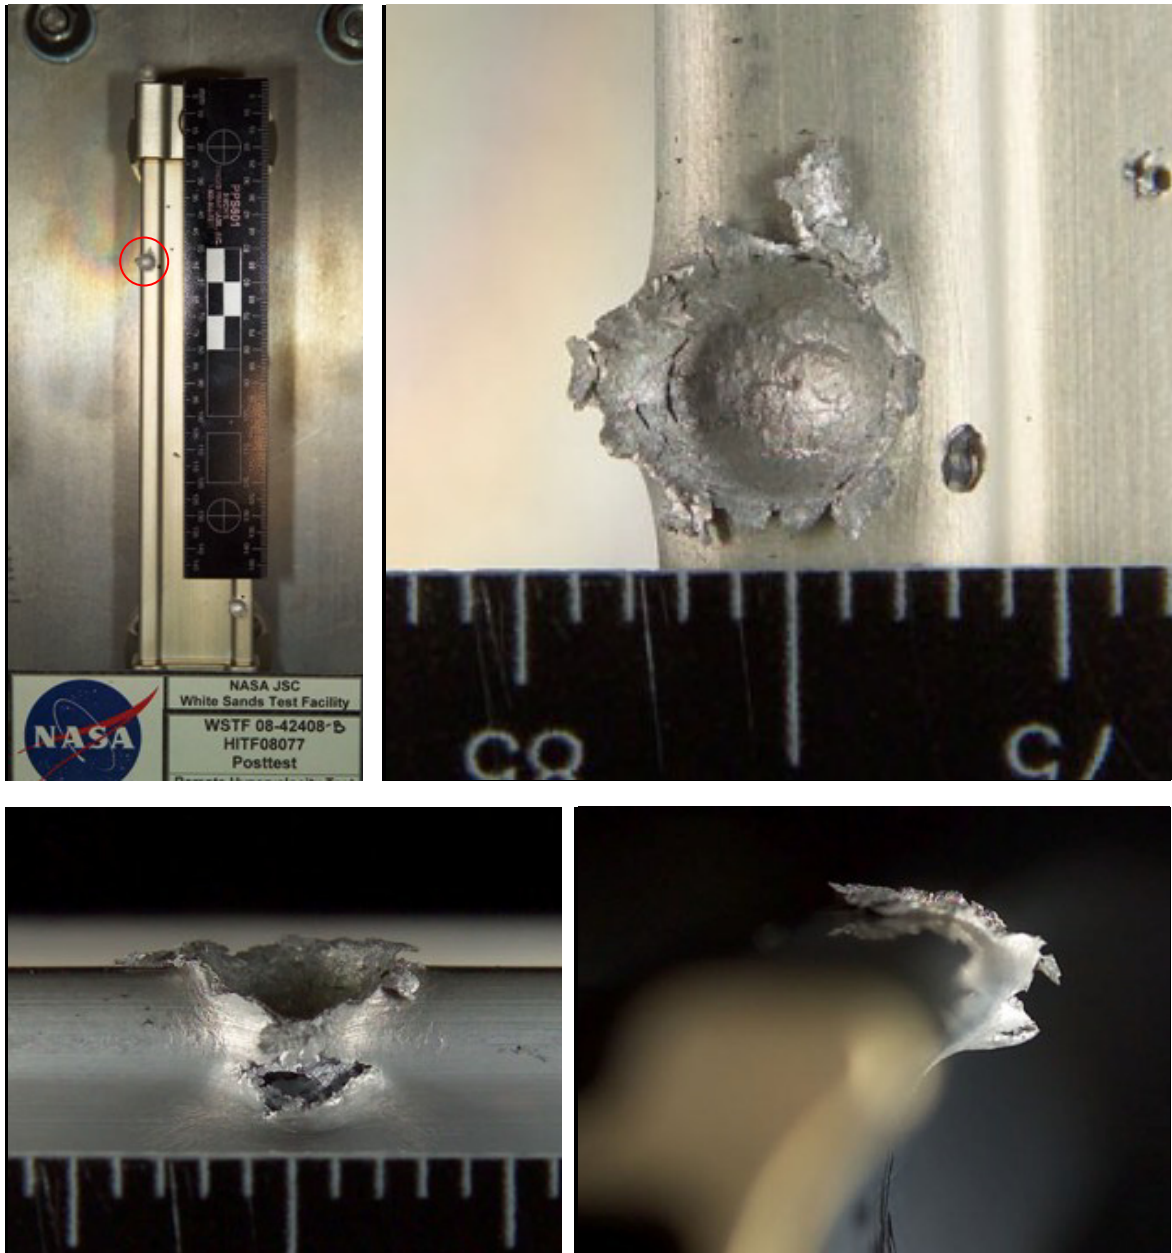
The handrails were subject to normal and oblique (45°) impact by aluminum spheres 1.0 - 2.0 mm in diameter at ~6.8 km/s. Different impact locations on the handrail structure were considered in order to replicate a wide range of possible in-flight scenarios. For non-penetrating impacts, the authors recorded crater lip heights of 0.9-2.0 mm. For penetrating impacts, front and rear-side crater lip heights of up to 2.0 mm and 4.6 mm respectively were measured. Sharp-edges were observed on the crater lips in both non-penetrating and penetrating impacts, an example of which is shown in Figure 7.

**Figure 7:** Crater formation on an ISS handrail resulting from oblique (45°) impact of a 1.0 mm diameter Al2017-T4 sphere at 6.94 km/s. Maximum crater lip height measured as 1.7 mm on side of handrail.

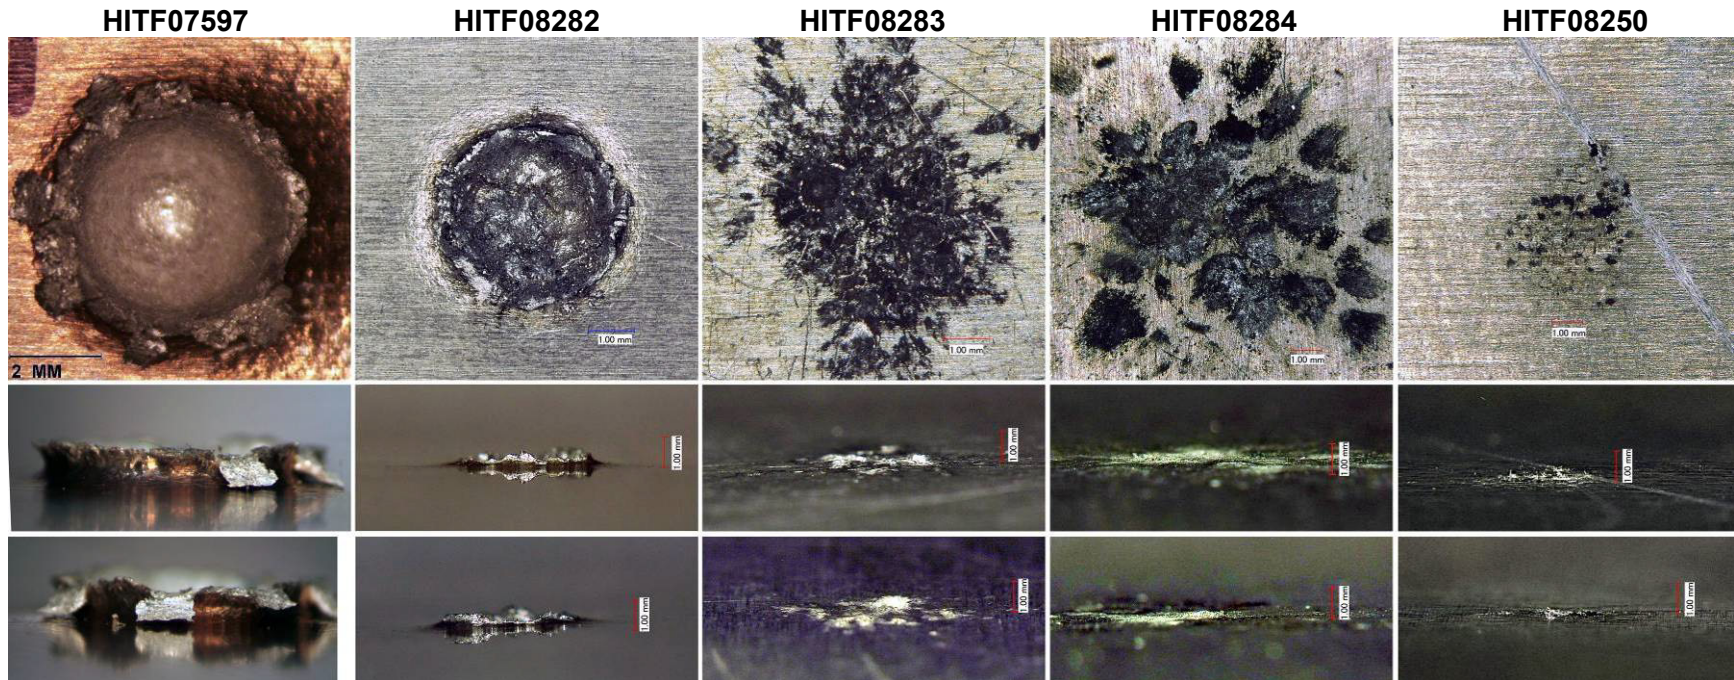
0.8 mm. All four overwrap configurations were capable of reducing the crater depth and diameter, however only the beta-cloth and OCF+BC overwraps were effective at reducing the crater lip height. A comparison between the impact generated crater in the unshielded handrail (from [4]) and the handrails protected by the overwraps is given in Figure 25 (for normal tests) and Figure 26 (for oblique tests). In Figure 25 it can be seen that the impact crater in the unshielded handrail is clearly defined with a well-formed lip protruding above the plate surface. Of the overwrap configurations, only the FRSI target shows a cleanly formed crater with a discernable lip, however the diameter of the crater and height of the protruding lip are clearly smaller than that of the baseline target. The target plate wrapped by the OCF+BC configuration shows a small crater and a number of deposits and dents in the target surface, however there is very little protrusion above the target plane. The target plates covered with the DROCF+BC and Beta-cloth configurations show no discernable crater formation, only some discoloration and shallow denting of the target surface. For the oblique tests a clearly formed crater and protruding crater lip is observed on the unshielded target. Cratering of the target plate is apparent on the FRSI target as well as that of the OCF+BC and DROCF+BC. Only the Beta-cloth configuration appears to have prevented formation of any impact crater. On the FRSI target the crater is cleanly formed and has a clearly observable lip protruding from the target surface. For the OCF+BC configuration, multiple overlapping craters can be observed, suggesting fragmentation of the projectile during impact with the overwrap. Although the craters are cleanly formed, there is minimal protrusion of material above the target surface. A similar damage profile is seen on the DROCF+BC target, which shows a single cleanly formed crater (albeit with diameter significantly smaller than that of the unshielded target) with minimal protrusion of the crater lip above the target surface. The Beta-cloth configuration shows minimal damage to the target plate.

Of the four configurations tested, the beta-cloth overwrap proved the most effective at limiting damage to the underlying metallic handrail. Given the comparatively large areal density of the beta-cloth overwrap ( $0.463 \text{ g/cm}^2$ ), this is to be expected. The only configuration to show a significant amount of damage to the outer surface was the FRSI overwrap in the oblique impact tests. It is important to note, however, that this damage was predominantly a removal of the silicon rubber coating and did not significantly reduce the thickness of the underlying Nomex felt. Considering the compressed thickness of the four overwrap configurations is larger than the measured crater lip height in all 8 impact experiments, all four overwrap configurations must be considered successful in preventing contact between EVA crewmember gloves and MMOD cut hazards (for the specific impact conditions and handrail configuration tested).

**Figure 25:** Comparison of impact crater profile in an unshielded Al 6061-T6 plate (representative of an ISS handrail) and overwrap shielded plates impacted by a 1.0 mm diameter Al 2017-T4 sphere at  $6.77 \pm 0.22$  km/s with normal incidence ( $0^\circ$ ).

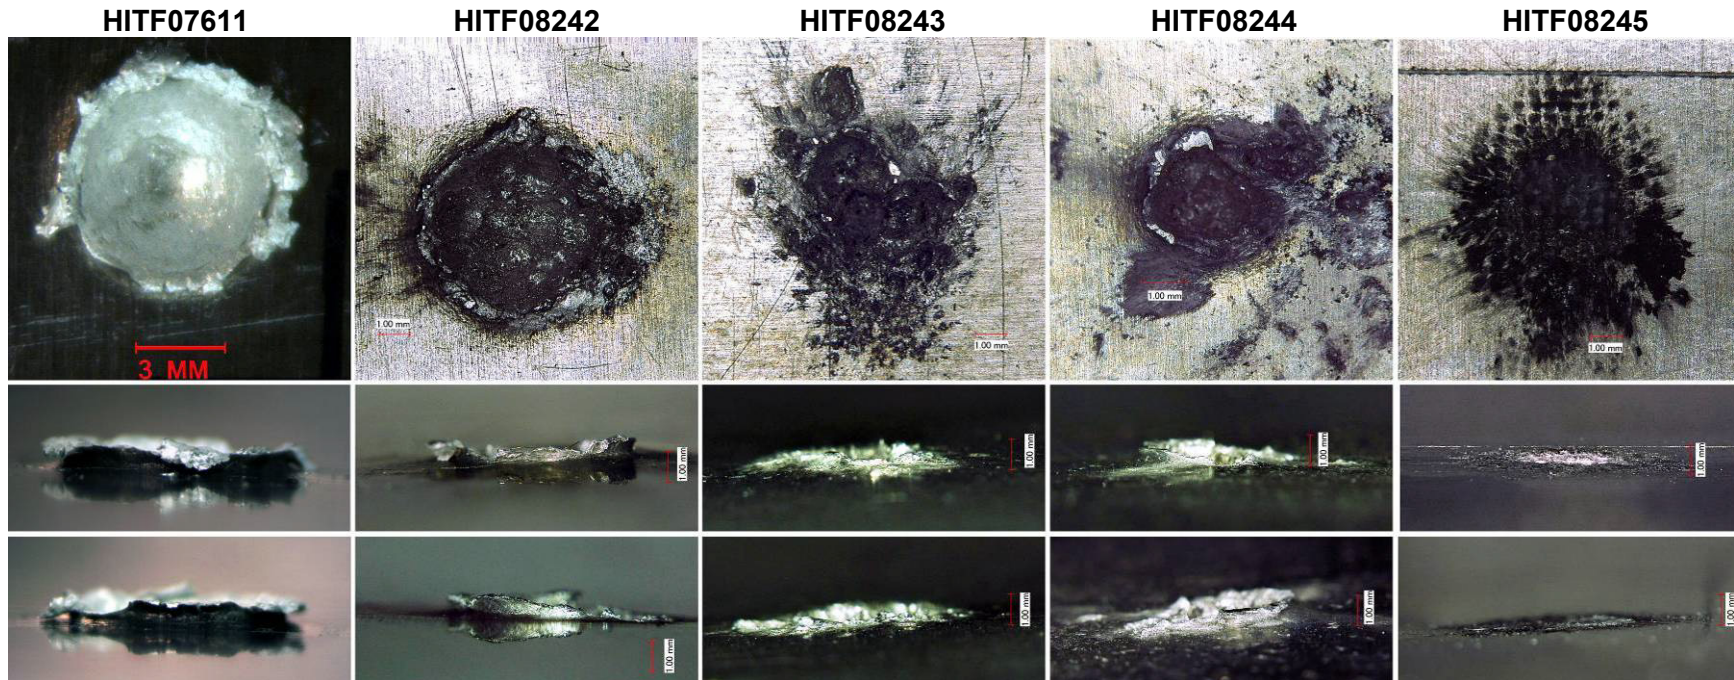
**Figure 26:** Comparison of impact crater profile in an unshielded Al 6061-T6 plate (representative of an ISS handrail) and overwrap shielded plates impacted by a 1.5 mm diameter Al 2017-T4 sphere at  $6.94 \pm 0.09$  km/s with oblique incidence ( $45^\circ$ ).

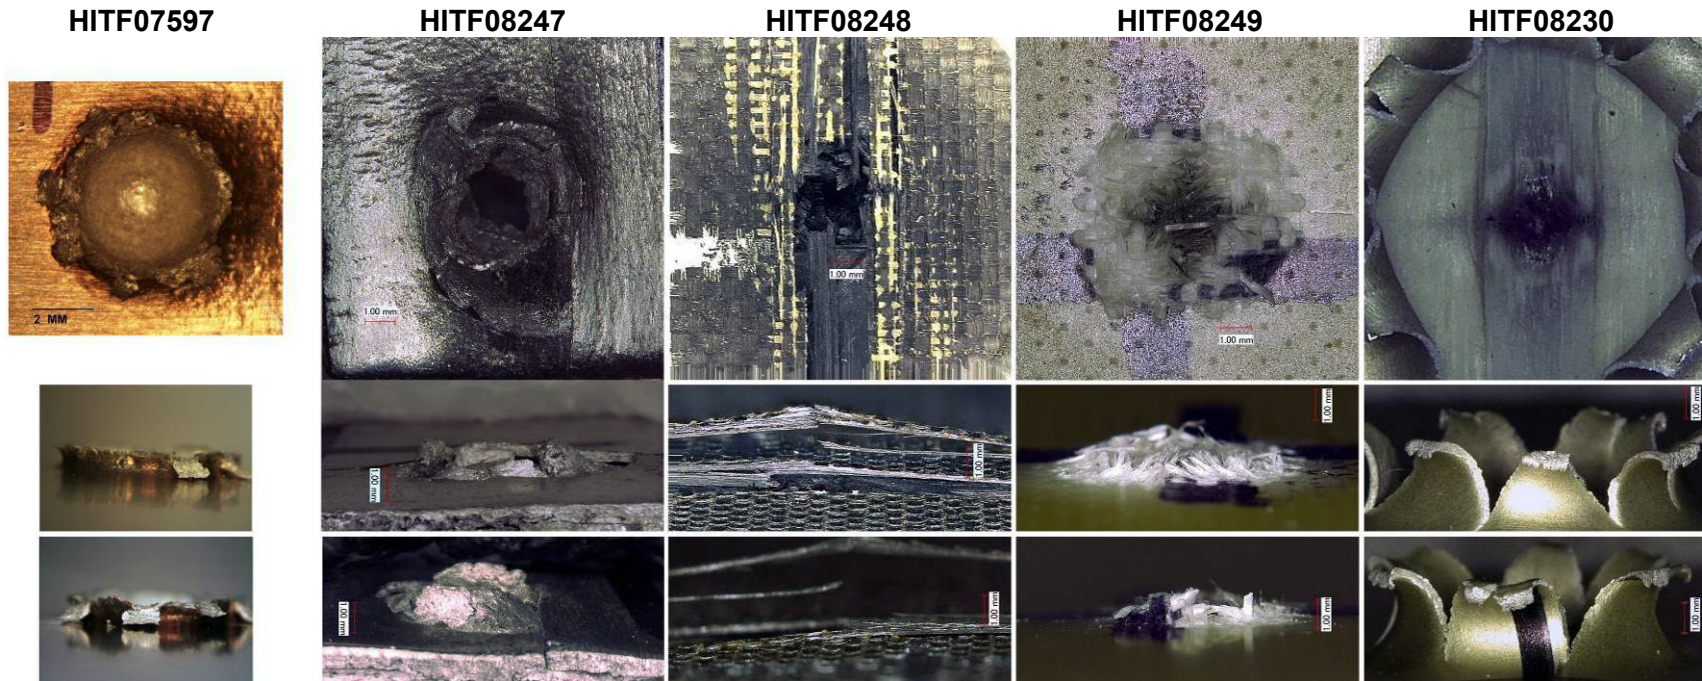
In Table 5 two of the four alternate materials tested were shown to reduce the lip height of MMOD craters compared to a baseline Al6061-T6 target when impacted by a 1.0 mm diameter Al2017-T4 sphere at normal incidence with a velocity of  $6.91 \pm 0.08 \text{ km/s}$ . There was no measurable crater lip on CFRP laminate, however there was a degree of surface spallation about the impact site, including groups of single ply thick material that protruded above the target surface. Surface spallation is limited by the outer plain weave fabric layer (compared with a u.d. outer layer), however it is still considered that the surface spallation may be hazardous to EMU gloves (potentially more so than the sharp crater lips on metallic handrails). As such, this particular CFRP laminate is considered unsuitable as a potential material for ISS handrails. By increasing the number of fabric layers on the outer surfaces of the laminate, the degree of surface spallation can be reduced, which should be considered in any further investigations. The other material to decrease the height of the cut hazard was the NP500CR fiberglass.

For this material, fractured and delaminated fibers protruded above the target surface. Unlike the CFRP laminate however, these protrusions were not rigid, nor did they extend beyond the local impact site (see Figure 27). In this case the epoxy material has been completely removed from the protruding fibers, and it is considered that the puncture hazard of the fibers is minimal. The Glare fiber metal laminate provided the largest crater lip height, 3.3 times that of the original Al6061-T6 material. As shown in Figure 27, the outer aluminum layer of the FML peeled back from the glass/epoxy composite layer during impact, resulting in a large crater diameter with very sharp petalled edges. By modifying the laminate layup such that there are a number of glass/epoxy layers on the outer surface, it is expected that the height of any damage features would be reduced. The Nextel 610/pure Al metal matrix composite provided similar performance (in terms of protruding crater lip height) to that of the baseline Al6061-T6 handrail. The Nextel fiber reinforcements act to increase the stiffness of the pure aluminum and reduce its ductility. A more brittle material would be expected to form smaller protruding crater lips given the reduced plastic flow sustained in the material.

In Figure 27, it can be seen that the outer layer of the MMC laminate fractured about the impact site, resulting in almost no protrusion above the target surface. Indeed, the 1.0 mm lip height was measured from the laminate 2<sup>nd</sup> layer. The MMC target is penetrated by the projectile, resulting in a rear side damage feature with a maximum height of 2.45 mm. Given that the thickness of the MMC was less than that of the baseline handrail target, this does not indicate a decreased performance. However, for penetrating impacts using a 1.5 mm and 2.0 mm projectile on the baseline Al6061-T6 target in [4], a maximum exit hole lip height of 1.9 mm was measured (normal impact). Therefore, it is considered that the performance of the Nextel 610/pure Al MMC is worse than that of the baseline aluminum alloy.

**Figure 27:** Comparison of impact crater profile in a simulated ISS aluminum handrail and alternate handrail materials (from left to right: Al 6061-T6, MMC, CFRP, fiberglass, FML) impacted by a 1.0 mm diameter Al 2017-T4 sphere at  $6.91 \pm 0.08$  km/s with normal incidence ( $0^\circ$ ).
