Helios High Altitude Long Endurance Mission Mishap

Photos Taken of HP03-2 26 June 2003

Photos Taken of HP03-2 Following Mishap

The Helios Mishap Root Causes

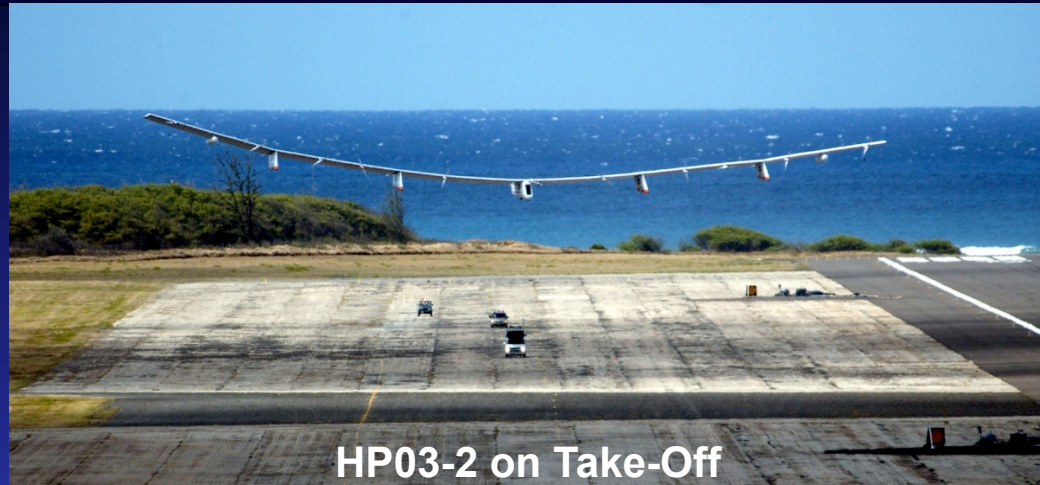
HP03-2 on Take-Off

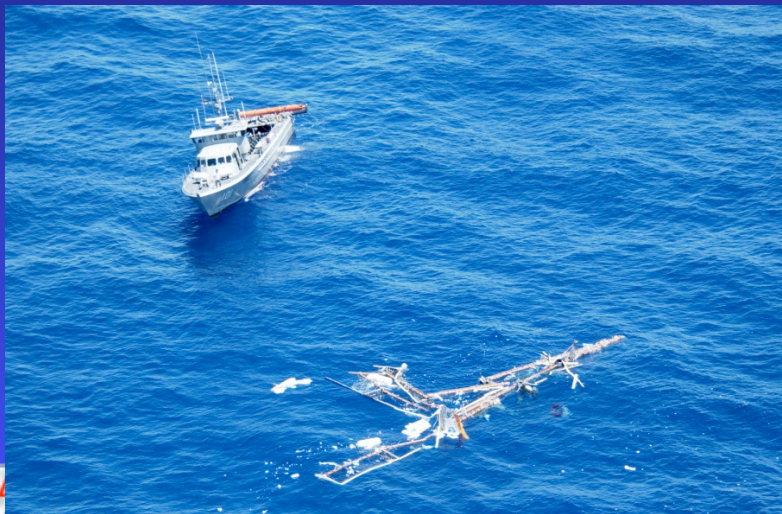
- The aircraft entered a series of severe pitch oscillations, resulting in some failure of the secondary structure, and could no longer generate lift
- The aircraft impacted the water within the confines of the Pacific Missile Range Facility, approximately 10 miles west of the island of Kauai
- Except for loss of the aircraft, no property damage, environmental hazard, or personnel injury resulted from the mishap
- Approximately 70% of the aircraft (by weight) was recovered, including the two hydrogen fuel tanks

Helios Upon Impact with the Ocean
