NASA/TP-2009-214769

A Summary of NASA and USAF Hypergolic Propellant Related Spills and Fires

B. M. Nufer
Kennedy Space Center, Florida

June 2009

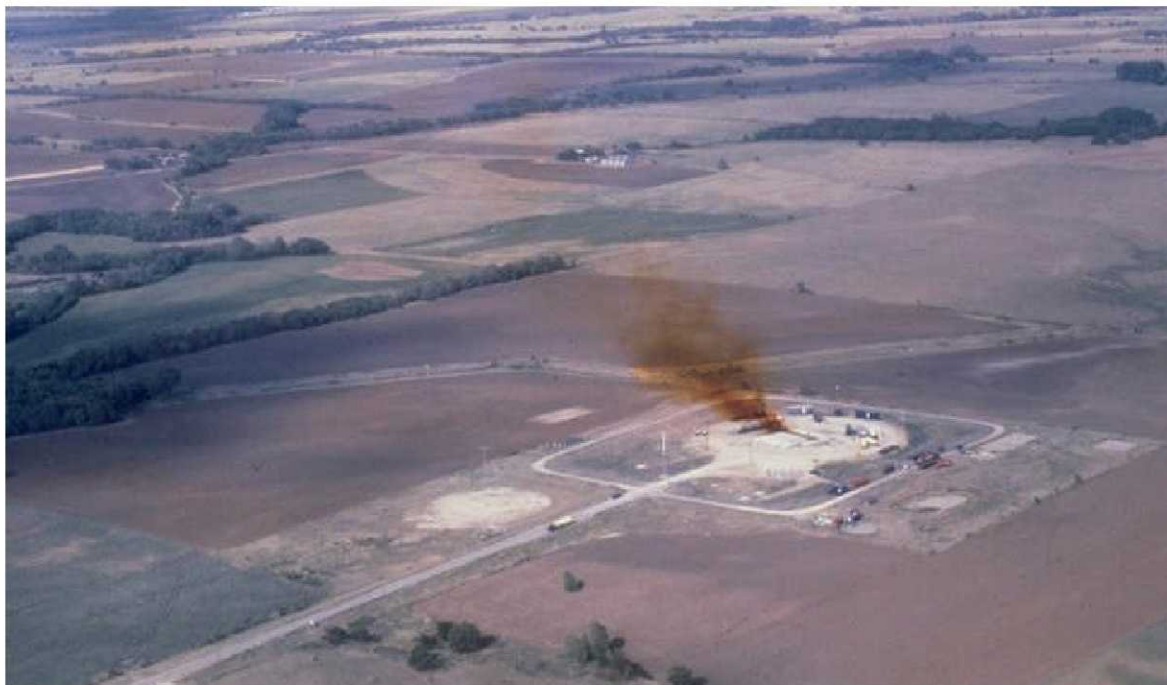
Very high concentrations of NO₂ vapors traveled from the silo into the connecting cableway to the blast lock area, which was located just outside of the control center where several personnel were located (see Figure 5-1). All the personnel located in the blast lock area managed to escape the vapors by exiting through the access portal at ground level. The personnel in the control center would normally be isolated from the silo; however, two technicians involved in the spill opened the airlock door to try and obtain assistance for their supervisor who was in need of immediate medical attention. The two technicians and four other control center personnel then evacuated through the emergency escape hatch, once they realized the immediate danger of the situation. The nearby town of Rock, Kansas had to evacuate about 100 people as a result of the vapors that were escaping from the silo (see Figure 5-2).

Figure 5-2: Aerial View of N_2O_4 Vapor Cloud Coming from Missile Silo 533-7

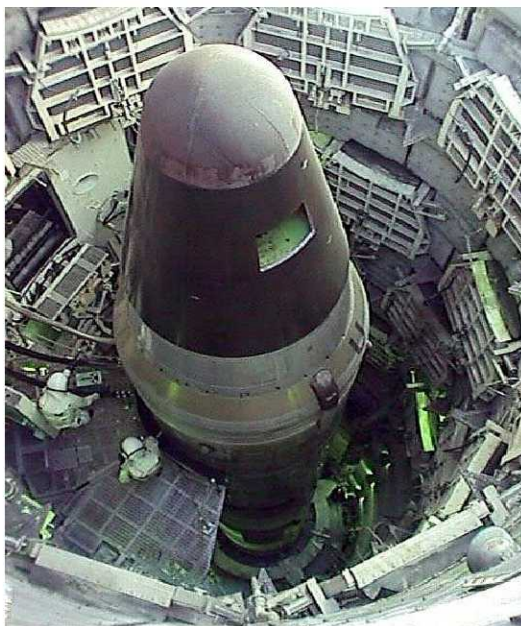
At about 6:30 PM on September 18, 1980, an airman was conducting a maintenance operation on level two (see Figure 7-1) of the underground silo when he accidentally dropped a large wrench socket. The standing platforms were hydraulically-controlled, flip-down structures with a rubber boot mounted between the platform and the rocket. The socket fell hitting the standing level two platform and bounced in the direction of the rocket where it slipped through the small gap between the rubber boot (which had become pliable over the years) and the Titan II rocket. It fell about 70 feet before hitting the thrust mount near the base of the rocket. The socket then bounced into and ruptured the stage one fuel tank (proximate cause). Approximately 11,140 gallons of A-50 drained into the bottom of the silo. Fuel vapors heated up the silo and caused the pressures in the non-ruptured propellant tanks to rise substantially.

Figure 7-1: Technicians Working on Fold-Down Platform in Titan Silo Level 2

- All workers should wear a belt with lanyards to attach tools
 - Operational human error is, therefore, the root cause
- Cloths should be placed on the platforms to prevent tools from bouncing off the metal

- The Titan II missile silo platforms should be renovated to increase safety
- The training and qualification program was insufficient prior to the incident (a root cause)

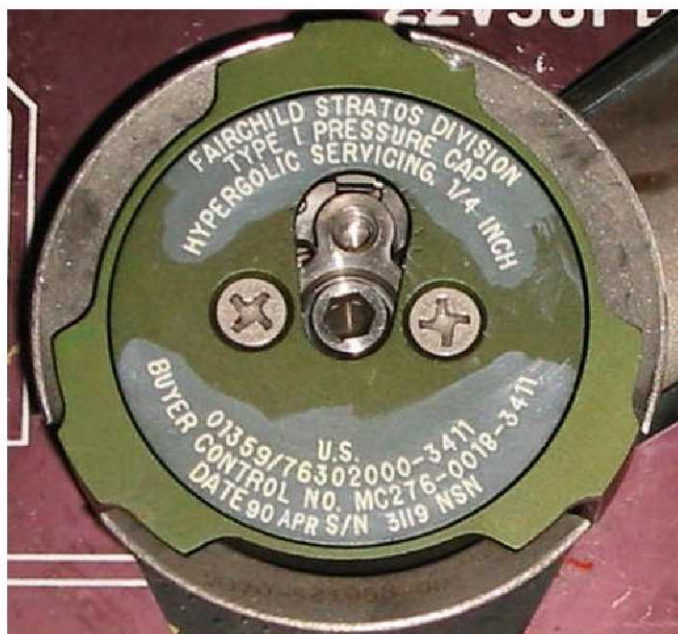
Figure 8-2: Fairchild ½-inch Flight Cap

During the MD338 flight cap installation procedure, on roughly July 14, 1981, the work step correctly called for the installation of a ½-inch cap (part number MC276-0018-2811) onto the AHC. The cap that was staged for installation was the misidentified ¼-inch cap. When a ¼-inch cap is placed onto a ½-inch

AHC, the dimensions of the stem allow for the actuation of the ½-inch AHC poppet (reference Figure 29-1 for an illustration of this) if the proper force is applied to the cap and poppet. This is exactly what happened. An oxidizer vapor release was reported when the technician tried to install the ¼-inch cap (proximate cause). The root causes are human error, improper configuration management, and improper vehicle design. The original flight cap design should not have enabled this type of incident to occur. The technician received minor injuries from exposure to NO₂ vapors. Close attention needs to be paid to the identification of flight caps and other hardware to prevent an event like this from occurring again (which it does on November 4, 1992 at WSTF).

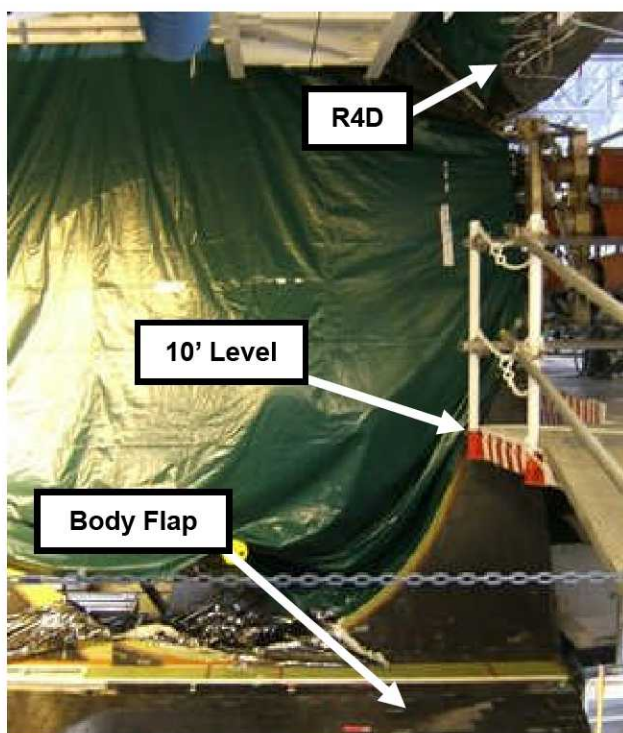
On May 24, 1985, while preparing for the removal of R4D (down-firing thruster on the Space Shuttle right pod) from OV-099, there was an MMH spill in OPF1 on the 10-foot level west side. R4D was being removed as a result of an in-flight anomaly related to a heater failure on the thruster. The manifold had been drained of its propellant and it was thought that a purge through the MD348 line (which connects to the manifold) and out the thruster nozzle purge adapter was sufficient to remove the liquid and most of the fuel vapors. Figure 18-1 shows a purge adapter in a cutaway of a primary thruster nozzle. During the part of the procedure where the purge adapter was being removed, approximately one cup of liquid MMH spilled from the thruster and down onto the body flap (which is illustrated relative to thruster R4D in Figure 18-2). The body flap was partially covered with spill protection sheets. The OPF1 hypergol exhaust fans were activated and the facility was immediately evacuated. It was recorded that some of the liquid MMH had saturated the body flap tile filler bar. It is unknown if the tile had to be removed. Unlike N_2O_4 , which was known to breakdown Koropon primer (from the STS-2 N_2O_4 spill mentioned previously), the effect of MMH on Koropon was not well known in 1985.

Figure 18-2: View of Bottom of Right Pod with Orbiter in OPF

There are three possible proximate causes to this spill. A combination of two or more of the following causes is also possible. The first involves an improper configuration in which the flexhose that was being used for the procedure had previously been utilized for a similar operation on the left pod thruster L1U's manifold. This flexhose was several feet longer than the flexhose that was normally used for the right pod manifold evacuations. It was routed from the R4D thruster purge adapter to the 19-foot level above, then down to the eductor on the 10-foot level. This excessive length in hose may have allowed for a "u-shaped" low point trap to be formed in which liquid MMH could have collected. The second possible proximate cause involved a procedural error made by the engineers on console. The evacuation could have created a pressure differential across the liquid MMH. When the eductor was deactivated and removed, this pressure differential may have pushed the liquid into the thruster chamber. The third possible proximate cause was the liquid had collected in the thruster chamber (see Figure 18-1) and the purge was of insufficient duration to remove all the liquid MMH or the liquid trap may have prevented the vacuum source from evaporating all the residual fuel that remained around the purge adapter. A definitive proximate cause was never determined.

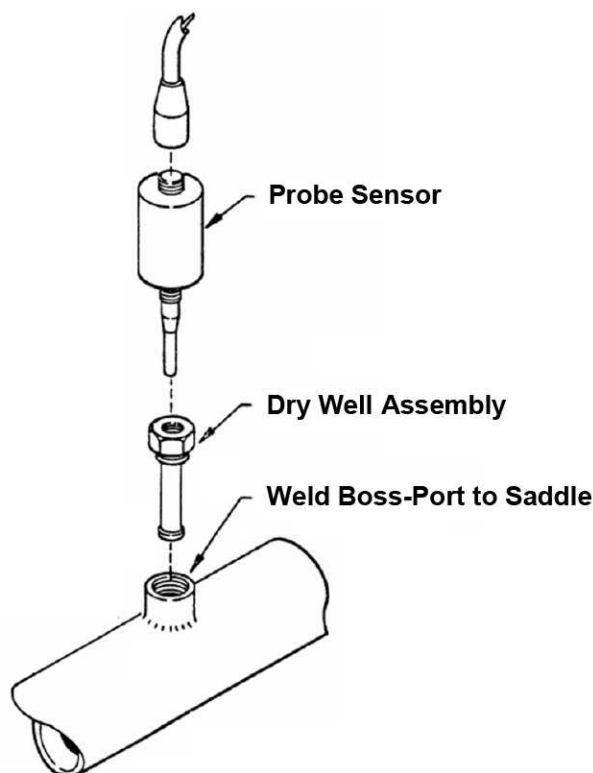
This incident took place during an annual calibration of temperature transducers and other components, using an OMI. The technician was correctly informed by the engineer on console to remove a specific temperature transducer from the MMH return line. The technician mistakenly removed the dry well and temperature transducer assembly (shown in Figure 20-1) rather than the temperature transducer alone (proximate cause). If the temperature transducer was removed properly, there would not have been a spill. The following is a quote from the mishap report that explains the incident:

"The LSOC hypergolic mechanical technician actually performing the task of transducer removal used incorrect shop practice and loosened the wrong nut. Instead of using a one-inch wrench to retain the dry well in place while loosening the transducer lock nut that threads into the dry well, he used the wrench to loosen the dry well. He then used his hand to unscrew the transducer thinking he was extracting the transducer from the dry well while he was actually unscrewing the transducer dry well assembly from the three-inch MMH line. A mixture of fluid and vapor MMH immediately erupted from the line sending a column 10 to 12 feet in the air."

Figure 20-1: Transducer and Dry Well Assembly

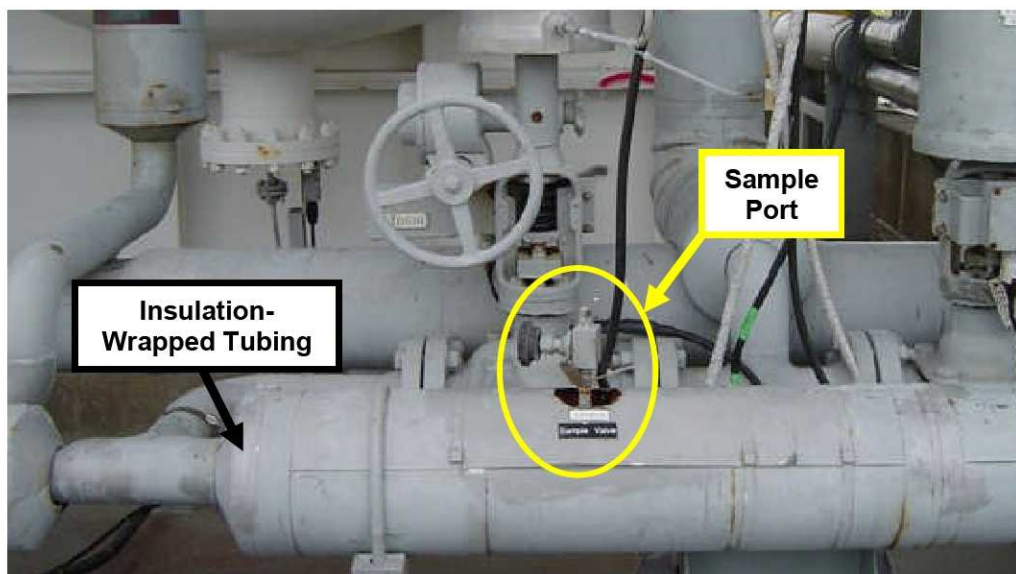
Figure 23-1: Photograph of Sample Port

On May 25, 1988, at the Pad 39B oxidizer farm, technicians were completing an N₂O₄ sampling operation. During the operation, the technicians detected a small leak at the interface between the sampling valve and the tubing (see Figure 23-1). The sampling operation was delayed until the leak could be fixed. The repair was finally scheduled to be worked about a month later during the afternoon of June 23, 1988. The removal of some local insulation was required to fix the leak along with re-torquing the fitting that connected the sample valve to the tubing. This was all completed that afternoon.

At about 10:30 PM on June 23, 1988, the sampling operation was successfully repeated. This was followed by the disconnection of the sampling flexhose from the sample port. When the flexhose was removed, liquid N₂O₄ spilled (about two tablespoons) into the small well surrounding the sample port. It was not uncommon to have a small amount of residual N₂O₄ remaining in the sample flexhose when it was disconnected. The spilled N₂O₄ reacted with the adhesive used for the attachment of the insulation to the tubing and ignited (proximate cause of the fire). The fire burned itself out in about 10 to 15 seconds before the technicians in SCAPE could return with a fire hose. There were no injuries to the personnel working the operation and the only hardware damage was to the insulation, which was replaced.

The insulation had been installed within hours of the sampling procedure; therefore, it was not given the appropriate time to fully cure. The adhesive used to attach the insulation to the tubing was found to

contain volatile hydrocarbons. This allowed for a chemical reaction to take place between the adhesive and N_2O_4 , causing ignition. The root cause of this incident was operational human error as a result of not allowing the insulation adhesive to fully cure.

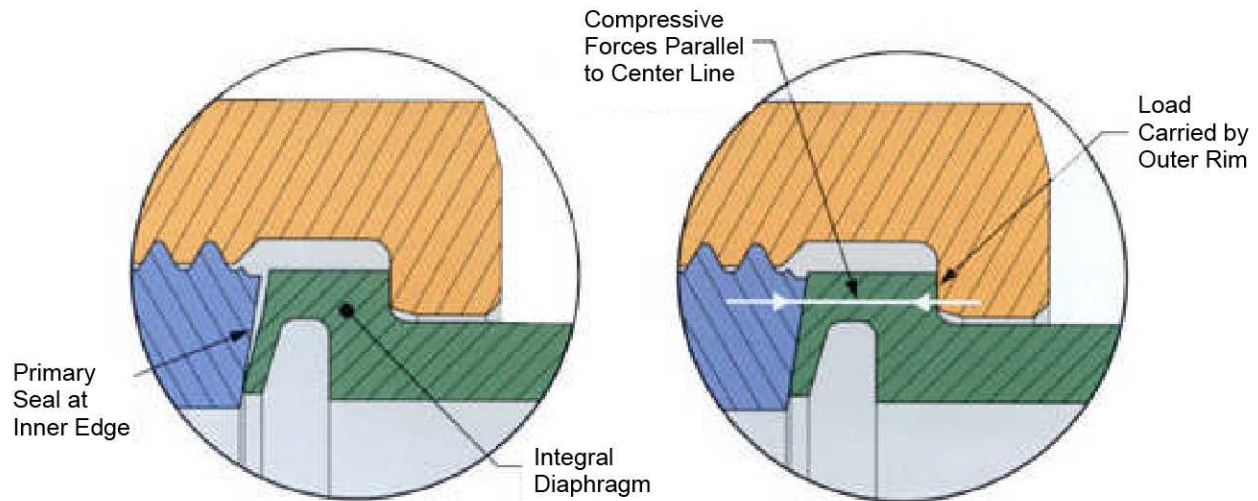
Figure 24-2: Cross-Section of Dynatube Sealing Surface

First, the exact location of the leak within the pod had to be found (a cutaway view of the Space Shuttle OMS pod can be seen in Figure 24-1). This was difficult because the internals of the aft pods and forward module are not meant to be accessed while the vehicle is at the launch pad. The location of the leak had been isolated to the LRCS N_2O_4 system or the associated tubing through monitoring of the instrumentation in the LCC. The leak was measured to be 0.26 psi per hour (about 800 standard cubic centimeters per hour) and a TVC found the concentration of NO_2 vapor to be 15 ppm at the vehicle vent door. This later decreased to 3 ppm. An access door was removed on the pod's outer skin and several internal thermal blankets were removed. A long section of PVC pipe was then inserted into the pod to function as a guide for a borescope. Using a borescope, the leak was finally isolated (after a six hour search) to a ½-inch dynatube fitting on the MD224 leg (the N_2O_4 propellant tank ullage vent). A cross-section view of a dynatube is shown in Figure 24-2 and a photograph of the leak location can be seen in Figure 24-3.

The proximate cause of the leak was found to be a scratched dynatube. This was discovered during ground processing two missions later when the pod was removed in the OPF and sent to the HMF for repair. It was determined that the scratch must have occurred either when the dynatube was disconnected in October of 1987 to allow access to a nearby valve for a removal and replacement or when it was reconnected in late December of 1987. Following the reconnection, the dynatube fitting passed all leak checks. Transport vibrations may have “altered” the state of the connection between the HMF, OPF, and launch pad; however, this is highly unlikely since dynatubes do not typically change mechanical state, especially with safety wire installed. The Kersey report states that “The most probable cause was that the mass spectrometer probe operator probed the wrong RCS propellant system (i.e. MMH instead of N_2O_4).” Operational human error was the root cause of this incident along with improper training. This categorization was given as a result of the incident being a consequence of either an inadequate inspection of the dynatube sealing surface or an error made during the leak check of the dynatube.

After a week of deliberation, the “clamshell” was selected as it was the least invasive method to stop the leak prior to launch and it could be completed at the launch pad. Furmanite FSC-6B was used as the sealing compound as a result of it having the best compatibility characteristics with N_2O_4 . The FRF was finally completed on August 10, 1988 following a few hardware-related delays. The repair of the oxidizer vapor leak began on August 17, 1988 with the cutting of two holes in the aft 1307 bulkhead (the bottom of the payload bay with the orbiter in the vertical orientation) and the top of the pod beneath the bulkhead. The dynatube’s safety wire was removed and a “clamshell” (shown in Figure 24-5) was placed over the leak. The Furmanite sealing compound was then injected. The leak was eliminated; therefore, the Space Shuttle Program cleared Discovery for launch, which successfully occurred on September 29, 1988, a few weeks later than the original launch date of September 6, 1988. The delay was a result of multiple items including the FRF test delays, return to flight SRB testing delays in Utah, and the N_2O_4 leak on LP04.

A question was raised concerning the accuracy of the mass specification leak check, which was the leak detection method used on this dynatube in December of 1987. As a result, a new policy was implemented to independently verify zero leakage using two separate methods. Currently, the Space Shuttle hypergol systems utilize a hazardous vapor (“sniff”) leak check, in addition to the mass specification leak check of individual fittings when they are disconnected for any reason.

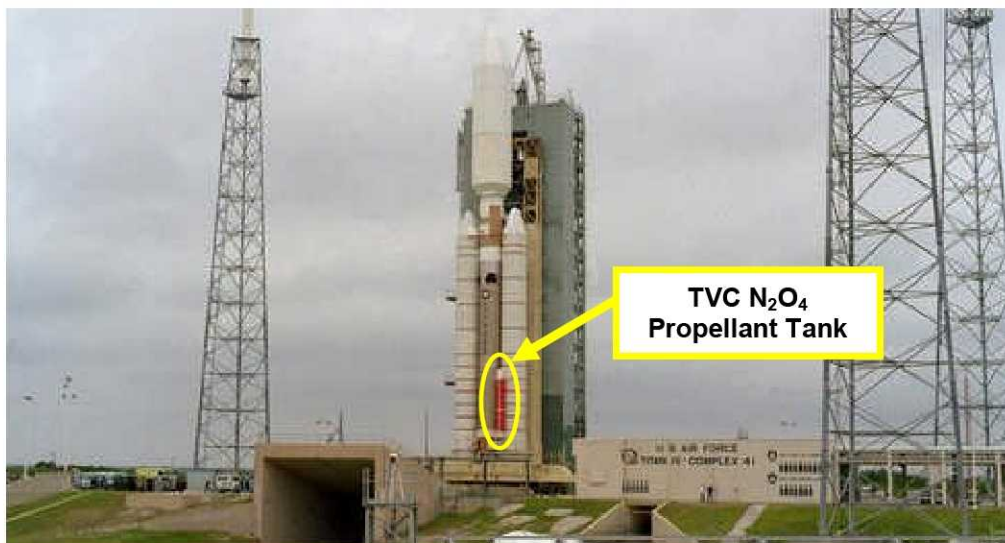
Figure 31-1: SLC-41 with Titan IV A (Servicing Structure Retracted)

On August 20, 1994, at Space Launch Complex 41 (SLC-41) on CCAFS there was a large release of liquid N_2O_4 . Oxidizer was being loaded into the Titan IV A's solid rocket motor (SRM) thrust vector control (TVC) system in preparation for the launch of the National Reconnaissance Office's Mercury Electronic Intelligence or ELINT satellite on August 27, 1994. The N_2O_4 was used to alter the combustion in the Titan IV A SRM nozzle and, therefore, provide TVC. A photograph of the SLC-41 launch pad with a Titan IV A is shown in Figure 31-1. A diagram of the Titan IV A's TVC system is shown in Figure 31-2 with the numbered callouts listed in Table 31-1. The incident occurred about three and a half hours after sunrise

when the solar heat caused the pressure to increase in the N_2O_4 tubing while the system was in a static configuration.

The pressure increase went unnoticed by the engineers and technicians. Remote data monitoring was available on the launch vehicle, but not on the propellant transfer systems (GSE). Local dial gauges likely showed the increase in pressure; however, there were no technicians monitoring these particular gauges. The pressure rise eventually caused a weld seam to fail at the base of the transfer system (proximate cause). This portion of the N_2O_4 servicing GSE lacked a relief valve, thus allowing the propellant in the tubing to become “liquid locked” since a drain-back and purge had not been completed (improper design; a root cause). There was no damage to the GSE (excluding the ruptured tubing) or vehicle hardware and there were no reported injuries.

Another root cause of this incident was determined to be frivolous procedure deviations. The loading team and Launch Conductor had experience with successfully delaying the oxidizer drain-back and purge; however, this experience was based on insulated oxidizer tubing. The tubing at SLC-41 had recently been removed and replaced with non-insulated tubing as a result of the moisture trapped in the insulation causing accelerated corrosion. The loading team and the Launch Conductor either did not recall this or they were never told.

There are requirements for launch Pads 39A and 39B to have seamless pipe throughout and to have relief valves in tubing that could become “liquid locked.” Following the incident at SLC-41, the procedures were changed to preclude this sort of incident from happening in the future. The procedure deviation approval rules were also reaffirmed to the loading team and Launch Conductor.

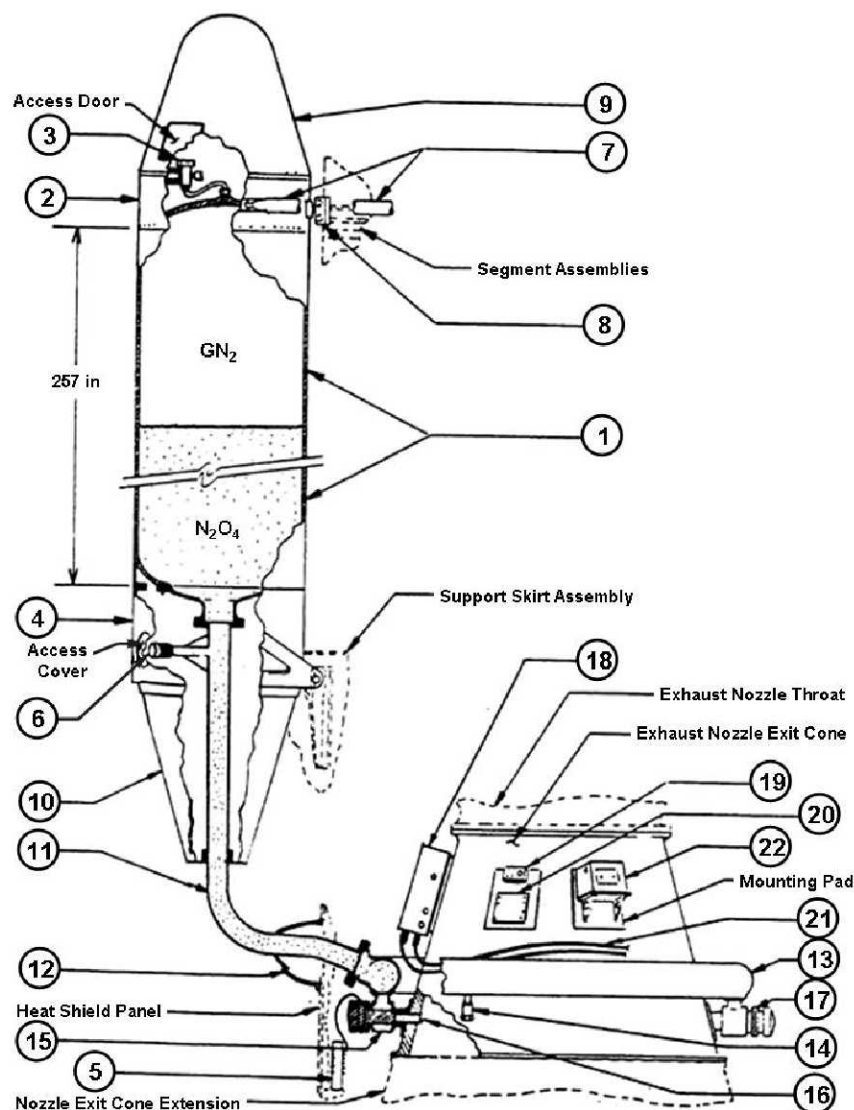
Figure 31-2: Titan IV A TVC System Schematic (see Table 31-1 for references)

On July 16, 1997 engineers at VAFB SLC-4E were remotely pressurizing the two N₂O₄ propellant tanks, one each on the two Titan IV A's SRM TVC systems. Reference Figure 31-2 for a diagram of the TVC system. The propellant tank servicing was completed without incident about nine days prior to the pressurization. Each tank contained about 8,400 lbs (702 gallons) of liquid N₂O₄. The rocket was being prepared for a planned mid-July 1997 launch on a Department of Defense mission to replace an aging reconnaissance satellite. Figure 37-1 shows a Titan IV A configuration at its launch pad and points out the location of the N₂O₄ tank.

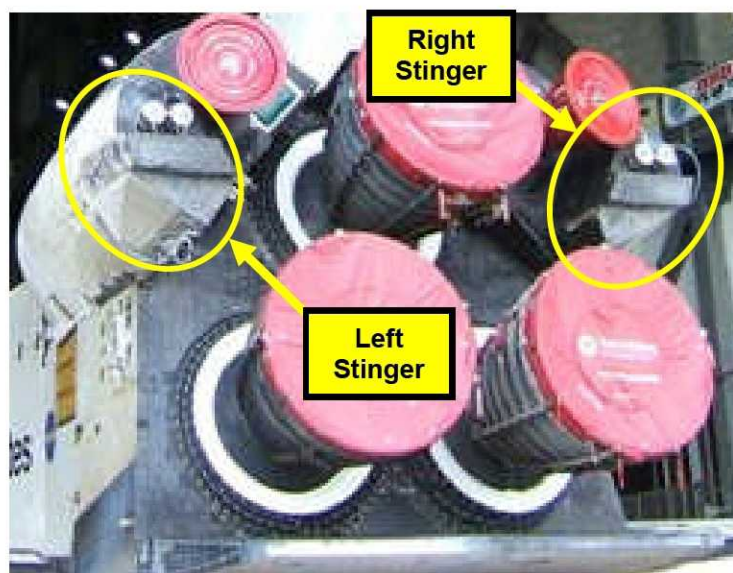
Figure 32-1: Stinger Locations on Orbiter

During the STS-69 OV-105 flow, while performing a thruster L3D removal and replacement, an MMH flame was reported in the Space Shuttle left OMS pod stinger area (see Figure 32-1 for the relative location of the stingers). The technician in SCAPE was preparing to inspect the dynatube (approximately an hour after the thruster was removed) with a mirror when he reported a small flame on the MMH thruster feedline dynatube. Another technician was unable to find any water to put out the fire and mistakenly picked up an alcohol bottle and sprayed the flame which produced a small flash near the feedline, igniting the residual MMH inside it. It is believed that the technician thought the spray bottle was Freon. It was reported that the flame was extinguished by the technician placing his SCAPE glove over the dynatube end. This was probably not the best idea since MMH can react exothermically in a rigid volume and burn in an atmosphere 2.5% to 98% by volume in air.

Prior to the reported fire, the technician removed the Aclar (plastic film) bag from the open end of the thruster feedline dynatube fitting. This fitting connects the manifold to the thruster. When he did this, he noted that there was an exceptionally large amount of fuel vapor present and some liquid MMH was dripping from the open line. The technician proceeded to place the aspirator directly on the feedline dynatube (the procedure and known practice was to place the aspirator perpendicular to the dynatube exit). This was likely the proximate cause of the fire. The engineer on console then noted that the manifold pressure dropped from 16 psia indicated to 6 psia indicated in about five seconds (the transducer had a 2 psi offset). The manifold pressure stabilized to 16 psia indicated after a couple minutes. At this point, the technician was instructed by the engineer to remove the aspirator from the dynatube. He did this and then left the area to find a mirror to aid in the dynatube inspection. When he approached the dynatube with the mirror he noted a "cream/yellowish color" flame and "heat waves." As previously mentioned, he proceeded to put out the flame with his glove after the other technician doused the area with alcohol.

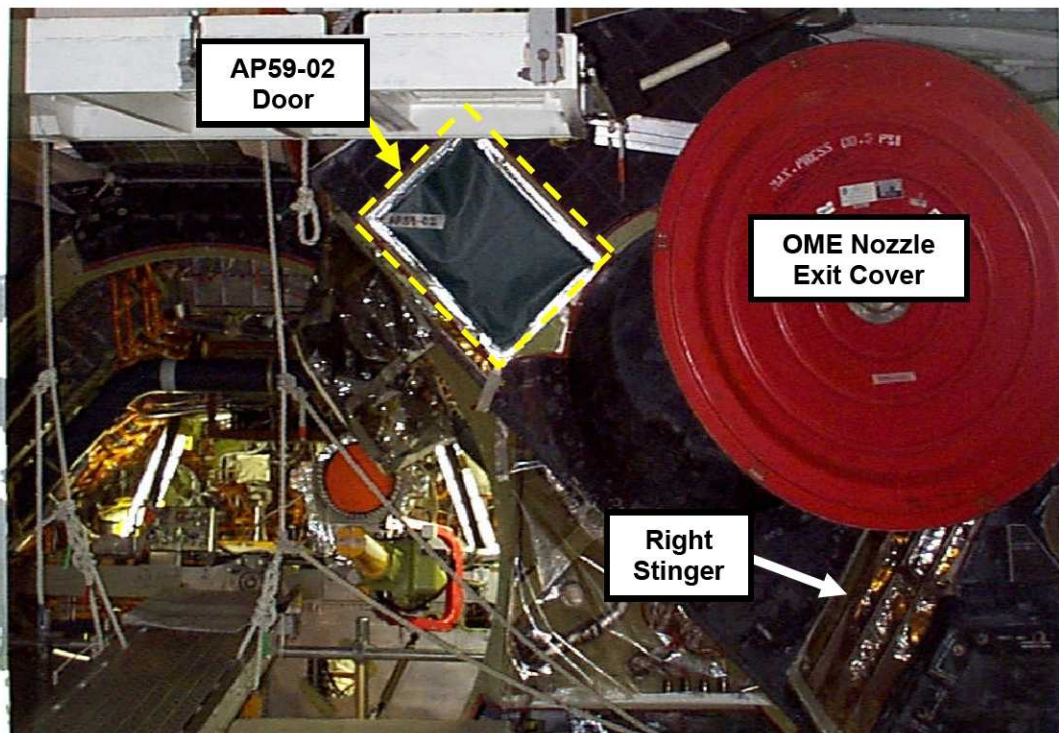
Figure 33-2: Color Photograph of Right Pod and Orbiter Aft

During the STS-69 OV-105 flow, while performing a thruster R1A removal and replacement, a fire broke out in the Space Shuttle right OMS pod stinger area. The fire burned strongly for about 30 seconds and a smaller flame burned for about one minute and 45 seconds. The size of the flame was estimated to be approximately 15 inches x 11 inches x 11 inches with a damage region of approximately 22 inches x 14 inches x 14 inches in the stinger. The materials that burned included several ounces of fuel, a shop light, and the Orcofilm spill protection (flame retardant covering films). Figure 32-1 is a still image from the video recording during the fire and Figure 33-2 is a clearer color photograph of the same area for reference.

A technician in SCAPE was disconnecting the R1A thruster MMH feedline dynatube during a thruster removal and replacement procedure. The procedure was initiated following an in-flight anomaly that occurred on the thruster during on-orbit operations (R1A primary thruster failed off due to a low chamber pressure). The N_2O_4 dynatube had already been disconnected and double-bagged in attempt to contain the residual vapors that were being released from the fitting. The technicians were told to place an aspirator near the N_2O_4 dynatube and proceed with the fuel feedline disconnect operation. When the seal of the fuel dynatube was broken by the technician using a wrench, he noted that there were “large drops of fuel being siphoned away by the aspirator.” Immediately following this, a fire erupted. There were six SCAPE personnel in the area when the fire was first reported. The proximate cause of this incident was the disconnection of the dynatube without knowing that there was liquid fuel within the tubing.

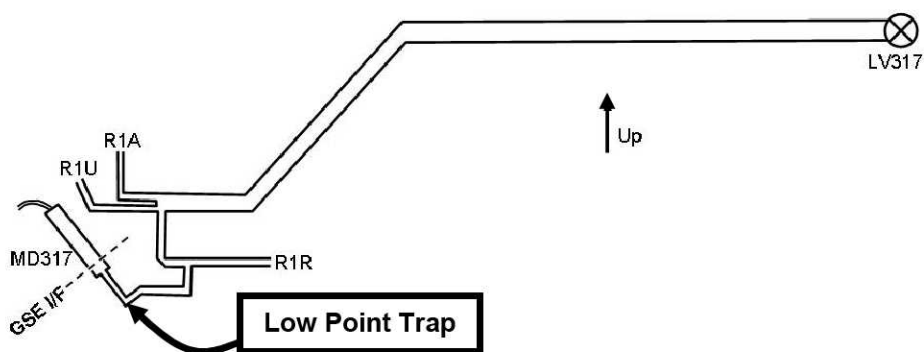
Figure 33-3: Approximate Manifold 1 Layout Schematic

Another possible scenario (not included in the formal mishap report) for the pressure increase was put forth stating the pulse purges were unable to remove all the liquid MMH as a result of a low point trap present in the manifold near the MD317 (manifold 1 drain/purge QD) AHC interface. Figure 33-3 shows the basic layout and low point in fuel manifold 1 in the right pod stinger area. It is believed that during the purge, gas was unable to enter the line through the MD317 QD to displace the liquid MMH out of the manifold. This was a result of a small bubble that had formed in the low point as a result of helium coming out of the liquid MMH/helium solution. The helium slowly coming out of solution may have been the source of the pressure rise in the manifold rather than a leaking manifold isolation valve. Once the fire started, it heated the area thus increasing the pressure and pushing additional fuel out of the fuel feedline that was trapped. In both scenarios (leaking manifold isolation valve or helium coming out of solution), liquid MMH was present in the manifold line just prior to and during the fire and the manifold pressure increase went unnoticed.

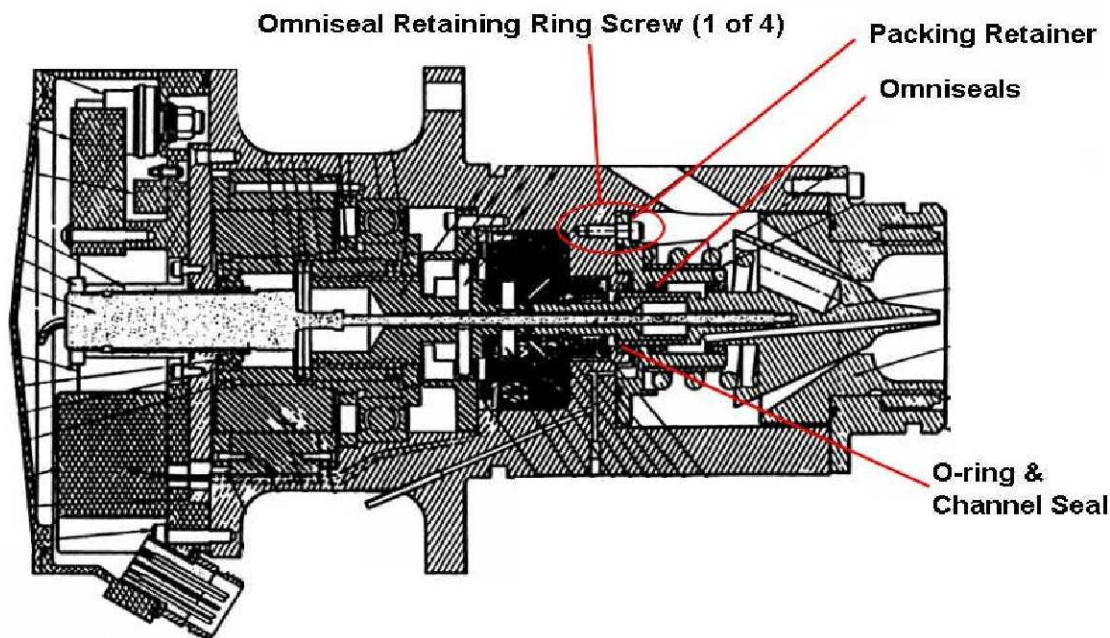
Figure 37-3: Titan IV A TVC EMV Cutaway View

The component design change was driven by the difficulty in manufacturing the EMVs, as well as some of its internal components becoming obsolete. A cutaway view of the EMV is shown in Figure 37-3. The intent of the valve redesign was to make as few changes as possible to allow for consistent manufacturing, part machining, and part procurement, as well as using the same outer housing of the valve to allow the new FCV to essentially be "dropped in" without any TVC system modifications. There are several noted differences between the two valve designs. One significant difference is their method of fastening the packing retainer to the omniseals. Both designs utilize an omniseal to isolate the N_2O_4 from the valve's electronic compartment. However, the original EMV design fastened the omniseal and packing retainer using four screws, whereas the superseding FCV design employed a snap-ring to fasten the retainer. The four mechanical screws on the EMVs left a much smaller gap (if any) between the component surfaces, whereas the FCVs snap ring design, while sufficient for its launch duty, had a large enough gap between the component surfaces that the liquid Bio T-200A cleaning solvent was able to accumulate on the omniseal spring.

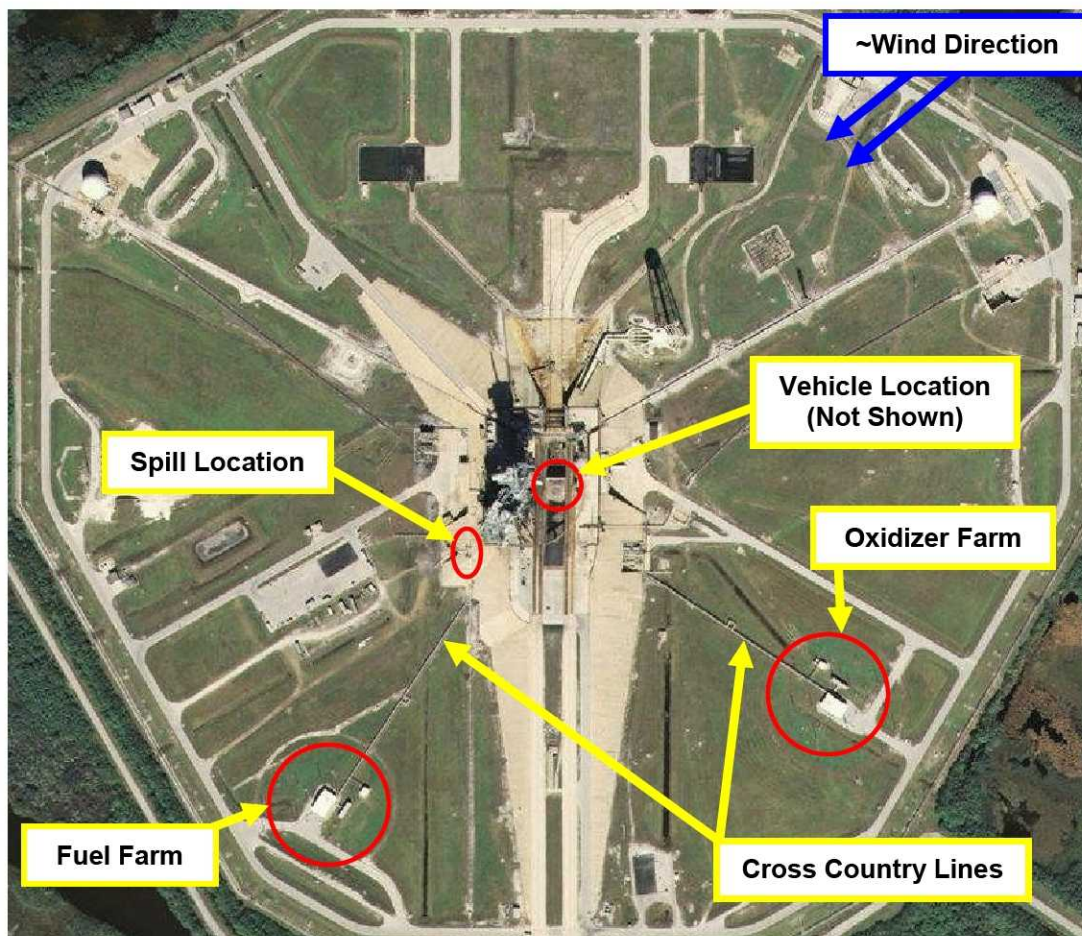
Figure 38-1: Geographic Layout of Launch Pad 39B

The SCAPE van driver was the first to detect the spill when he smelled oxidizer in the area of the fuel farm (see Figure 38-1 for a geographic layout of Pad 39B). Safety officials at the launch pad perimeter noted the source of the oxidizer vapors was the Pad 39B west slope. Three technicians in SCAPE were directed to proceed to the general area of the vapor source from their location on launch pad tower 107-foot level. Upon arrival, the technicians noted that heavy N_2O_4 (NO_2) vapors were leaking from both the inlet and outlet flanges of the return cross-over valve. They also noted that there were still several

gallons of liquid N_2O_4 on the ground near the flanges and at the bottom of the slope in a grassy area. Sparks were seen shortly after the arrival of the technicians; therefore, two of the three evacuated. Some of the liquid N_2O_4 that had flowed down the slope incline contacted the electrical conduits routed along the ground that supplied power to nearby lighting. The technicians were unaware that the N_2O_4 had dissolved some of the cabling insulation.

Since it was late at night, the technicians could not see the entire spill area very well. This was a result of the area being poorly lit during nighttime operations. Therefore, the technicians decided to activate some additional lighting at the cross-over valve complex. When power was issued to the lights there were several sparks and a small electrical fire ensued. The lights were quickly turned off and the small fire was put out with water. During the clean-up effort, one technician inhaled N_2O_4 (NO_2) vapors as a result of his SCAPE suit zipper not being secured. He was sent to the OHF and released later that night.

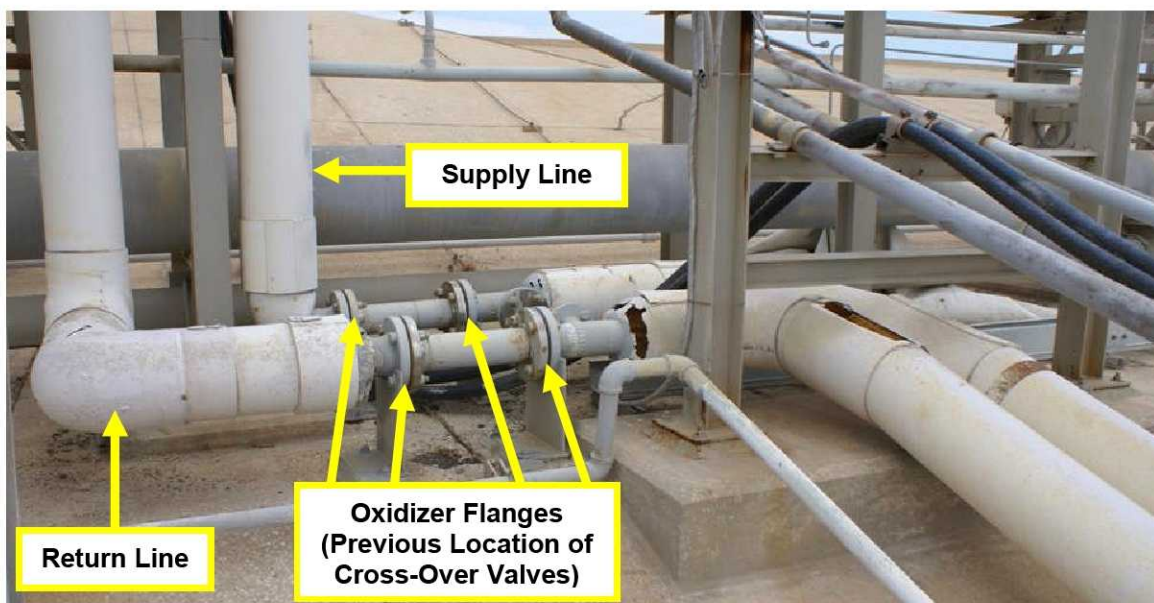
Figure 38-2: Former Site of Oxidizer Cross-Over Valve Complex at Pad 39B

Following this incident, the Pad 39B drawings were updated to require the installation of the proper flange seals. All the cross-over valves were removed and replaced with flanged pipe as they were no longer needed for hypergolic propellant loading. This reduced processing time on the valves and greatly reduced the risk of a leak at the valve flanges. Figure 38-2 is a photograph of the location where the cross-over valve complex was previously located at Pad 39B and Figure 38-3 is a photograph of the location of the Pad 39B fuel cross-over valve complex with the fuel farm and Vehicle Assembly Building in the background.

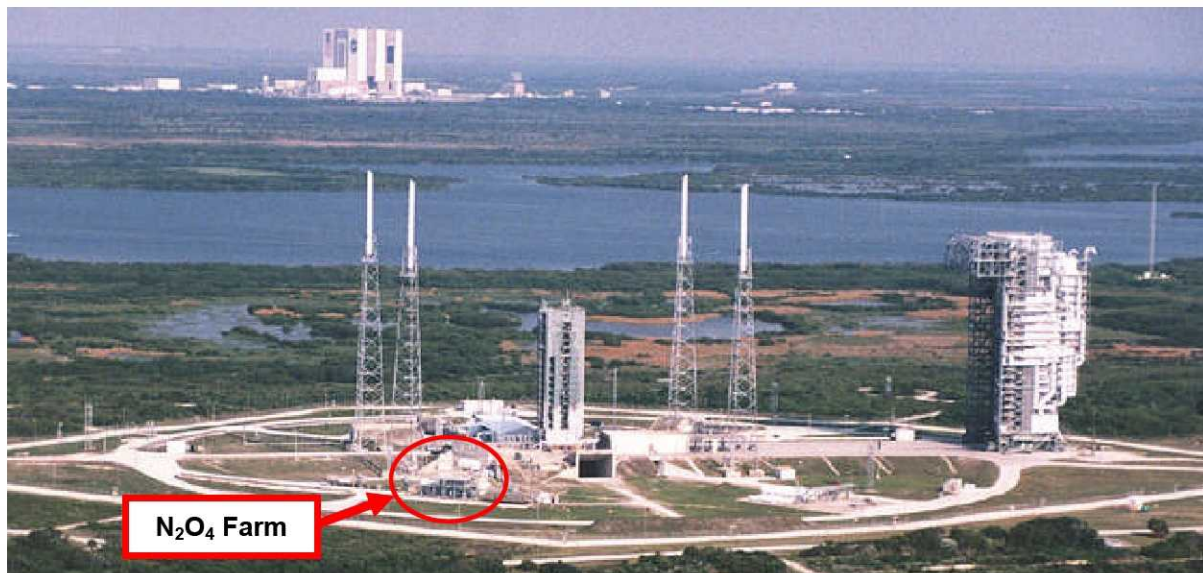
Figure 43-1: LC-40 at CCAFS

On August 12, 2003, at CCAFS launch Pad LC-40 (shown in Figure 43-1) during the bleed-in operation for the B36 Stage II (Titan IV) propellant load, the oxidizer centrifugal pump exploded (proximate cause of the N₂O₄ spill). The Titan IV launch vehicle was being loaded in preparation for the September 9, 2003 launch of the National Reconnaissance Office's payload. Along with the liquid N₂O₄ release of approximately 40 gallons, the explosion created a large amount of shrapnel which caused significant damage to the surrounding GSE. The pump was completely destroyed as shown in Figure 43-2. Fourteen people reported to an on site health facility. They were all later released without injury. The storage tank holding several thousand gallons of liquid N₂O₄ remained intact with minimal damage. An extensive investigation was initiated as a result of the Space Shuttle Program using these same pumps at Pads 39A and 39B (eight pumps in four locations) along with the Titan program which used them at LC-40.

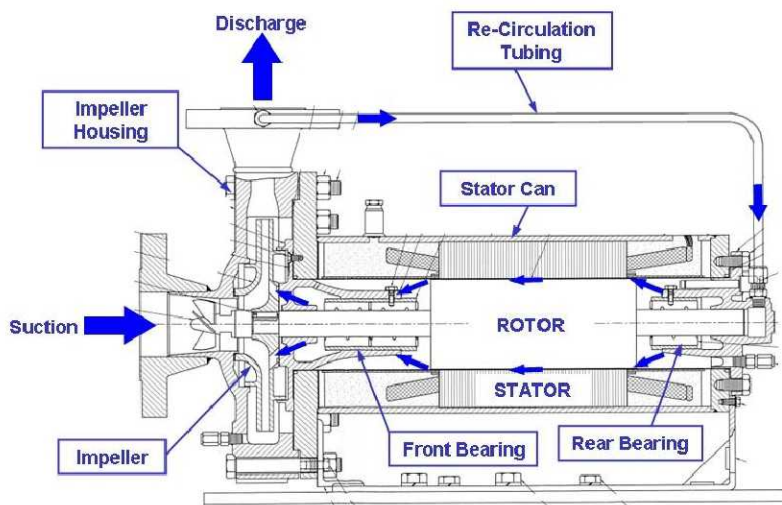
Figure 43-3: Pump Schematic

The incident failure analysis concluded, according to Crass, that there was a “cooling anomaly at the [carbon graphite journal] bearings...leading to [an explosion] in the stator can winding area.” It was found that the most likely contributor to this was a clogged filter in the pump recirculation loop that circulates liquid through the rotor cavity to cool the front and rear bearings as illustrated in Figure 43-3. Data analysis showed that the upstream and downstream temperature transducers indicated an increase in temperature of 8 °F across the pump. The low flow rate of 40 gpm and high ambient temperatures (high of 86 °F for 8/12/2003) accelerated the failure of the pump. At these flow conditions, the pump was not

able to be properly lubricated as a result of the high vapor pressure of liquid N_2O_4 (these particular pumps are designed to be lubricated with the liquid that they are pumping). The excessive bearing wear led to damage to the stator liner can, allowing oxidizer to leak onto the hot copper windings. The N_2O_4 reacted with the copper winding insulation and caused the coil wire to short, which was the proximate cause of the explosion.

Following the explosion, there were some design changes made to the pumps since an improper pump design was a root cause, these changes include the following:

- Machining of the pump from a single billet of stainless steel rather than casting them
- Serrations were added on the impeller housing and rear bearing housing for improved sealing capability
- The addition of a thermowell for thermocouple monitoring rather than the old thermoswitch which proved to be unreliable

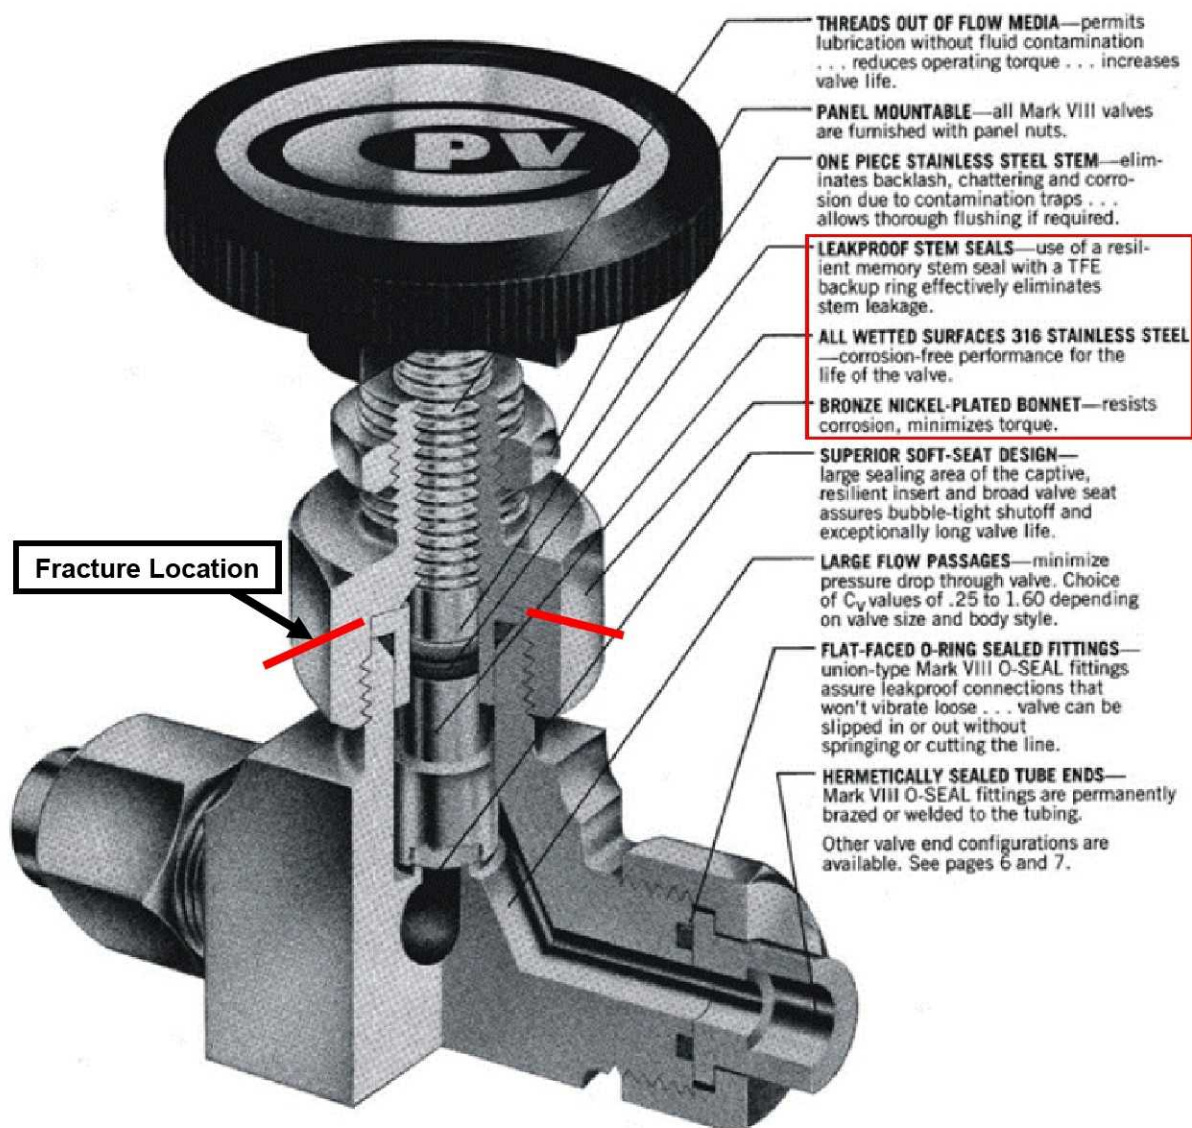
Figure 45-2: Schematic of Failed Manual Valve

The failure began as an intergranular crack in the nickel-plated, aluminum bronze bonnet threads (fracture surface shown in Figure 45-1). It is believed that the crack began as a result of the ethylene propylene rubber and Teflon soft seals allowing corrosive agents to slowly leak into the thread region. Figure 45-2 shows a cross-section cutaway of the manual valve. The Teflon soft seals can be seen clearly near the middle of the threaded shaft. The corrosive agents reacted with ammonia, which came from the decomposition of N_2H_4 ($N_2H_4 \rightarrow 1/3 N_2 + 4/3 NH_3$). This accelerated the local corrosion and cracking. This was the first failure for this type of valve since they were procured and installed in several hypergolic systems at WSTF in 1994.

The valve had been cycled roughly 380 times and seen approximately 177 pressure cycles at around 400 psia (the last 42 cycles were in 2005) since its installation in September of 1994. In 2005 testing began on the IAPU system using high-purity N_2H_4 (rather than monopropellant grade N_2H_4) to determine if there were any significant differences in the corresponding catalyst bed temperatures. High-purity hydrazine is defined as 99.5% pure N_2H_4 . Monopropellant grade N_2H_4 has a purity of 98.3%. During the testing, an internal leak was discovered in the system. The workaround of this internal leak was to alter the system valve configuration. The new configuration had the soon-to-be failed 1/2-inch manual valve in-line with the main catch tank and the bypass catch tank which resulted in a pressure of 50-psia on the manual valve that subsequently failed. While in this static configuration, the manual valve bonnet fractured and was ejected from the valve into the test cell, spilling the N_2H_4 . The altering of the nominal configuration could be considered a root cause, along with the improper design (primarily material incompatibility) of the manual valve, itself.

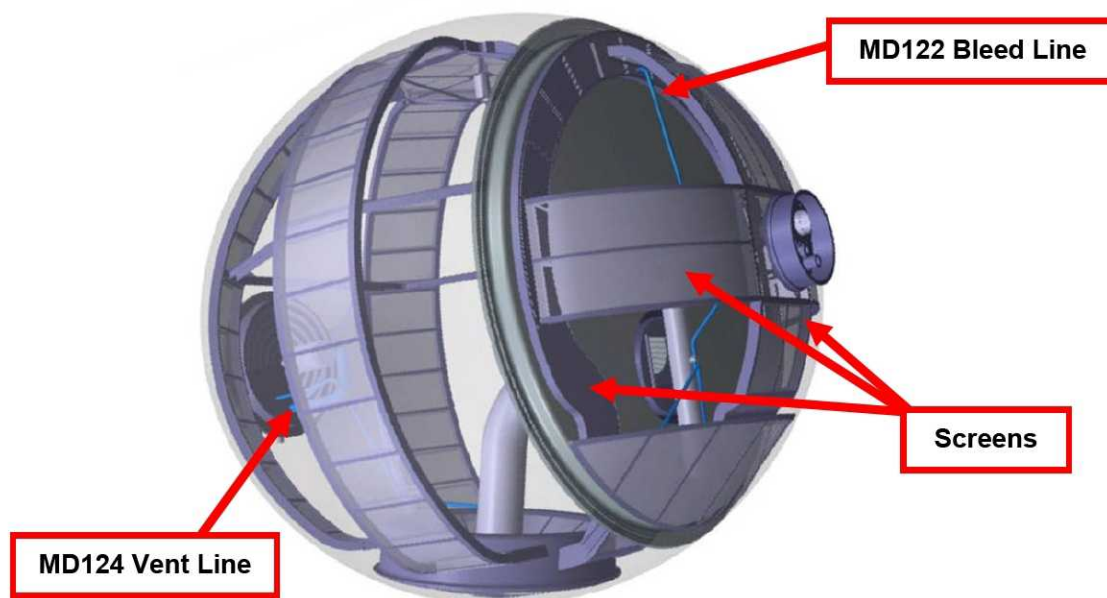
Figure 46-1: Solid Model of RCS Propellant Tank in (Roughly) the Horizontal Orientation

With the vehicle in a horizontal orientation, the MD122 line runs from the high point of the oxidizer tank lower compartment channel, through an interface at the tank outlet flange, and out to an AHC located in an externally accessible door on the FRCS outer mold line (AP28-00 door). It is known through pressure measurements that the MD122 and MD120 connected GSE lines were clear of any liquid immediately following the two, five-minute purges; however, it is not known if the propellant acquisition system channel in the lower compartment was broken down (i.e. it did not contain any liquid). If the screen was not completely broken down, it is possible that liquid oxidizer “wicked” up the screen following the purges to the point where MD122 connects to the acquisition screens. See Figure 46-1 for visual aid of the propellant acquisition system screens and the MD122 line. The absence of liquid in the lines can be confirmed by noting that there was not any significant pressure increase in the lines. The tank was *not* in thermal equilibrium. The tank shell (skin) temperature rose from 49 °F, when tank venting was complete, to 58 °F, when MD124 GSE vent valve was opened for the emergency vent through MD124 in the upper compartment of the tank. When the two purges were complete the tank shell temperature was 54 °F. From the time of the spill to the emergency MD124 vent, the tank shell temperature rose from 57 °F to 58 °F. The fluid and gas temperatures likely rose by a degree or two during this time.

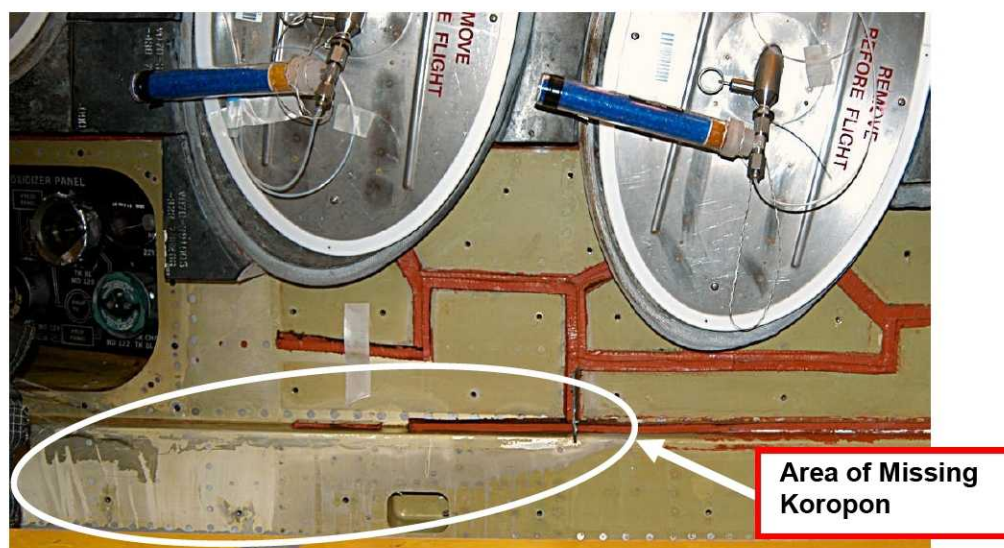
Figure 46-3: View Looking at R/H Side Down-Firing Thrusters (F2D & F4D)

The spilled oxidizer appears to have reacted with Koropon, RTV, and silver plating (nutplates and barrel nut elements). The oxidizer vapors reacted with the Koropon and removed a large area, as shown in Figure 46-3, and passed through the nutplate holes and around the perimeter of the phenolic QD service panel into the interior of the FRCS module, as shown in Figure 46-4, causing damage to the Koropon on the interior side of the FRCS module.
