NASA/TM—2009-215802

Failure Analysis of Sapphire Refractive Secondary Concentrators

Jonathan A. Salem
Glenn Research Center, Cleveland, Ohio

George D. Quinn
National Institute of Standards and Testing, Gaithersburg, Maryland

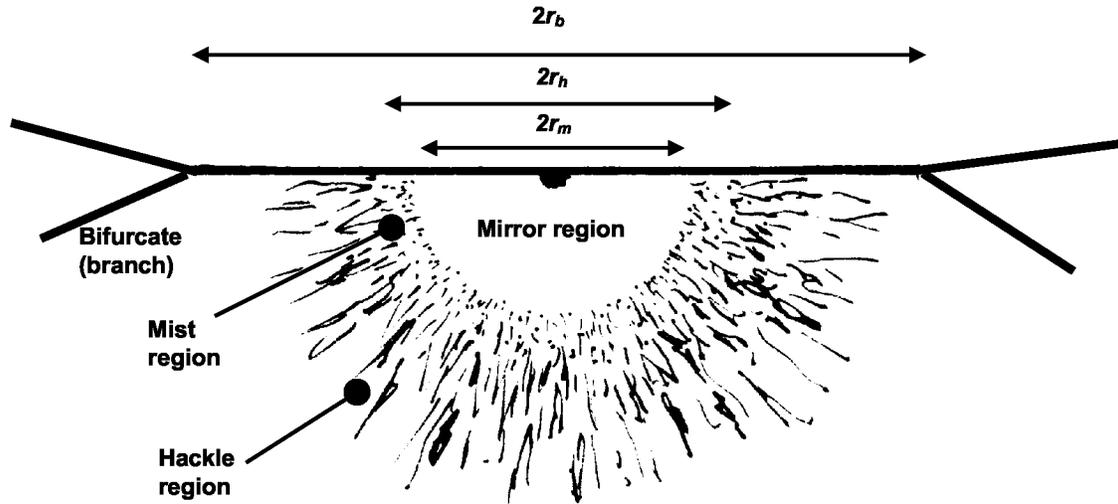
Figure 29.—Idealized regions and boundaries formed around a failure origin on the surface of a part that was exposed to uniform tension stress. The distance r_m is the radius of the boundary for the onset of mist, the distance r_h is the radius of the boundary for the onset of hackle, and the distance r_b is the radius of the boundary for the onset of branching. Problems in interpreting single crystal fracture mirror markings often force one to use the branching distance for quantitative stress estimates.

Assuming that the room temperature fracture constants are applicable, the 44 mm bifurcation distance used with Equation (3) implies a stress of only ~44 MPa. This is much less than the 250 MPa or larger strengths exhibited by well polished sapphire tested at low temperatures (Ref. 8). This very low stress estimate is consistent with the observation that the contact crack origin was moderately large. Large cracks require very little stress to trigger fracture.

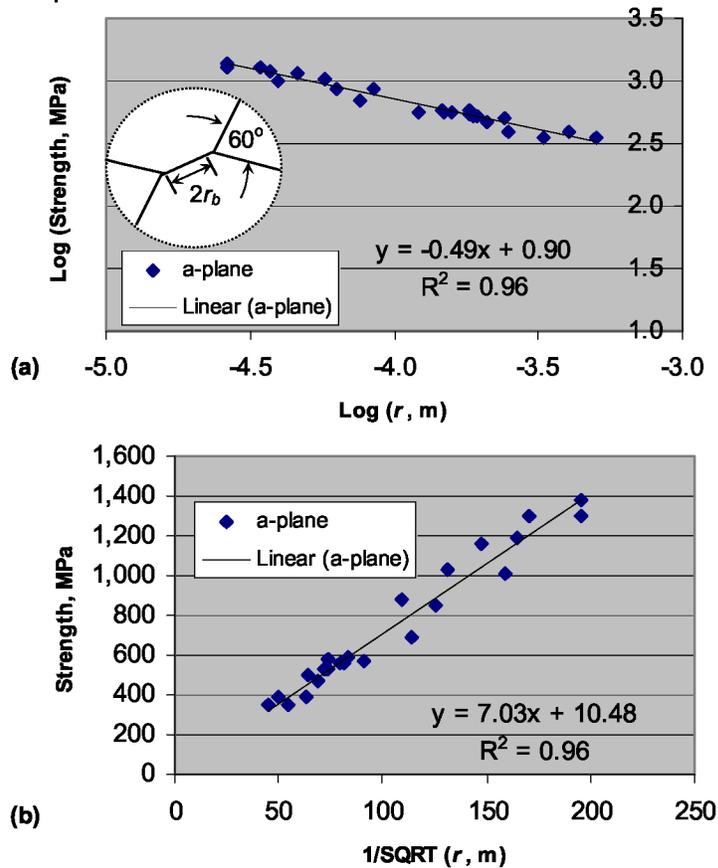
where σ_{th} is interpreted as either a threshold stress for branching or a residual stress (Refs. 7 and 13). Equations 1 to 3 yield A_b of 7.2 ± 0.6 , 7.9 ± 1.5 , and $7.0 \pm 0.3 \text{ MPa}\sqrt{\text{m}}$ for the sapphire respectively, with $M = -0.49$ and $\sigma_{th} = 11 \text{ MPa}$, as shown in Figure 30. These results compare well with those in (Ref. 7), implying a relatively constant value for alumina. The presence of a slight residual stress is not surprising, considering the grinding damage observed on the specimens via X-ray topography (Ref. 8), but this would be very shallow. During measurement of the branch lengths, several specimens were observed to exhibit fracture on the r -plane and bifurcation onto another r -plane. When the principal stresses were resolved on the r -plane, similar A_b resulted.

Figure 30.—Room temperature fracture strength as a function of branching length for the a -plane of sapphire tested in four-point flexure: (a) fit to Equation (2) and (b) fit to Equation (3). Strength data from Reference 8.

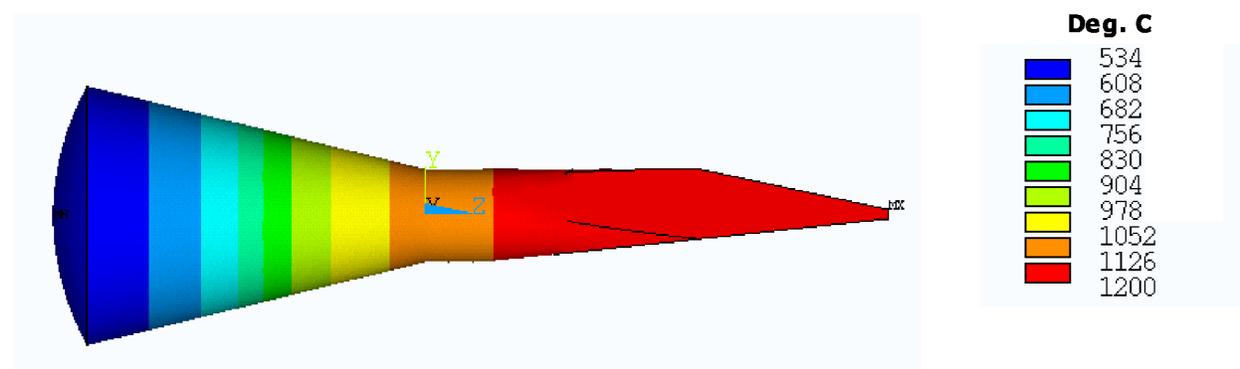
Figure 31.—Temperature distribution in sapphire crystal for receiver temperature of 1200 °C with exposed cone design.

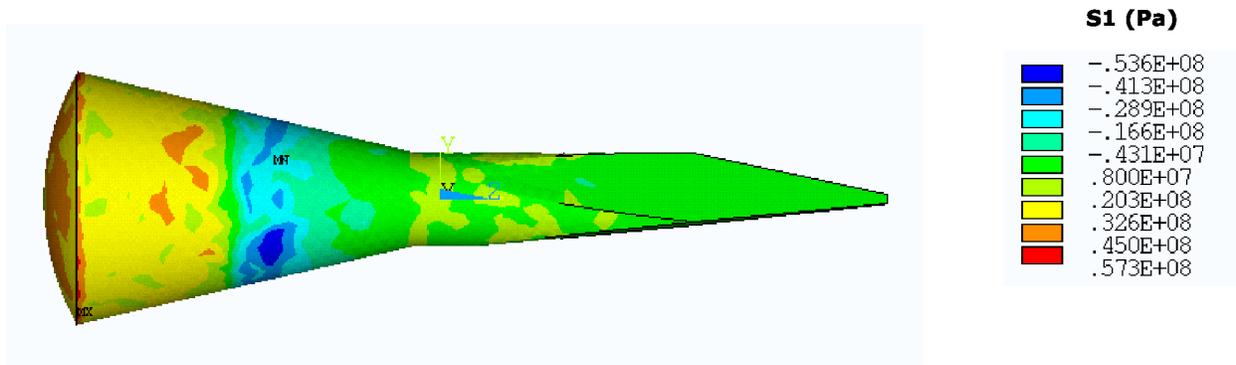
In order to understand the stress state in the RSC and design better RSC systems, finite element analyses were performed by using the single crystal thermal and elastic constants (Ref. 14). The resulting thermal and stress profiles are shown in Figures 31 and 32 for the first concentrator and indicate a maximum principal tensile stress of 57 MPa at the rim of the front lens face of the concentrator where the *a*- and *m*-axes exit, near the actual failure. This is in reasonable agreement with the value of 44 MPa based on fractographic measurement.

As noted previously, the radial cracking suggests that tensile hoop stresses at the rim caused fracture in both concentrators. The origins were also located near the rims, where shielding and clamping may alter the temperature profiles relative to those estimated by the FEA analyses based upon the assumed boundary conditions. Better modeling with more realistic boundary conditions may give improved stress estimates in the front face rim regions.

Figure 32.—First principal stress distribution in sapphire crystal for receiver temperature of 1200 °C with exposed cone design. Stress results are in Pa.

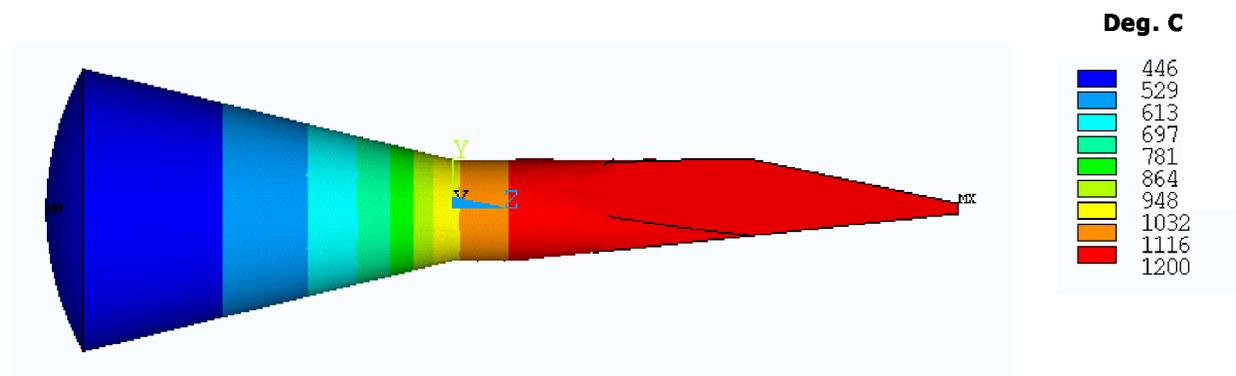
Figure 33.—Temperature distribution in sapphire crystal for covered cone design with a receiver temperature of 1200 °C.

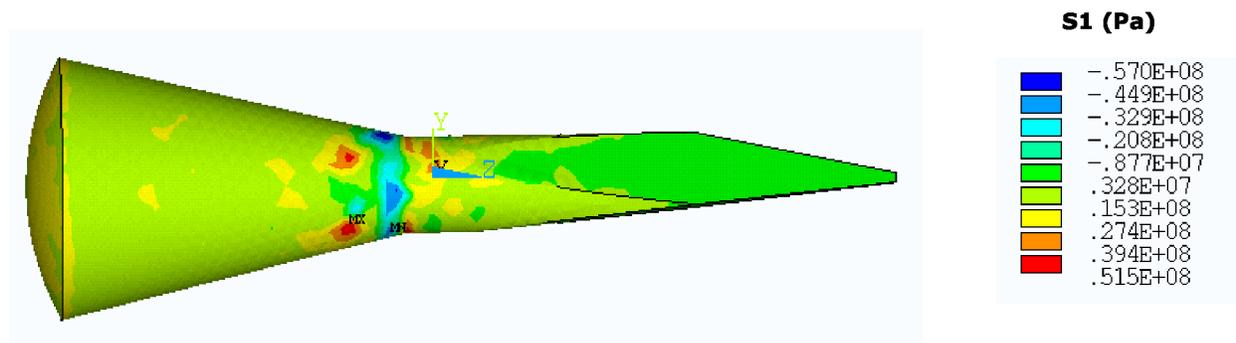
For the second concentrator, FEA modeling (covered cone design, 1200 °C) shown in Figures 33 and 34 indicates somewhat lower tensile stress of about 20 to 25 MPa on the lens face. Peak stresses up to 52 MPa occur just before the transition from the lens cone to the extractor rod.

Figure 34.—First principal stress distribution in sapphire crystal for receiver temperature of 1200 °C with covered cone design. Stress results are in Pa.

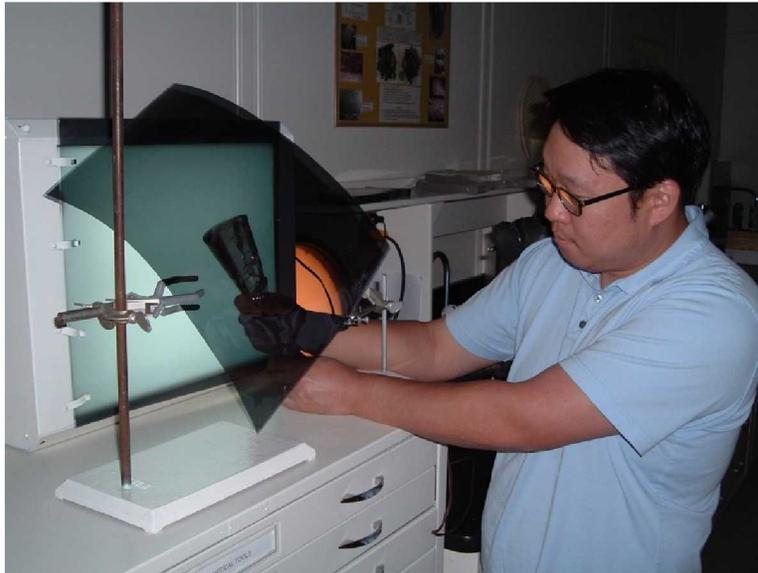
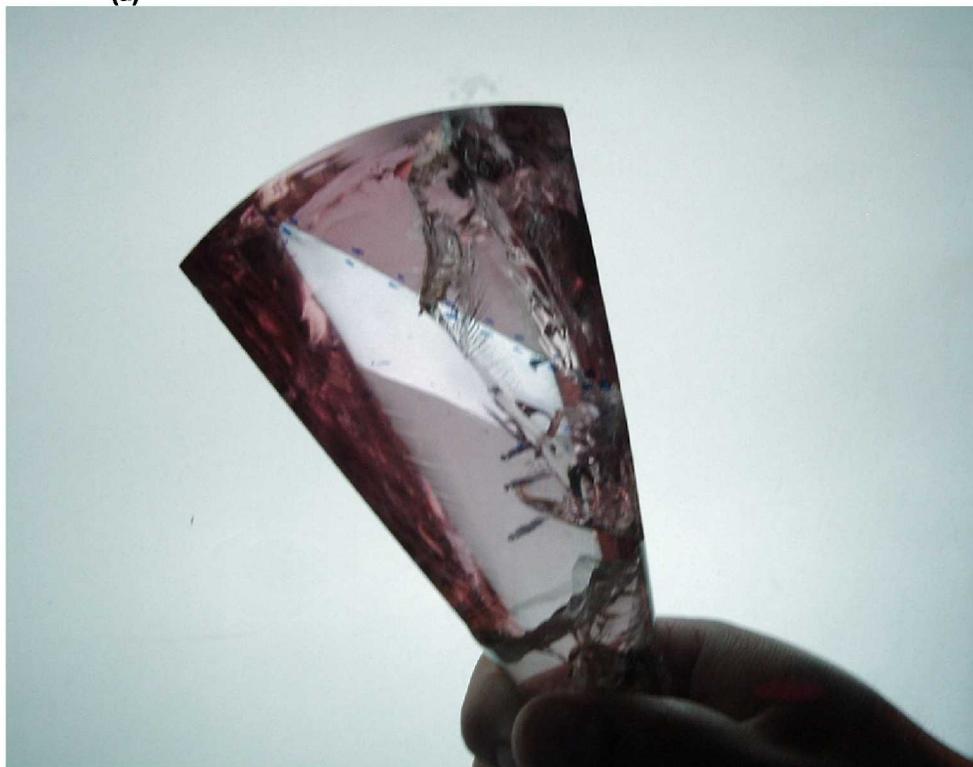
Figure A2.—An improvised Polariscope examination device. (a) shows a common light box is with two polymer polarizing sheets. One is clipped to the light box, the other is held by a clamp on the post in the foreground. Piece 1 of concentrator 1 is placed in between and rotated about. (b) shows a photo of the twin.
