Current Space Station Experiments Investigating Component Level Electronics Repair

Prepared for the
Space 2009 Conference and Exhibit
sponsored by the American Institute of Aeronautics and Astronautics
Pasadena, California, September 14–17, 2009

Abstract

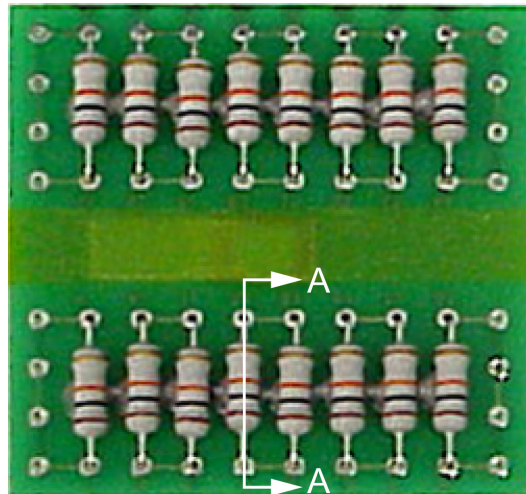
Figure 1.—An unused SoRGE circuit board and drawing of a resistor and two joint locations. The soldering occurs on the bare leg of the resistor, forming the soldered fillet. Solder flows into the through hole and forms the flowed fillet on the resistor body side of the circuit board.

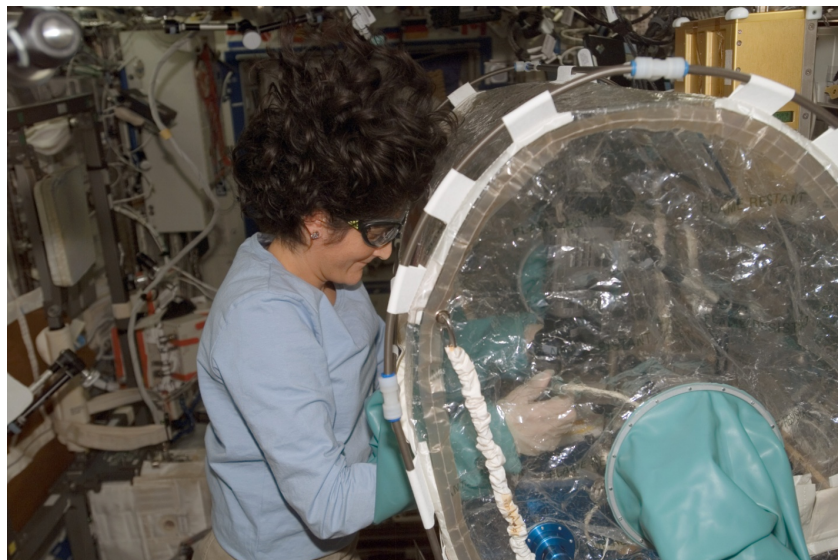
ISS015E06769
Figure 2.—Astronaut Sunita Williams works on SoRGE within the Containment Area aboard the ISS.

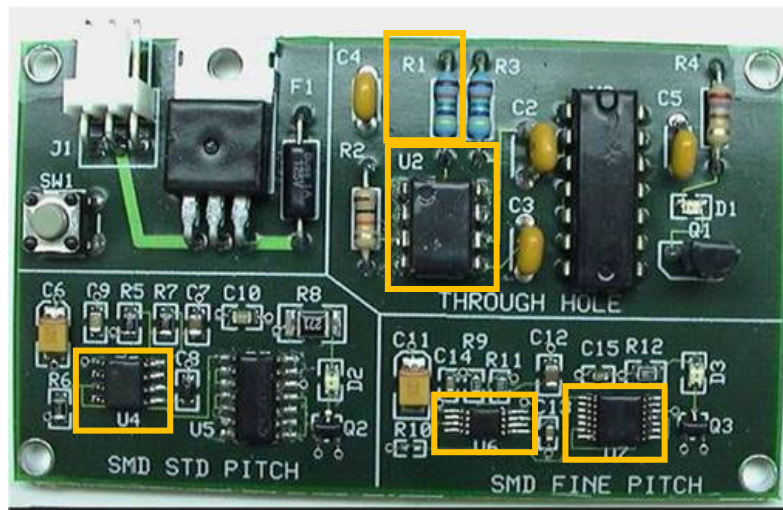
Figure 3.—The CRE-1 circuit board, with R1, U2, U4, U6, and U7 positions highlighted.

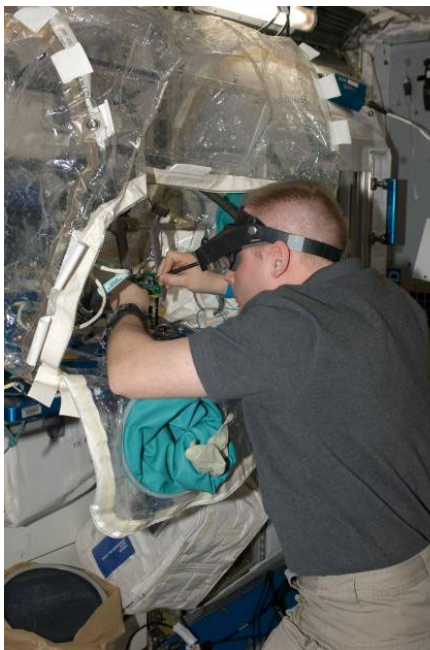
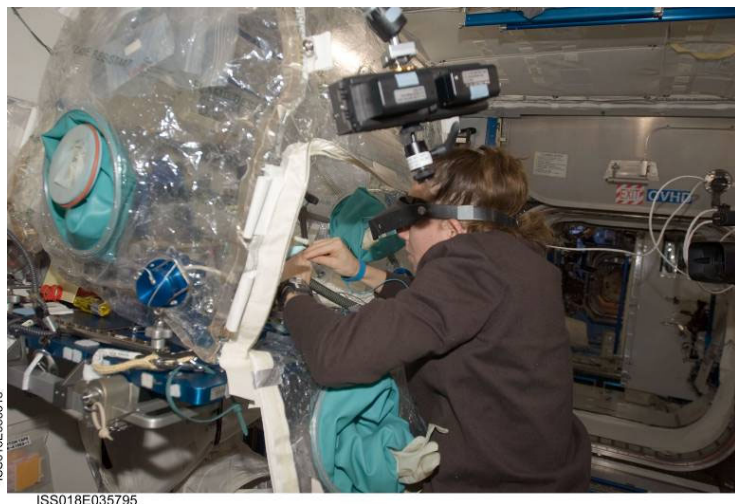
Figure 4.—Astronauts Michael Fincke (left) and Sandra Magnus (right) perform CRE-1 operations in the Containment Area aboard the ISS.

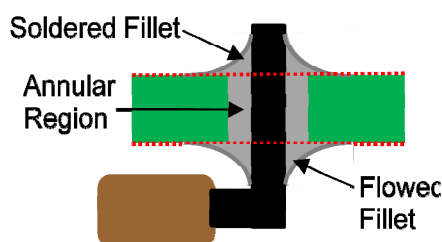
Figure 6.—Drawing of the three regions of a solder joint: the soldered fillet, where heat and solder are applied, the annular region within the circuit board through-hole, and the flowed fillet near the resistor.
