# Lessons Learned From The EMU Fire And How It Impacts CxP Suit Element Development & Testing

**Presenter: Terry Hill**

**15 Sep 08**

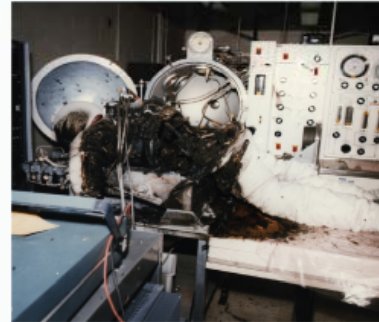
On the afternoon of April 18, 1980, Hamilton Standard personnel were conducting an Extravehicular Mobility Unit (EMU) Performance Record Test in room 121 of building

7. The test involved the use of 900 psi O<sub>2</sub> and 6200 psi O<sub>2</sub>. At 1:22 p.m., a flash fire occurred. One technician suffered first and second degree burns over 32% of his body and was taken to the hospital. Another technician got his hand burned, requiring first aid. The fire actuated an overhead sprinkler; two CO<sub>2</sub> extinguishers were used. The Houston fire department responded and assured the extinction of the fire. ■

- Regulator vaporized in less than 1 second
- O<sub>2</sub> availability allowed for metal to burn
- O<sub>2</sub> depress less than 2 seconds
- Softgoods burned until extinguished - ~1-2 minutes

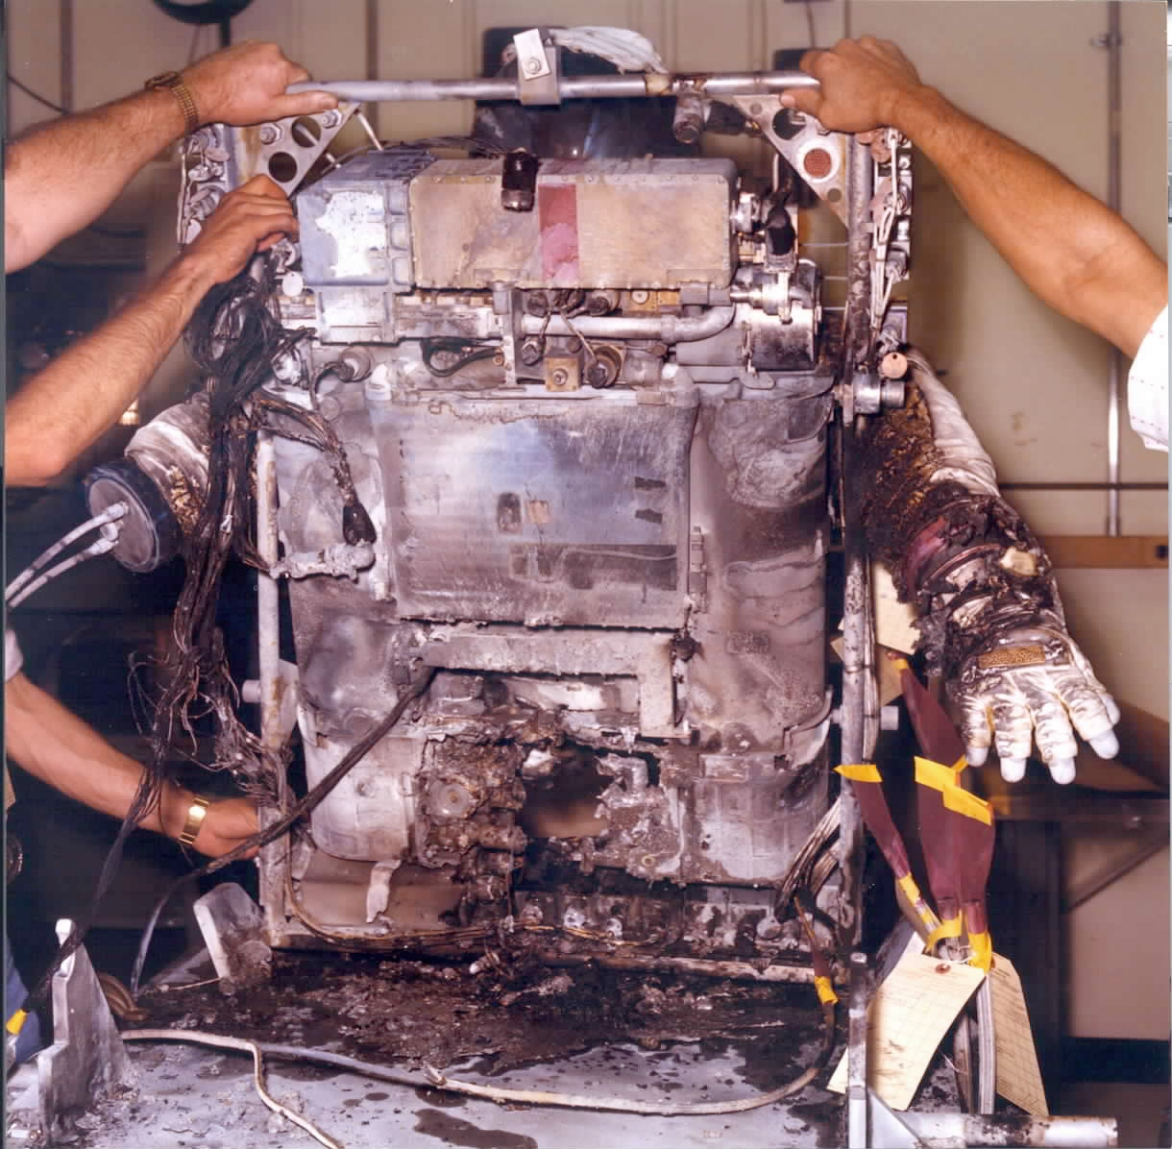
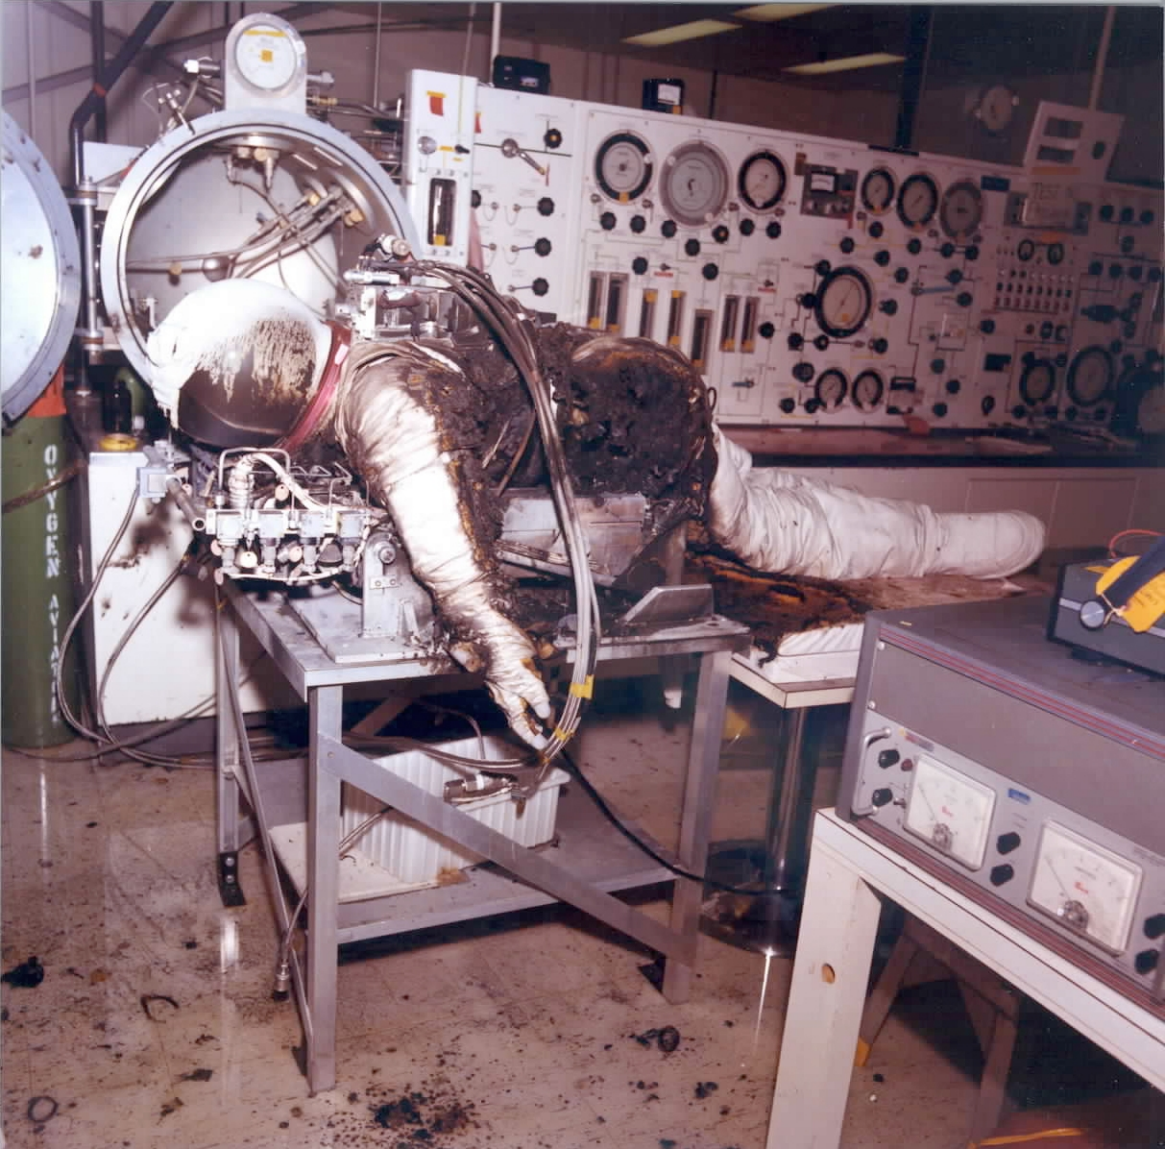
## INVESTIGATORS FILE REPORT ON CAUSE OF SPACESUIT BACKPACK FIRE

A NASA board investigating the April 18 flash fire in a spacesuit backpack found where the fire started and recommended 11 ways to improve safety and reliability of the system.

While the exact cause was not found, the four most probable causes of ignition were cited in the board's report to Johnson Space Center Director Christopher C. Kraft, Jr., after five weeks of engineering detective work that included more than 2,000 unsuccessful attempts to reproduce the fire.

The fire apparently started when the technician switched the secondary oxygen pack to the "spacewalk" position during a performance test in a clean room in the Crew Systems Laboratory. The secondary pack is attached to the bottom of the main backpack and provides 30 minutes of emergency oxygen for breathing and to maintain suit pressure if the main oxygen source fails.

Ignition took place in a V-shaped passage which serves to restrict the flow of oxygen between a shut-off valve and a chamber in the pack's regulator module, the investigating board determined. It said the four most probable causes were:

After ignition on April 18, the regulator module burned through and an oxygen-rich jet of flame burned the lower torso of the attached spacesuit.

The 11 recommendations of the board are:

° Replace existing silicone o-rings with silicone o-rings having improved ignition resistance.

° Consider establishing a committee consisting of NASA and non-NASA personnel to collect existing high-pressure oxygen data, review and clarify existing design standards and requirements, recommend any necessary supplements to presently available information and publish a comprehensive standard for the design and use of high-pressure oxygen equipment used in the space program.
