Space Station Control Moment Gyroscope Lessons Learned

Abstract

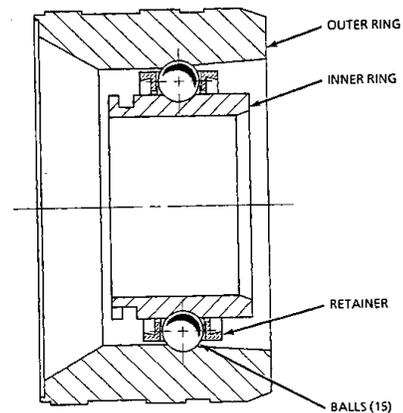
Figure 3. CMG Spin Bearing Assembly

The Spin Bearings, shown in Figure 3, are single angular-contact ball bearings with modified inner and outer races. There are 15 steel balls mounted in a retainer to maintain consistent ball motion. The spin bearings are lubricated with KG80, a super refined mineral oil, in an active oiler system. Pairs of cartridge heaters mounted near the outer race of each bearing are provided to maintain the lubricant above the pour point temperature and in the range of 15.6°C to 26.7°C (60°F to 80°F) during cold orbital conditions.

The failure investigation confirmed that the HR spin bearing of CMG1 suffered a failure after 1.3 years of operation. This spin bearing was severely damaged and the rings were separated. Exposure to high temperature was clearly evident. Verification testing of the active oiler system flowrate could not be performed due to the extensive damage from high temperature. The inner raceway contained a significant amount of smeared metal. A secondary raceway was generated when some of the balls were driven from the manufactured raceway and became wedged between the outer race land and inner race land on the load side of the inner race. Two balls were fused together with severe skidding damage at both the inner and outer race contact locations. The remaining 13 balls were of various size and shape. The inner race was seized to the flywheel shaft and required the machining of two axial slots for removal from the flywheel shaft. The outer raceway also contained smeared metal and was stuck in the bearing housing steel sleeve. The outer race was seized in the bearing cartridge steel sleeve and was also machined out using a similar technique. No damage was done to bore of the steel sleeve during the outer race removal process. The retainer was almost completely destroyed, with only two significant pieces remaining, showing that the cage appeared to split circumferentially down the center line. The two major fragments remaining each had portions of several ball pockets. A smaller segment containing several pads on which the cage is guided by the inner race land was also recovered. There was no obvious evidence that the cage had experienced unusual wear either within the ball pockets or at the pad-land interface.

The SM side bearing (non-failed side) was in good condition. Adequate lubrication was noted in the ball race contact zone and at the retainer pad and inner race land interface. The balls were bright with some wear tracks that are considered consistent with operation time. Except for one uneven wear track on the outer race, the wear tracks on both races are considered nominal for the operational time. A ring of degraded lubricant was noted on the inner race land, which is abnormal for the accumulated operating time. The retainer was not damaged and did not contain any evidence of unstable operation or distress. Inspection verified the location of the SM bearing wear tracks were consistent with CMG1's lifetime load conditions. Additionally, testing of the active oiler system verified that the lubricant flow was consistent with the presence of fresh oil in the bearing.
