#### JANNAF Lessons Learned Panel Selected Saturn V History

Skip Urquhart Jacobs – ESTS-Group NASA/Marshall Space Flight Center Huntsville, Alabama

May 2010

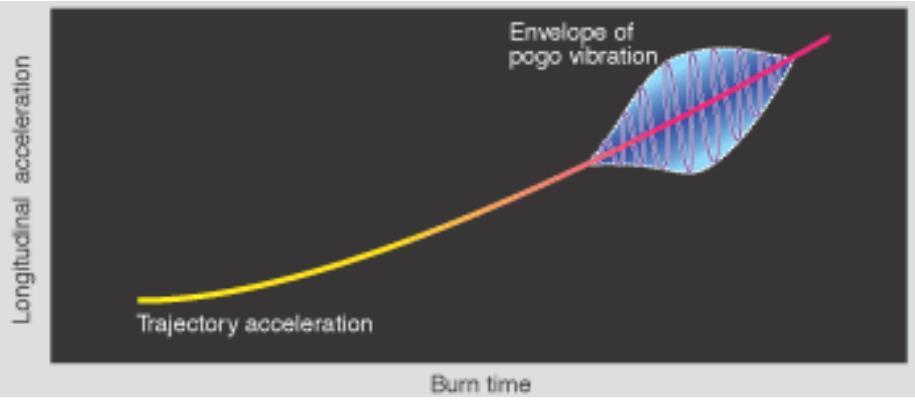
- Pogo occurs when the natural frequency of a propellant feed line comes close to a readily excited rocket longitudinal structural vibration natural frequency.
- Maximum Pogo response corresponds to close tuning of the structural and hydraulic frequencies.
- On Saturn V, accelerations up to 17 g's (Zero To Peak) at the Launch Vehicle/Payload Interface and up to 34 g's at an Engine have been observed.

- Nicknamed "Pogo" because it causes the Rocket to stretch and compress like a Pogo stick.
- First recognized with the Titan II in 1962, Pogo remains a prime consideration in design of launch vehicles today.
