NASA/TM-2010-216840
NESC-RP-10-00608

Wilkinson Microwave Anisotropy Probe (WMAP) Battery Operations Problem Resolution Team (PRT)

*Keys, Denney J./NESC
Goddard Space Flight Center, Greenbelt, Maryland*

August 2010

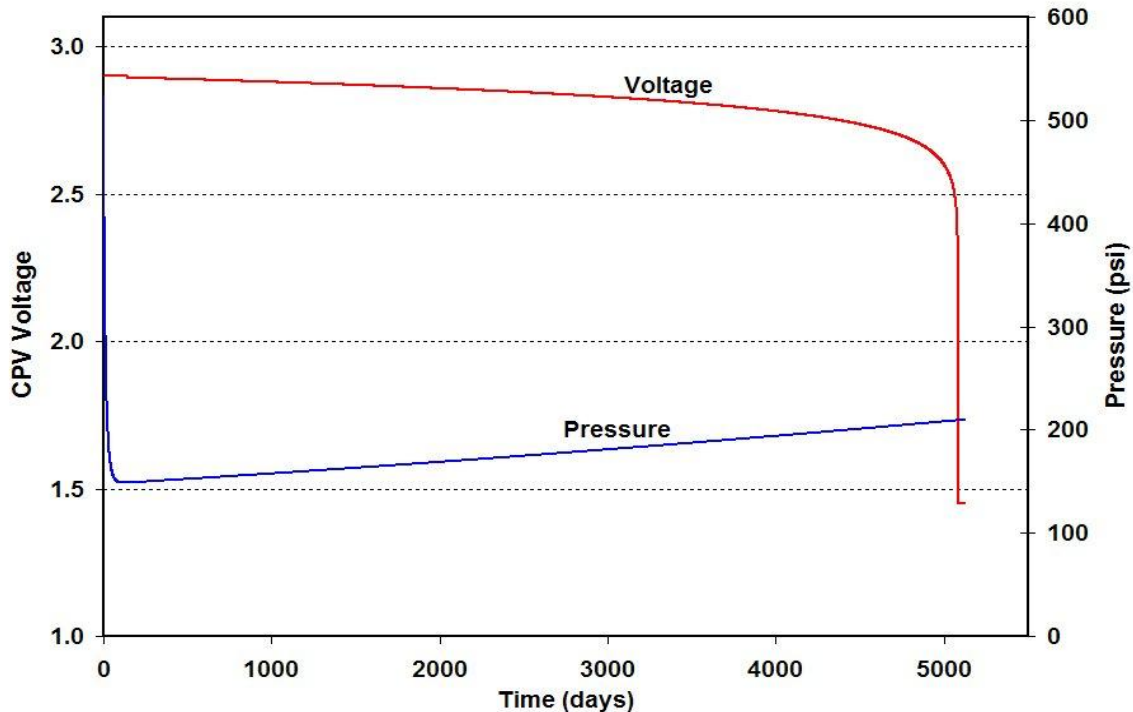
Figure 7.1-1. Modeling of NiH₂ Cell Behavior Using Low Trickle Charge Rate (Zimmerman)

Of note for the modeling results performed:

- Modeling based on previously developed IPV 23 ampere-hour cell model.
- Cell in model initially at 80 percent SOC, which would be comparable to launch/on-orbit condition experienced by WMAP.
- Model included a drop to about 10 percent SOC in 6 months assuming capacity walk-down due to operation using a V/T clamp level insufficient to maintain full charge.
- Thereafter, model SOC response dropped slowly over the next 13+ years, while pressure slowly increased.

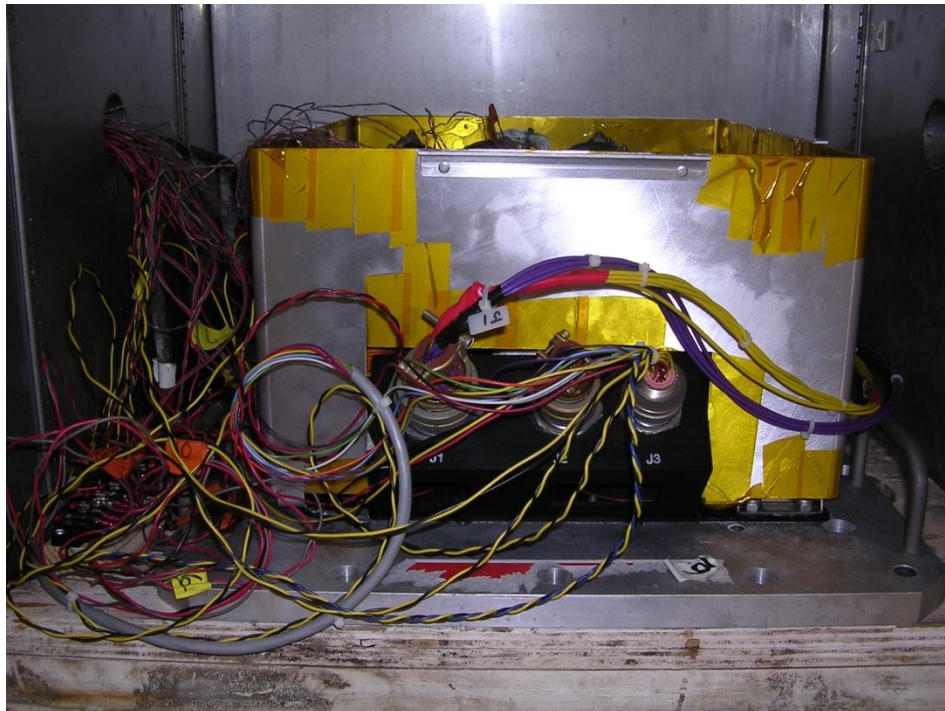
The battery capacity determined at 11.5A discharge rate at 5 o C was 31.1 Ah with CPV vessel controlling the capacity. The charge retention for the battery in the 72-hour test was 66% (to 2V).

The battery capacity determined at 11.5A discharge rate at 5 o C was 31.1 Ah with CPV vessel controlling the capacity. The charge retention for the battery in the 72-hour test was 66% (to 2V). The state of charge when the battery is trickle charged at 10 mA after a full charge at 2.3A for 16 hours was found to decrease as measured by the decrease in pressure of 242 Psi for CPV #4 and 315 psi for CPV #5.

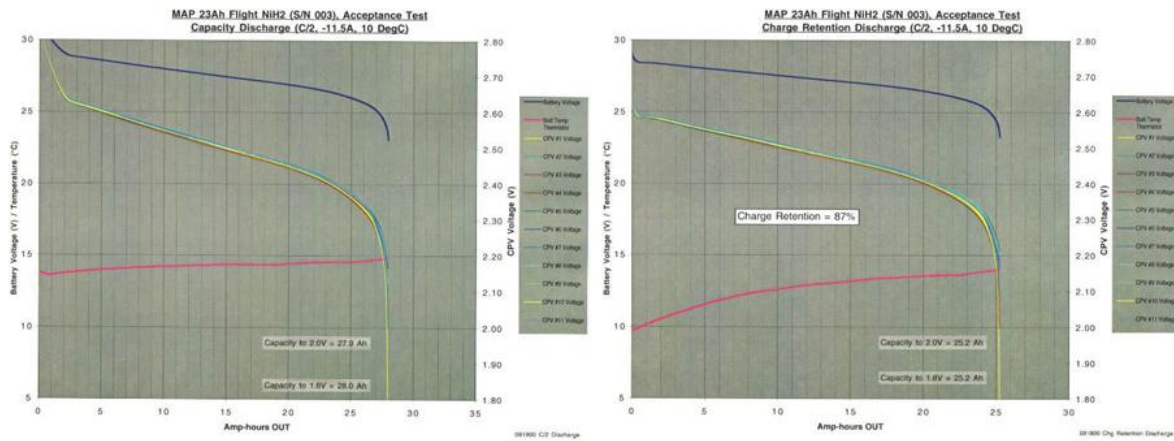
WMAP Capacity and Charge Retention Flight Battery Acceptance Test Results

**Flight Battery Acceptance testing suggests a minimum charge rate of 37.5 mA at BOL to maintain full charge.
Nominal performance noted for test results.**

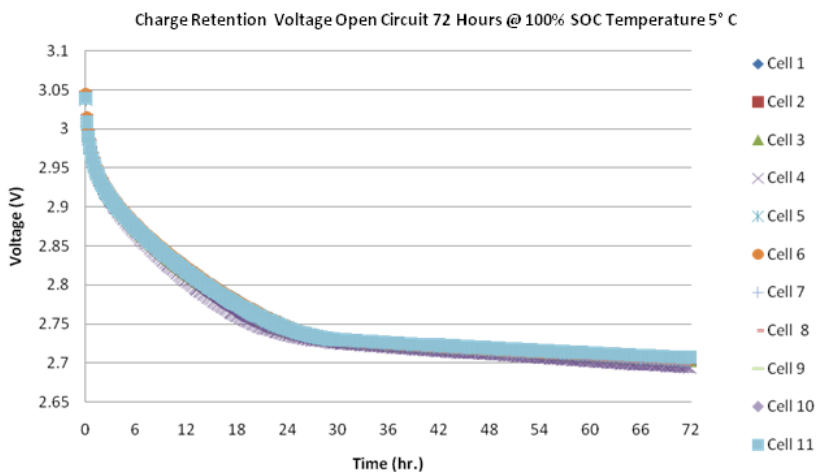
WMAP Flight Spare (Test) Battery Charge Retention Results (at 5°C)

CPV voltages decreased as expected during open circuit stand, but were generally tapering to a stable performance.

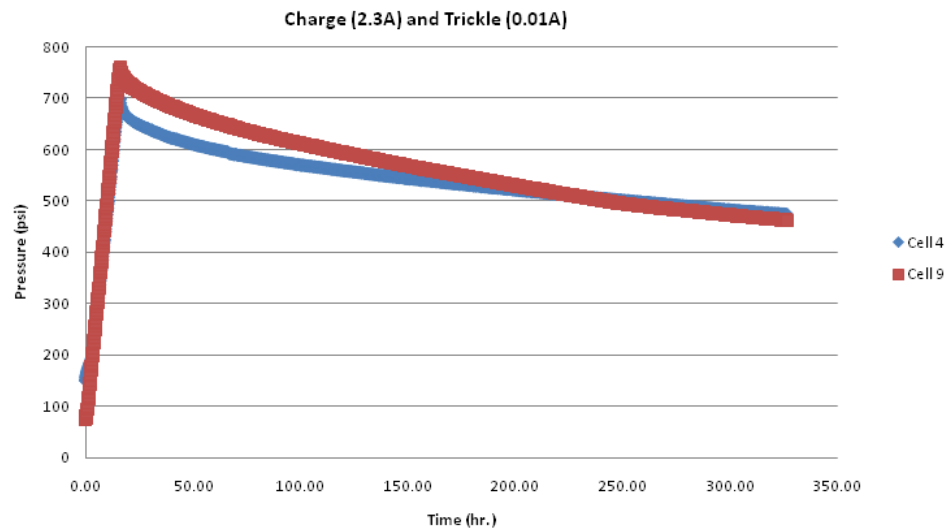
WMAP Flight Spare (Test) Battery Pressure (Capacity) Response Under Low Trickle Charge Rate (C/2300) at High SOC (at 5°C)

Capacity fade beginning at full state of charge and low trickle charge rate was comparable to open circuit stand results.

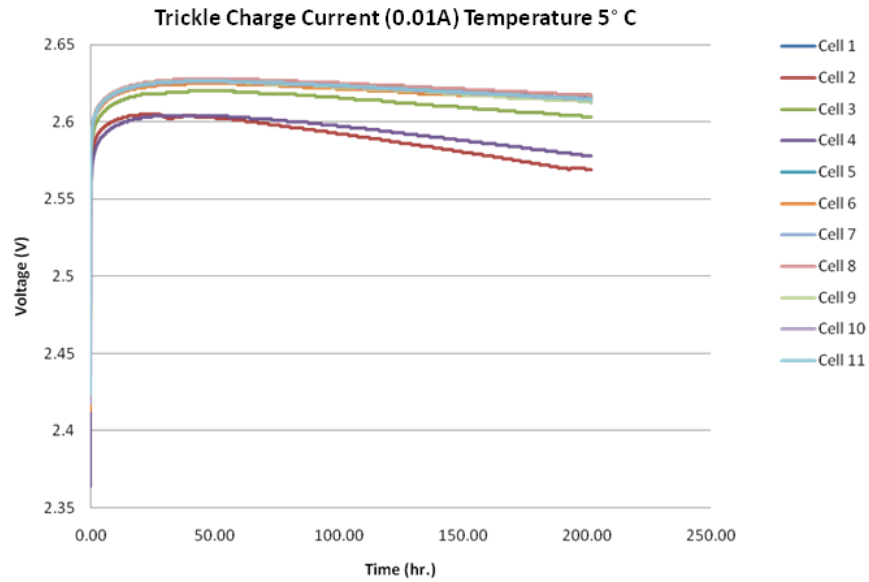
**WMAP Flight Spare (Test) Battery Voltage Response Under Low
Trickle Charge Rate (C/2300) at Low SOC (at 5°C)**

Voltage characteristics also followed comparable characteristics to open circuit stand testing with signs of divergence for several cells.

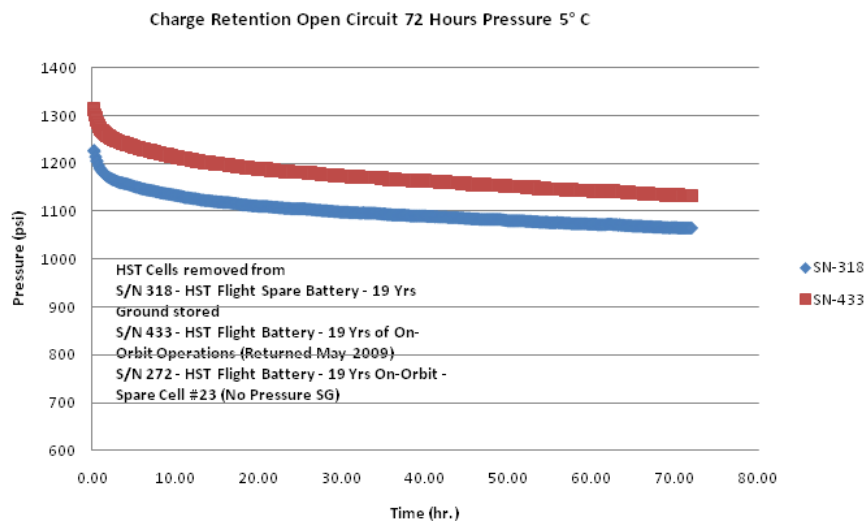
Comparison Sample HST (aged cells) Charge Retention Test Results (at 5°C)

Open circuit stand pressure response of selected 1989 HST cells for comparison.

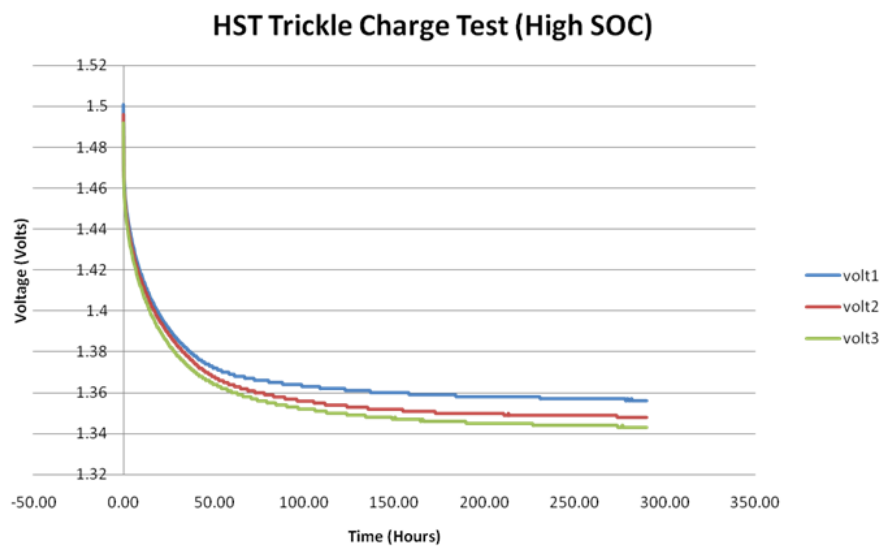
Comparison Sample HST (aged cells) Voltage Test Results High SOC/Low Trickle Charge (at 5°C)

HST cell voltages stabilized under simulated low trickle charge testing at high SOC.

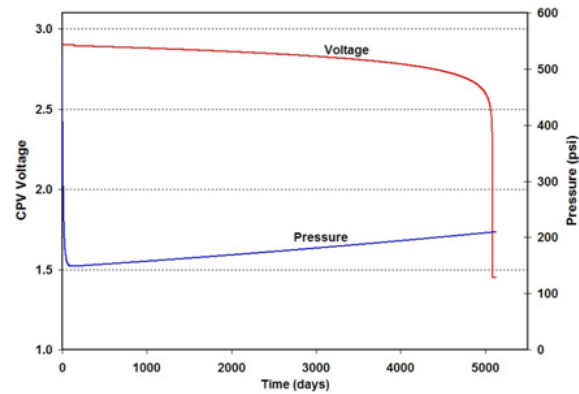
- Based on IPV 23 ampere-hour cell model.
- Cell initially at 80% state-of-charge (SOC).
- Dropped to about 10% SOC in 6 months.
- Thereafter, SOC dropped slowly over the next 13+ years, while pressure slowly increased.

- As pressure increased, the self-discharge rate increased.
- At 13.92 years, the self-discharge rate exceeded the trickle charge rate, and the cell voltage collapsed.
- This is expected NiH₂ cell behavior.
