Ultrasonic Monitoring of Ply Crack and Delamination Formation in Composite Tube Under Torsion Load

P. H. Johnston, C. W. Wright, J. N. Zalameda
NASA Langley Research Center
Hampton, VA, USA
Patrick.H.Johnston@nasa.gov

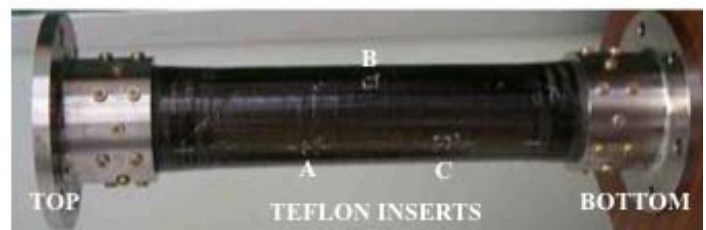
Three 13 μm thick Teflon inserts, labeled A, B, and C in Fig. 1, were placed in the composite wall. Inserts A and C, each 1.27 cm X 1.27 cm, lay just under the outer surface of the composite, while insert B, 0.63 cm X 0.63 cm, lay just inside the inner surface. The inserts were intended to simulate preexisting delamination damage and serve as possible damage growth initiation sites.

Figure 1. Photograph of the composite cylinder specimen. Labels A, B and C indicate the locations of Teflon inserts.
