HYPERGOLIC PROPELLANTS: THE HANDLING HAZARDS AND LESSONS LEARNED FROM USE

B. Nufer

NASA Kennedy Space Center, Engineering Directorate, Fluids Division, Hypergolic and Hydraulic
Systems Branch

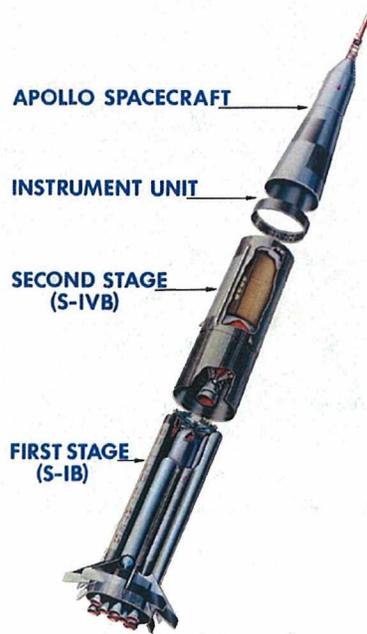
Figure 4: Saturn 1B Launch Vehicle

The N_2O_4 spill occurred when a vacuum was applied to the Command Module Reaction Control System (RCS) propellant tank prior to the second dry-run servicing test. It was later determined that a quick disconnect (QD) servicing valve had become blocked during the initial dry-run test (proximate cause). When the vacuum pump was brought online for the second dry run, oxidizer was pulled into the pump's oil sump and then subsequently released out of the oil sump tank vent port. Technicians used the standard procedure at the time, which was to dilute the propellant using water. This, unfortunately, resulted in the formation of nitric acid. Approximately 400 gallons of water were used to dilute the N_2O_4 which ultimately ran down the side of the launch vehicle and into the instrument unit ring, as seen in Figure 4 in the Saturn 1B cutaway view.

The damage to the vehicle was extensive and the delay was several weeks. The cleanup on the ground level of LC-34 took several days. A de-stack was completed to remove the instrument unit ring for repair. Most of the wiring in the instrument unit was removed and cleaned. Four cables were replaced and five connectors were rebuilt. Three of the outside antennas were also replaced along with the Saturn IB fin #4 and liquid oxygen bay three door. The forward skirt was removed from the Saturn IV B segment to allow for access inside the launch vehicle. The primary concern for the vehicle was long term corrosion. The vehicle design organization eventually became comfortable with proceeding to launch following several tests. This incident led to the following process and design changes:

- Following use, every QD was disassembled, cleaned, and all soft good were replaced
 - An inadequate maintenance plan was considered the root cause of this incident

- All subsequent GSE tests were performed using a referee fluid such as Freon or alcohol

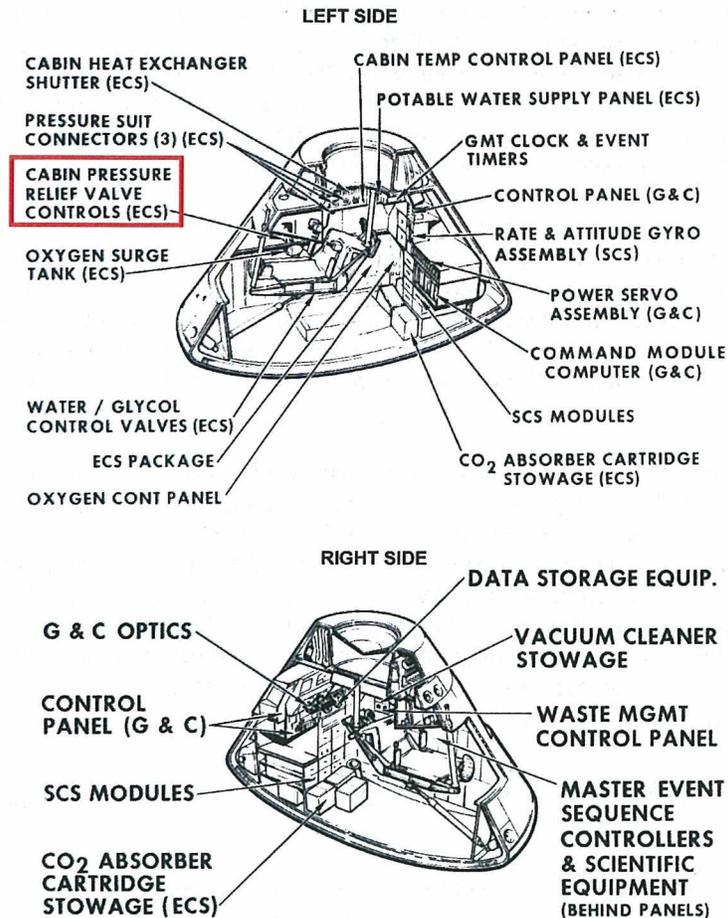
Figure 6: Apollo Command Module Interior Cutaway

The exposure greatly altered the astronauts' abilities to complete assigned tasks in a timely manner; therefore, they experienced a very rough landing along with the poor luck of having the capsule splash-down in the "Stable 2" configuration, which meant it was inverted in the water and thus closed off from the outside air with the relief valves closed. Following splash-down, the crew was forced to don their oxygen masks, but in the interim before Stafford could retrieve and distribute the masks, Brand (who was sitting closest to the relief valve, see Figure 6) lost consciousness.

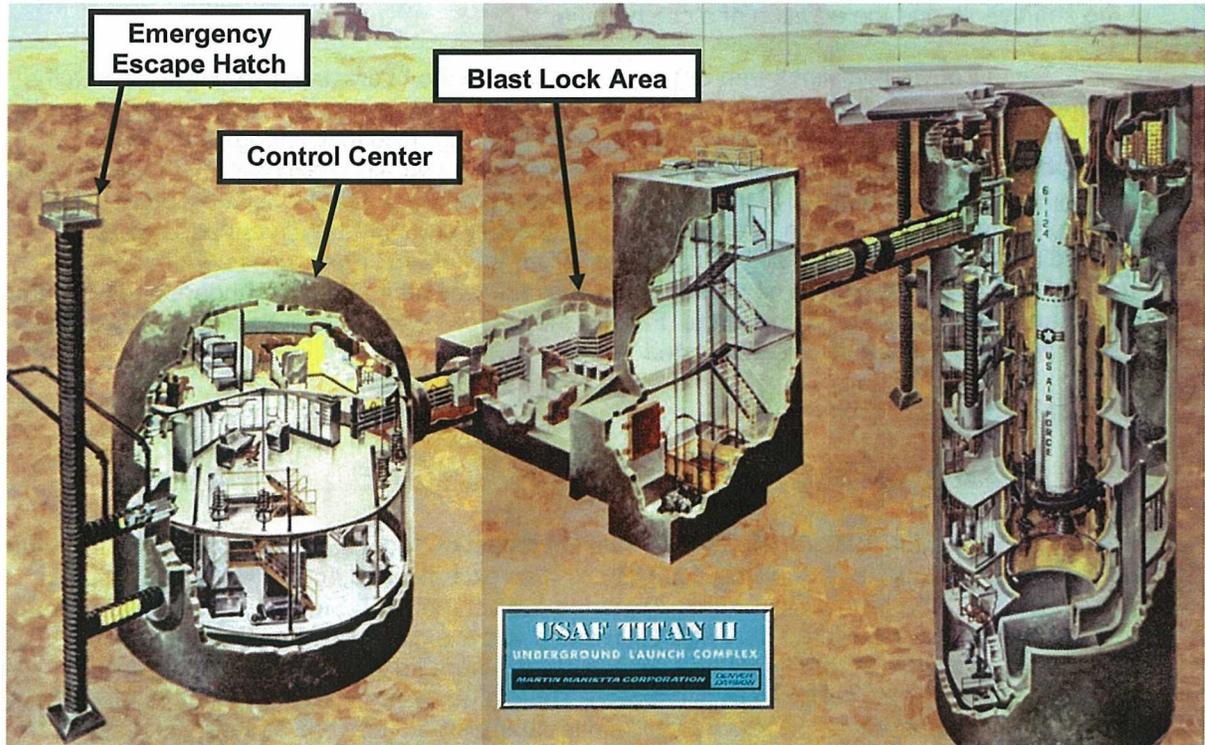
Figure 7: Underground Titan II Missile Complex

Very high concentrations of NO₂ vapors traveled from the silo into the connecting cableway to the blast lock area, which was located just outside of the control center where several personnel were located (see Figure 7). All the personnel located in the blast lock area managed to escape the vapors by exiting through the access portal at ground level. The personnel in the control center would normally be isolated from the silo; however, two technicians involved in the spill opened the airlock door to try and obtain assistance for their supervisor who was in need of immediate medical attention. The two technicians and four other control center personnel then evacuated through the emergency escape hatch, once they realized the immediate danger of the situation. The nearby town of Rock, Kansas had to evacuate about 100 people as a result of the vapors that were escaping from the silo (see Figure 8).

It was later discovered that the suit of the supervisor had failed, introducing him to dangerous levels of N₂O₄ (NO₂) vapors, which was ultimately fatal to him within minutes of being

- Proper configuration control of GSE components, in this case the filter, is highly important in the handling of toxic chemicals, especially hypergols (root cause of the incident)
- Emergency procedures and safing must always be reviewed, practiced, and ingrained in the minds of personnel working with toxic chemicals
- Procedural oversight may have been beneficial
- Proper isolation of bulk propellant should be inherently designed into any rocket propulsion system and used accordingly during loading operations
- Personal protective equipment (PPE) should be inspected prior to every use

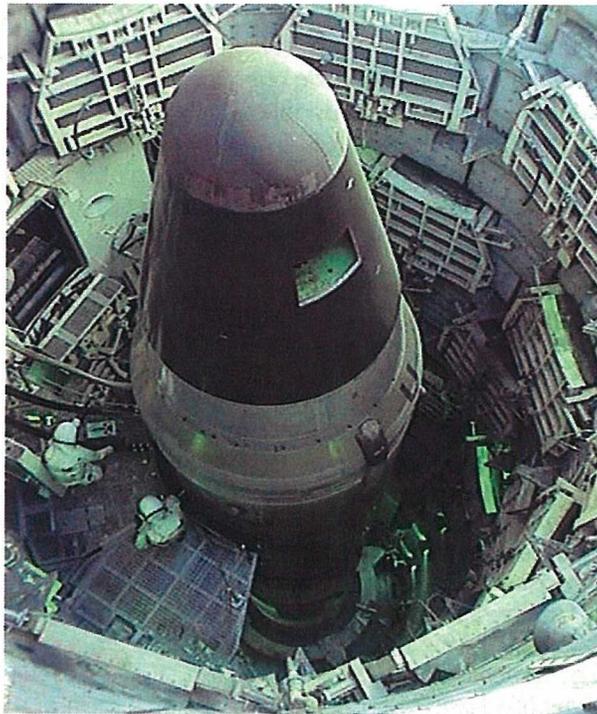
Figure 9: Technicians Working on Fold-Down Platform in Titan Silo Level 2

At about 6:30 PM on September 18, 1980, an airman was conducting a maintenance operation on level two (see Figure 9) of the underground silo when he accidentally dropped a large wrench socket. The standing platforms were hydraulically-controlled, flip-down structures with a rubber boot mounted between the platform and the rocket. The socket fell hitting the standing level two platform and bounced in the direction of the rocket where it slipped through the small gap between the rubber boot (which had become pliable over the years) and the Titan II rocket. It fell about 70 feet before hitting the thrust mount near the base of the rocket. The socket then bounced into and ruptured the stage one fuel tank (proximate cause). Approximately 11,140 gallons of A-50 drained into the bottom of the silo. Fuel vapors heated up the silo and caused the pressures in the non-ruptured propellant tanks to rise substantially.

- All workers should wear a belt with lanyards to attach tools
 - Operational human error is, therefore, the root cause
- Cloths should be placed on the platforms to prevent tools from bouncing off the metal

- The Titan II missile silo platforms should be renovated to increase safety
- The training and qualification program was insufficient prior to the incident (a root cause)

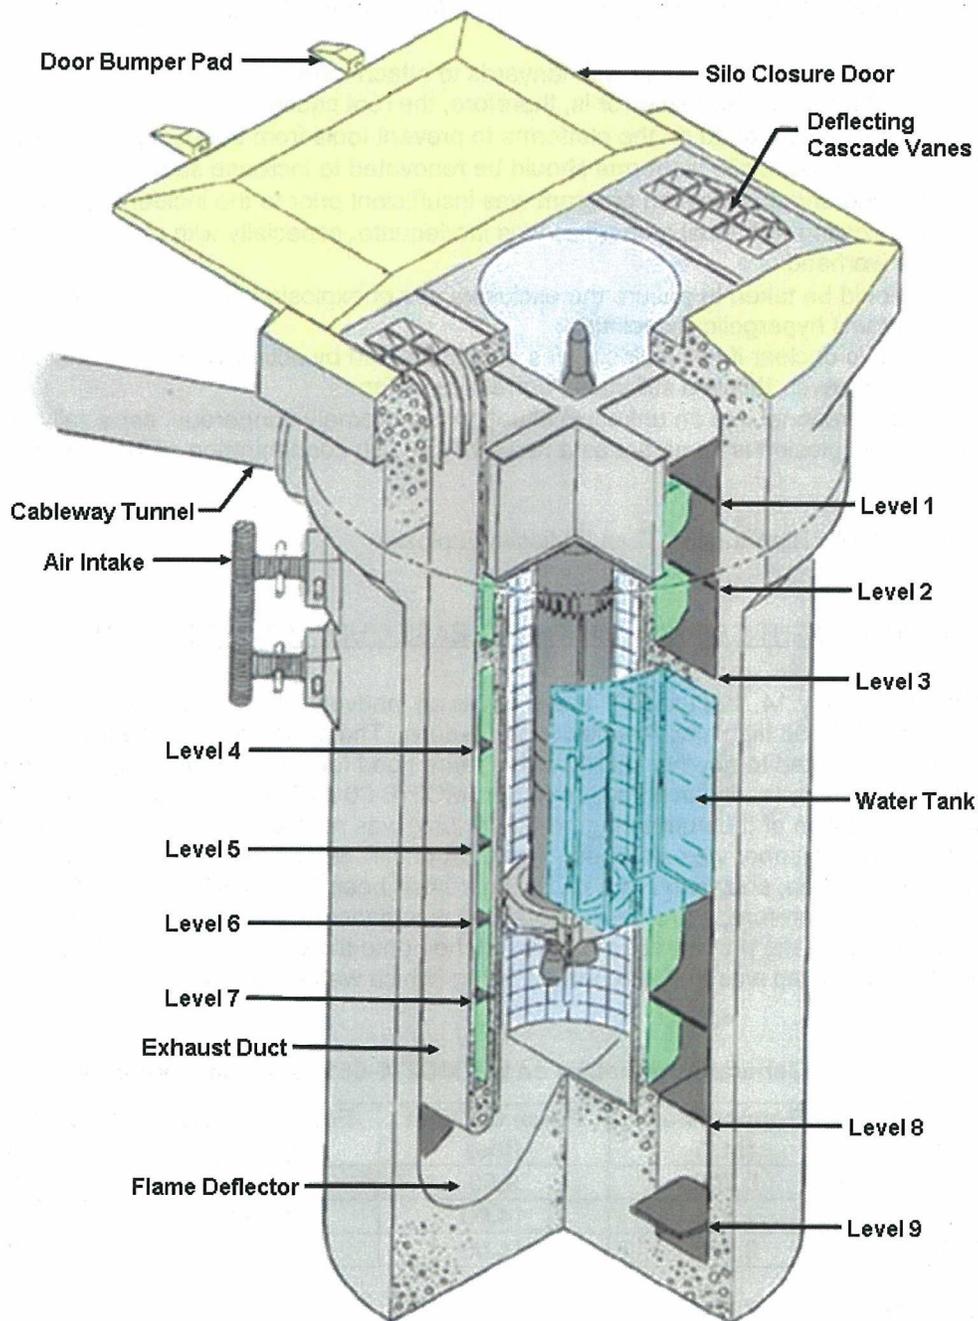
Figure 10: Titan II Missile Silo

It was reported that the explosion blew the 740-ton reinforced concrete and steel silo door (see Figure 10 for a depiction of the Titan II missile silo) 200 feet into the air and 600 feet from the silo. The rocket's second stage, with the W53 thermonuclear warhead attached, was launched out of the silo following the explosion of the first stage. The second stage then supposedly blew up in midair, (it contained about 1,730 gallons of A-50 and 3,120 gallons of N_2O_4) sending the undetonated warhead several hundred feet from the silo. The W53 warhead had a mass of 8,136 lb and a yield of 9,000 kilotons (the Hiroshima bomb "Little Boy" was estimated at about 15 kilotons). Luckily the warhead's safety features operated as they were designed. There was no reported loss of radioactive material.

The 374-7 Titan II missile silo complex was completely destroyed. The estimated value of the silo in 1980 was approximately \$225,000,000. In October of 1981, President Reagan announced that all of the Titan II ICBM launch sites across the United States would be deactivated by October of 1987. Along with this action being part of the strategic modernization program, the deactivation was related to this incident and the previously mentioned incident at McConnell AFB. Silo 374-7 was the first Titan II silo to be deactivated. The 308th strategic missile wing was completely deactivated on August 18, 1987.

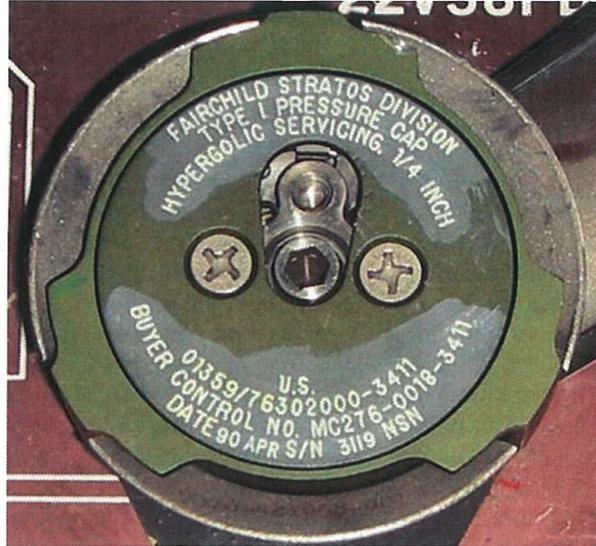
Figure 11: Fairchild 1/2-inch Flight Cap

During the MD338 flight cap installation procedure, on roughly July 14, 1981, the work step correctly called for the installation of a 1/2-inch cap (part number MC276-0018-2811) onto the AHC. The cap that was staged for installation was the misidentified 1/4-inch cap. When a 1/4-inch cap is placed onto a 1/2-inch AHC, the dimensions of the stem allow for the actuation of the 1/2-inch AHC poppet (reference Figure 30 for an illustration of this) if the proper force is applied to the cap and poppet. This is exactly what happened. An oxidizer vapor release was reported when the technician tried to install the 1/4-inch cap (proximate cause). The root causes are human error, improper configuration management, and improper vehicle design. The original flight cap design should not have enabled this type of incident to occur. The technician received minor injuries from exposure to NO₂ vapors. Close attention needs to be paid to the identification of flight caps and other hardware to prevent an event like this from occurring again (which it does on November 4, 1992 at WSTF).

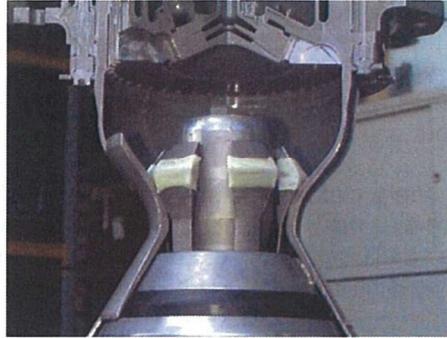
Figure 20: Space Shuttle Thruster Chamber Cutaway with Purge Adapter Installed

There are three possible proximate causes to this spill. A combination of two or more of the following causes is also possible. The first involves an improper configuration in which the flexhose that was being used for the procedure had previously been utilized for a similar operation on the left pod thruster L1U's manifold. This flexhose was several feet longer than the flexhose that was normally used for the right pod manifold evacuations. It was routed from the R4D thruster purge adapter to the 19-foot level above, then down to the eductor on the 10-foot level. This excessive length in hose may have allowed for a "u-shaped" low point trap to be formed in which liquid MMH could have collected. The second possible proximate cause involved a procedural error made by the engineers on console. The evacuation could have created a pressure differential across the liquid MMH. When the eductor was deactivated and removed, this pressure differential may have pushed the liquid into the thruster chamber. The third possible proximate cause was the liquid had collected in the thruster chamber (see Figure 20) and the purge was of insufficient duration to remove all the liquid MMH or the liquid trap may have

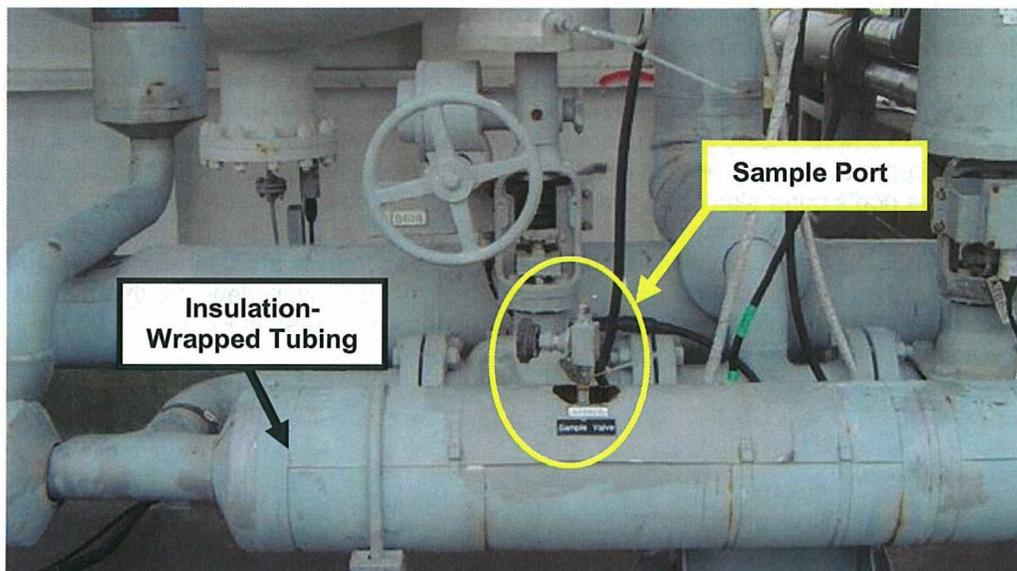
Figure 24: Photograph of Sample Port

On May 25, 1988, at the Pad 39B oxidizer farm, technicians were completing an N₂O₄ sampling operation. During the operation, the technicians detected a small leak at the interface between the sampling valve and the tubing (see Figure 24). The sampling operation was delayed until the leak could be fixed. The repair was finally scheduled to be worked about a month later during the afternoon of June 23, 1988. The removal of some local insulation was required to fix the leak along with re-torquing the fitting that connected the sample valve to the tubing. This was all completed that afternoon.

At about 10:30 PM on June 23, 1988, the sampling operation was successfully repeated. This was followed by the disconnection of the sampling flexhose from the sample port. When the flexhose was removed, liquid N₂O₄ spilled (about two tablespoons) into the small well surrounding the sample port. It was not uncommon to have a small amount of residual N₂O₄ remaining in the sample flexhose when it was disconnected. The spilled N₂O₄ reacted with the adhesive used for the attachment of the insulation to the tubing and ignited (proximate cause of the fire). The fire burned itself out in about 10 to 15 seconds before the technicians in SCAPE could return with a fire hose. There were no injuries to the personnel working the operation and the only hardware damage was to the insulation, which was replaced.

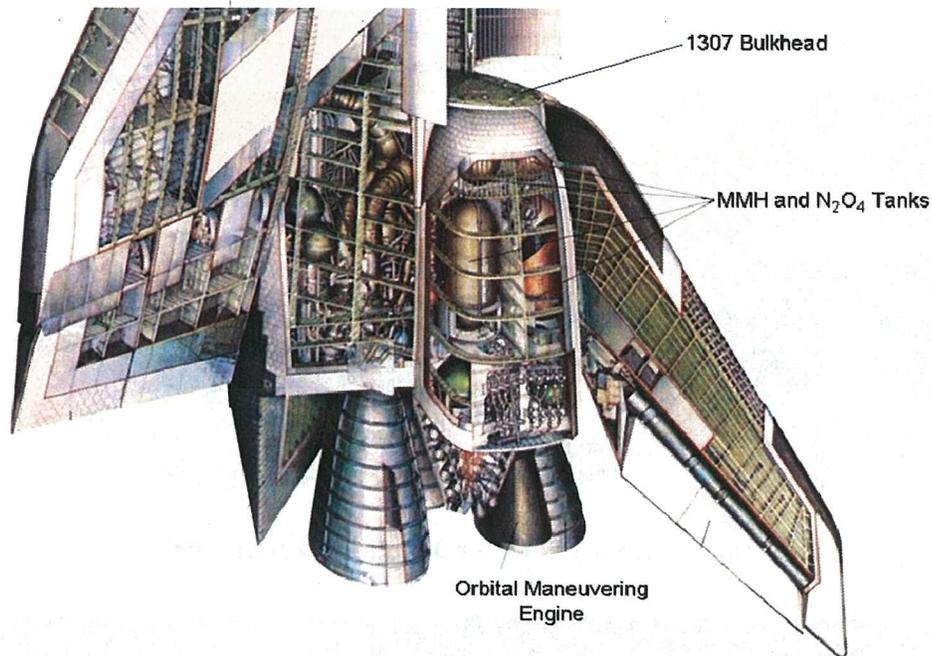
Figure 25: Cutaway View of Space Shuttle Orbiter Aft

First, the exact location of the leak within the pod had to be found (a cutaway view of the Space Shuttle OMS pod can be seen in Figure 25). This was difficult because the internals of the aft pods and forward module are not meant to be accessed while the vehicle is at the launch pad. The location of the leak had been isolated to the LRCS N_2O_4 system or the associated tubing through monitoring of the instrumentation in the LCC. The leak was measured to be 0.26 psi per hour (about 800 standard cubic centimeters per hour) and a TVC found the concentration of NO_2 vapor to be 15 ppm at the vehicle vent door. This later decreased to 3 ppm. An access door was removed on the pod's outer skin and several internal thermal blankets were removed. A long section of PVC pipe was then inserted into the pod to function as a guide for a borescope. Using a borescope, the leak was finally isolated (after a six hour search) to a ½-inch dynatube fitting on the MD224 leg (the N_2O_4 propellant tank ullage vent). A cross-section view of a dynatube is shown in Figure 26 and a photograph of the leak location can be seen in Figure 27.

The engineering team came up with the following solutions to resolve the leaking dynatube:

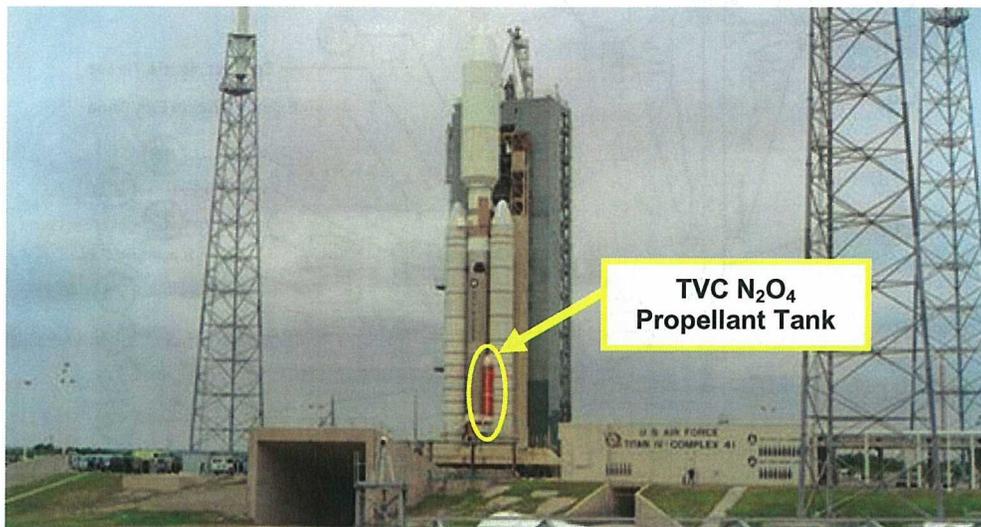
Figure 31: SLC-41 with Titan IV A (Servicing Structure Retracted)

On August 20, 1994, at Space Launch Complex 41 (SLC-41) on CCAFS there was a large release of liquid N₂O₄. Oxidizer was being loaded into the Titan IV A's solid rocket motor (SRM) thrust vector control (TVC) system in preparation for the launch of the National Reconnaissance Office's Mercury Electronic Intelligence or ELINT satellite on August 27, 1994. The N₂O₄ was used to alter the combustion in the Titan IV A SRM nozzle and, therefore, provide TVC. A photograph of the SLC-41 launch pad with a Titan IV A is shown in Figure 31. A diagram of the Titan IV A's TVC system is shown in Figure 32 with the numbered callouts listed in Table 2. The incident occurred about three and a half hours after sunrise when the solar heat caused the pressure to increase in the N₂O₄ tubing while the system was in a static configuration.

The pressure increase went unnoticed by the engineers and technicians. Remote data monitoring was available on the launch vehicle, but not on the propellant transfer systems (GSE). Local dial gauges likely showed the increase in pressure; however, there were no technicians monitoring these particular gauges. The pressure rise eventually caused a weld seam to fail at the base of the transfer system (proximate cause). This portion of the N₂O₄ servicing GSE lacked a relief valve, thus allowing the propellant in the tubing to become "liquid locked" since a drain-back and purge had not been completed (improper design; a root cause). There was no damage to the GSE (excluding the ruptured tubing) or vehicle hardware and there were no reported injuries.

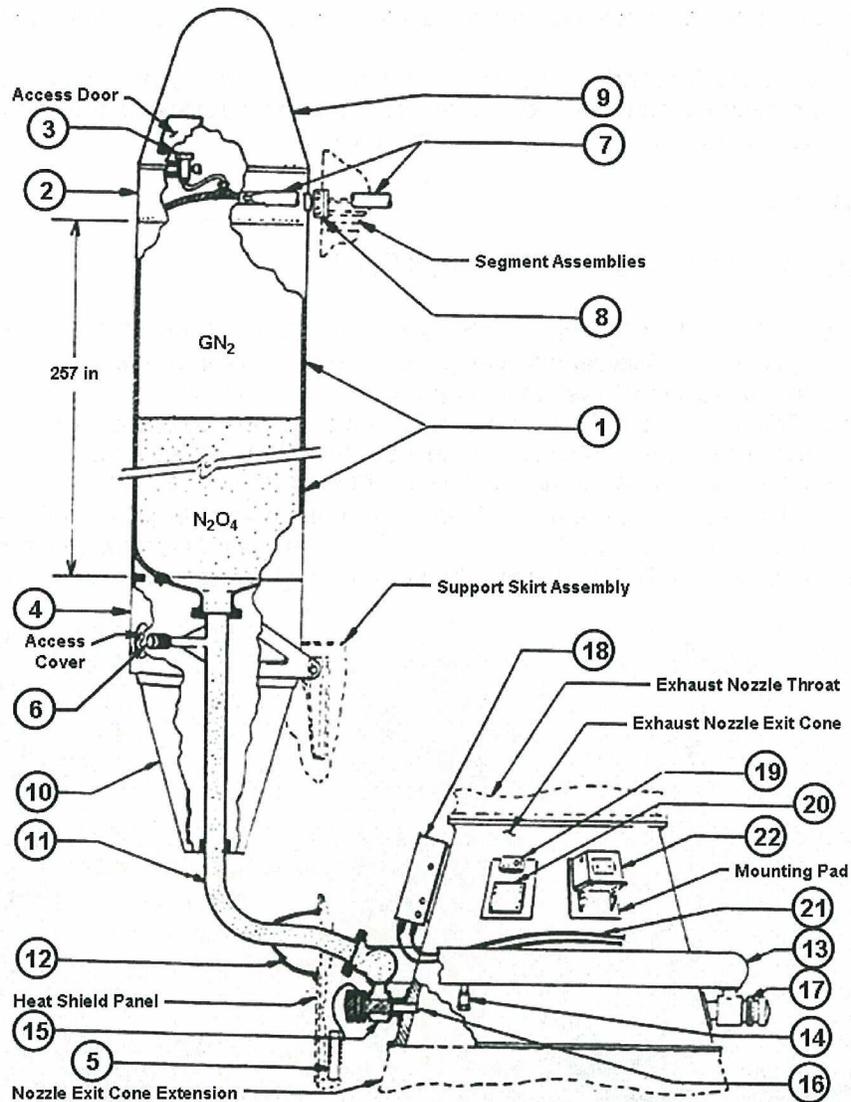
Figure 32: Titan IV A TVC System Schematic (see Table 2 for references)

Usually this tubing would not contain any propellant unless a loading operation was underway; although, schedule pressure led to the decision to halt the propellant drain-back and purge following the loading. The processing schedule had been delayed by a couple hours as a result of addressing a leak on a fill and drain valve on the SRM TVC system. Once the fill and drain valve leak was repaired, other non-related, time-critical work required attention on the upper stage of the Titan IV rocket. As a result, the Launch Conductor delayed the purge of the oxidizer loading system by several hours since these two operations could not be conducted in parallel. Once the upper stage task was completed, the Launch Conductor delayed the purge again to allow the engineers and technicians to prepare for the fuel loading operation. Fifteen minutes after the vehicle fuel tanks were loaded for flight, the N₂O₄ GSE tubing ruptured. The release amount was approximately 350 to 400 gallons into the launch pad transfer slip.

Another root cause of this incident was determined to be frivolous procedure deviations. The loading team and Launch Conductor had experience with successfully delaying the oxidizer drain-back and purge; however, this experience was based on insulated oxidizer tubing. The tubing at SLC-41 had recently been removed and replaced with non-insulated tubing as a result of the moisture trapped in the insulation causing accelerated corrosion. The loading team and the Launch Conductor either did not recall this or they were never told.

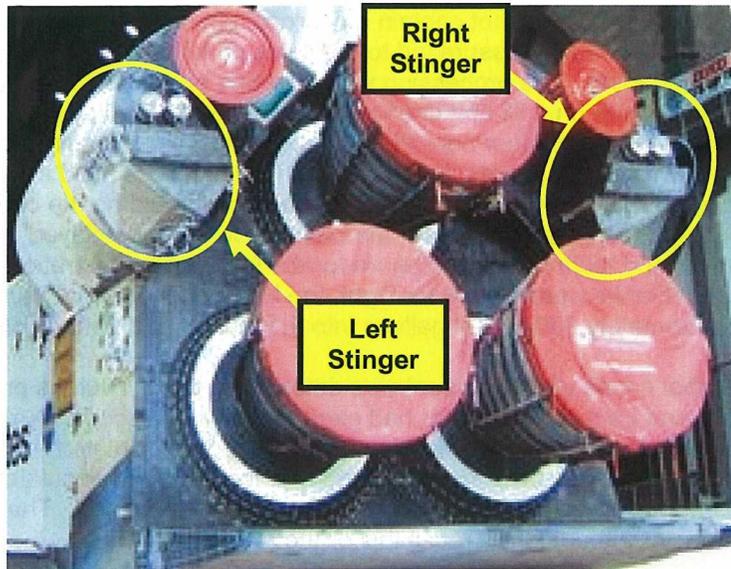
Figure 33: Stinger Locations on Orbiter

During the STS-69 OV-105 flow, while performing a thruster L3D removal and replacement, an MMH flame was reported in the Space Shuttle left OMS pod stinger area (see Figure 33 for the relative location of the stingers). The technician in SCAPE was preparing to inspect the dynatube (approximately an hour after the thruster was removed) with a mirror when he reported a small flame on the MMH thruster feedline dynatube. Another technician was unable to find any water to put out the fire and mistakenly picked up an alcohol bottle and sprayed the flame which produced a small flash near the feedline, igniting the residual MMH inside it. It is believed that the technician thought the spray bottle was Freon. It was reported that the flame was extinguished by the technician placing his SCAPE glove over the dynatube end. This was probably not the best idea since MMH can react exothermically in a rigid volume and burn in an atmosphere 2.5% to 98% by volume in air.

Prior to the reported fire, the technician removed the Aclar (plastic film) bag from the open end of the thruster feedline dynatube fitting. This fitting connects the manifold to the thruster. When he did this, he noted that there was an exceptionally large amount of fuel vapor present and some liquid MMH was dripping from the open line. The technician proceeded to place the aspirator directly on the feedline dynatube (the procedure and known practice was to place the aspirator perpendicular to the dynatube exit). This was likely the proximate cause of the fire. The engineer on console then noted that the manifold pressure dropped from 16 psia indicated to 6 psia indicated in about five seconds (the transducer had a 2 psi offset). The manifold pressure stabilized to 16 psia indicated after a couple minutes. At this point, the technician was instructed by the engineer to remove the aspirator from the dynatube. He did this and then left the area to find a mirror to aid in the dynatube inspection. When he approached the dynatube with the mirror he noted a "cream/yellowish color" flame and "heat waves." As previously mentioned, he proceeded to put out the flame with his glove after the other technician doused the area with alcohol.

It was later determined through analysis that an MMH decomposition (exothermic) reaction had occurred in the thruster feedline and there was likely a flame present. When the aspirator was placed onto the dynatube, it removed the inert GN_2 from the line and replaced it with an inrush of air. The residual MMH that remained as a thin film around the inner diameter of the tube began to react with the oxygen in the air. When the decomposition reaction reached a temperature of $382^\circ F$ within the interior of the feedline, ignition occurred. A flame will persist until the fuel is exhausted or the oxidizer is removed or exhausted. In this case, the glove of the technician's SCAPE suit removed the oxidizer.

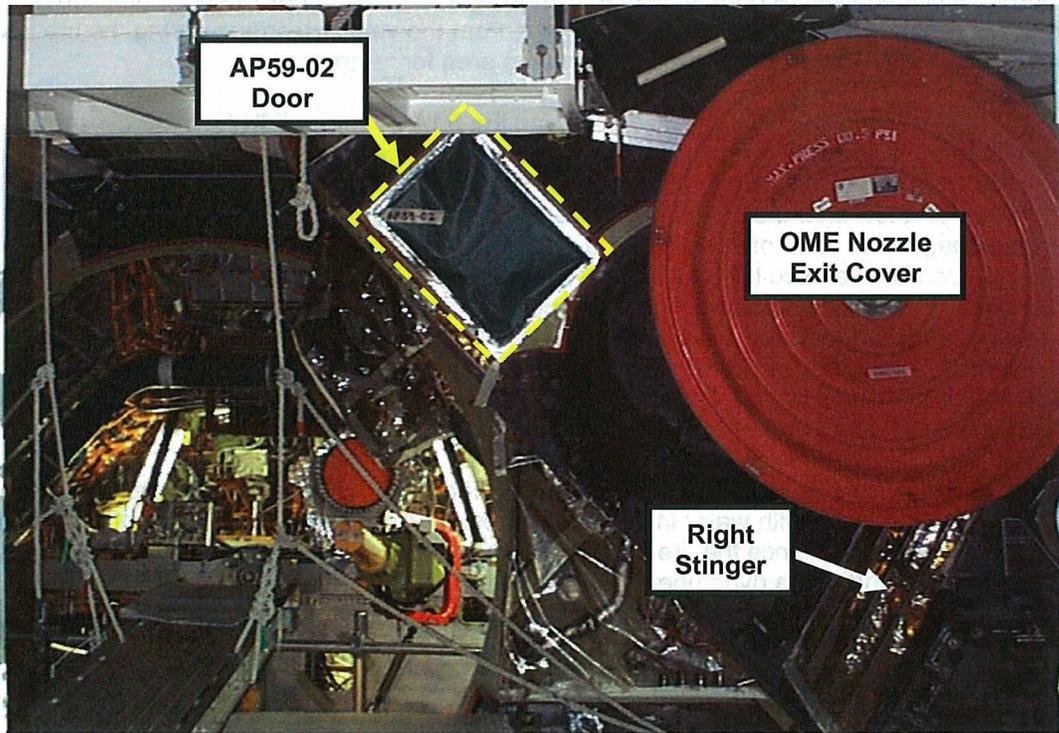
Figure 35: Color Photograph of Right Pod and Orbiter Aft

During the STS-69 OV-105 flow, while performing a thruster R1A removal and replacement, a fire broke out in the Space Shuttle right OMS pod stinger area. The fire burned strongly for about 30 seconds and a smaller flame burned for about one minute and 45 seconds. The size of the flame was estimated to be approximately 15 inches x 11 inches x 11 inches with a damage region of approximately 22 inches x 14 inches x 14 inches in the stinger. The materials that burned included several ounces of fuel, a shop light, and the Orcofilm spill protection (flame retardant covering films). Figure 34 is a still image from the video recording during the fire and Figure 35 is a clearer color photograph of the same area for reference.

Following the fire, the oxidizer feedline was plugged and the fuel feedline fitting was tightened to safe the system. There were no reported injuries. There was an appreciable amount of damage to flight hardware from the fire and the water that was used to extinguish it, including several RCS thrusters, three purge ducts, some electrical harness ties, and eight thermal control system (TCS) blankets. This damage required removal of the OMS pod for refurbishment at the HMF. A total of 33 PRACA items were taken for damage as a result of the fire. The three purge ducts, eight thermal blankets, and four propellant line clamps were removed and replaced with like items along with thrusters R1R, R1U, R3A, R3R, R3D, and R1A (which was removed in the OPF immediately following the fire). The only thrusters that had fire damage were R1R, R1U, and R3A, the rest were required to be removed since they were located on the same manifold as another thruster that was being removed. The thrusters were refurbished and returned to logistics as usable spares.

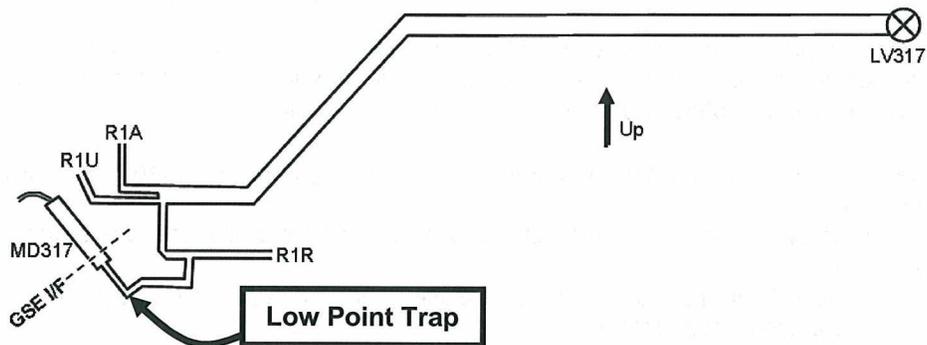
Figure 36: Approximate Manifold 1 Layout Schematic

Another possible scenario (not included in the formal mishap report) for the pressure increase was put forth stating the pulse purges were unable to remove all the liquid MMH as a result of a low point trap present in the manifold near the MD317 (manifold 1 drain/purge QD) AHC interface. Figure 36 shows the basic layout and low point in fuel manifold 1 in the right pod stinger area. It is believed that during the purge, gas was unable to enter the line through the MD317 QD to displace the liquid MMH out of the manifold. This was a result of a small bubble that had formed in the low point as a result of helium coming out of the liquid MMH/helium solution. The helium slowly coming out of solution may have been the source of the pressure rise in the manifold rather than a leaking manifold isolation valve. Once the fire started, it heated the area thus increasing the pressure and pushing additional fuel out of the fuel feedline that was trapped. In both scenarios (leaking manifold isolation valve or helium coming out of solution), liquid MMH was present in the manifold line just prior to and during the fire and the manifold pressure increase went unnoticed.

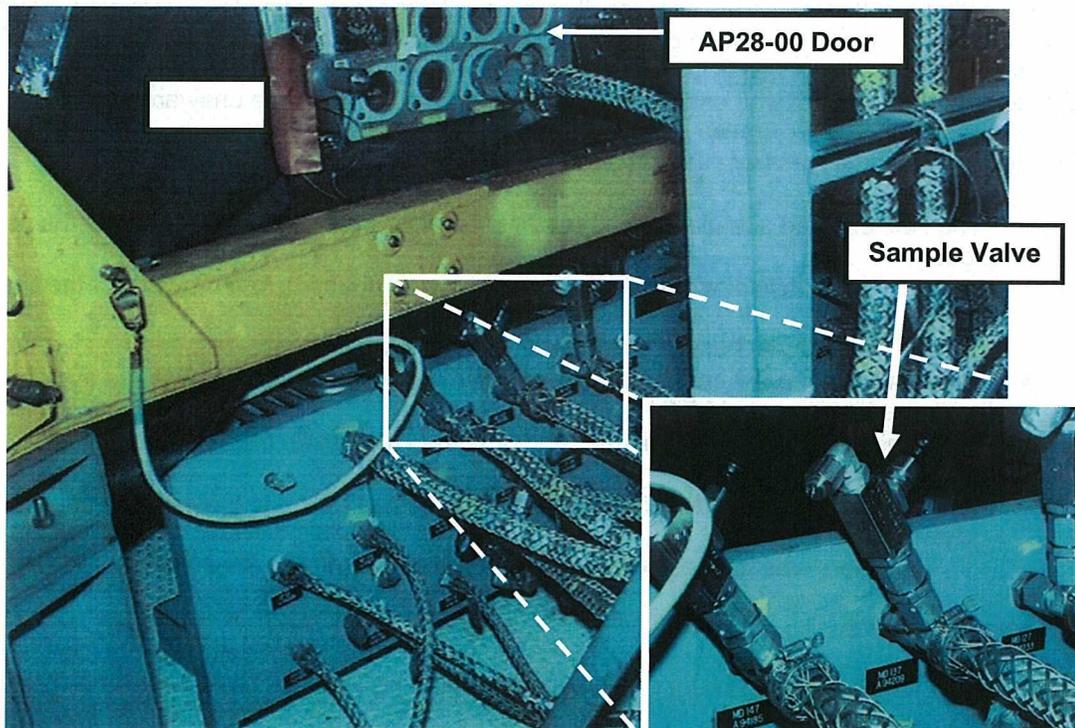
Figure 37: MD137 Flexhose Sample Valve

One technician powered up the aspirator and then began to remove the sampling valve outlet cap from the MD137 flexhose (see Figure 37 for a close-up view of the sampling valve). A TVC of the area was then performed with a resulting reading of 0.0 ppm. The technician laid the aspirator hose on the side of the rack, which was not a suitable position to capture any liquid or vapor that may be released from the valve outlet as the procedure stated.

The technicians were then at the point in the procedure where the valve was to be opened. The procedure was written to imply that there may be some vapor released from the valve when it was opened. Liquid MMH was not expected, but, as it turns out, there was a liquid

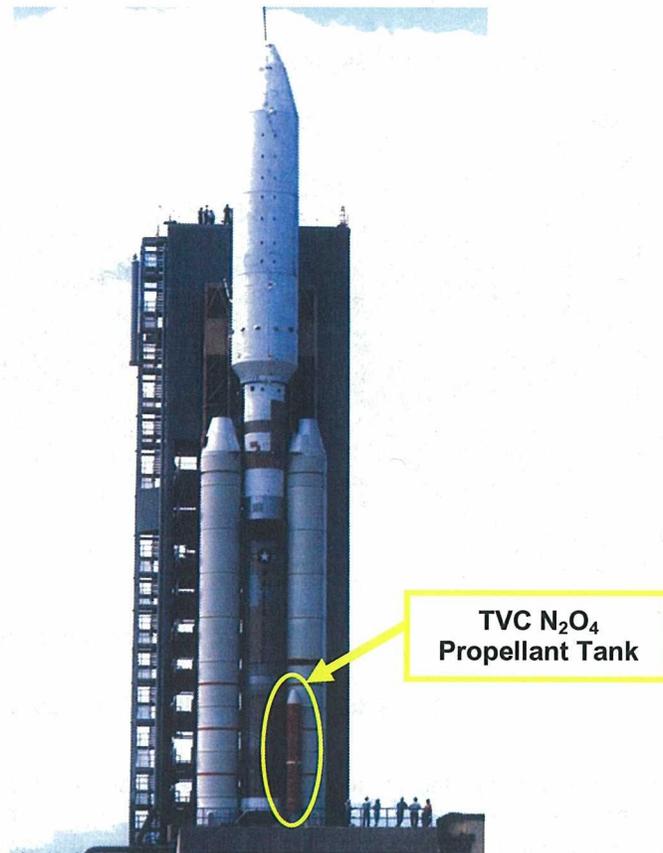
Figure 38: Titan IV A on Launch Pad

satellite. Figure 38 shows a Titan IV A configuration at its launch pad and points out the location of the N_2O_4 tank.

About 20 minutes after initiating the propellant tank pressurization, liquid N_2O_4 was observed to be streaming out of the aft skirt heat shield region on *both* SRMs. There were no reported injuries and the flight hardware had minimal collateral damage (mainly on the SRM nozzles). At the time of the observed N_2O_4 release (likely initially noticed by the signature brownish-orange NO_2 vapors characteristic of an N_2O_4 spill) the propellant tanks were at a pressure of about 830 psi. The target pressure was about 1,040 psi. The engineers quickly began to depressurize the propellant tanks, which had the immediate affect of decreasing the rate of propellant release. The tanks were vented from their initial pressure of about 830 psi to a final pressure of 38 psi, at which time the N_2O_4 release ceased. At that time, all systems were secured and the operation terminated. It was decided to offload all of the propellant from the subject tanks, so about eight hours later, the engineers and technicians began the offloading procedure. This operation was completed without incident. Following the offload and evacuation of the TVC N_2O_4 system and tubing, the total amount of propellant transferred was estimated. About 1,160 gallons of N_2O_4 was re-captured as a result of the drain-back. This logically implies that about 244 gallons of N_2O_4 was released to the atmosphere.

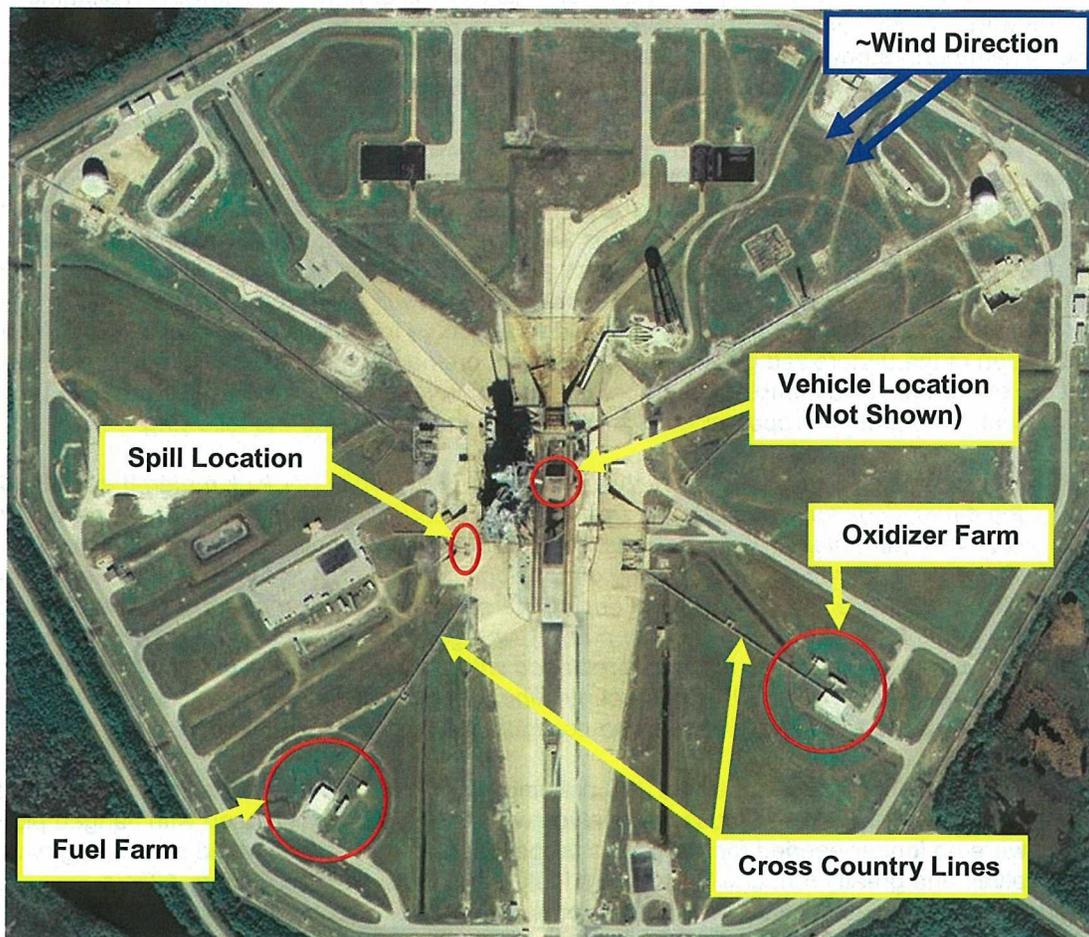
Figure 42: Geographic Layout of Launch Pad 39B

During the N_2O_4 GSE drain down following OV-102’s oxidizer servicing, the cross-over valves were closed. A water hammer effect from the liquid column in the GSE lines opened a gap at the cross-over valve flanges (inlet and outlet). This gap enabled liquid oxidizer to leak out onto the launch pad slope (the concrete incline from ground level to the base of the launch tower).

The SCAPE van driver was the first to detect the spill when he smelled oxidizer in the area of the fuel farm (see Figure 42 for a geographic layout of Pad 39B). Safety officials at the launch pad perimeter noted the source of the oxidizer vapors was the Pad 39B west slope. Three technicians in SCAPE were directed to proceed to the general area of the vapor source from their location on launch pad tower 107-foot level. Upon arrival, the technicians noted that heavy N_2O_4 (NO_2) vapors were leaking from both the inlet and outlet flanges of the return cross-over valve. They also noted that there were still several gallons of liquid N_2O_4 on the ground near the flanges and at the bottom of the slope in a grassy area. Sparks were seen shortly after the arrival of the technicians; therefore, two of the three evacuated. Some of the liquid N_2O_4 that had flowed down the slope incline contacted the electrical conduits routed along the ground that supplied power to nearby lighting. The technicians were unaware that the N_2O_4 had dissolved some of the cabling insulation.

Since it was late at night, the technicians could not see the entire spill area very well. This was a result of the area being poorly lit during nighttime operations. Therefore, the technicians decided to activate some additional lighting at the cross-over valve complex. When power was issued to the lights there were several sparks and a small electrical fire ensued. The lights were quickly turned off and the small fire was put out with water. During the clean-up effort, one technician inhaled N_2O_4 (NO_2) vapors as a result of his SCAPE suit zipper not being secured. He was sent to the OHF and released later that night.

Following this incident, the Pad 39B drawings were updated to require the installation of the proper flange seals. All the cross-over valves were removed and replaced with flanged pipe as they were no longer needed for hypergolic propellant loading. This reduced processing time on the valves and greatly reduced the risk of a leak at the valve flanges. Figure 43 is a photograph of the location where the cross-over valve complex was previously located at Pad 39B and Figure 44 is a photograph of the location of the Pad 39B fuel cross-over valve complex with the fuel farm and Vehicle Assembly Building in the background.

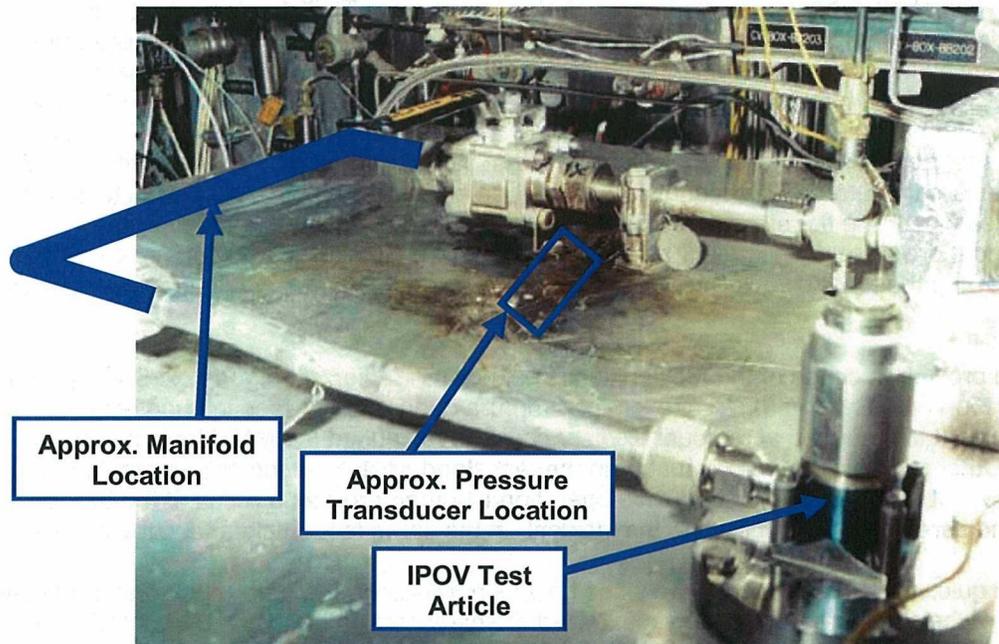
Figure 45: IPOV Test Setup

On March 25, 2003, in Test Cell 831 at WSTF, during the life cycle testing of an N₂O₄ Improved Pilot Operating Valve (IPOV), there was an explosion. Following the explosion, there was an N₂O₄ vapor release (approximately three quarts) into the test cell. There were no reported injuries since the cell was vacated prior to starting the test. It was found that a pressure transducer had catastrophically failed as a result of a material incompatibility within the pressure transducer (proximate cause). Figure 45 is a photograph of the test setup following the explosion with the relative location of the pressure transducer prior to the explosion.

The IPOV was in the process of being validated following some modifications that were made to the valve. The operating pressure at the valve inlet was approximately 276 psia. The test was simply flowing liquid N₂O₄ from one tank into another by cycling the valve. The pressure transducer was in the system to monitor this inlet pressure. Approximately 36,000 (of the planned 80,000) cycles of the valve, with a flow duration of approximately 80 ms and a maximum flowrate of 1.91 lb/sec, had been completed when the explosion occurred. The proper emergency procedures were immediately implemented following the incident. These procedures included securing the test cell and deactivating the air handler for both the test cell and the attached building. There was no reported fire following the explosion.

Initial inspections of the pressure transducer indicated that the transducer failed as a result of one of the following: over-pressurization, inadequate design, or cyclic fatigue at a highly stressed location. Since the pressure transducer failed, data from it at around the time of the failure may be suspect; therefore, the investigation included a detailed inspection of the nearby system tubing to determine if there was an over-pressurization event. Close inspection of the pressure transducer itself would indicate if the transducer failed from cyclic fatigue or was subject to a ductile failure from a single overload event.

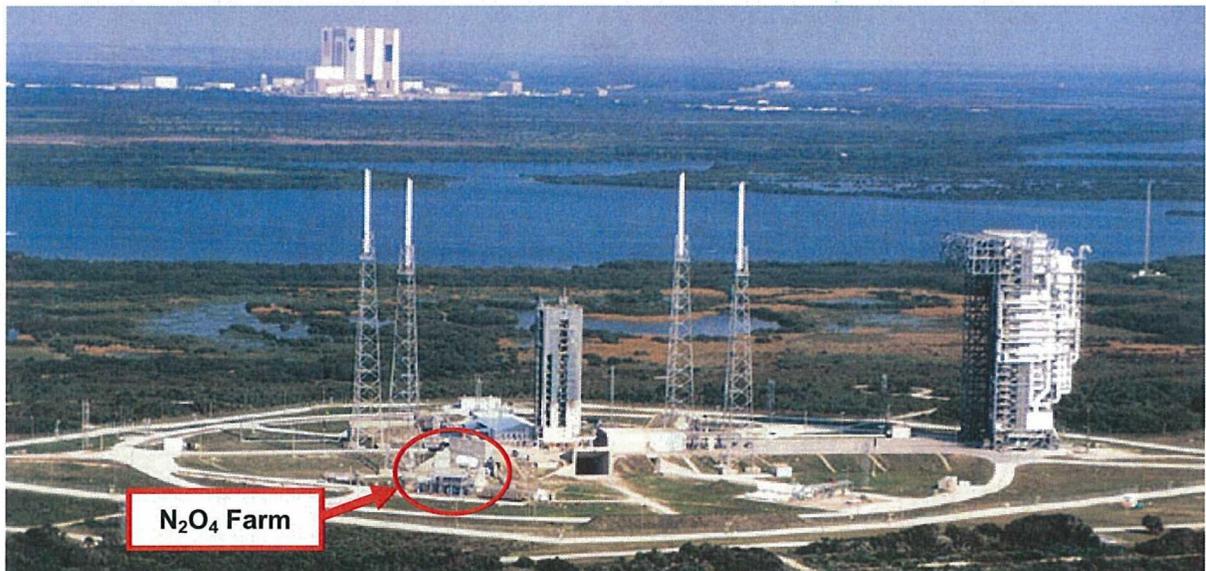
Figure 47: LC-40 at CCAFS

On August 12, 2003, at CCAFS launch Pad LC-40 (shown in Figure 47) during the bleed-in operation for the B36 Stage II (Titan IV) propellant load, the oxidizer centrifugal pump exploded (proximate cause of the N₂O₄ spill). The Titan IV launch vehicle was being loaded in preparation for the September 9, 2003 launch of the National Reconnaissance Office's payload. Along with the liquid N₂O₄ release of approximately 40 gallons, the explosion created a large amount of shrapnel which caused significant damage to the surrounding GSE. The pump was completely destroyed as shown in Figure 48. Fourteen people reported to an on site health facility. They were all later released without injury. The storage tank holding several thousand gallons of liquid N₂O₄ remained intact with minimal damage. An extensive investigation was initiated as a result of the Space Shuttle Program using these same pumps at Pads 39A and 39B (eight pumps in four locations) along with the Titan program which used them at LC-40.

The engineers had noticed a decrease in the oxidizer pump flow rate (34-50 gpm versus 200 gpm) during the 18,600 gallon loading of the Stage I N₂O₄ tanks. A meeting was held to discuss this reduction in flow rate in which the contractor and government team chose to continue on with the Stage II load. The consensus of the meeting was that an internal filter had become partially clogged at the oxidizer farm. The personnel had seen this sort of occurrence previously. Operational human error is considered a root cause as a result of the loading team not investigating the decreased flow rate issue further.

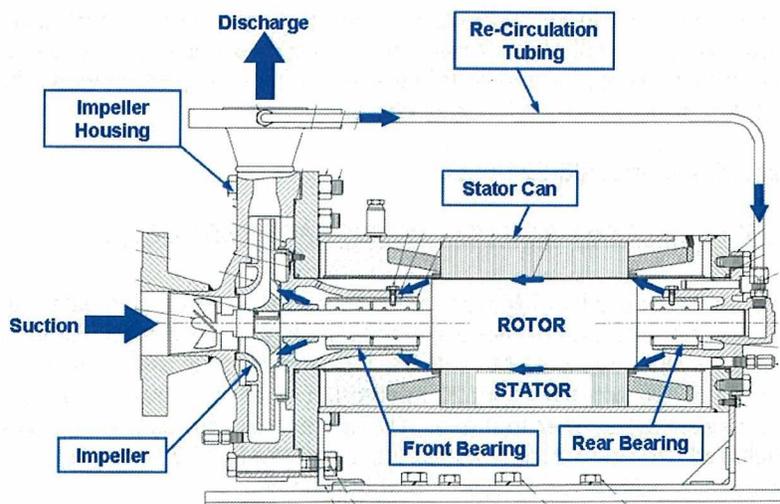
Figure 49: Pump Schematic

The incident failure analysis concluded, according to Crass, that there was a “cooling anomaly at the [carbon graphite journal] bearings...leading to [an explosion] in the stator can winding area.” It was found that the most likely contributor to this was a clogged filter in the pump recirculation loop that circulates liquid through the rotor cavity to cool the front and rear bearings as illustrated in Figure 49. Data analysis showed that the upstream and downstream temperature transducers indicated an increase in temperature of 8 °F across the pump. The low flow rate of 40 gpm and high ambient temperatures (high of 86 °F for 8/12/2003) accelerated the failure of the pump. At these flow conditions, the pump was not able to be properly lubricated as a result of the high vapor pressure of liquid N_2O_4 (these particular pumps are designed to be lubricated with the liquid that they are pumping). The excessive bearing wear led to damage to the stator liner can, allowing oxidizer to leak onto the hot copper windings. The N_2O_4 reacted with the copper winding insulation and caused the coil wire to short, which was the proximate cause of the explosion.

Following the explosion, there were some design changes made to the pumps since an improper pump design was a root cause, these changes include the following:
