HYPERGOLIC PROPELLANTS: THE HANDLING HAZARDS AND LESSONS LEARNED FROM USE

B. Nufer

NASA Kennedy Space Center, Engineering Directorate, Fluids Division, Hypergolic and Hydraulic
Systems Branch

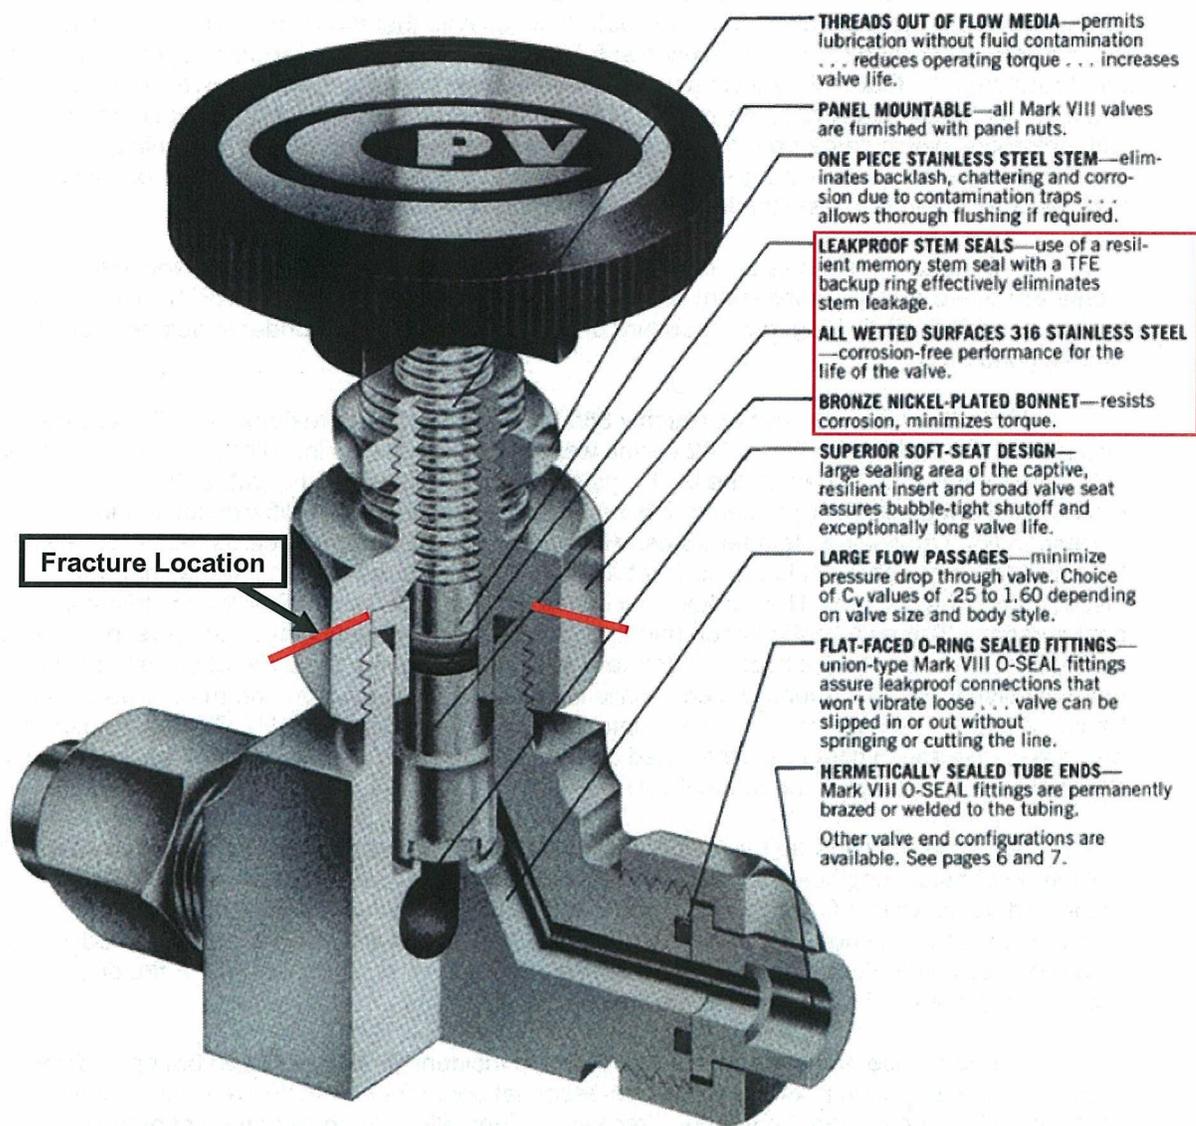
Figure 51: Schematic of Failed Manual Valve

The failure began as an intergranular crack in the nickel-plated, aluminum bronze bonnet threads (fracture surface shown in Figure 50). It is believed that the crack began as a result of the ethylene propylene rubber and Teflon soft seals allowing corrosive agents to slowly leak into the thread region. Figure 51 shows a cross-section cutaway of the manual valve. The Teflon soft seals can be seen clearly near the middle of the threaded shaft. The corrosive agents reacted with ammonia, which came from the decomposition of N_2H_4 ($N_2H_4 \rightarrow 1/3 N_2 + 4/3 NH_3$). This accelerated the local corrosion and cracking. This was the first failure for this type of valve since they were procured and installed in several hypergolic systems at WSTF in 1994.

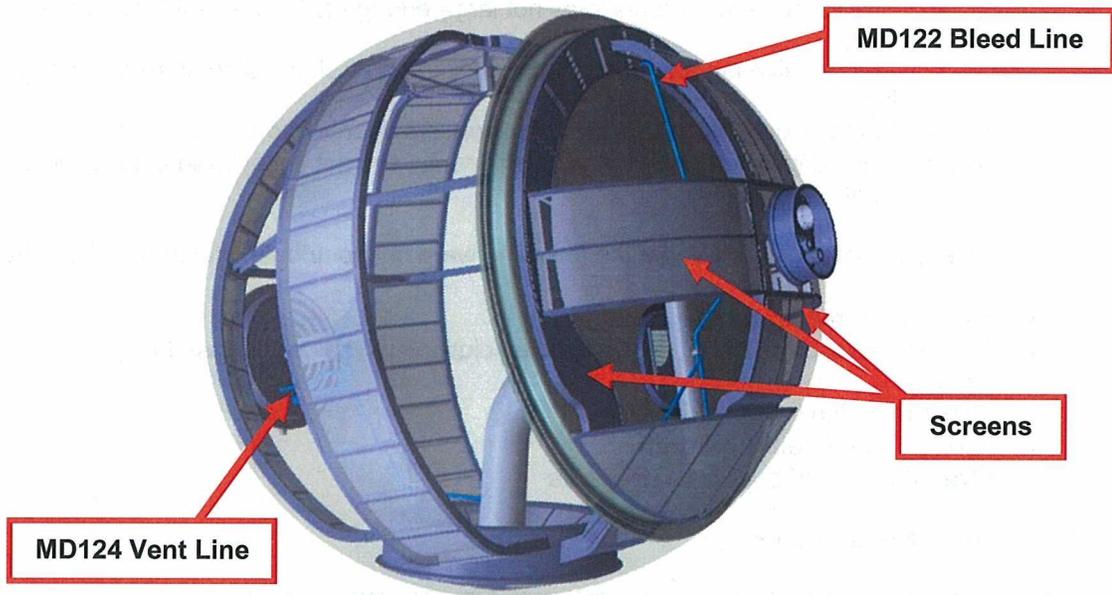
Figure 52: Solid Model of RCS Propellant Tank in (Roughly) the Horizontal Orientation

With the vehicle in a horizontal orientation, the MD122 line runs from the high point of the oxidizer tank lower compartment channel, through an interface at the tank outlet flange, and out to an AHC located in an externally accessible door on the FRCS outer mold line (AP28-00 door). It is known through pressure measurements that the MD122 and MD120 connected GSE lines were clear of any liquid immediately following the two, five-minute purges; however, it is not known if the propellant acquisition system channel in the lower compartment was broken down (i.e. it did not contain any liquid). If the screen was not completely broken down, it is possible that liquid oxidizer "wicked" up the screen following the purges to the point where MD122 connects to the acquisition screens. See Figure 52 for visual aid of the propellant acquisition system screens

and the MD122 line. The absence of liquid in the lines can be confirmed by noting that there was not any significant pressure increase in the lines. The tank was *not* in thermal equilibrium. The tank shell (skin) temperature rose from 49 °F, when tank venting was complete, to 58 °F, when MD124 GSE vent valve was opened for the emergency vent through MD124 in the upper compartment of the tank. When the two purges were complete the tank shell temperature was 54 °F. From the time of the spill to the emergency MD124 vent, the tank shell temperature rose from 57 °F to 58 °F. The fluid and gas temperatures likely rose by a degree or two during this time.

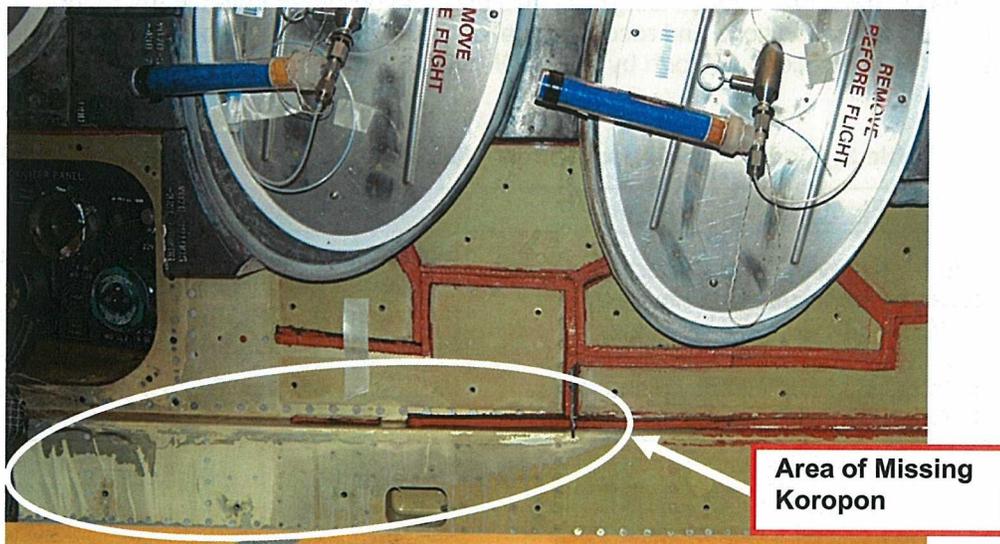
Figure 54: View Looking at R/H Side Down-Firing Thrusters (F2D & F4D)

The spilled oxidizer appears to have reacted with Koropon, RTV, and silver plating (nutplates and barrel nut elements). The oxidizer vapors reacted with the Koropon and removed a large area, as shown in Figure 54, and passed through the nutplate holes and around the perimeter of the phenolic QD service panel into the interior of the FRCS module, as shown in Figure 55, causing damage to the Koropon on the interior side of the FRCS module.

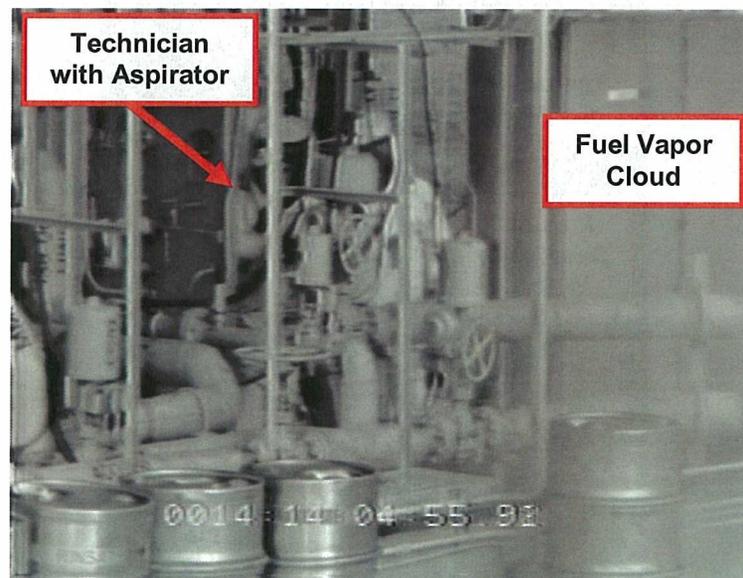
Figure 56: Screen Capture of Video during Spill

On the morning of January, 14, 2010 during the fuel servicing operation for the Space Shuttle mission STS-130, about 1 gallon of MMH was spilled onto the ground from an open line where a pressure transducer had been removed. Several more gallons were contained in the toxic vent system by utilizing a vacuum aspirator below the spilling MMH. There were no injuries and no hardware damage. The pressure transducer was discovered as failed shortly after the computer autosequencer was activated from the LCC to fill the GSE tubing with liquid. Once the lines are filled with liquid at the fuel farm, the two series centrifugal pumps are brought online to initiate the flow to the launch tower.

In preparation for the component removal, the tubing was purged to clear out residual liquid MMH and fuel vapors. All the necessary valves were closed to isolate the particular section of the servicing system tubing. Once a spare component was obtained, the pressure transducer was removed from its ¼-inch lines that connect to the three-inch fuel supply pipe that runs to the launch tower at launch pad 39A. A few drops of fuel were noted when the pressure transducer was removed. During an inspection by the SCAPE technicians, it was found that they had the incorrect connection fittings. The technicians relocated to their work bench several dozen feet away to swap the connection fittings from the old pressure transducer to the new one. Console operators in the LCC began to notice “smokiness” on their closed circuit, black and white video monitors. This was not reported to the technicians who relocating back to the removal site. When they arrived, the SCAPE technicians reported a steady stream of liquid MMH coming from the ¼-inch tube from which the pressure transducer was removed. One technician immediately placed an aspirator below the line to collect the liquid (shown in Figure 56) while the other began to douse the area with water from a nearby fire hose. Direction was given by the console engineers to use a manual overdrive wheel on an upstream valve in attempt to isolate the liquid source. The leak was stopped by this action.

Normally, when this component is replaced the system is dry as a result of weeks without use. However, in this case, the system had just been wetted and then purged. It is well known that it takes a few days for the propellant to completely drain back into the storage tank from the servicing distribution system tubing. The liquid accumulated in the tubing (and subsequently spilled out the ¼-inch line) as a result of a leaking upstream pneumatically operated flow control valve, which is shown in Figure 57.

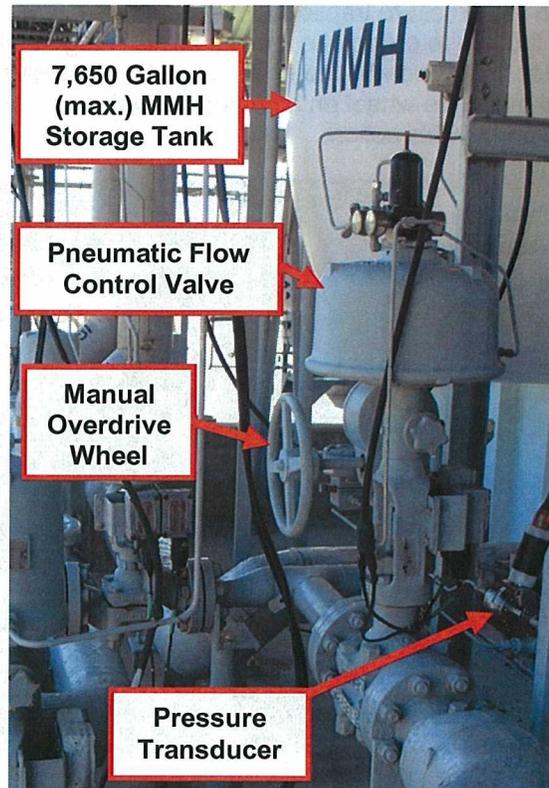
Figure 57: Pad 39A Fuel Farm Pressure Transducer Location

The pneumatically operated flow control valve also has a manual override hand wheel to use in the event of loss of pneumatic pressure. The valve is designed to be normally open to allow liquid to flow from the launch tower back into the storage tank. Prior to the spill, it was known by some of the test team that this particular valve required manually driving it closed to fully seat the internal seals. This was not performed prior to opening the system for the pressure transducer replacement (the proximate cause).

The root cause of this incident was improper training. Following the spill the engineering and technician team met and identified the following four primary lessons learned:

- Prior to removal of the pressure transducer, the proper fittings were not identified resulting in the technicians having to improvise and use the fittings from the old transducer.
- The open port from which the pressure transducer was removed was left unattended for several minutes. Technicians should be trained to make every effort to avoid leaving an open system unattended.
- The leak path through the pneumatic flow control valve was not known by the entire console test team. This is easy to say in hindsight, but if the entire team was aware of this characteristic of the valve, the spill may not have occurred.
- Reporting of the spill did not follow the approved KSC environmental procedures.
