Failure Analysis of Space Shuttle Orbiter Valve Poppet

Materials Science and Technology 2010
October 20, 2010
Houston, Texas

Rick Russell
Materials and Processes Engineer
Materials Science Division, NE-L4
Kennedy Space Center, Florida

Failure of Space Shuttle Orbiter Flow Control Valve (FCV) Poppet

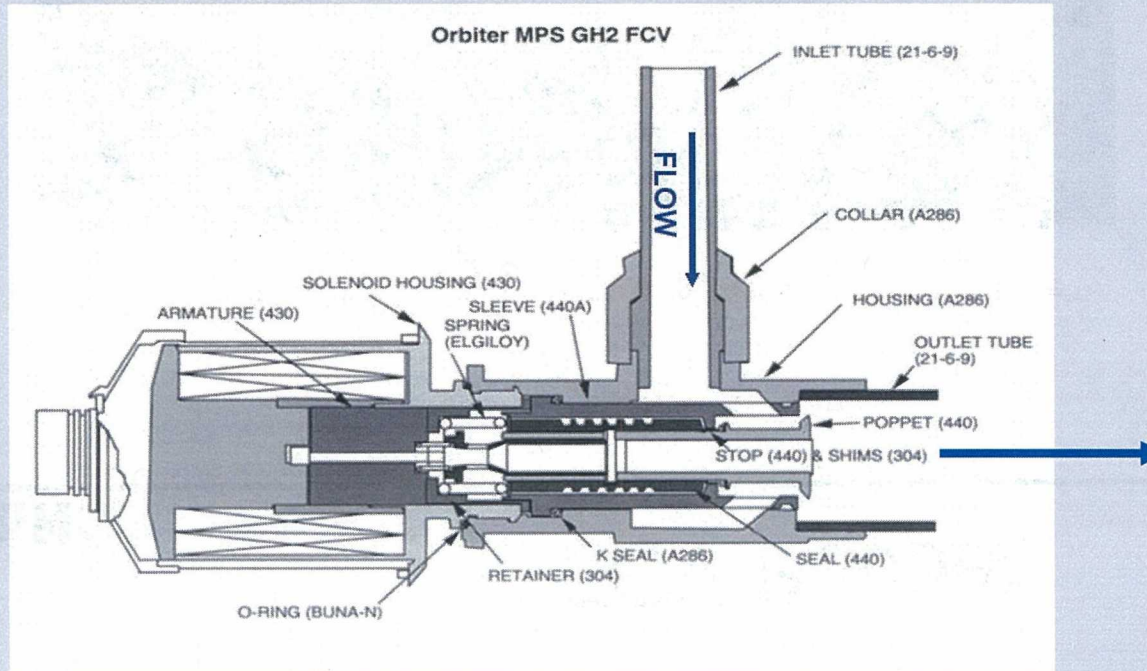
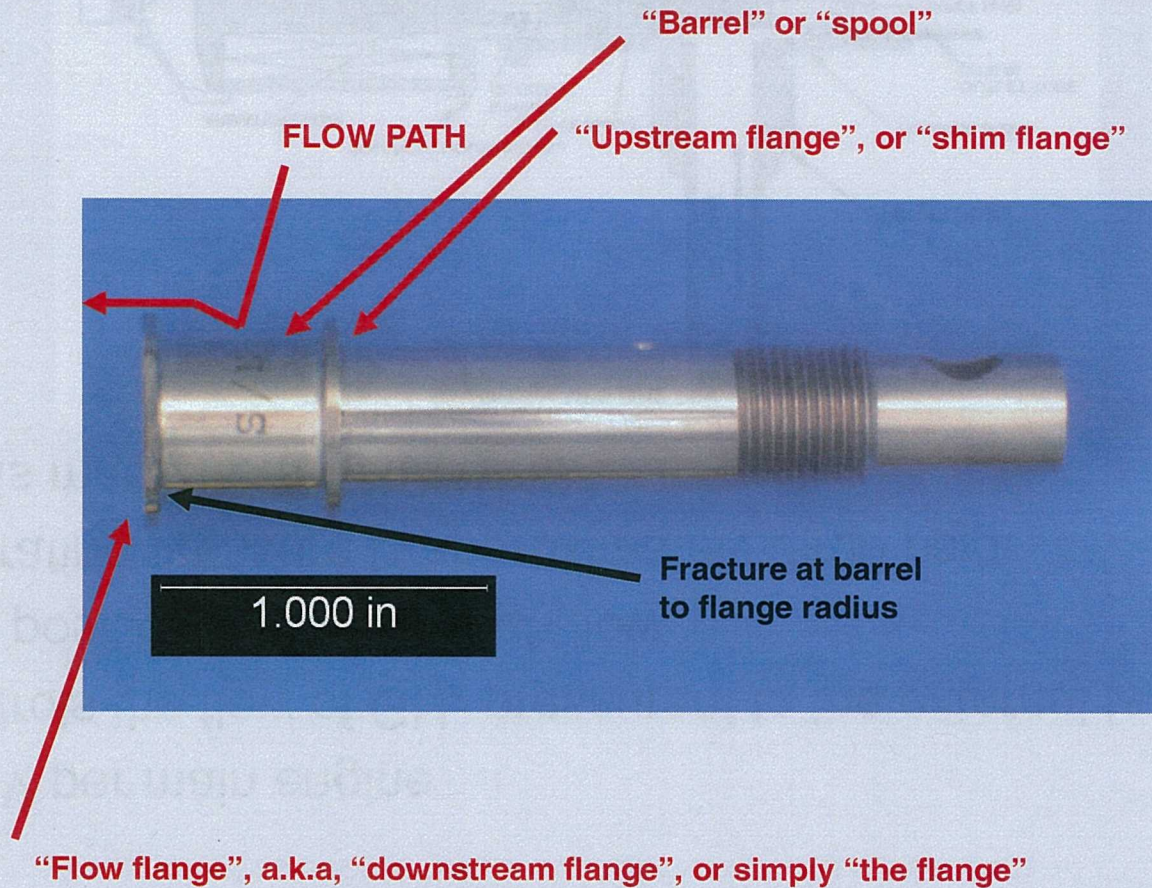
- One FCV per main engine
 - Controls the flow of GH₂ pressurant to the external tank (ET)
 - Two positions: low and high flow
 - Operating pressure is approximately 3400 psig
- Poppet is made from CRES 440A

- Poppet fracture surface exhibited five (5) distinct zones:
 - Zones 1 & 2: Initial “thumbnails”
 - Zone 3’s (2): Circumferential propagation
 - Zone 4 & 5: Propagation through the flange and final fracture
- Fracture initiation occurred at middle of the body-to-flange radius and primarily propagated circumferentially along the radius, then through the flange thickness
 - The general plane of the fracture was $\sim 45^\circ$ from the flange face

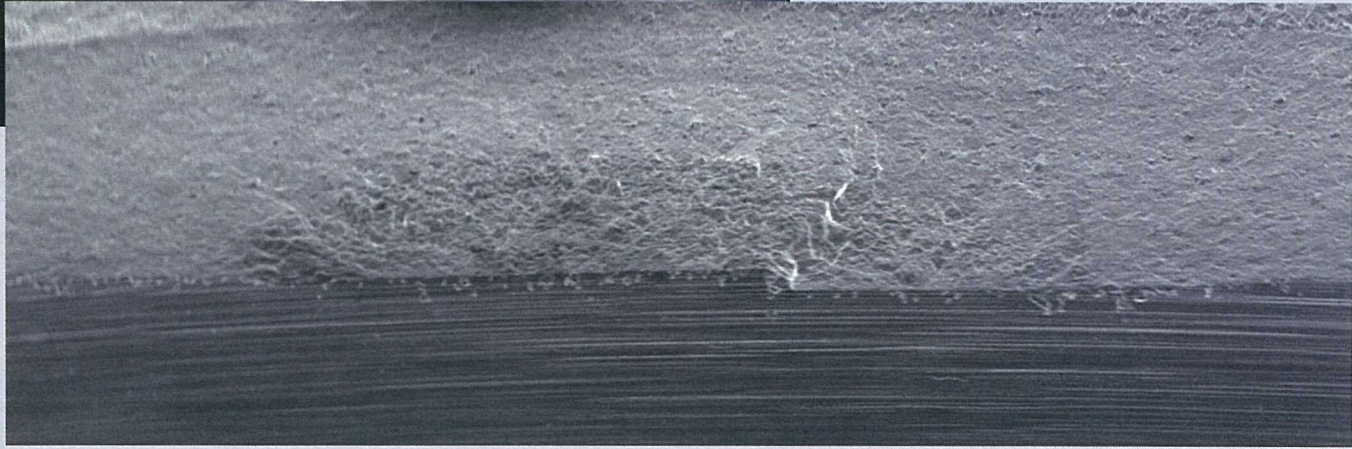
- Fracture initiated on two planes along the radius surface, then merged together into one plane

- Scanning electron fractography revealed:
- small, semi-planar areas
- rounded ridges
- exposed carbide particles,
- “divots”, which presumably resulted from spherical carbides being pulled out (i.e., carbide decohesion).
- No substantial secondary or intergranular cracking
- No striations

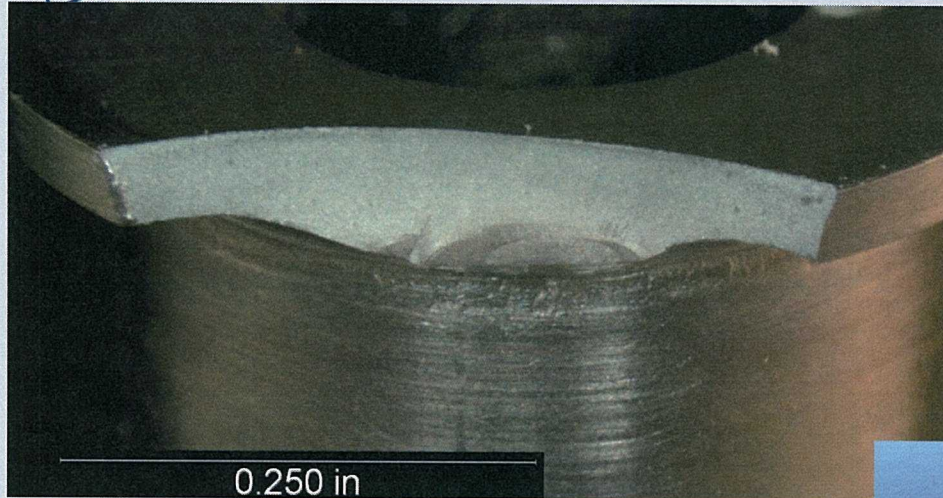
- The test results were very inconsistent, with lighter test loads resulting in relatively fast failures
- More importantly, the “quick failures” exhibited the thumbnail zones characteristic of the original failure
- Conclusion: The thumbnail cracks were pre-existing

The thumbnail zones of the test articles exhibited fracture features that were very similar to that of the original failure
