# The Reconstruction and Failure Analysis of The Space Shuttle Columbia

Aircraft Airworthiness and Sustainment Conference – Australia

August 20, 2010

NASA Materials Science Division

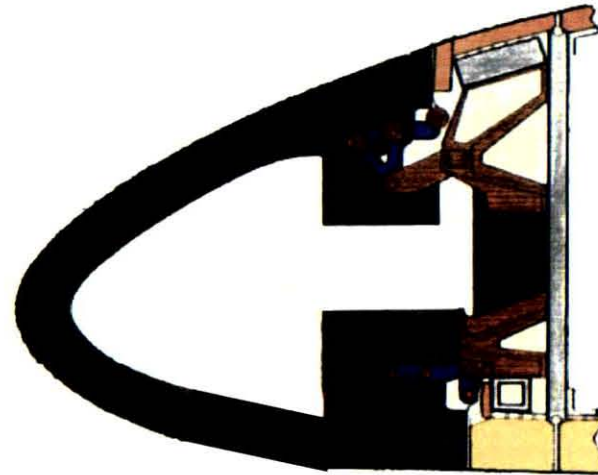
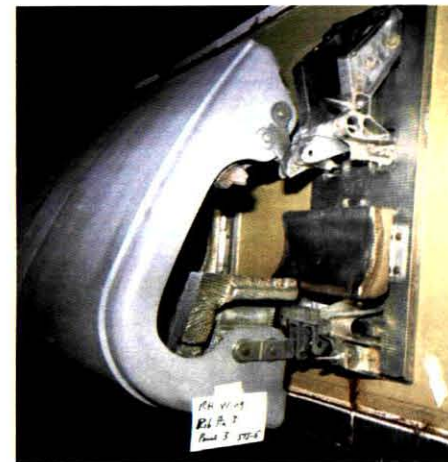
- Unique indications of heat damage:
  - ◆ Excessive overheating and slumping of carrier panel tiles
  - ◆ Eroded and knife-edged RCC rib sections
  - ◆ Heavy deposits on select pieces of RCC panels

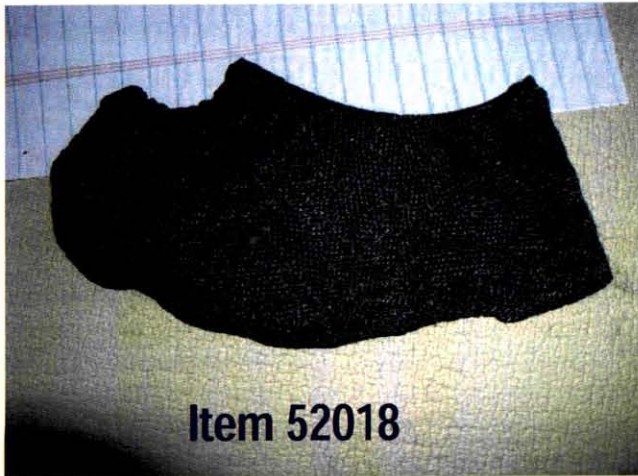
Item 52018

7025 to 52018 interface shows severe thermal erosion – thickness ranges from 0.270 to knife edge of 0.040

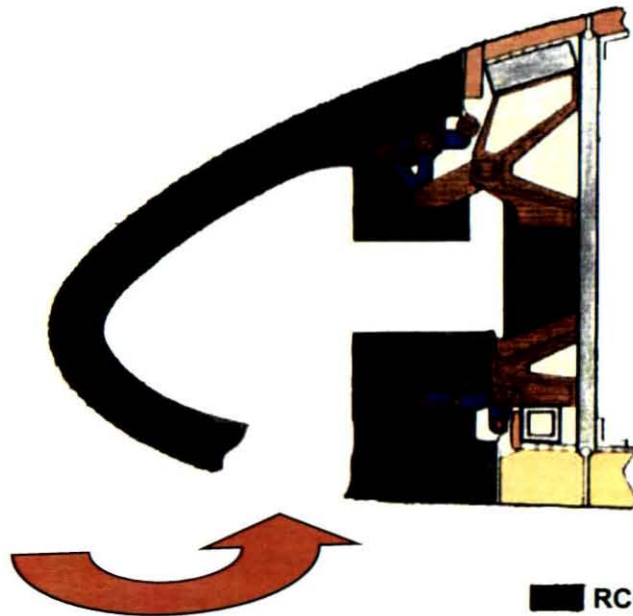
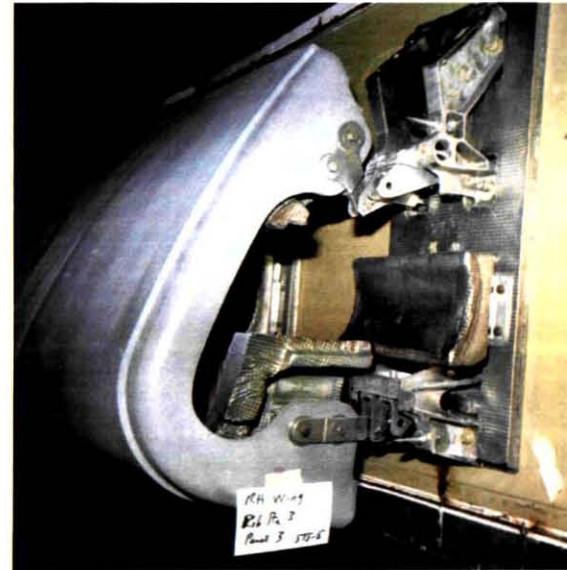
- Wing failure initiated in the panel 8 area
  - ◆ Most likely at the panel 8 area near 8-9 joint
  - ◆ Condition existed before or shortly after entry interface

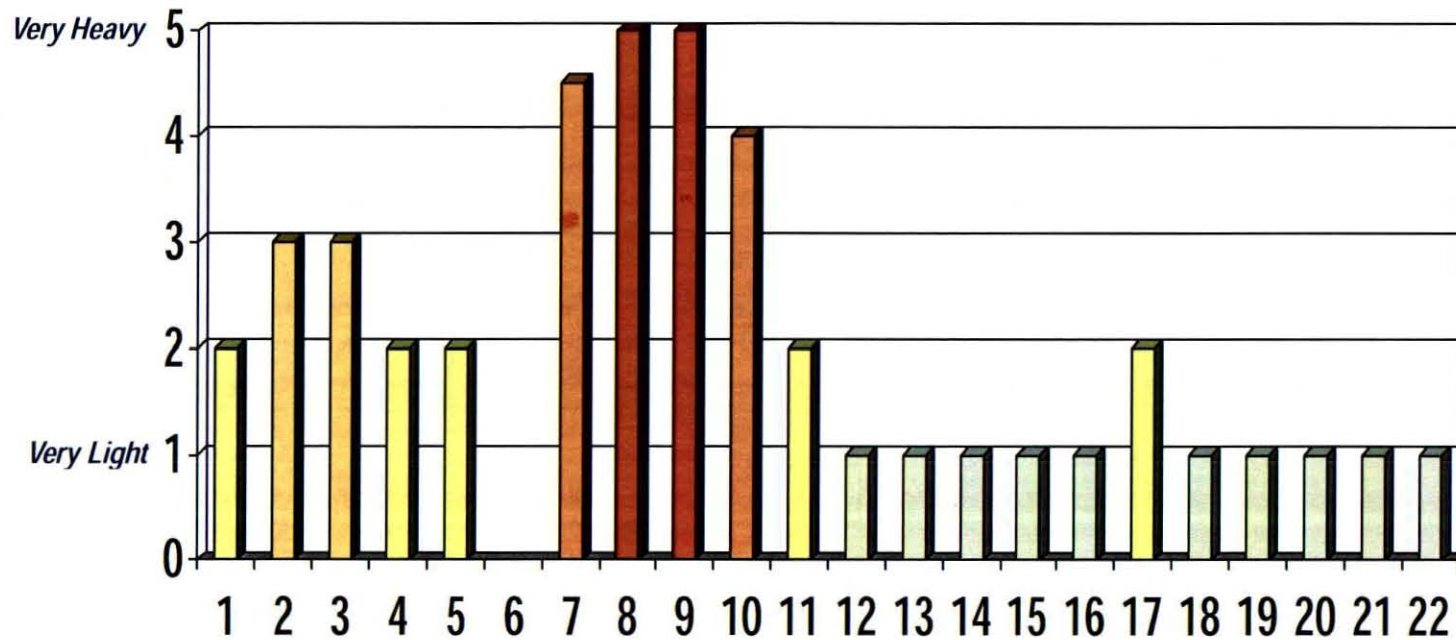
# Relative Metallic Deposition on L/H Wing Materials

**Distribution of metallic deposition volume  
was centered around panels 8 & 9**

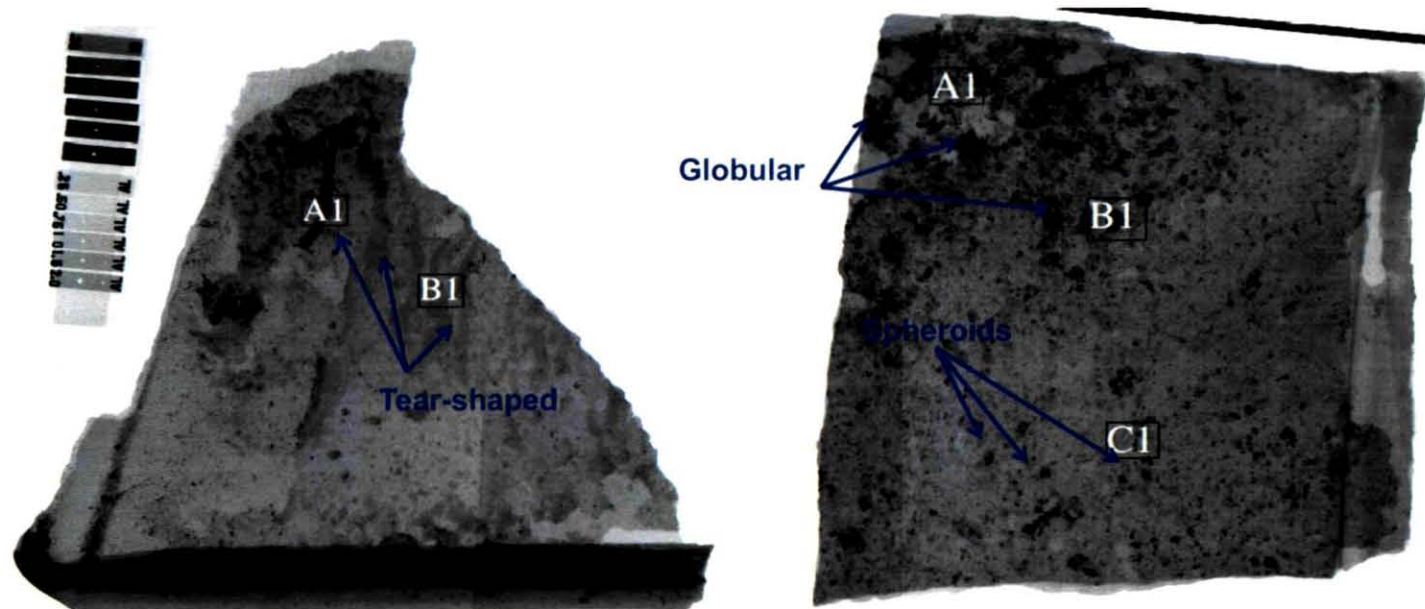
- Four types of deposit patterns were identified from LH RCC Panel 8:
  - ◆ Uniformly thick; Spheroidal; Tear-shaped; Globular

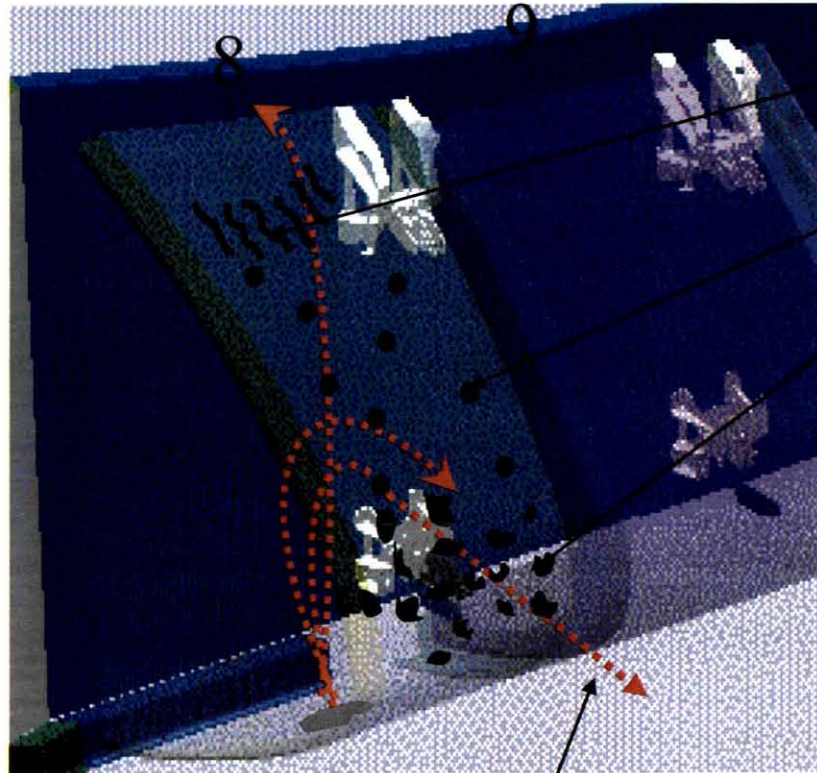
# Proposed Breach Location and Plasma Flow

Flow Exiting through RCC 8 on to lower Carrier Panel 9 tiles

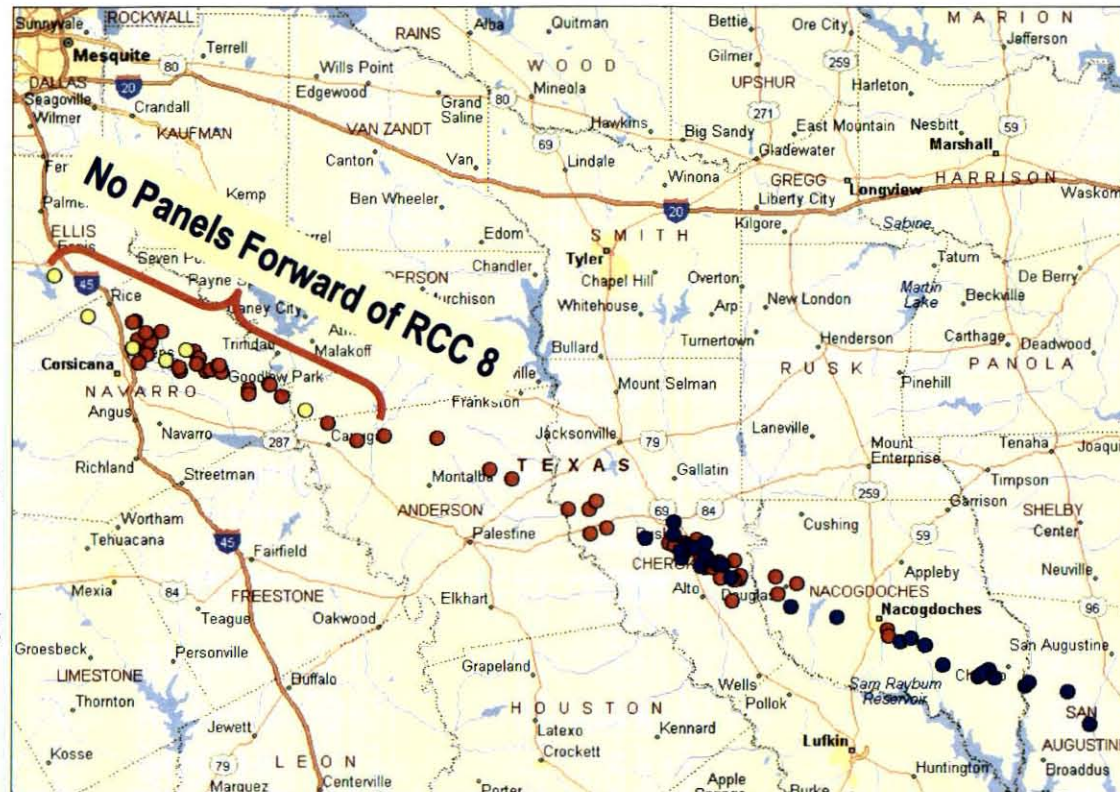
# Corroborating Information - RCC Panel Debris Locations

- Panels at RCC 8 and Aft Dropped First
- All Eroded RCC Pieces (in 8 & 9) Found to the West
- R/H Wing Panels and L/H Wing Panels 1-8 Found to the East

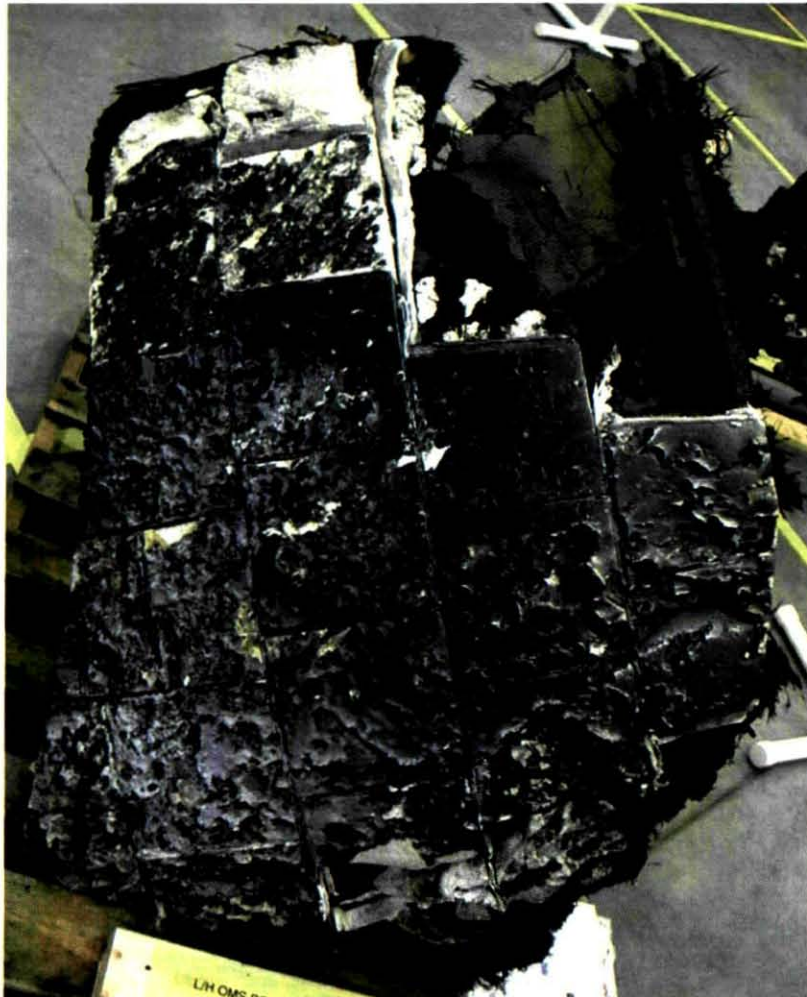
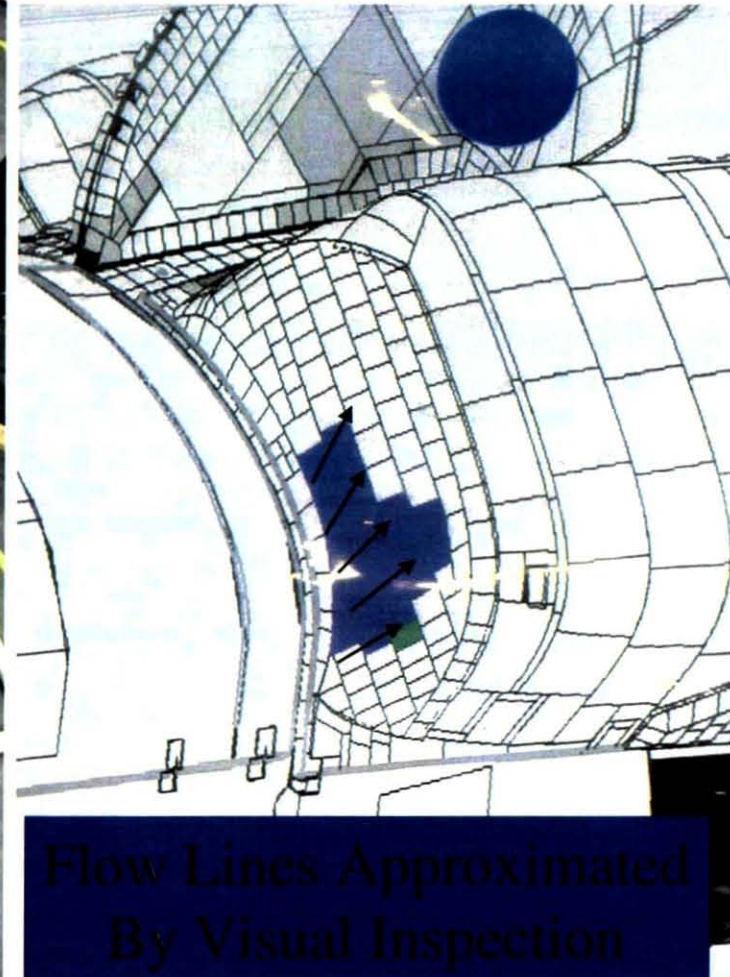
# Corroborating Information – LH OMS Pod Analysis

Flow Lines Approximated  
By Visual Inspection
