AIAA Space 2011 Conference

NASA/MOD Operations Impacts from Shuttle Program

# NASA/MOD Operations Impacts from Shuttle Program

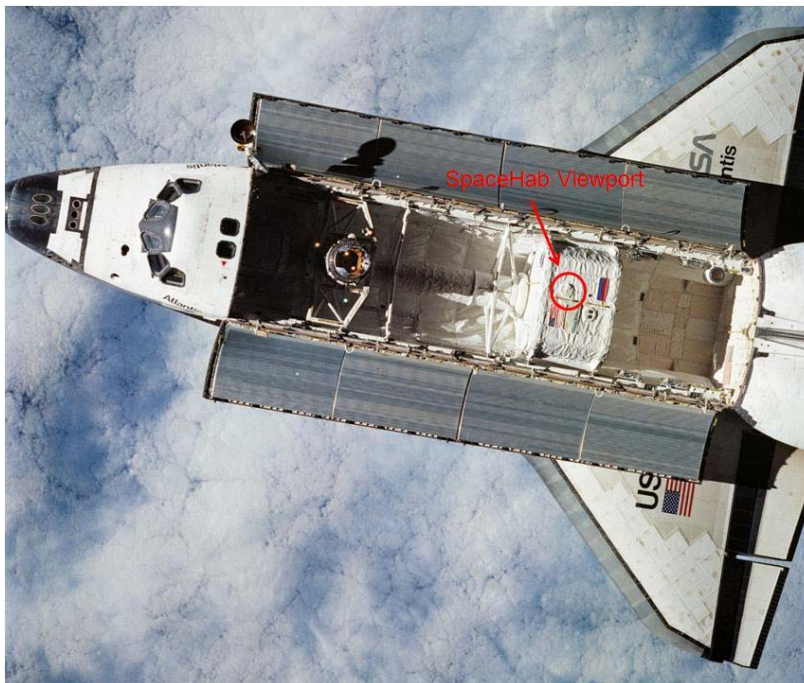
**Figure 5: View of Shuttle showing location of SpaceHab viewport.**

This mission carried a single module SpaceHab in the payload bay. The SpaceHab's main purpose was to provide increased habitable volume for storage and science payloads, connected to the crew cabin via the external airlock. On the top of the SpaceHab was a viewport window that fortuitously was directly underneath the 9-12 Latch Gang. See Fig. 5 for a photo of the SpaceHab within the Shuttle's payload bay; each gang of latches (1-4, 5-8, 9-12, and 13-16) occupies one of the four radiator panels that line the payload bay doors from forward to aft.

From the aft windows of the flight deck, the crew reported that Latch Gang 9-12 appeared to be open, but due to the distance away from the window, they were not entirely certain, even using binoculars. The MMACS team asked the crew to ingress the SpaceHab module (which required opening the hatch from the middeck into the airlock) and look out the overhead viewport. The crew reported that the 9-12 Latch Gang was definitely open; they confirmed this by visually comparing to Latch Gang 5-8 which was already confirmed to be in the open position and to a diagram in an orbiter systems data book. The MMACS team then had the crew drive the 9-12 centerline

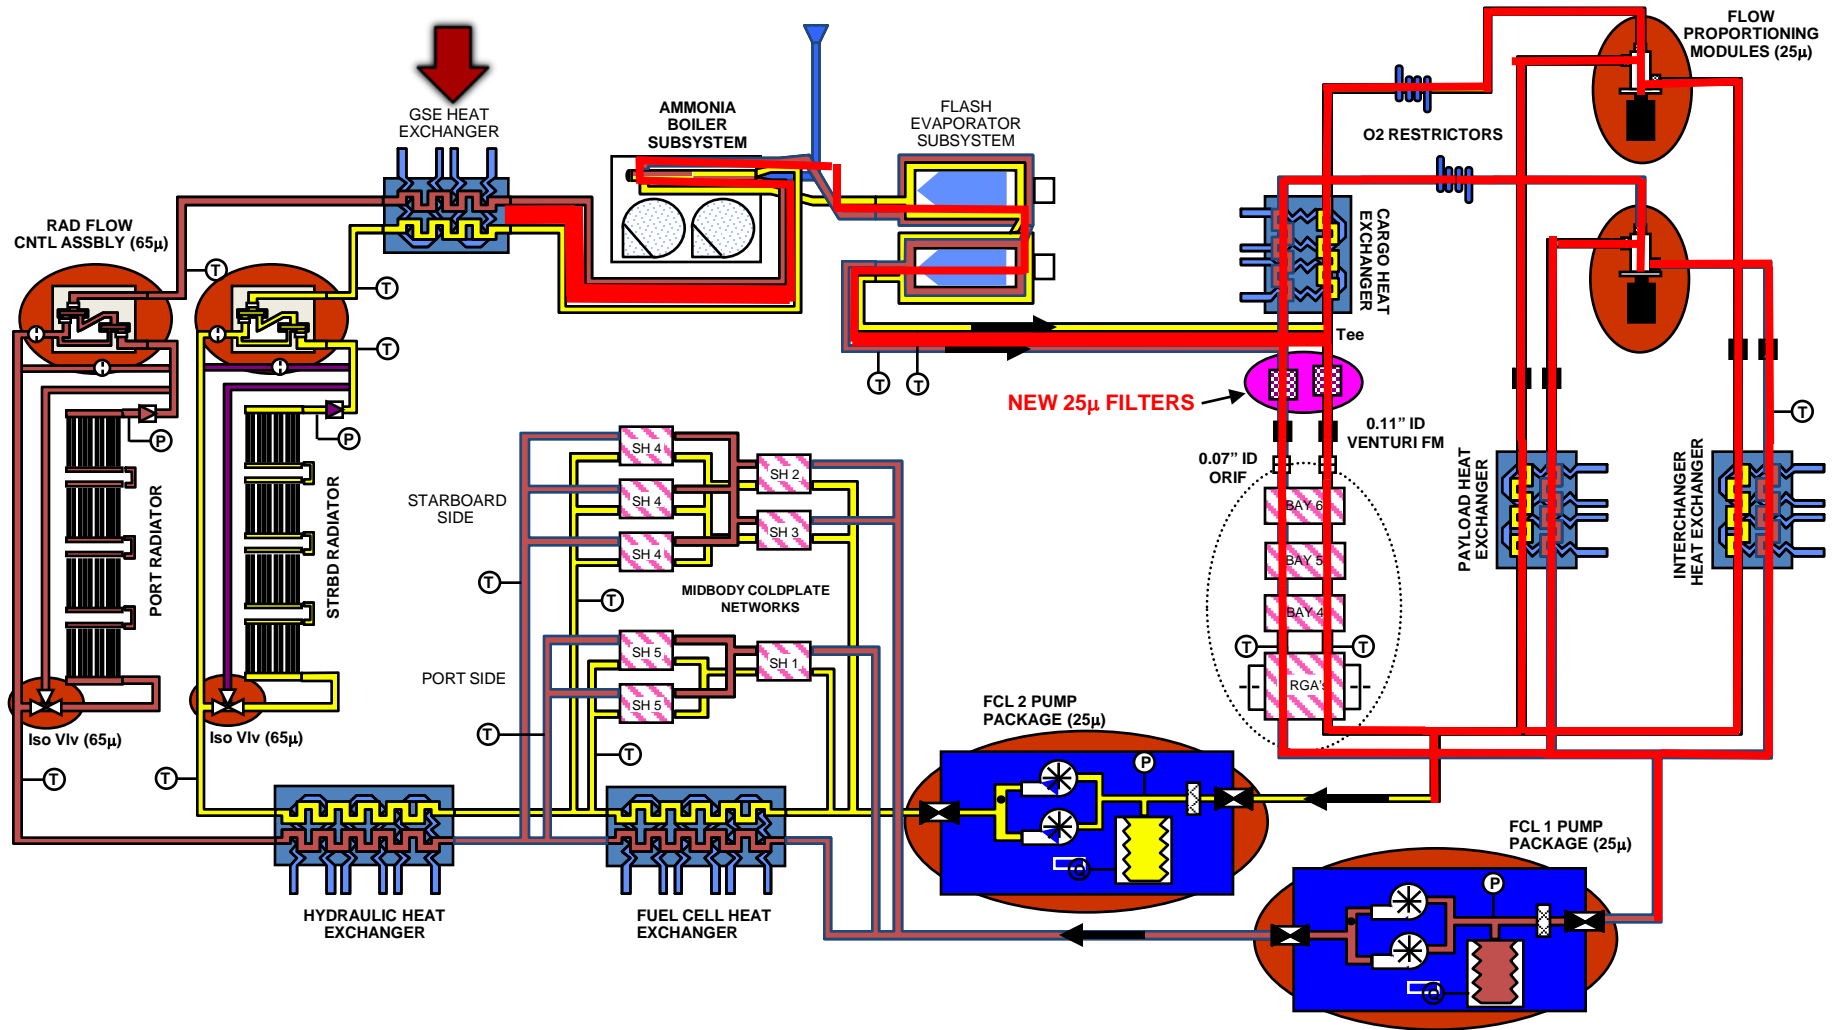
# Shuttle Thermal Control System

- The Water/Freon Interchanger at far right is where all of the Orbiter's coolant loops intersect, and if the Freon temperature is cold enough it could freeze the water, rupture the interchanger, and cause the complete loss of cooling to the Orbiter.

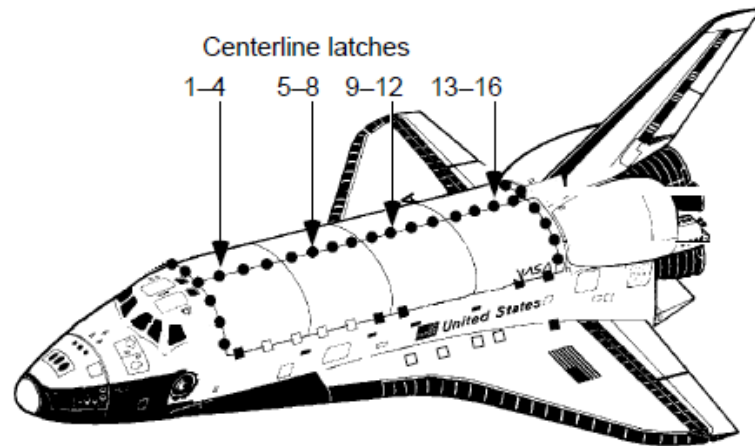
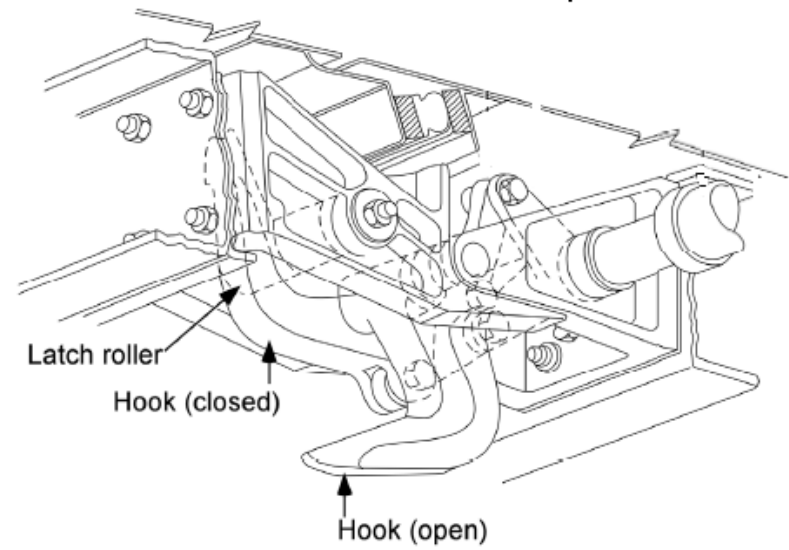
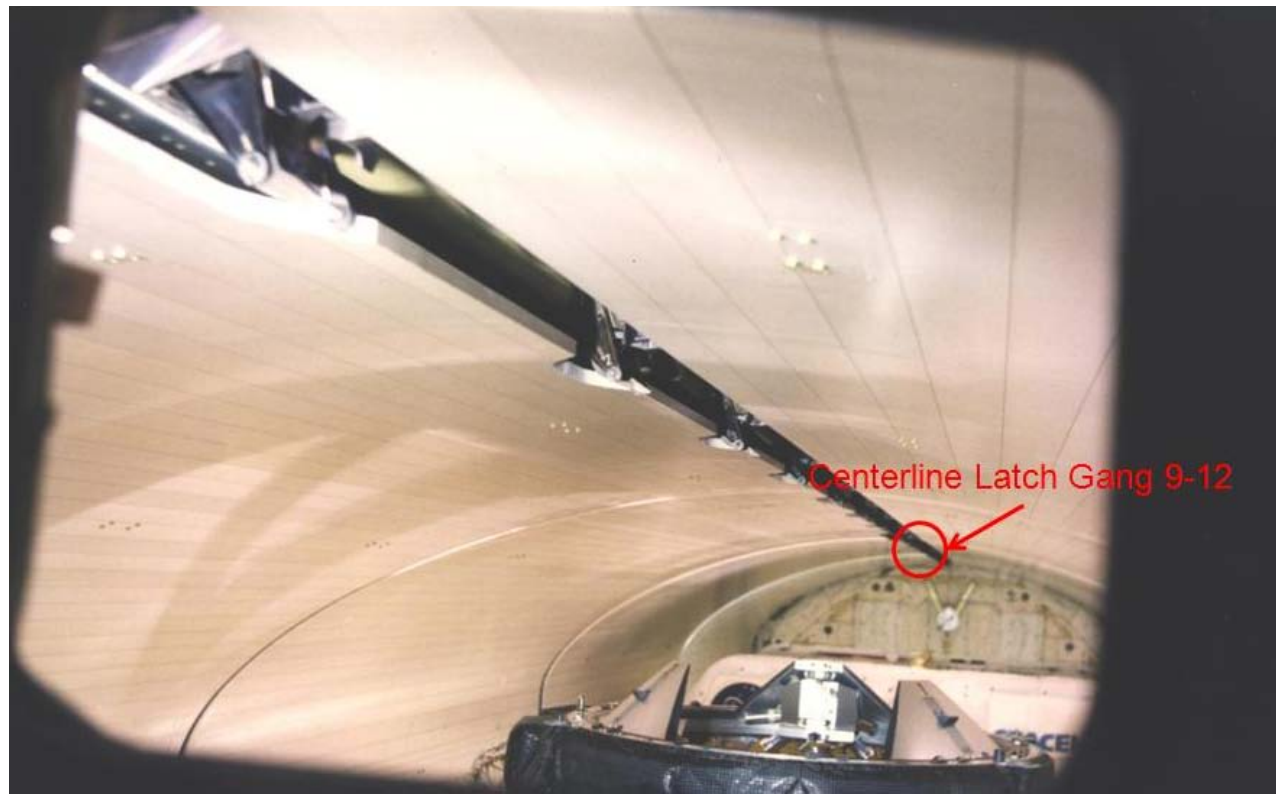
Centerline Latch Closeup

- Crew closed PLBDs to prepare for Entry
  - Weather was poor, so team waived off for the day
- During PLBD opened (performed to regain vehicle cooling for orbit ops) centerline latch gang 9-12 appeared to never open
  - Two microswitches indicated latch did not reach end of travel.
- Control team was in a time critical situation
  - Could the PLBDs be opened to regain cooling?
  - Did the Shuttle require an emergency deorbit?

- PLBD centerline latch gang 9-12
  - Came off two closed microswitches
  - Did not receive two open microswitches
  - Alternating current traces were inconclusive
    - Latch gang 5-8 and 9-12 were driven simultaneously
      - Latch gang 5-8 reached end of travel at the expected time
- PLBDs cannot be opened with one centerline latch gang closed
- Potentially unsafe to open PLBDs with centerline latch gang at undetermined position
- NEED TO DETERMINE THE LATCH POSITION

As a result of this failure, the Deorbit Prep Backout procedures were changed to separate the opening of centerline Latch Gangs 5-8 and 9-12 by driving them sequentially instead of simultaneously. Since both Latch Gangs drive one motor each on ac buses 1 and 3, by opening the Latch Gangs separately the currents are not overlaid and can be monitored individually to verify if the Latch Gang actually drove to the release position.

Additionally, the PLBD Opening steps in the Backout procedures were moved earlier in the timeline to give more troubleshooting time should a failure occur. This would allow for more time to determine PLBD health and status as well as to target additional landing sites should one be needed.

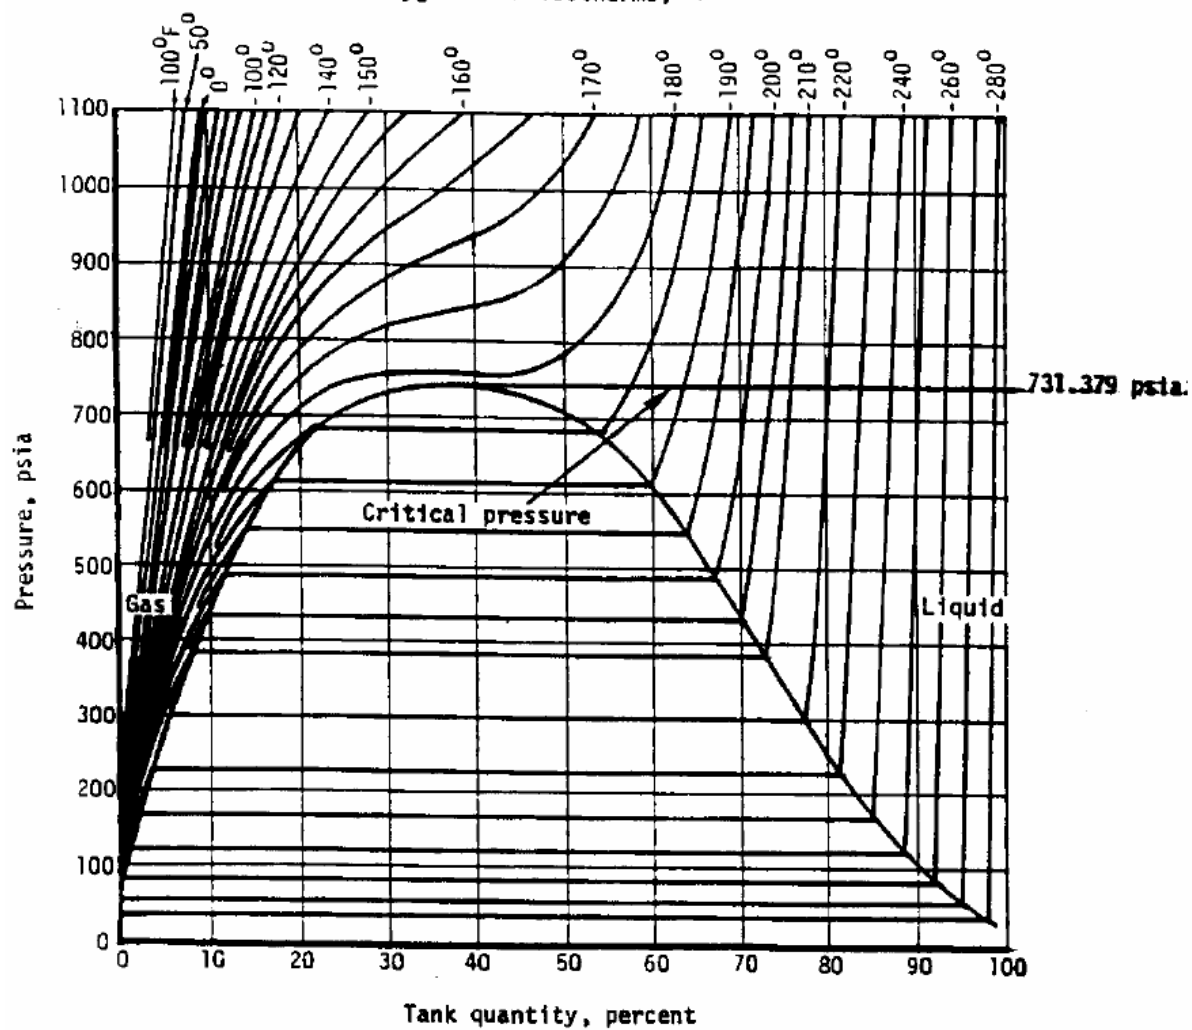
Oxygen tank isotherms, °F

Typically a pressure drop will be seen across one or two tanks; to see all five was alarming and had never been seen before. Predicting which tanks would be expected to drop and how much they recover is difficult. The team expected Tanks 3 and 4 to drop due to their quantity being closest to a value known to cause trouble during destrat
