A Comparative Analysis of Two Full-Scale MD-500 Helicopter Crash Tests

Justin Littell

ATK Space Systems, NASA Langley Research Center MS 495, 12 W. Bush Rd, Hampton Virginia 23681

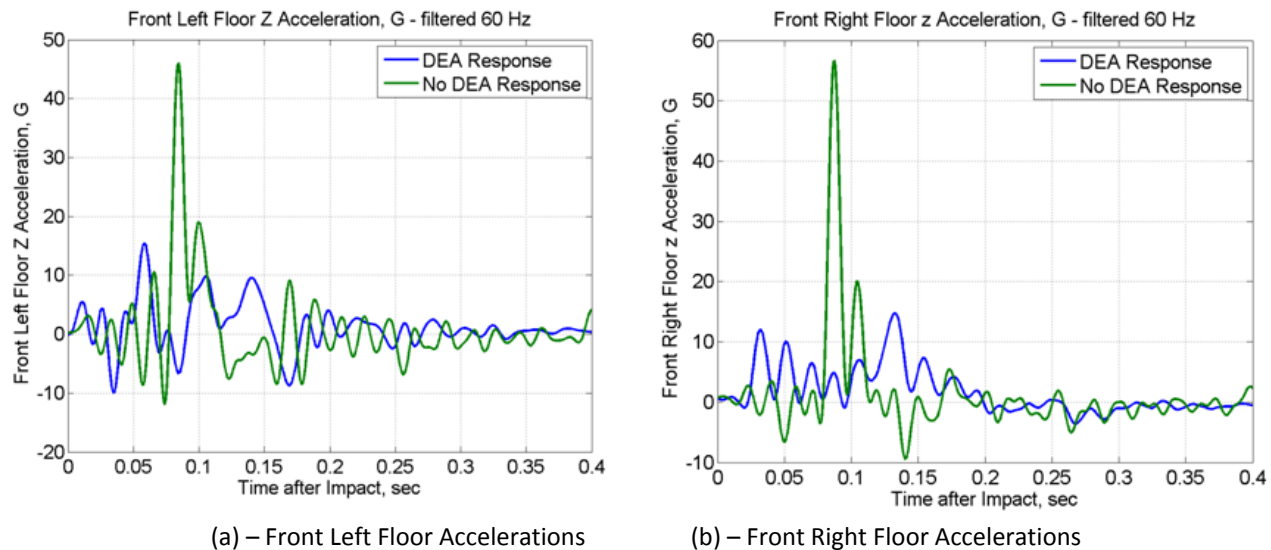
Fig. 13 Front floor accelerations

The left front floor acceleration peaks at approximately 45 g on the left and 55 g on the right for the baseline test, and approximately 15 g for both the left and right for the test which did include the DEA. For the baseline test, the front right floor experienced the highest acceleration levels of the entire airframe. This was due to the downward pitch and high yaw in the test, in which the front right portion of the helicopter impacted the surface first. Next, Figure 14 shows vertical (z) accelerations from locations on the rear floor and on the rear bulkhead of the helicopter.

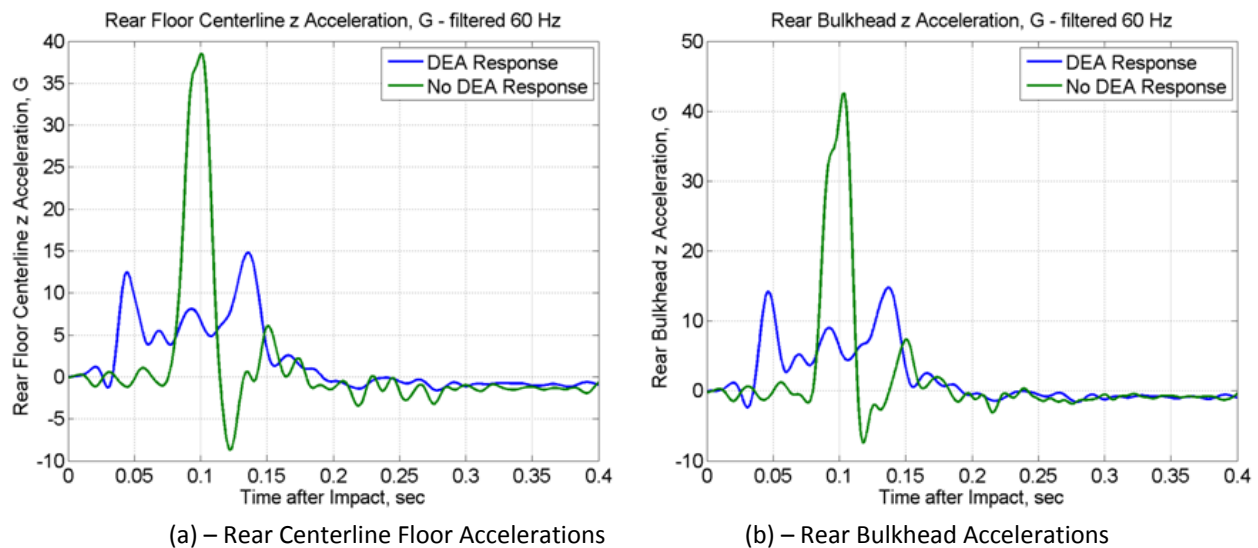
Fig. 14 Rear floor and bulkhead accelerations

The rear floor experienced a peak acceleration of approximately 40 g, while the rear bulkhead experienced approximately 42 g for the baseline test. The accelerations which did include the DEA showed peaks of approximately 15 g. One major difference between the two tests is the time history of the accelerations. The baseline test shows a large spike at approximately 0.1 seconds after impact, lasting approximately 40 ms. The test which included the DEA showed two peaks of less magnitude at either end of a longer pulse. The peak value at the beginning of the pulse is from the initial contact between the DEA and impact surface and the peak value at the end of the pulse is from bottoming out of the DEA. The length of the pulse was approximately 120 ms. The DEA effectively changed the shape of the impact pulse from a high magnitude, low duration pulse to a low magnitude, high duration pulse. This shape change is important when examining occupant injury. For occupant injury protection, since both the magnitude and the duration of the input pulse have an effect on occupant response [15], acceleration traces from the onboard occupants were examined next.

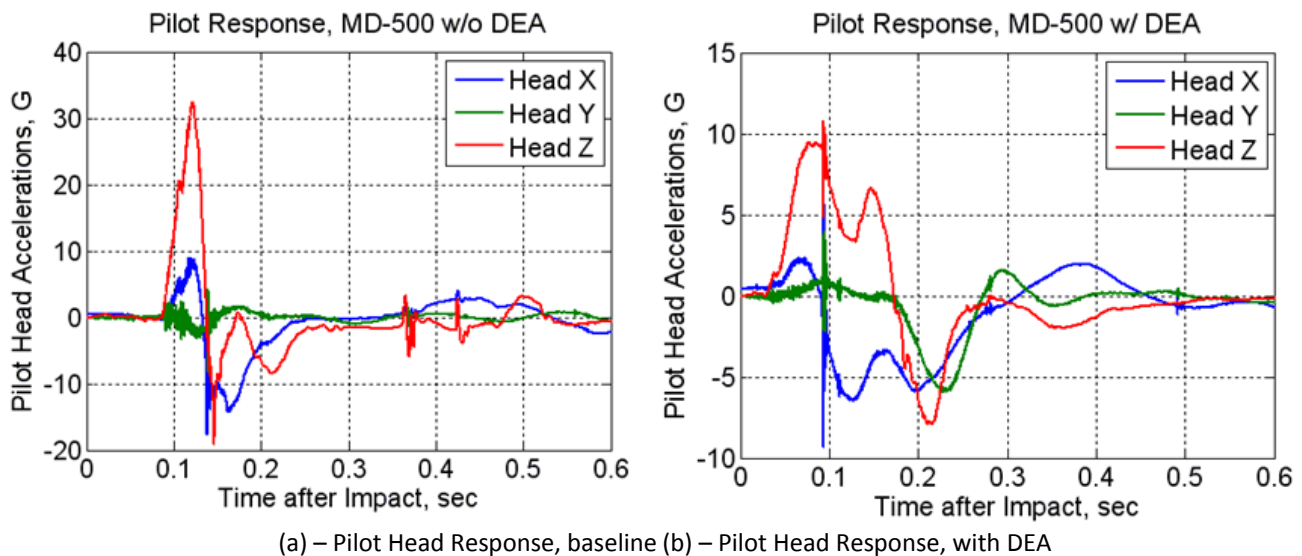
Fig. 15 Head Accelerations for the pilot

The results in Figure 15 show that the DEA attenuated the vertical (z) accelerations of the pilot's head from approximately 30 g to approximately 10 g, or by a factor of 3. The test which included the DEA also showed lower horizontal (x) accelerations as well, with magnitude attenuation of a factor of 2. The test which included the DEA, however, did show higher lateral (y) accelerations, presumably from the large amount of airframe yaw present in the impact conditions described previously. This lateral acceleration had effectively been removed for the baseline test. The data corresponds well with the photogrammetric impact condition data. Figure 16 shows the chest acceleration responses of the pilot for both tests. The baseline test is shown in Figure 16(a), while the test which included the DEA is shown in Figure 16(b).

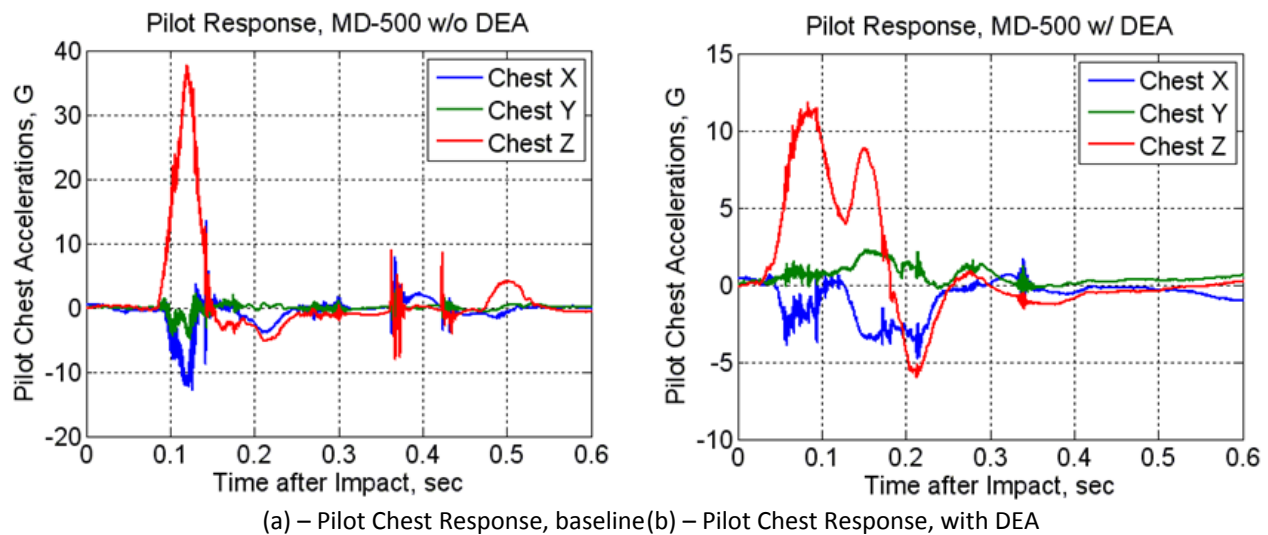
Fig. 16 Chest Accelerations for the pilot

The results in Figure 16 show that the DEA attenuated the vertical (z) accelerations for the pilot's chest from approximately 35 g to approximately 12 g, or by a factor of 3, which is similar to the results seen for the pilot's head. As with the head results, the test which included the DEA also showed lower horizontal (x) accelerations, but higher lateral (y) accelerations. This finding is attributed to the large amount of yaw present in the impact conditions for the test which included the DEA. Next, Figure 17 shows the acceleration responses from the pelvis of the pilot. The baseline test is shown in Figure 17(a), while the test which included the DEA is shown in Figure 17(b).

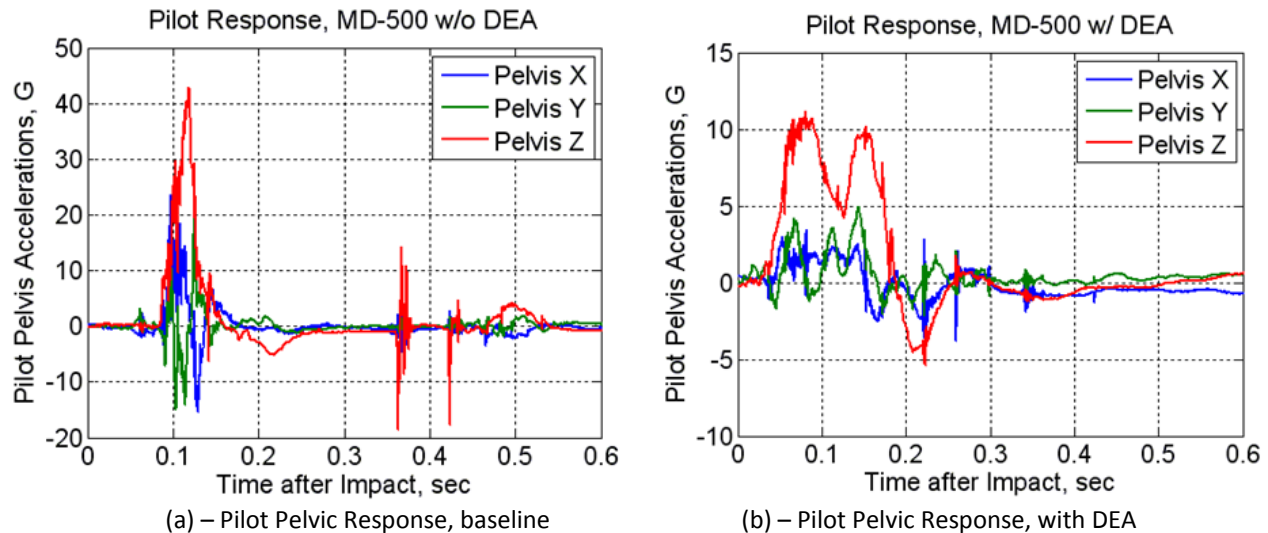
Fig. 17 Pelvic accelerations for the pilot

Pelvis accelerations matched trends seen for the occupant's head and chest. The pilot's pelvis experienced vertical (z) accelerations of approximately 40 g for the baseline test, while experiencing only 10 g in the test which did include the DEA. The test which included the DEA also attenuated the pilot's horizontal accelerations by a factor of two. The head, chest and pelvic results all show an attenuation of between 2 and 4 for vertical accelerations and approximately 2 for horizontal accelerations for the occupant representing the pilot of the helicopter. The other occupant acceleration time history results showed similar trends with similar magnitudes and, for brevity, are not shown. However, the occupant lumbar load values for all three occupants containing a lumbar load cell were examined. Lumbar load responses are reported in Figure 18.

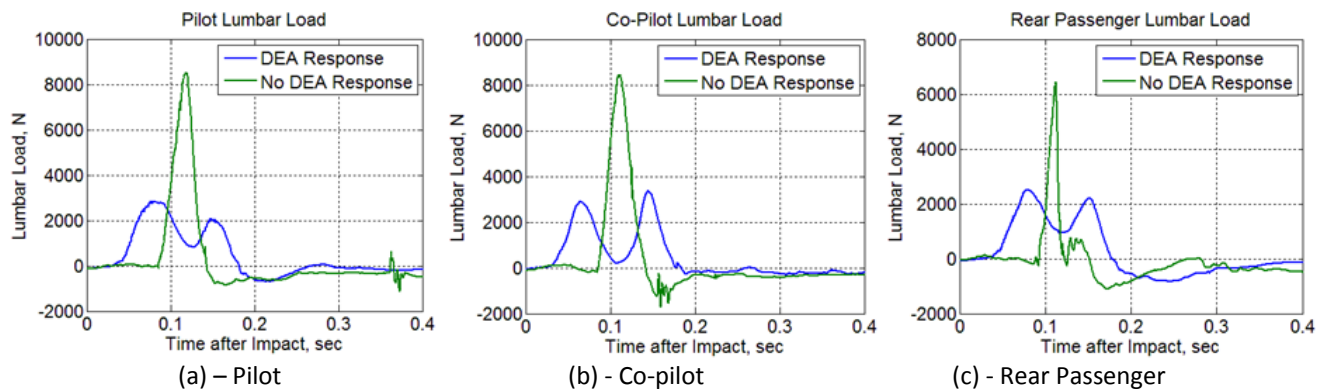
Fig. 18 Lumbar loads

The pilot and co-pilot's compressive lumbar loads reached similar magnitudes and durations for each test, presumably because they were seated in similar mesh bucket seats. The rear passenger's time history is slightly different due to its position on a bench seat. Comparing results between tests, the compressive lumbar load values were approximately 3860, 3372, and 2518 N (643, 758, and 566 lb) for the pilot, co-pilot and rear passenger, respectively, during the test which included the DEA; and 8536, 8461, and 6445 N (1919, 1902, and 1449 lb) for the pilot, co-pilot and rear passenger respectively for the test which did not include the DEA. The data was filtered using SAE CFC 600 with accordance to SAE J211 [16]. When evaluating potential for injury, FAR Part 27.562 (c) [17] establishes a lumbar limit of 6,672 N (1,500 lb) as being injurious. The loads incurred in the occupants were well below this limit for the test which included the DEA, but were over the limit for the front occupants for the test which did not include the DEA. This result indicated that, when examining the lumbar load data, the DEA protected the occupant sufficiently enough to avoid injury.
