# 47th AIAA/ASME/SAE/ASEE Joint Propulsion Conference & Exhibit

## Lessons Learned from the Space Shuttle Engine Hydrogen Flow Control Valve Poppet Breakage

Abstract authored by Hugo E. Martinez, in collaboration with John Albright, Stephen Damico, and John Brewer of NASA's Johnson Space Center, Engineering (EP4)

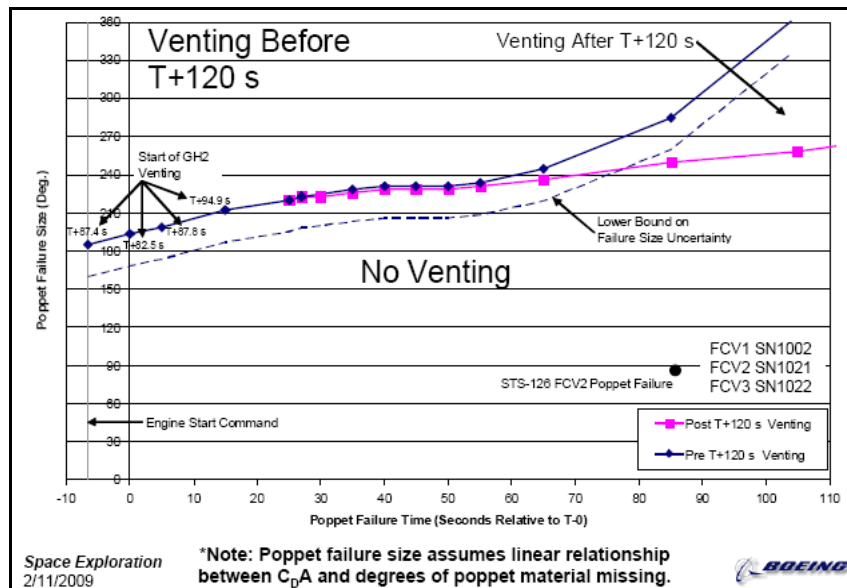
The ET pressure prediction model was used to determine the size of poppet circumference break needed to produce venting earlier than 120 seconds. This tool is used every flight to perform ET pressure predictions. STS-126 pressure profile after the poppet was broken was used to calculate the discharge coefficient ( $C_D$ ) of a broken poppet. That  $C_D$  was then used to calculate mass flow rate for any size poppet break. A parametric analysis was then run for one single poppet failure, varying the size of the poppet break and the time during flight that the poppet failed. From that data the chart in Figure X was developed showing the size of the poppet break as a function of mission elapsed time necessary to produce relief valve cracking prior to 120 seconds from lift-off. Fig. X shows that a poppet break of 150 to 180 degrees or larger would produce tank venting if it happened prior to 30 seconds into flight. After approximately 30 seconds single poppet breaks greater than 220 degrees would be required to produce venting.

**Figure X: Risk assessment analysis for overboard GH2 venting during first 120 sec of flight resulting from poppet failures given failure size and time of occurrence.**

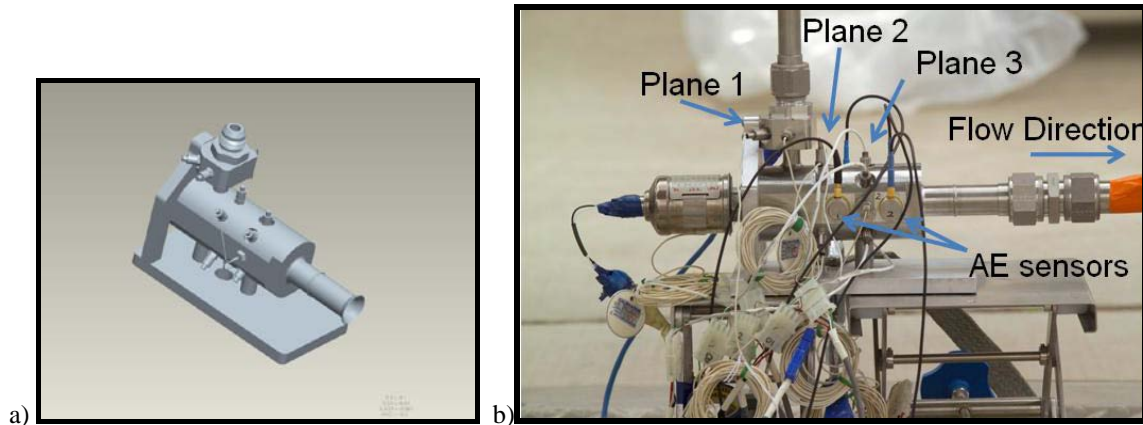
The solution was to build a ‘battleship’ FCV housing, see figure X. This housing was machined to match the current configuration FCV housing and outlet tube. The added thickness allowed each measurement to be custom fitted into the housing and sit flush with the flow stream.

**Figure X– a) Battleship test fixture design model, b) Battleship test fixture shown with the three instrumented planes. Also shown are the acoustic emission sensors mounted on the flat side of the battleship. NOTE: 2 more acoustic emission (AE) sensors are mounted on the other side of the Battleship that mirror the ones shown.**

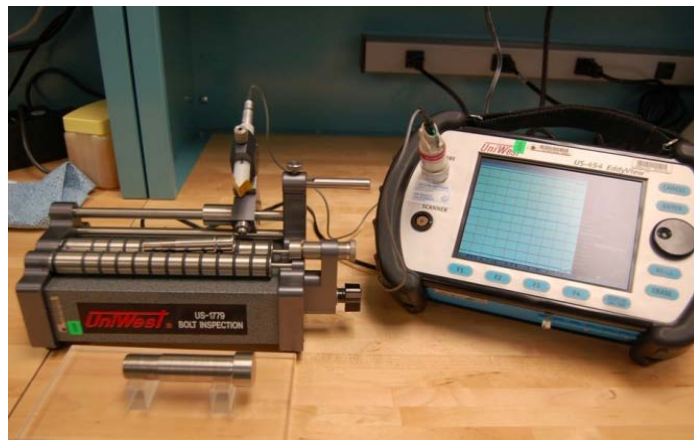
Following the STS-126 failure, other techniques were considered. Not having a clear understanding of the environment that drove the failure, and not having a forward fracture analysis, a critical crack size could not be determined. For this reason, a technique that could reliably detect the smallest crack size was desired. Borescope was known to be very limited as an inspection technique, but could be performed without removing the valve from the vehicle. During development of the x-ray imaging technique used on the failed FCV right after STS-126 landed, it was shown that, while it was possible to detect a broken poppet via high powered x-rays, the resolution for detection of small cracks did not exist. Computed Tomography (CT) on the fully assembled FCV component could detect a broken poppet more easily, but again it suffered from the inability to detect small cracks. Thus, it was concluded that disassembly of the valve was required in order to inspect for small cracks.

**Figure X:** Eddy Current Inspection tool
