Failure Investigation of an Intra-Manifold Explosion in a Horizontally-Mounted 870 lbf Reaction Control Thruster

Joseph G. Durning III¹ and Shayne C. Westover²
NASA Johnson Space Center, Houston, TX, 77058

Darren M. Cone³
NASA White Sands Test Facility, Las Cruces, NM, 88012

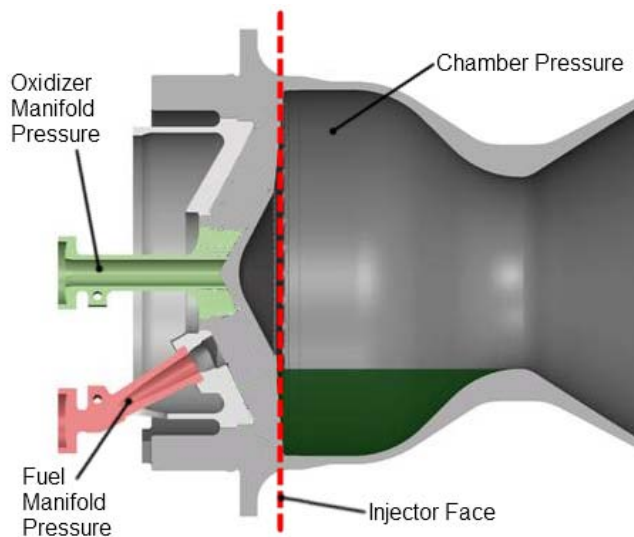
The “Chamber Pressure” measurement represents the pressure within the combustion chamber of the thruster as a result of the hypergolic propellant reaction. The “Fuel Manifold” and “Oxidizer Manifold” measurements represent the respective propellant fluid pressures in the distribution lines immediately upstream of the propellant isolation valves located on the thruster. The chamber pressure measurement is taken downstream of the thruster injector face while the fuel and oxidizer manifold pressure measurements are taken upstream of the thruster injector face. The thruster injector face therefore provides a pressure boundary between the chamber and the propellant manifolds such that dynamic response of the system can be identified by interpreting the propellant pressure and chamber pressure responses. Figure 8 illustrates the notional locations of the pressure measurements with respect to the injector face.

Figure 8. Cross sectional view of thruster L1L with pressure measurement locations annotated relative to the injector face.
