Lessons Learned from the Space Shuttle Engine Cutoff System (ECO) Anomalies

The Space Shuttle Orbiter's main engine cutoff (ECO) system first failed ground checkout in April, 2005 during a first tanking test prior to Return-to-Flight. Despite significant troubleshooting and investigative efforts that followed, the root cause could not be found and intermittent anomalies continued to plague the Program. By implementing hardware upgrades, enhancing monitoring capability, and relaxing the launch rules, the Shuttle fleet was allowed to continue flying in spite of these unexplained failures. Root cause was finally determined following the launch attempts of STS-122 in December, 2007 when the anomalies repeated, which allowed drag-on instrumentation to pinpoint the fault (the ET feedthrough connector). The suspect hardware was removed and provided additional evidence towards root cause determination. Corrective action was implemented and the system has performed successfully since then.

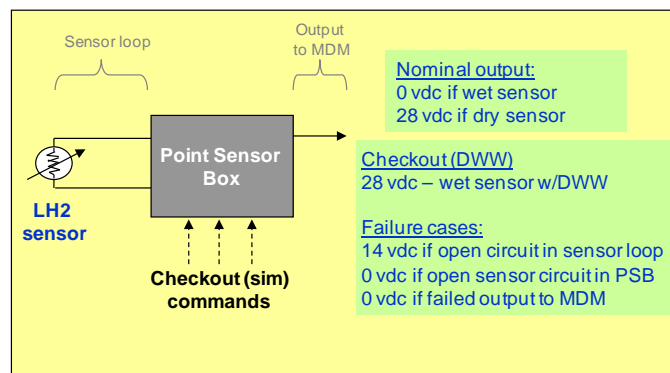
A WET state is also indicated should the PSB electronics fail to provide an output signal, or if an open circuit in the circuit between the PSB and the sensor develops. To help distinguish between a WET sensor output and a failed WET output, the box design includes self-check electronics which are activated by ground "sim" commanding (see Figure 3). The descriptive "dry when wet", or DWW sim command, provides a supplemental voltage that exceeds the box's trip level in order to override a WET condition. This ground checkout procedure has historically been conducted as a "snapshot" in time, typically over one minute, and only once propellants are loaded and in stable replenish. For this reason, the STS-114 and STS-115 ECO failures may have

Figure 3. Expected outputs for various scenarios

occurred much earlier than reported. (In fact, later usage on continuous DWW sim commands indicated that most failures were occurring hours earlier as the ET feedthrough connector was becoming wetted.)
