# Selected Lessons Learned in Space Shuttle Orbiter Propulsion and Power Subsystems

NASA/Johnson Space Center, Houston, TX 77058

Over its 30 years of space flight history, plus the nearly 10 years of design, development test and evaluation, the Space Shuttle Orbiter is full of lessons learned in all of its numerous and complex subsystems. In the current paper, only selected lessons learned in the areas of the Orbiter propulsion and power subsystems will be described. The particular Orbiter subsystems include: Auxiliary Power Unit (APU), Hydraulics and Water Spray Boiler (WSB), Mechanical Flight Controls, Main Propulsion System (MPS), Fuel Cells and Power Reactant and Storage Devices (PRSD), Orbital Maneuvering System (OMS), Reaction Control System (RCS), Electrical Power Distribution (EPDC), electrical wiring and pyrotechnics. Given the complexity and extensive history of each of these subsystems, and the limited scope of this paper, it is impossible to include most of the lessons learned; instead the attempt will be to present a selected few or “key” lessons, in the judgment of the authors. Each subsystem is presented separate, beginning with an overview of the hardware and thei

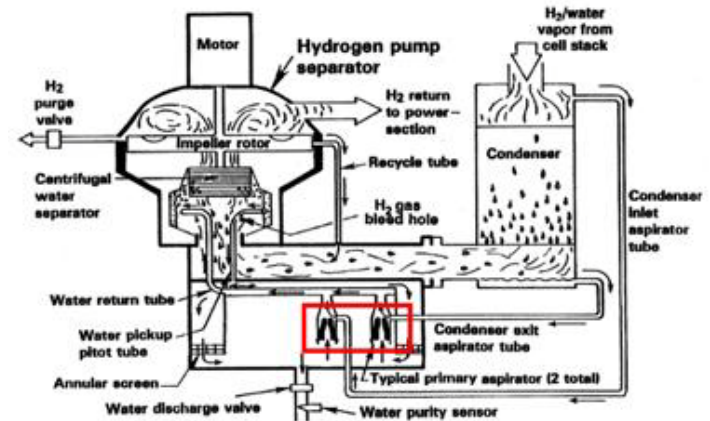
- STS-2 FC1 shutdown following H<sub>2</sub> pump/water separator failure and FC flooding.
  - ☀ Bus-tying the suspicious fuel cell with a healthy fuel cell is the method for monitoring performance of the suspect fuel cell when one fuel cell picks up the load from another.
  - ☀ For vital systems, redundancy in monitoring the system's health is as important as it is in the system itself.

Fuel Cell Hydrogen Pump Separator; aspirator tubes highlighted in red

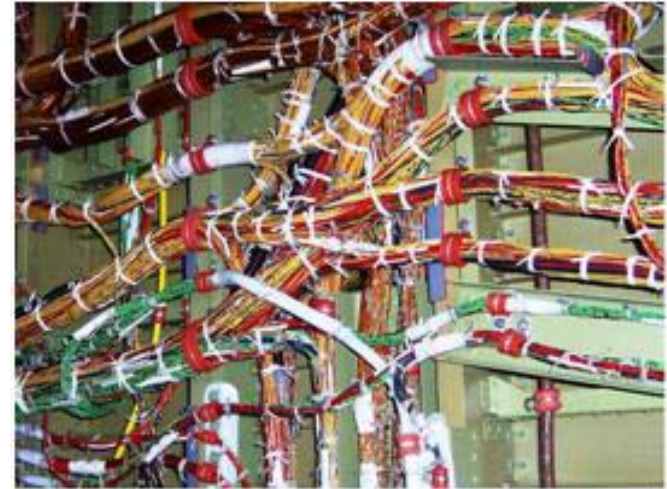
- STS-93 wire short description:
  - Short circuit in the AC system during ascent caused the loss of 2 main engine controllers.
  - Post flight investigation found the cause to be a damaged wire with an exposed conductor that contacted a nearby burred screw head.
  - As a result of the inspections, many other incidents were found of damaged wires and improperly protected wire harness.

- STS-93 wire short (Lessons):
  - ☼ Ground maintenance and vehicle modifications can cause damage like burrs on screw heads that lead to later wire damage.
  - ☼ Closeout inspections did not focus on inspecting the wiring.
    - ☼ Use auxiliary lighting and mirrors to inspect all accessible wiring.
  - ☼ Formalized and more clearly defined wire inspection criteria and processes. Perform periodic wiring inspections; particularly inspect for previously undetected wiring discrepancies.
    - ☼ Any primary wire insulation damage is unacceptable regardless of whether conductor is exposed or not.
  - ☼ Separate critical redundant wire runs and/or install barrier materials to protect against the effects of arc tracking.
  - ☼ Widespread use of chafe protection greatly reduced wire damage.
  - ☼ Enhanced workforce awareness and training is paramount in ensuring the health of electrical wiring.

**Orbiter wiring**

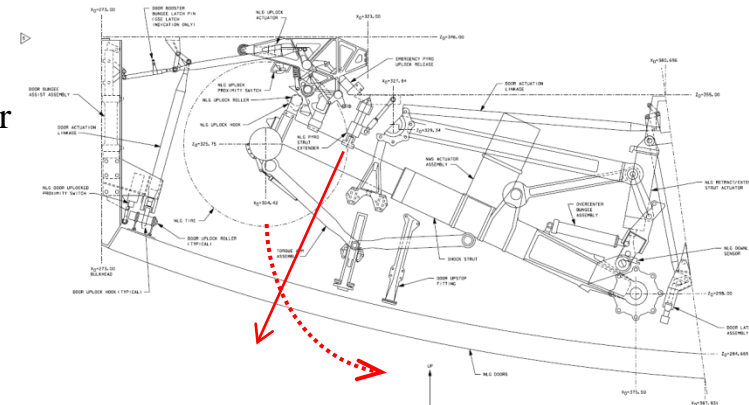
- STS-8 ejected Nose Landing Gear Extension Thruster.
  - ☼ Verify that hardware design and qualification testing account for all potential flight conditions.
  - ☼ Never assume contained air pressure is available as an assist to pyrotechnic performance.

NLG extension thruster and likely trajectory of piston and wheel on STS-8 landing
