# A Case Study on the Failure on Apollo 13

Brenda Lindley Anderson

NASA Marshall Space Flight Center

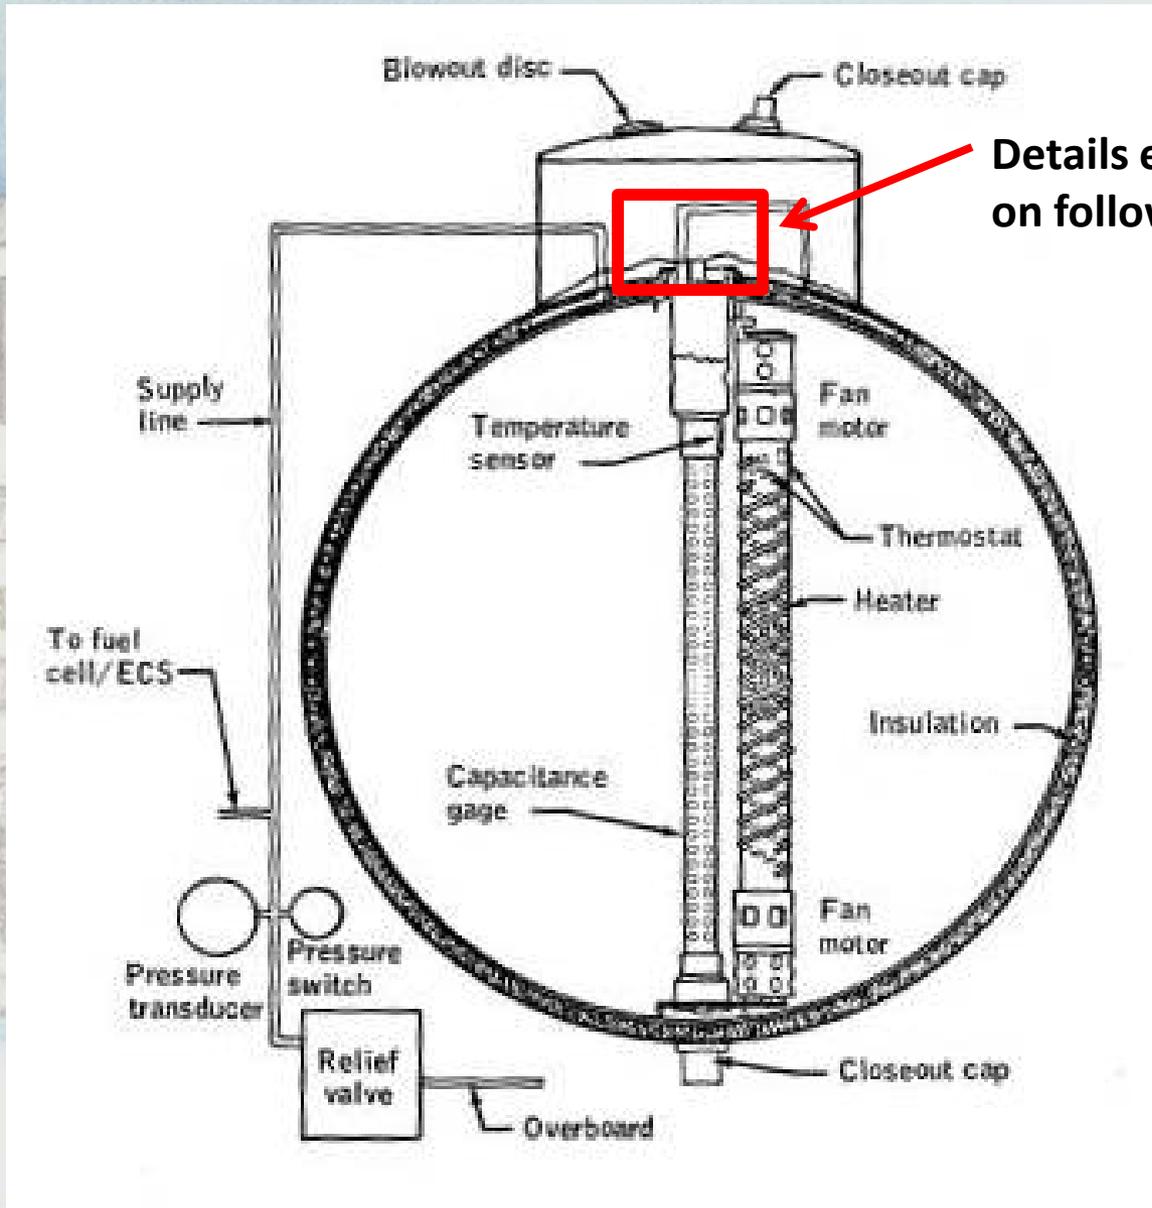
# Apollo Oxygen Tank Assembly

Details expanded on following chart

- Tank #2 was manufactured as two hemispheres and joined. Electrical and fill tubes are inserted. Bolting and wiring occurs through the opening at top.
- Weld porosity was detected and repaired.
- Upper fan motor extracted excessive current and was noisy, leading to replacement.
- Heater assembly tube required replacement, which included new heaters and fans.
